**Specialty Home Inspections
Presents**

**A Home Inspection Report On
14234 Reissen Ln., Houston, TX
Sold by Rosalba Cabrera, Listed By**

Tuesday, July 13, 2021

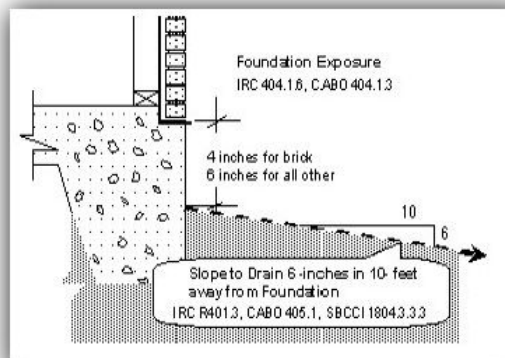
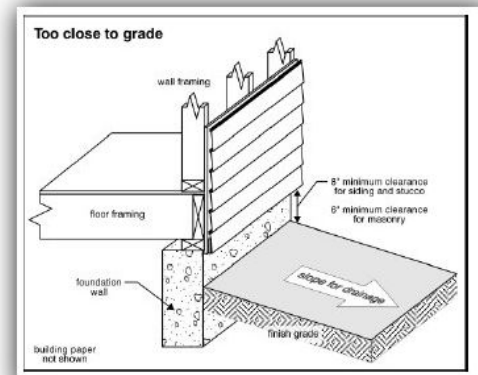
11. The front of the home has a down spout that terminates next to the foundation, needs some flex hose to guide the water away from the foundation.

14. It is recommended to correct the site drains to draw the water on the yard away from the foundation and towards the street as required by code.

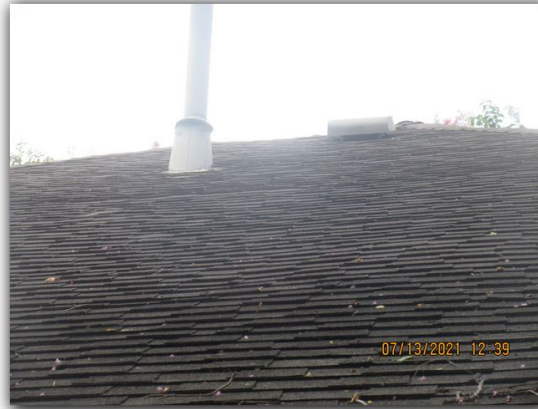
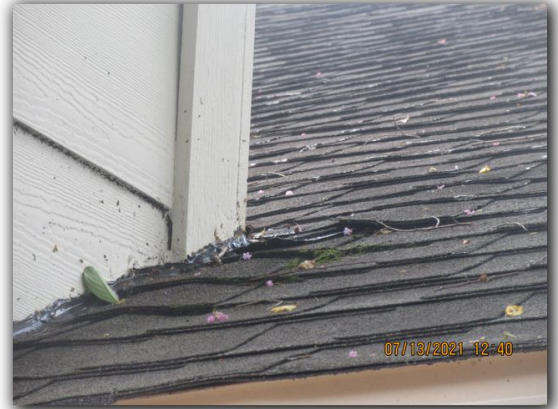
19. The plumbing roof jacks are lead and are in good condition but the base needs to be sealed and secured.

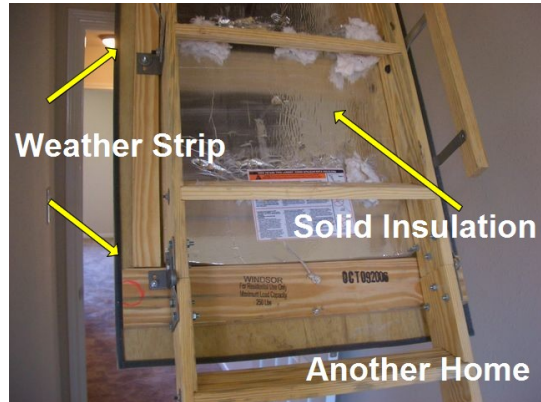
Subject property on the right and it is correct on the left side

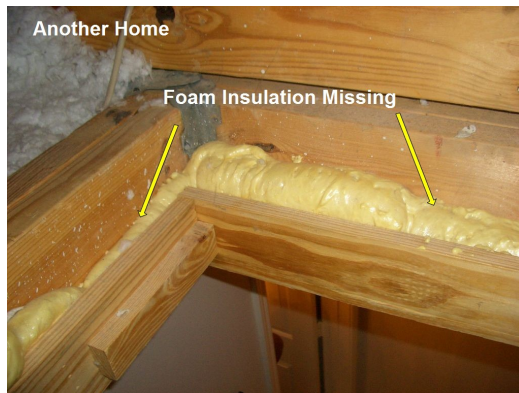
- 28. Missing foam insulation at the perimeter of the attic ladder frame as per code.
- 29. N1102.1.10 Air leakage. All joints, seams, penetrations, window and door assemblies and their respective jambs and framing; and other sources of air leakage (infiltration and exfiltration) through the building thermal envelope shall be caulked, gasketed, weather stripped, wrapped, or otherwise sealed to limit uncontrolled air movement (see photo below)

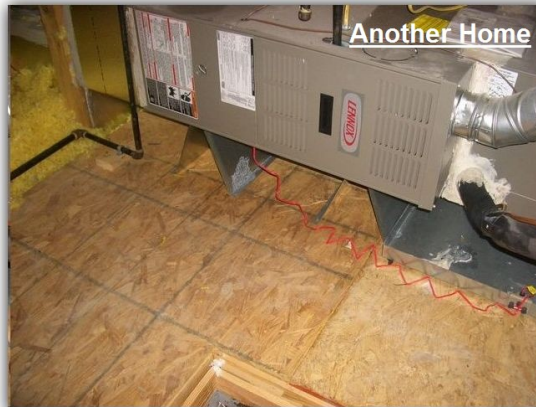
32. Improper decking methods, attic decking must be solid plywood with no obstructions in front of the furnace as per code and as seen on the left lower photo below.

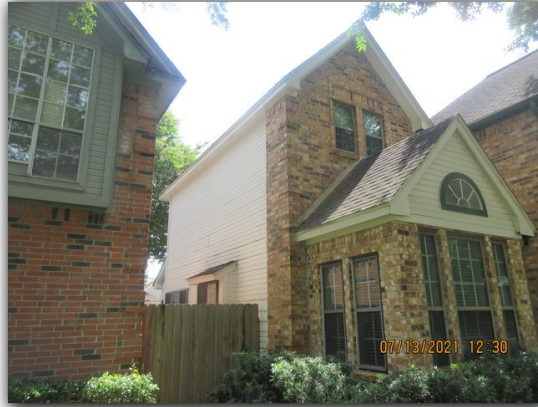
37. There is some minor wood rot at the front elevation at the base of the window on the window sill.

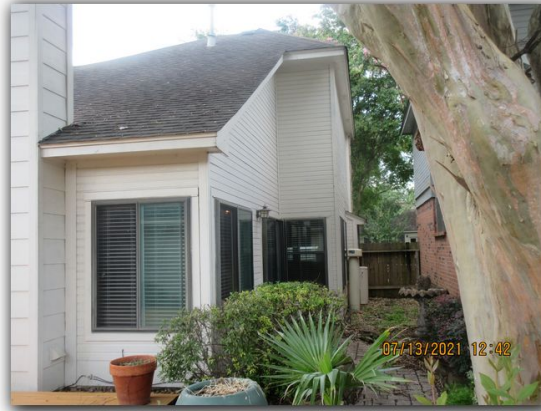
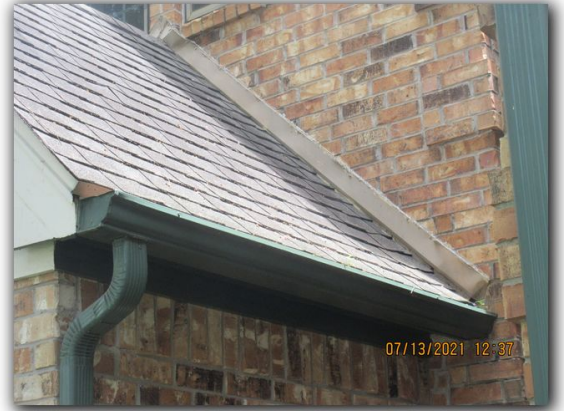
39. Missing metal flashing above arched window trim as per IRC code R-703.8.1.4 & R-703.1

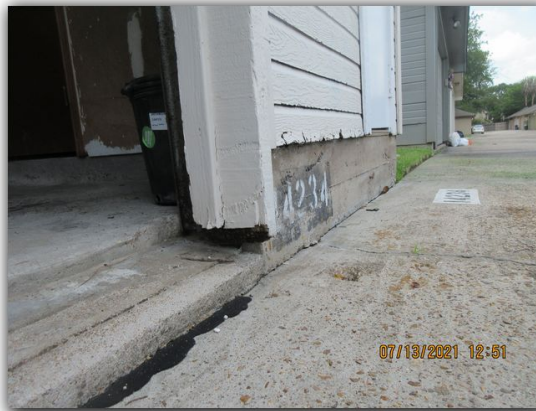
49. Garage door frame wood trim is too close to the ground, must be cut 45 degrees, painted at the base (sealed) and be two inches above the concrete floor to avoid water rot;

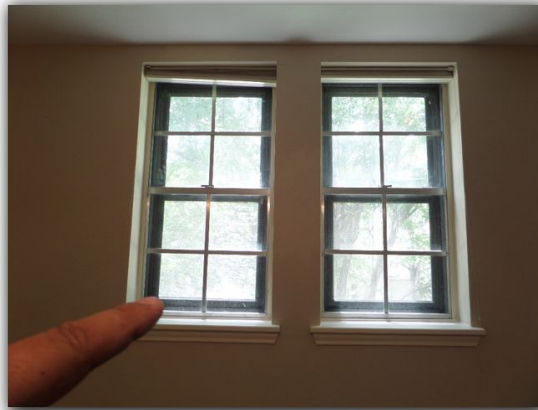
53. The screen as seen below is damaged on the exterior.

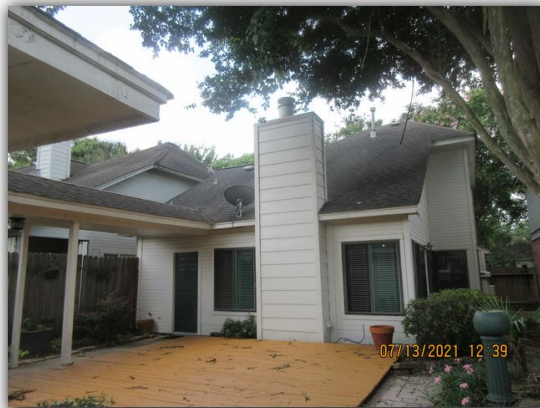
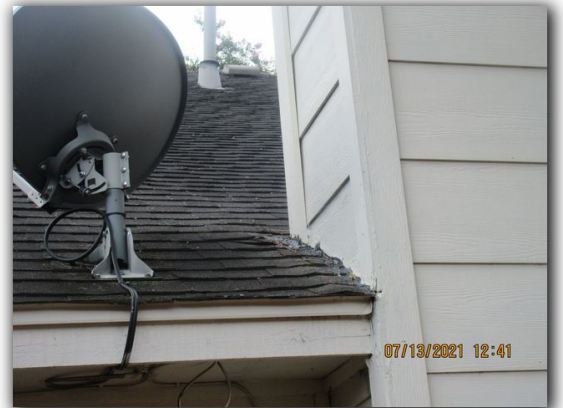
64. Fireplace and chimney must be serviced prior to use.

65. Missing a c-clamp, c-clamp on the damper keeps it open for carbon monoxide

venting, however when the fireplace is not in use such as in the summer, the vent should be closed.

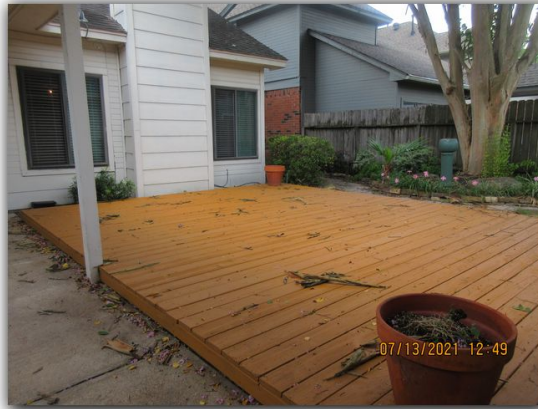
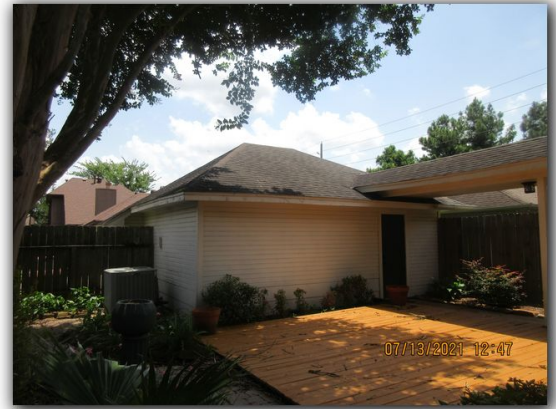
- 69. Breeze way at rear that originates at garage has a penetration in the garage that must be sealed as per code; The penetration must be sealed for fire purposes and to keep varmints from entering into the living area as per code;

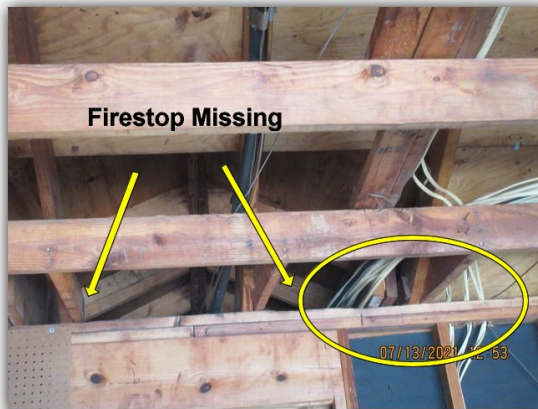
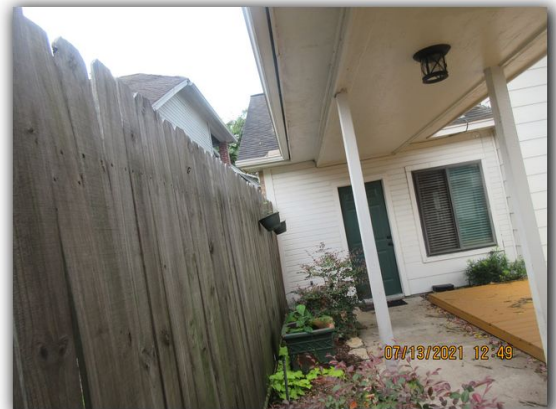
- 70. **E3302.3 Penetrations of firestops and draftstops.** Penetrations through fire blocking and draftstopping shall be protected in an approved manner to maintain the integrity of the element penetrated.

72. Improperly installed wiring method, the romex wires must be separated, not bunched at the breezeway entry point. Bunching wires can cause an increase in heat and cause a fire, a code violation at the draftstop.

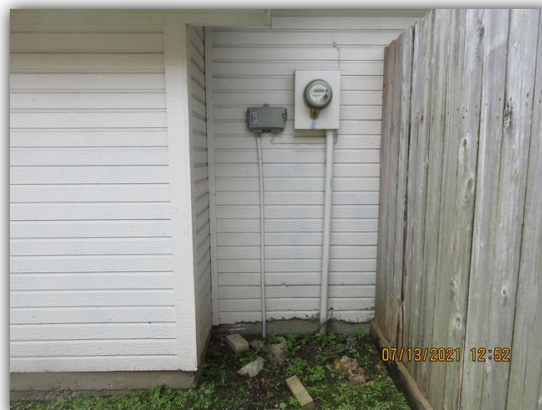
79. The main breaker and service is 100 amps that is adequate for the connected load.

80. Ground wire is not properly secured to the ground rod clamp, it is loose.

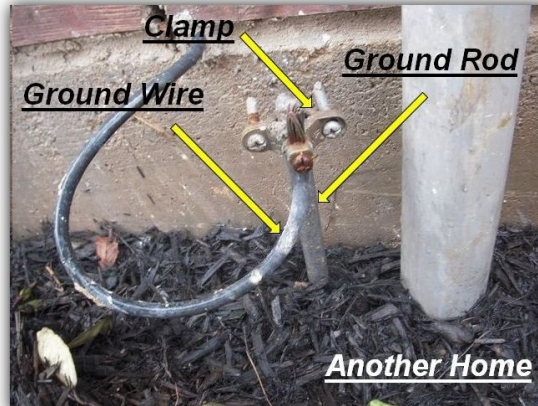
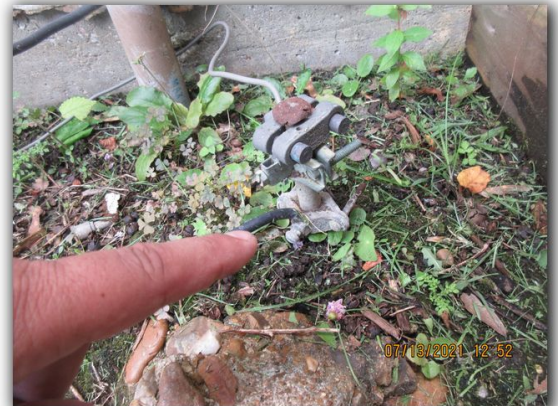
81. Ground rod must be above ground and visible, the ground rod clamp must be visible, the ground rod should extend at least six inches above the ground to be able to inspect and maintain the ground rod clamp, see photo below of another home with a properly installed ground rod.

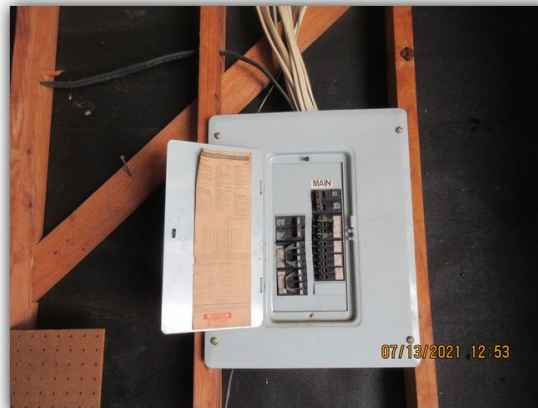
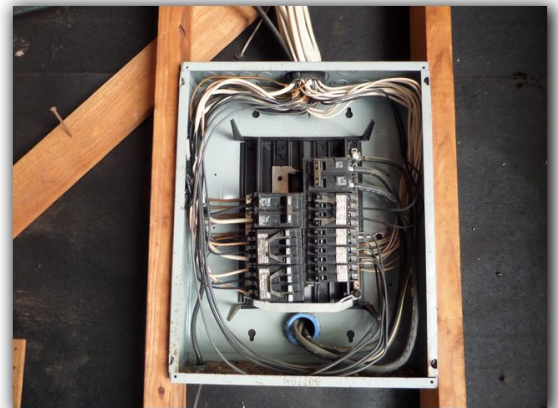
82. Main panel dead front cover is not labeled as per code.

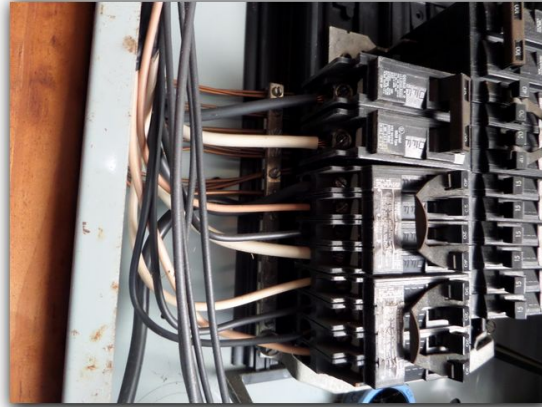
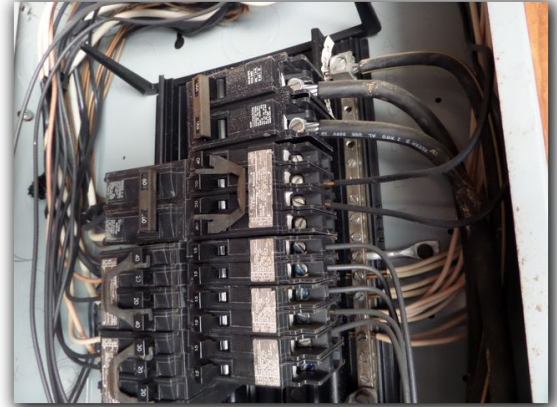
- 84. Missing arc fault interrupters as required by current code of 2008 and newer homes.
- 85. Code IRC 3802.11 requires arc fault interrupters in all circuits going into the living area.
- 86. Home is missing arc fault protection on the GFI's as required by current code.

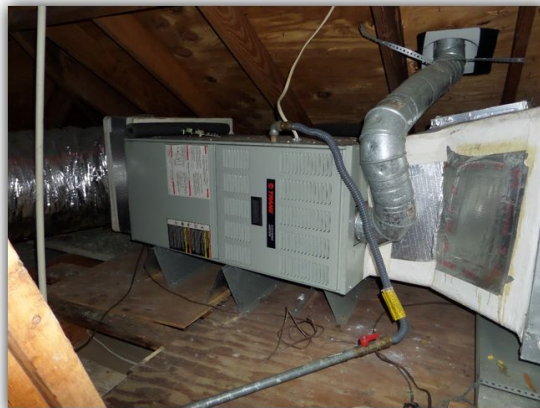
95. Home has a gas furnace located in the attic area.

96. The furnace was not active at the time of the inspection, gas not active.

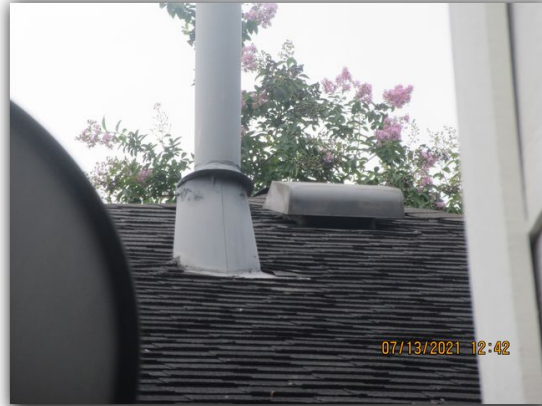
97. The vent pipe is not properly secured to the rafters as per code must have a strap at the beginning of the joint.

98. The vent pipe is a Type B with cap and collar as per code.

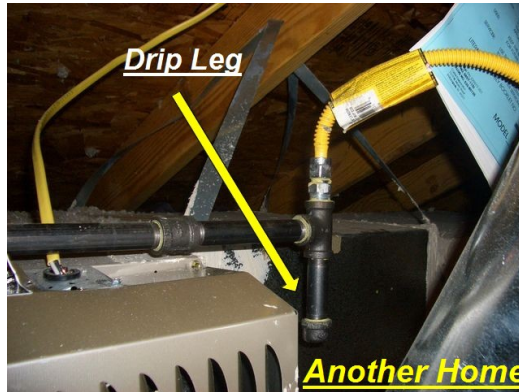
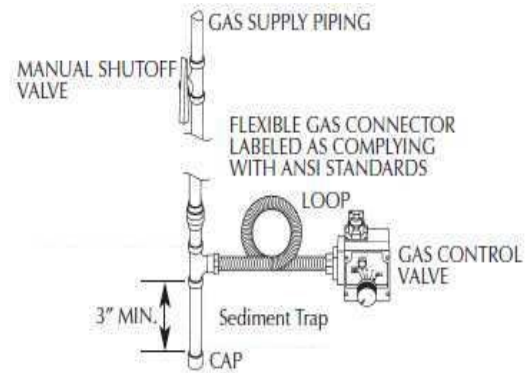
103 Missing a drip leg at the gas connector/gas flex as per code, see photo below of another home with a proper drip leg.

104The gas line was not bonded as per code.

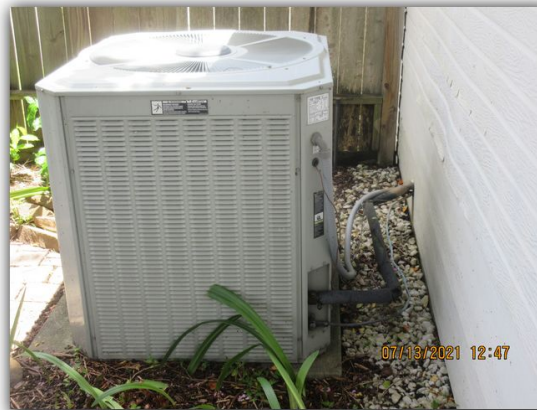
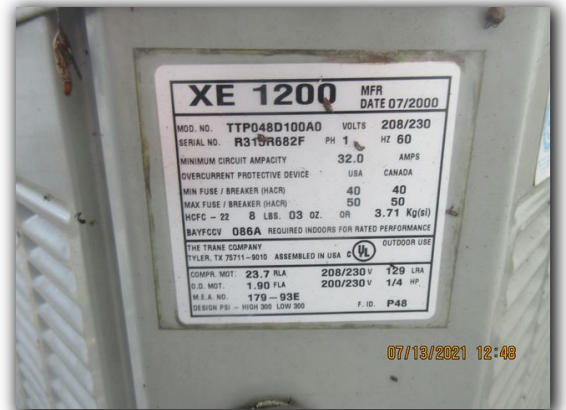
117 The system was active at the time of the inspection.

118 The system was not cooling properly at the time of the inspection.

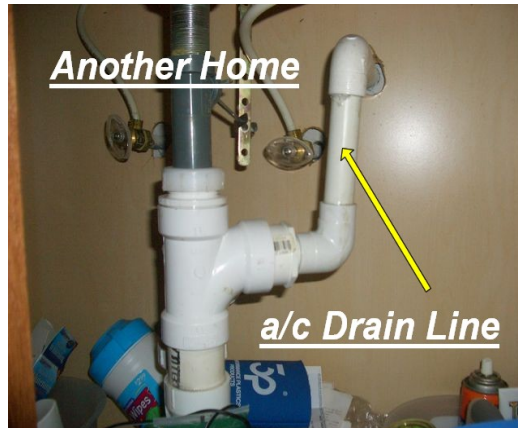
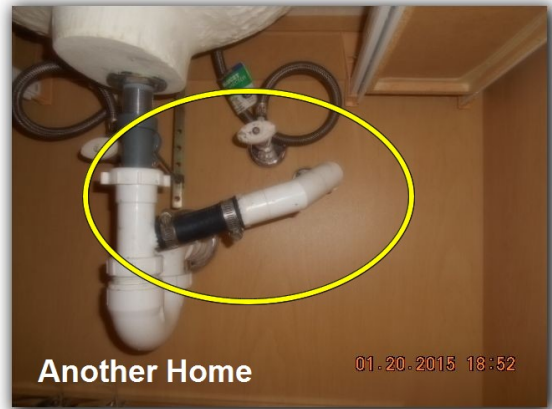
124The main drain line is PVC which is good.

125The primary drain line must be cleared.

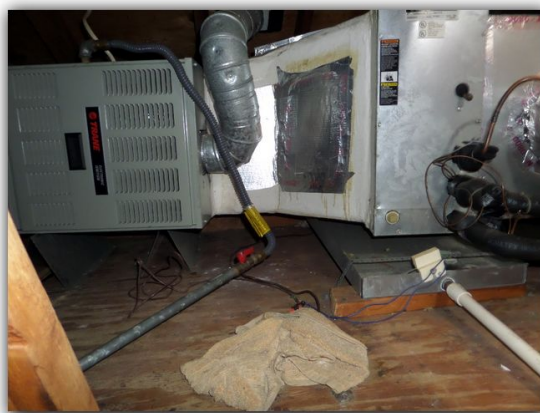
128The drain pan has a secondary drain line connected, termination not confirmed.

129The secondary drain line was viewed at the soffit as per code.

130Note: Termination of the secondary drain line was not confirmed other than that reported above. The secondary drain lines normally run under the attic insulation and the whole run is not viewable.

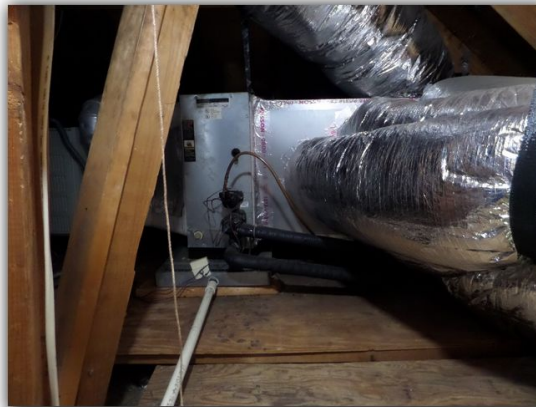
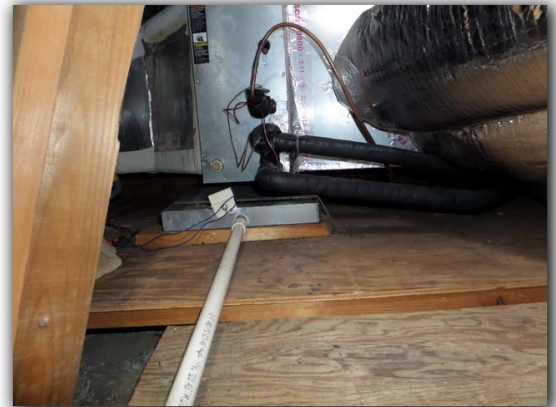
134Ducts must not be in contact with each or lay on top of the joists other or they will create condensation that is prone to mold and mildew issues.

135The ducts must be elevated and supported from the rafters.

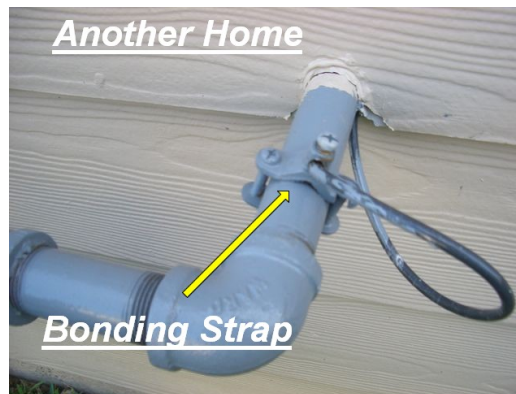
140 Gas meter was not bonded as required by code

141E3509.7 Metal gas piping bonding. Each aboveground portion of a gas piping system upstream from the equipment shutoff valve shall be electrically continuous and bonded to the grounding electrode system.

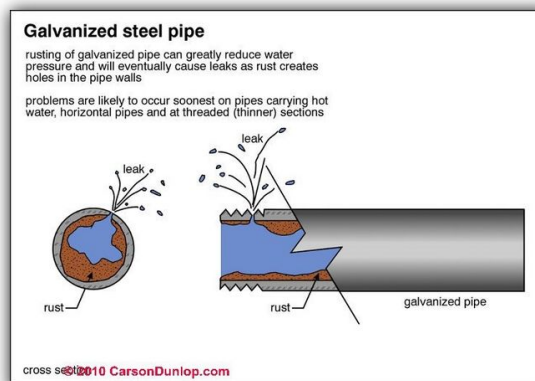
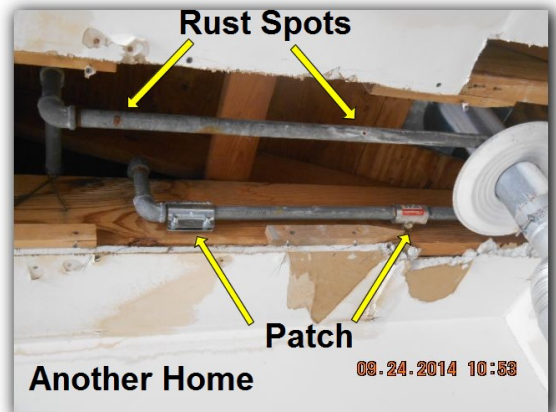
149 Home, as seen at the water heater has CPVC water lines which is good.

151 There is reason to believe due to limited viewing in the attic that the home has

galvanized pipes and part have been replaced with CPVC as the ones below on the water heater.

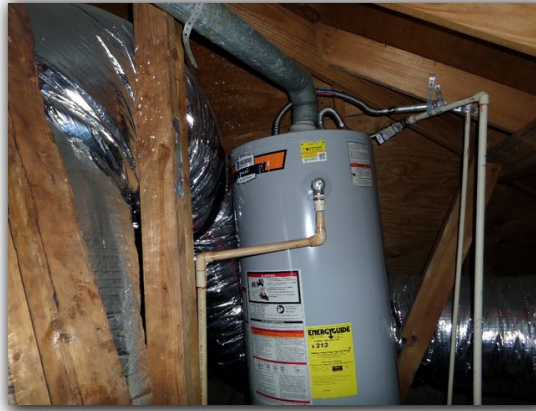
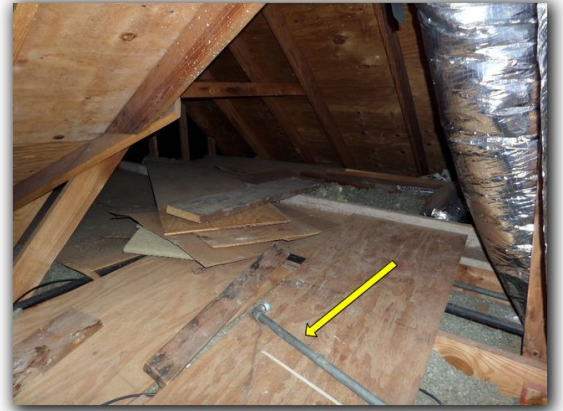
152.If the home has galvanize water lines they should be replaced in the near future before they fail as they are failing all over the U.S. due to age.

153.It is recommended that a PEX water supply system be considered a qualified plumbing contractor should be consulted to determine the scope of work and cost of the replacement.

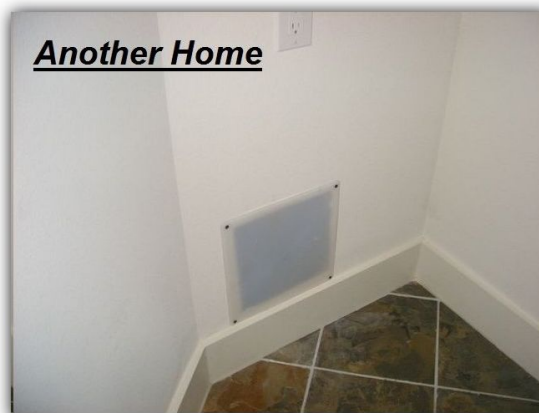
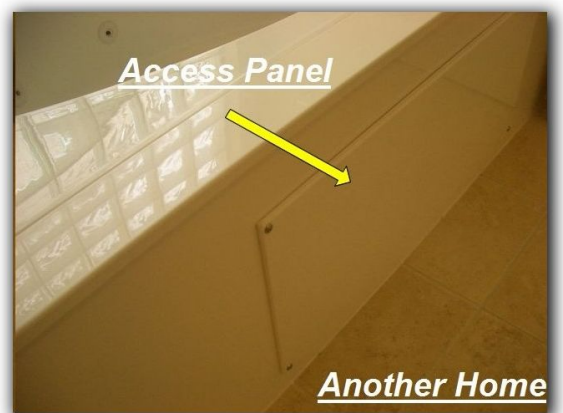
164Missing tub access panel at sheet rock wall as required by IRC code P-2704.1.

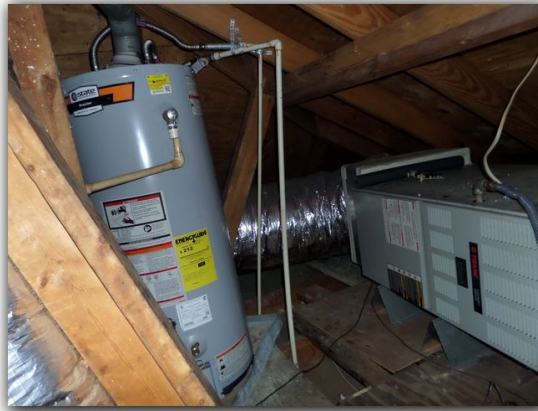
166The water heater is gas and was not active at the time of the inspection.

167The burner cover at the base needs to be properly secured.

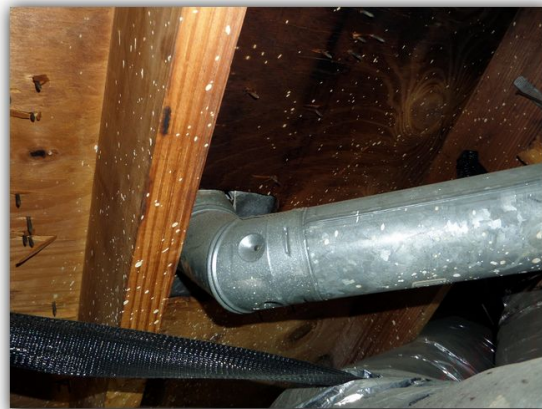
168The vent pipe is not properly secured to the rafters as per code.

169The vent pipe must not be in contact with the wood supports.

170The vent pipe must have a strap on each joint as per code.

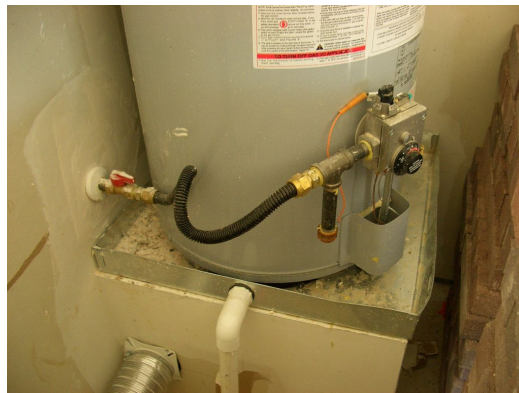
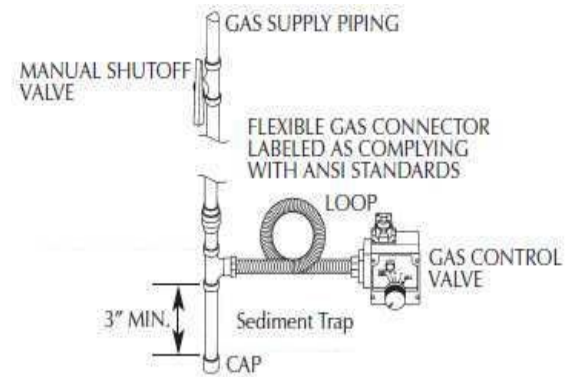
178The hot and cold water lines were not bonded to the gas line as per code

179E3509.6 Metal water piping bonding. The interior metal water piping system shall be bonded to the service equipment enclosure, the grounded conductor at the service, the grounding electrode conductor where of sufficient size, or to the one or more rounding electrodes used. The bonding jumper shall be sized in accordance with Table E3503.1. The points of attachment of the bonding jumper(s) shall be accessible.

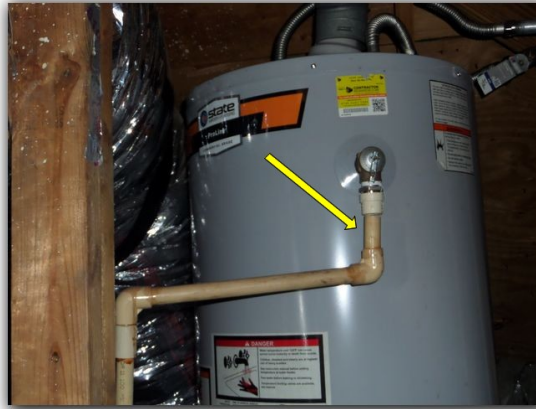
182 The PVC drain line at the T&P valve needs to be properly inserted into the joint and cemented.

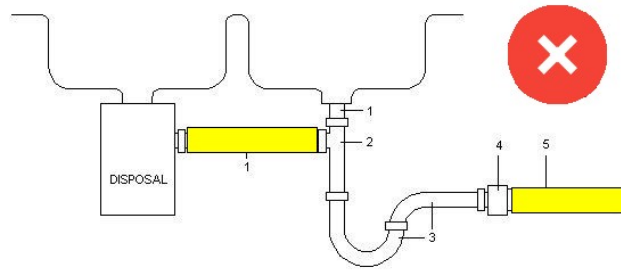
199 This existing drainage arrangement is deficient. As installed the system does not operate as required by code. The problem is with the "end outlet tee", item #2 in the illustration above. Here's what the innards of this part look like:

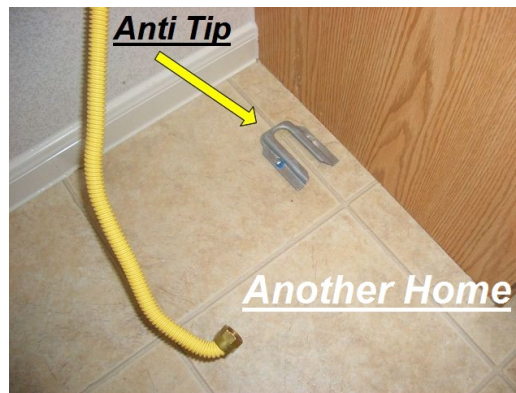
210The Missing an anti tip brace at floor as per code;

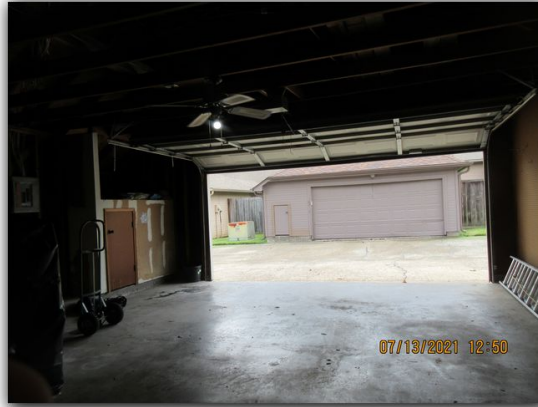
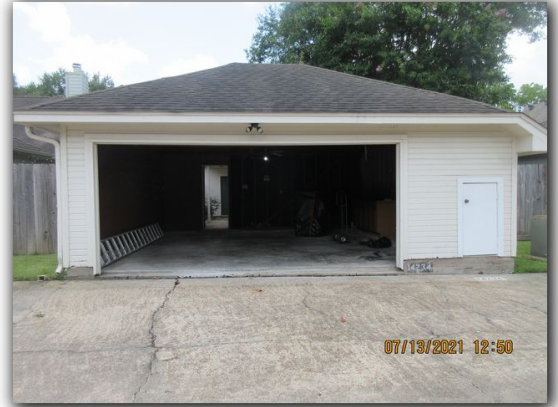
223The garage door opener is missing an auto return mechanism that needs adjustment.

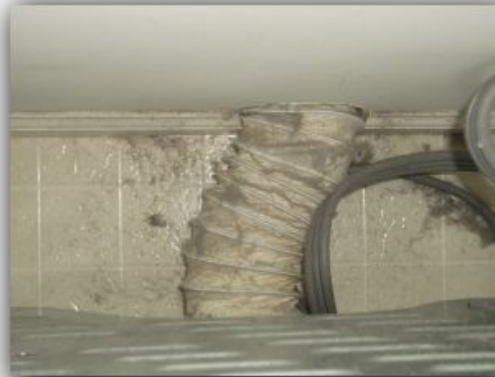
The most commonly seen improper type of dryer vent is flexible vinyl tubing. Vinyl is a type of plastic and it can easily melt and lead to a house fire. This material, most often white and ribbed, tends to allow for lint to readily accumulate. Lint is very flammable and all it takes is a small spark to ignite it leading to a house fire.

The more lint that fills a clothes dryer vent, the more energy the clothes dryer consumes to try to dry the clothes as air won't freely flow through the clogged vent material. This, in turn, causes the drying cycle to be much longer than normal and raises utility bills. The photo below shows an installation of vinyl tubing.

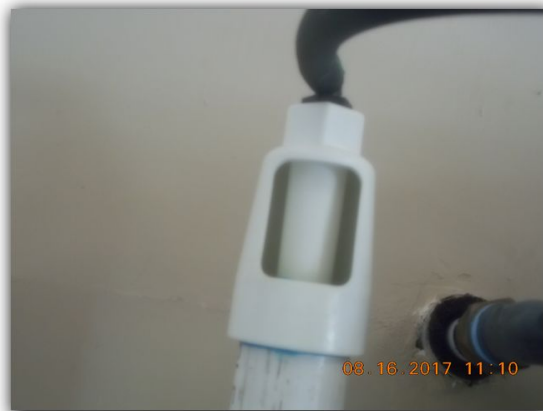
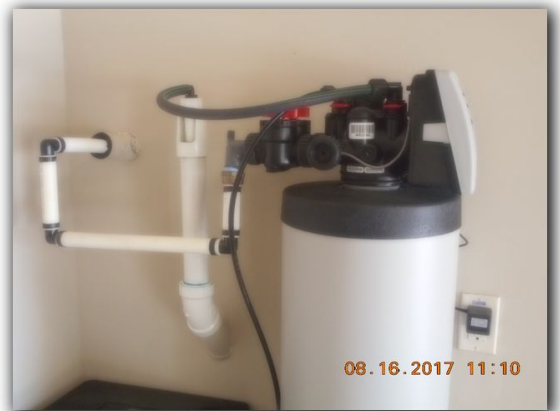
235The drain of the water softener is not properly terminating to the sewage system as per code.

236The drain on the photos below shows a proper air gap as per code.

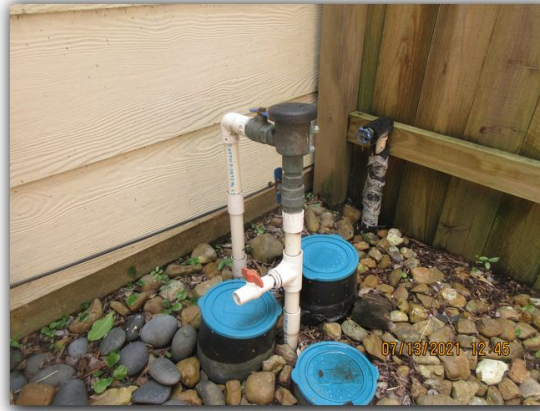
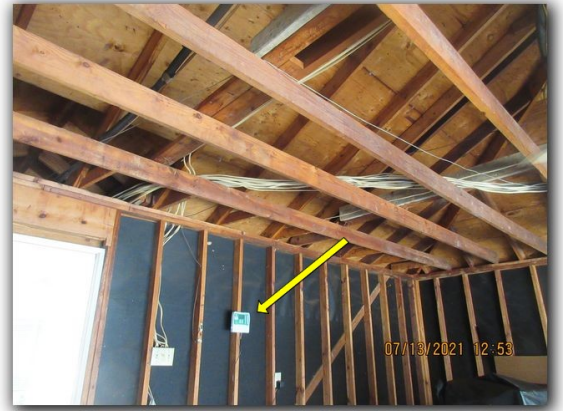
247 The back flow preventer riser is not fully insulated.

248 Control panel must be on a non GFI dedicated receptacle as per code E-3802.2.

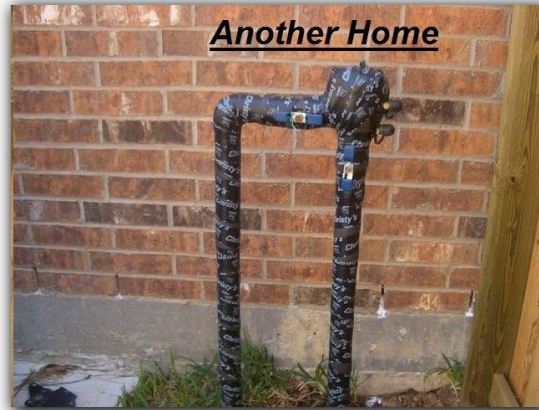
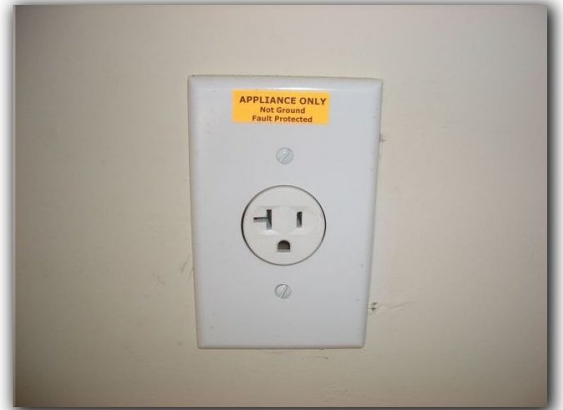
Proper type of receptacle for Sprinkler System Controls as per code

Properly insulated control head and lines

250 This inspector recommends a formal inspection of the sprinkler system by a licensed Irrigation System Inspector for proper installation and coverage of intended areas.
