North Star Inspections, Inc.

**72 Palos Verde
Panorama Village , TX 77304**

PROPERTY INSPECTION REPORT

Concerning: 72 Palos Verde, Panorama Village , TX, 77304
(Address or Other Identification of Inspected Property)

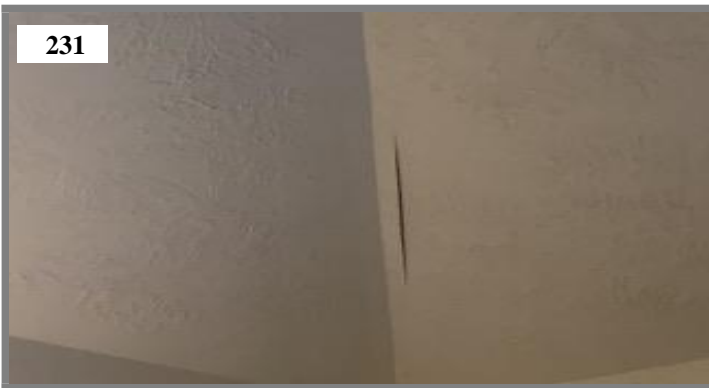
There is a loose drywall seam in the left rear vaulted ceiling .

loose ceiling seam upstairs left
