PROPERTY INSPECTION REPORT

Concerning: 17119 Horseshoe Bend, Waller, TX 77484

By: S. Brad Williams TREC# 23549 / Sunbelt Inspections 5/25/2021

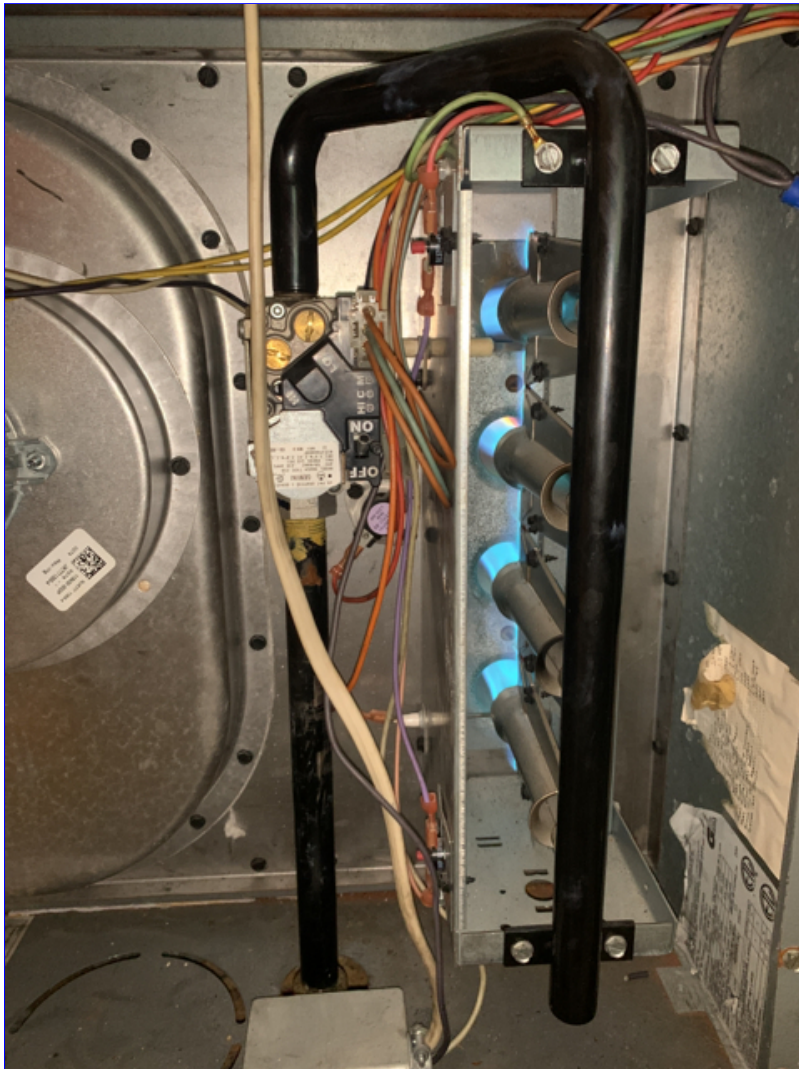
A. Photo 1(Picture) The unit appeared to operate normally using the standard controls. I could not determine if the heat exchanger is cracked or not without dismantling the furnace. Dismantling of components is outside of the scope of a standard home inspection.

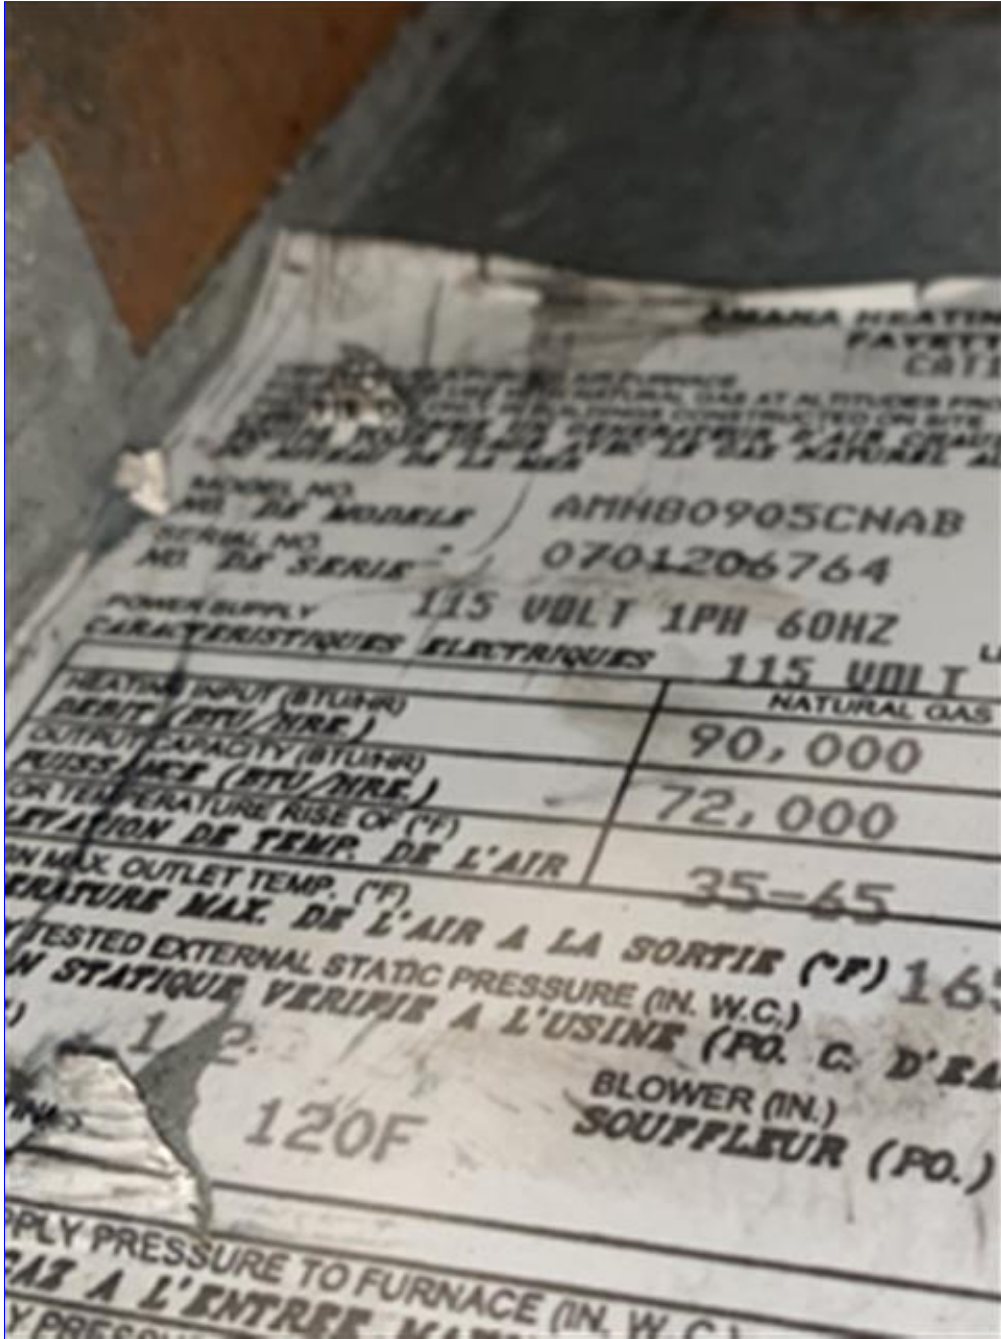
(2) Furnace service tag.

A. Photo 2(Picture) Furnace service tag.

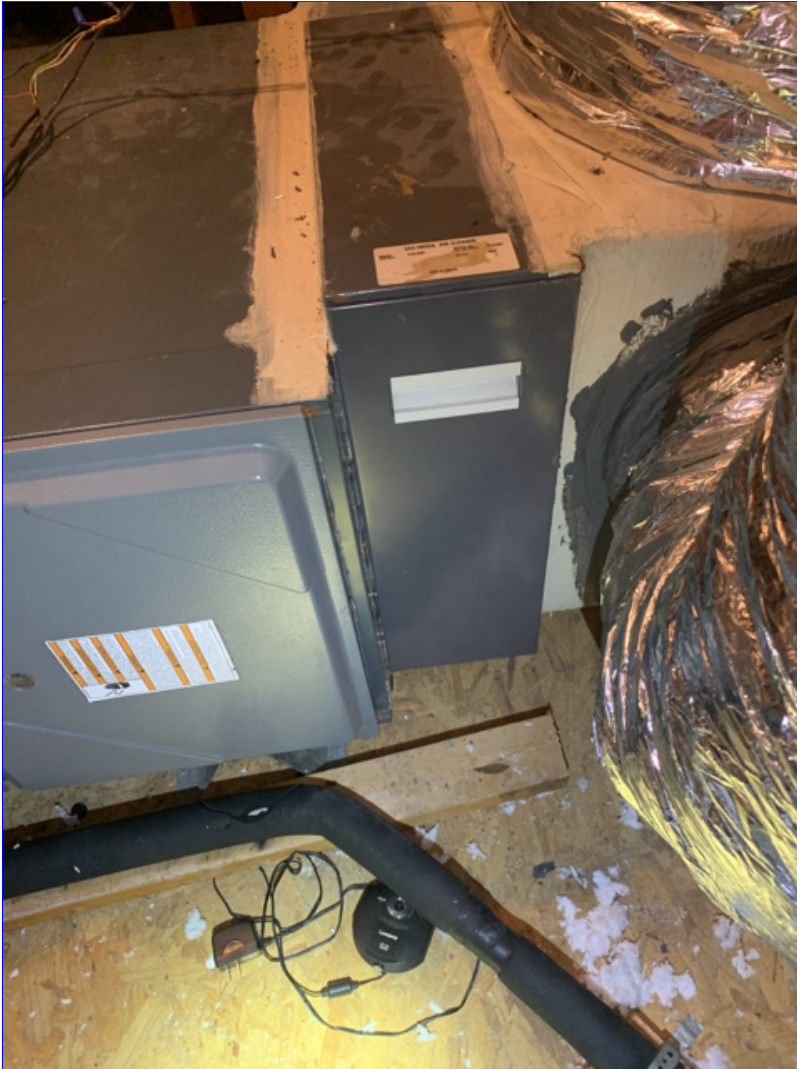
C. Photo 1(Picture) The filter location is in the attic.

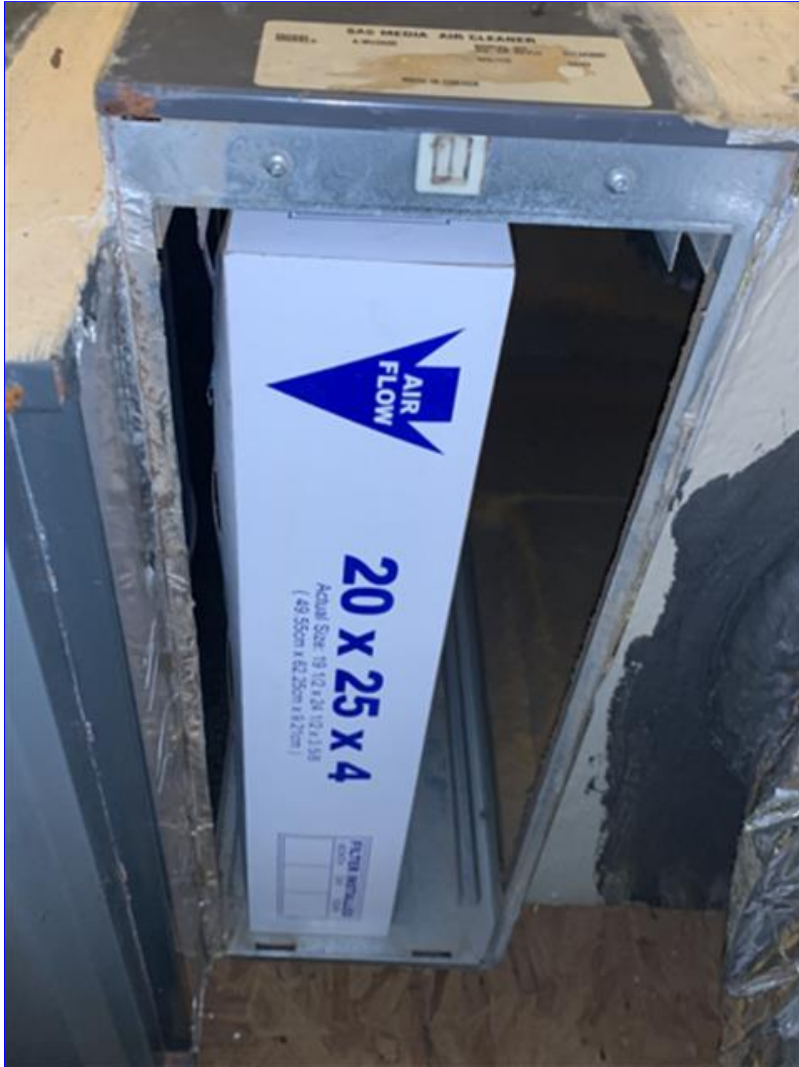
C. Photo 2(Picture) The filter location is in the attic.

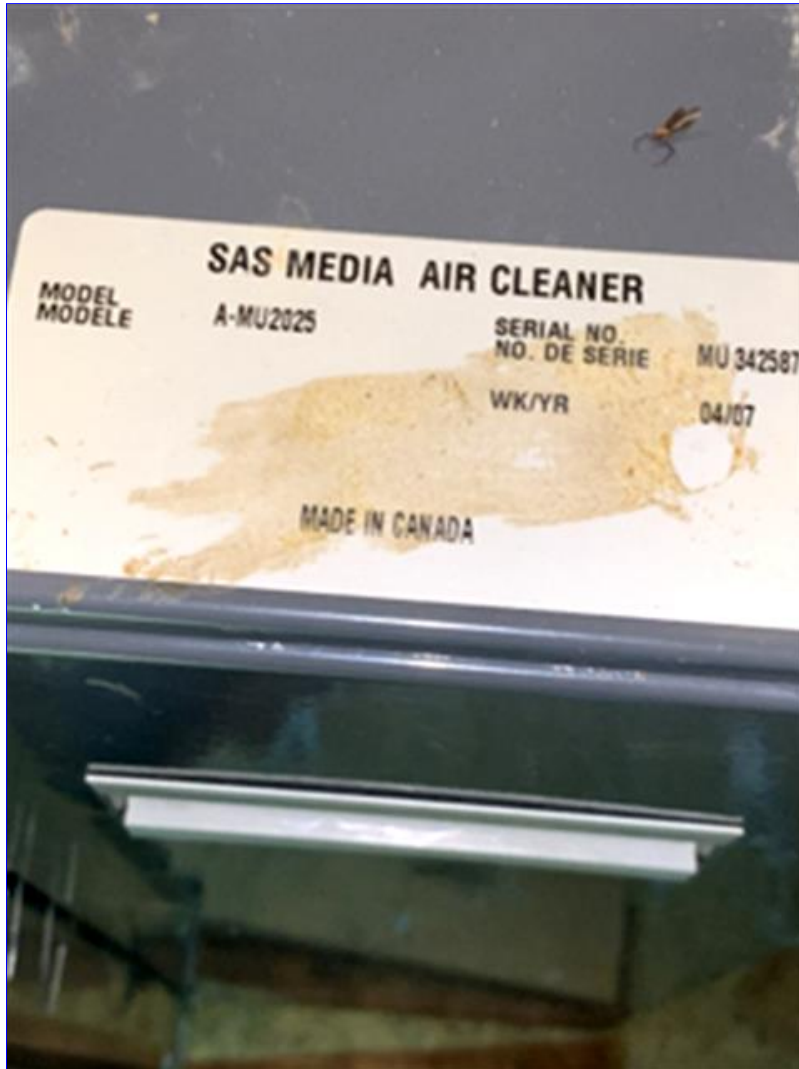
C. Photo 3(Picture) The filter location is in the attic.

(2) The currently installed filter is under-sized. Recommend correction.

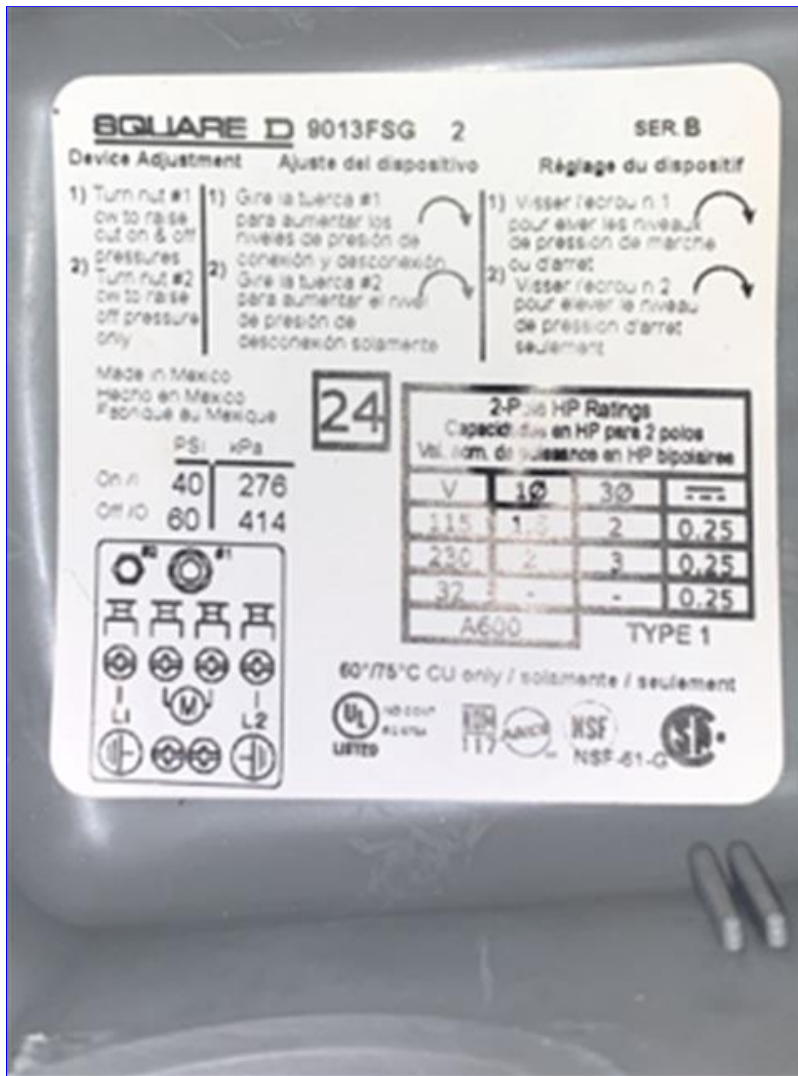
(2) A 40/60 Pressure switch is installed at the pressure tank.

B. Photo 1(Picture) A 40/60 Pressure switch is installed at the pressure tank.
