April 21, 2018

PROPERTY INSPECTION REPORT

Concerning: 2719 Newman St, Houston, TX 77098
(Address or Other Identification of Inspected Property)

By: Brendan Hirshey, Lic #22135 04/21/2018
(Name and License Number of Inspector) (Date)

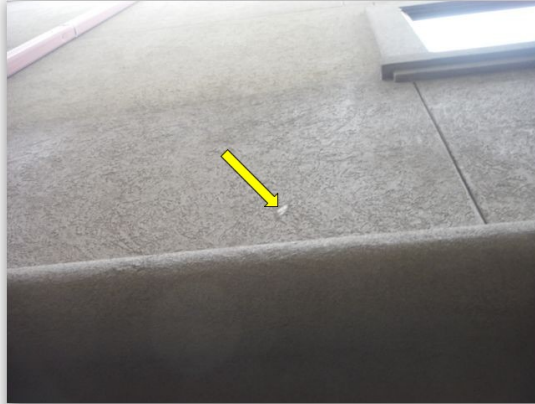
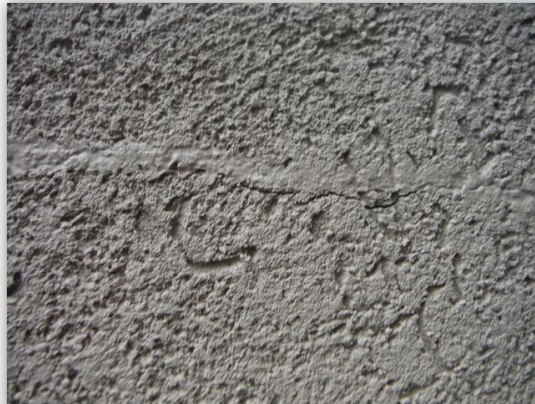
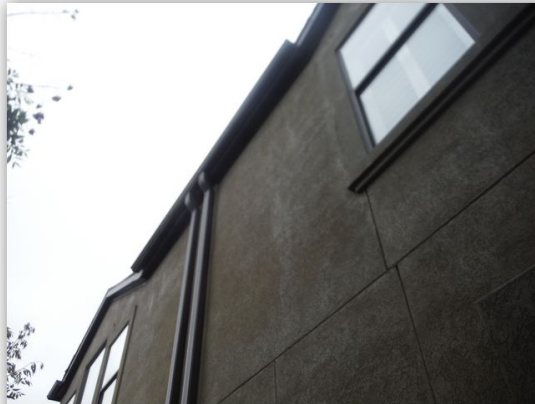
- The exterior stucco type veneer/cladding has inadequate clearance from the finished grade (ground). Most manufacturers require a minimum of 4- to 6-inches of clearance from the finished grade (ground).
- Some discoloration and/or staining of the stucco type veneer/cladding was observed on the west side of the structure.
- Some deterioration and/or damage to the stucco type veneer/cladding was observed on the west side of the structure.

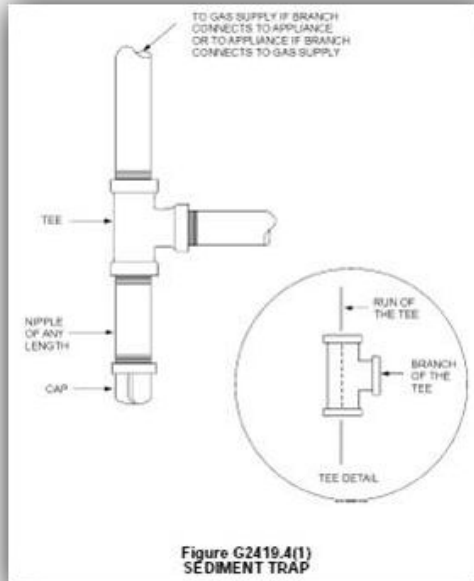
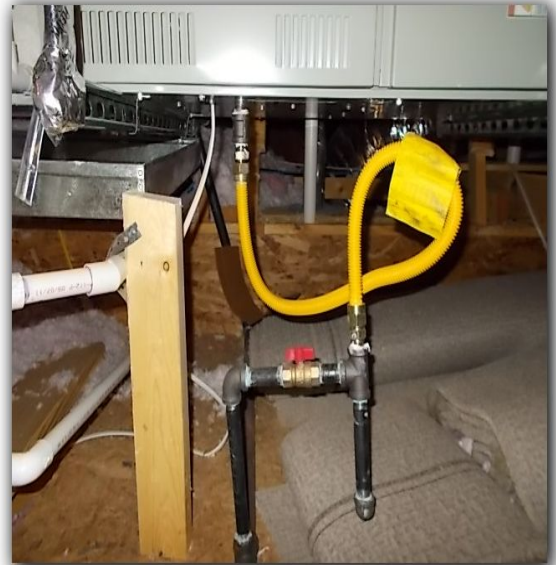
- The heater gas supply line is not equipped with a sediment trap just before the gas appliance connector. This condition does not meet current installation requirements and should be corrected.

Samples of correct sediment trap installation.

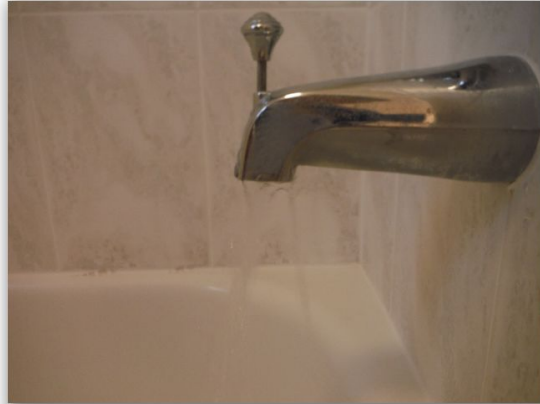
Shower

- The faucet assembly is not sealed at the wall. This condition has the potential to allow water to leak back into the wall cavity.

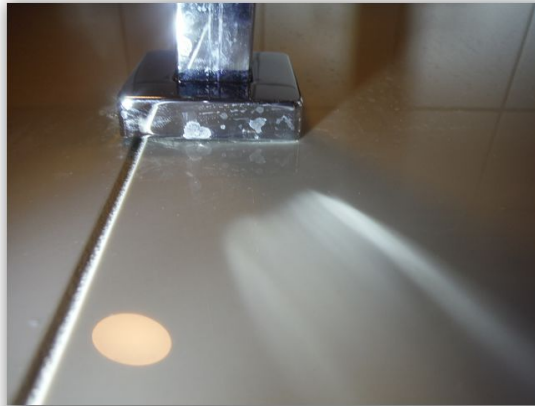
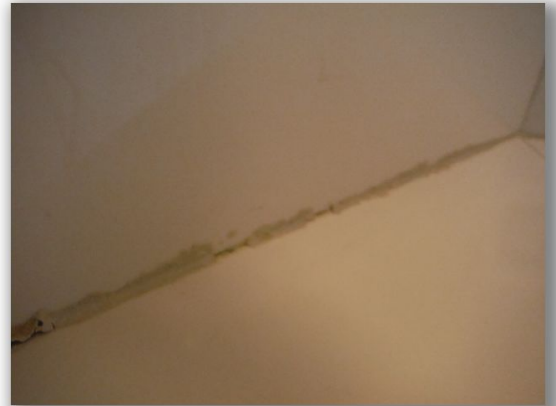
Master Bathroom

Shower

- The faucet assembly is not sealed at the wall. This condition has the potential to allow water to leak back into the wall cavity.
- Cracked, deteriorated and/or missing shower stall grout and/or caulking should be repaired or replaced as necessary.

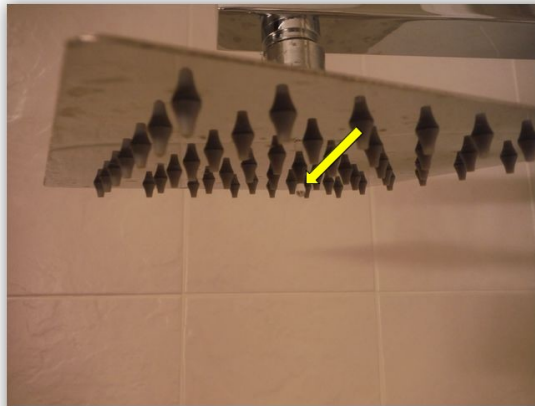
Downstairs Guest Bathroom

Shower

- The faucet assembly is not sealed at the wall. This condition has the potential to allow water to leak back into the wall cavity.
- The faucet has a slow leak when off.
- Cracked, deteriorated and/or missing shower stall grout and/or caulking should be repaired or replaced as necessary.

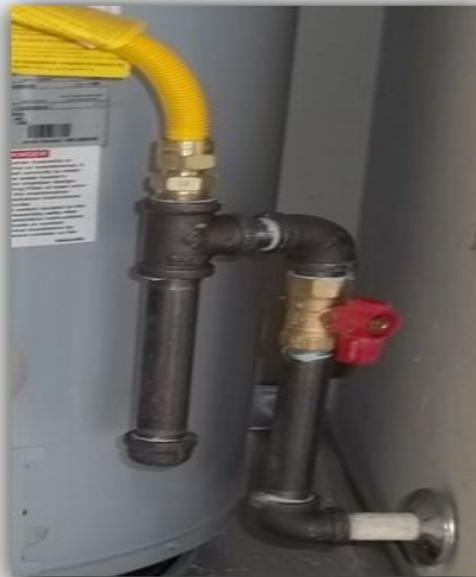
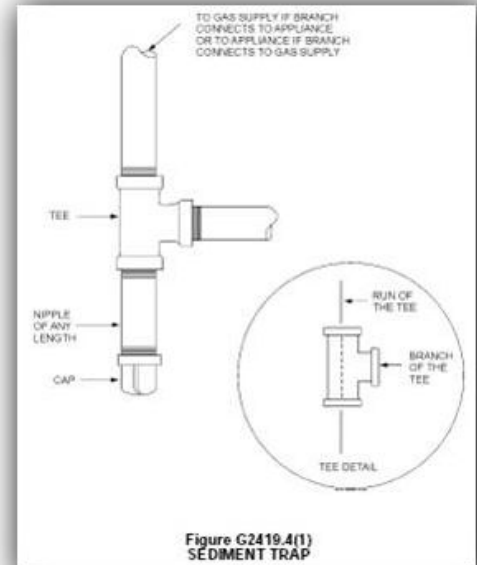
Samples of correct sediment trap installations

- The water heater is making a rumbling noise when operated. This is a good indicator that there is a lot of sediment in the bottom of the water heater tank. Cleaning and servicing is recommended.
- The water heater gas supply line is not equipped with a sediment trap just before the gas appliance connector. This condition does not meet current installation requirements and should be corrected.
- The roof level flue storm collar needs to be properly sealed to help prevent water intrusion into the structure.
- There is a surface damage on the water. This condition needs to be further evaluated and corrected.

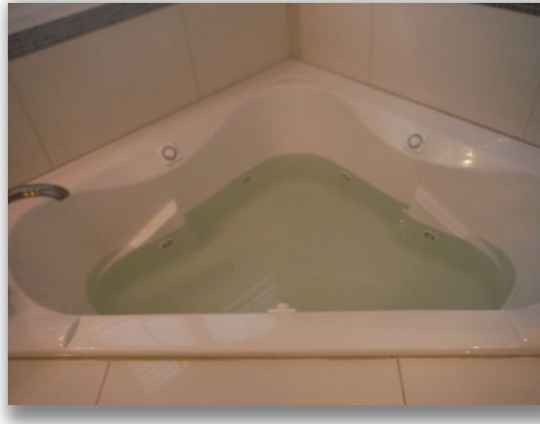
- I was unable to locate a ground fault circuit interrupter (GFCI) receptacle or breaker for the hydro-massage therapy equipment. The homeowner should be consulted on the location of this GFCI device. If there is no GFCI device installed on the hydro-massage therapy equipment circuit, a GFCI receptacle or breaker should be installed for reasons of safety.
- The hydro-massage therapy equipment appears to be inoperative at the time of this inspection. This condition should be further evaluated and corrected as necessary.

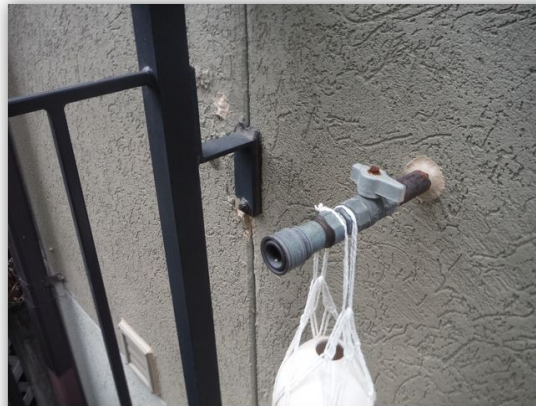
E. Gas Distribution System

- All unused gas valve ends should be capped off for safety purposes.

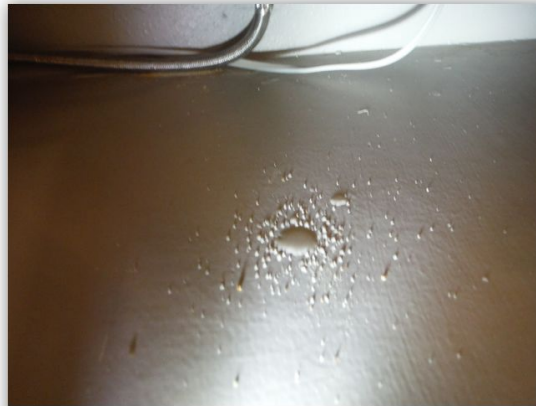
- The food waste disposer is leaking water into the cabinet area. This condition should be further evaluated and corrected as necessary.
- The electrical wiring to the disposal is exposed and should be enclosed in conduit.
- The disposer housing is corroded.

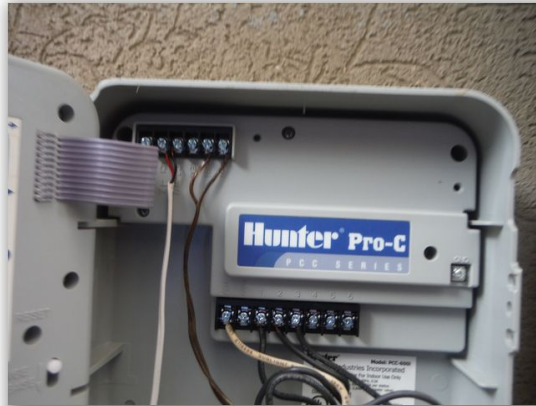
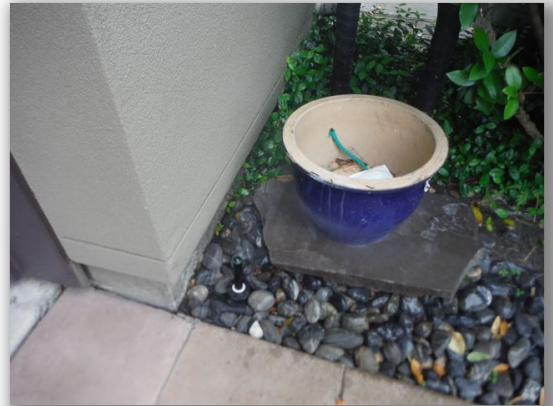
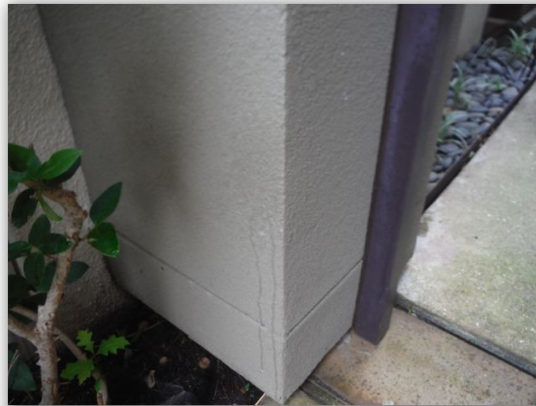
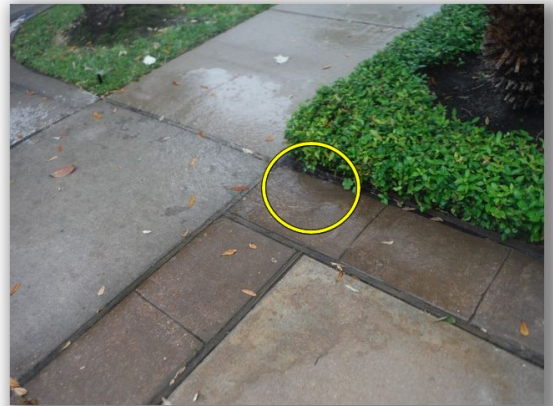
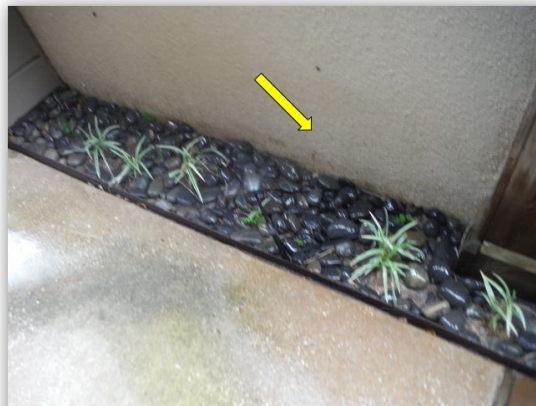
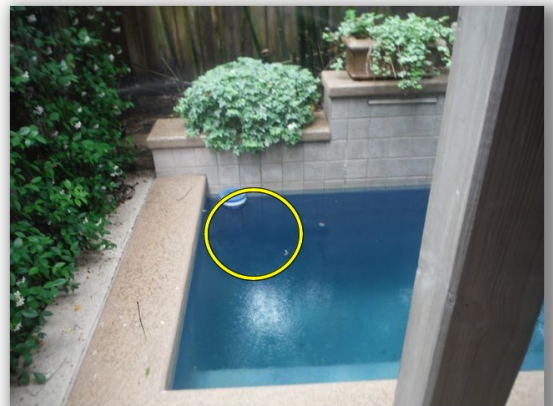
- One or more of the sprinkler heads need to be adjusted so not to spray water onto the exterior walls, surfaces or windows in stations; **1, 2, 3.**
- I was unable to locate a moisture (rain / freeze) sensor device for the sprinkler system. This is an **“as-built” condition**, but Per TREC standards of practice we are required to report this condition as a deficiency.
- There appears to be a sub-surface leak or damaged water lines in station(s); **2, 3.** The cause and remedy should be further evaluated and corrected as necessary.
- One or more of the sprinkler heads need to be adjusted so not to spray water into the pool in stations **3.**
