## **HEDDERMAN ENGINEERING, INC.**

REF: CONDITION OF PROPERTY SURVEY

At your request, a visual survey of the house located at 3211 Seminole Peak Lane, Katy, Texas, was made by Mr. Dennis Polk and Mr. Anthony Long.

**3211 Seminole Peak Lane**

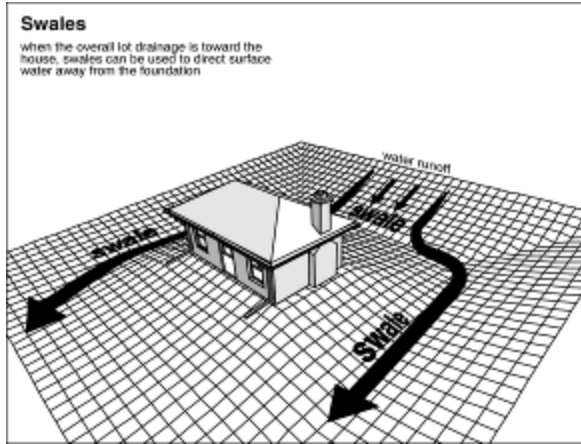
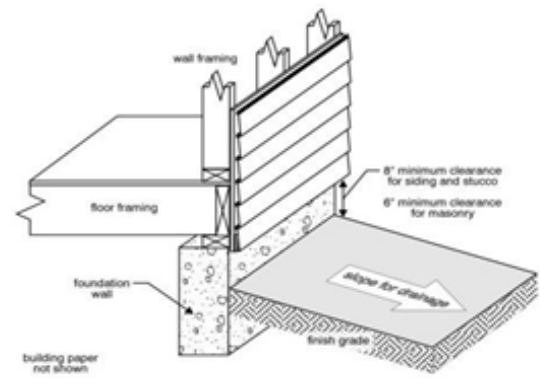
Poor Drainage

The perimeter drainage was observed to be poor at some areas where the lot is not sloped away from the house (6 inch drop in the first 10 feet) and water will pond. Poor drainage conditions near the foundation can contribute to foundation movement. It is recommended that a company specializing in drainage solutions be contacted to provide a recommended solution, along with a cost estimate to provide proper drainage.
