PROPERTY INSPECTION REPORT

Concerning: 3211 Seminole Peak Lane, Katy, TX 77494

By: Anthony Long # 22304

1/22/18

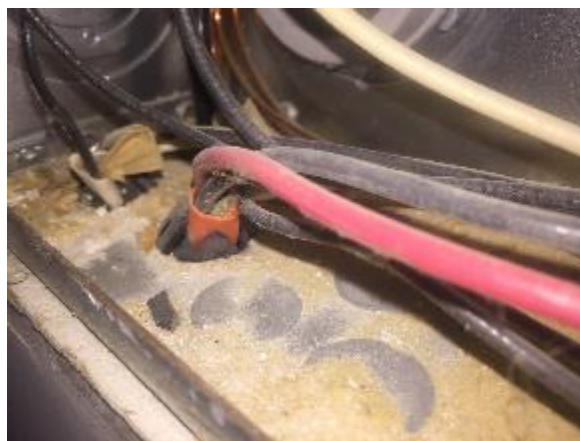
Foreign matter was observed in the panel box, which can be a safety hazard, and it is recommended that the panel be cleaned

Obtain Cost Estimate

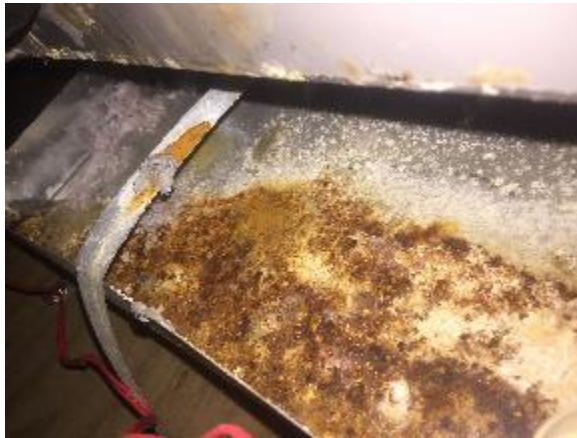
The overflow pan under the evaporator coil had rust in the pan, apparently from water overflowing the condensate drain line into the overflow pan. No water was in the pan at the time of the inspection, but, since we only ran the unit for a few minutes, it is recommended that the drain line be checked by an air conditioning service company.

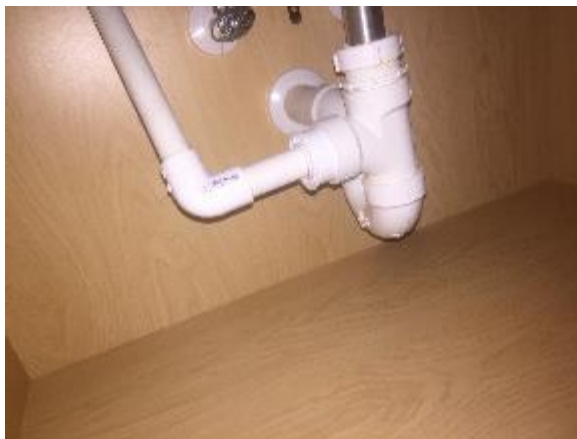
Primary Drain Line

The primary condensate drain line was observed to empty into the P-trap under the sink at the bathroom. This is correct, and no repairs are needed. However, for your information, it is pointed out that it is not uncommon to hear the sound of dripping water at the sink drain, which is related to the proper function of the drain line, and not to a leak at the sink, or in the wall.

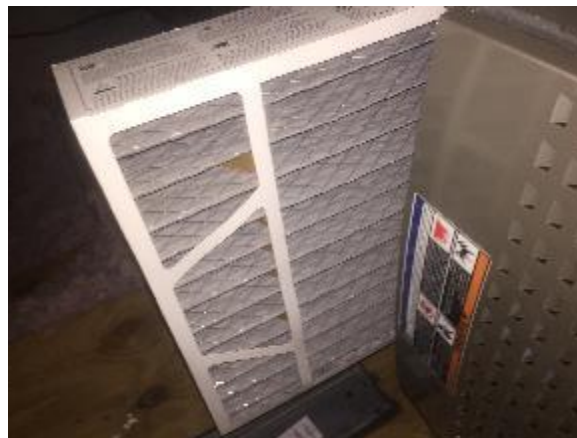
Return Air Chase

The return air was equipped with a media filter located in the attic at the furnace. We checked the filter, and it was dirty, and needed to be replaced at the time of the inspection. It is pointed out that filters should not be installed at the return air grills when media filters are installed.

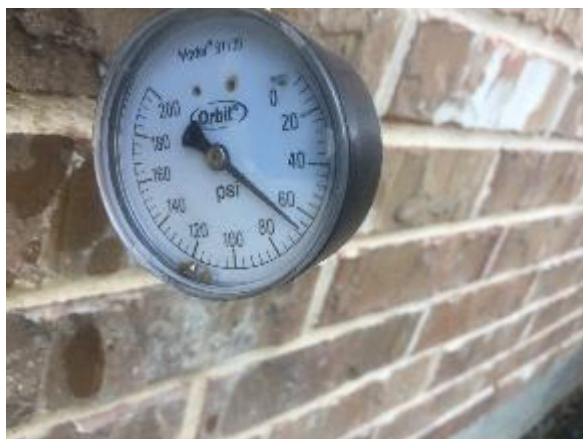
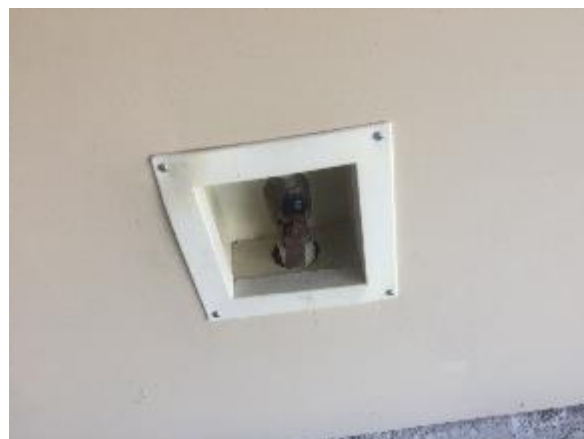
Water Service

The water pressure to the house at the time of the inspection was checked with a pressure gauge at the hose bib nearest the shut off valve, and the pressure was observed to be 65 psi. The shut-off valve for the main inlet water line was located inside the garage.

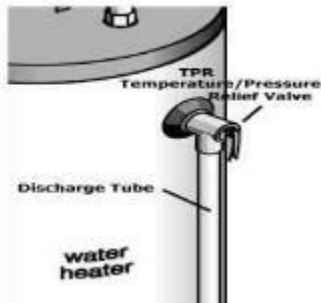
T/P Valve

The relief valve was not operationally checked at the time of the inspection. Valves typically do not reseat properly when they are operated, which causes the valves to leak. It is best to replace the relief valve every 2-3 years. (Information)

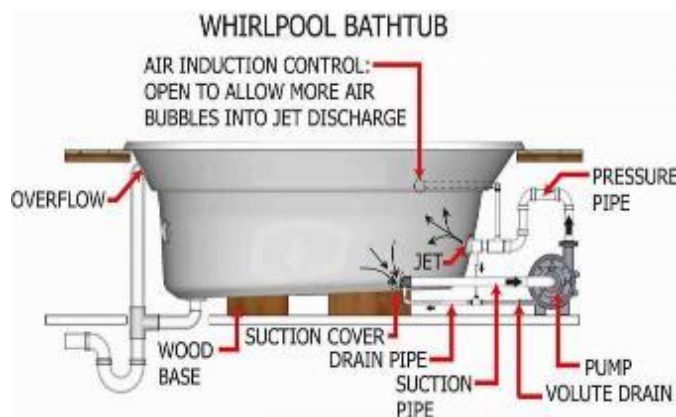
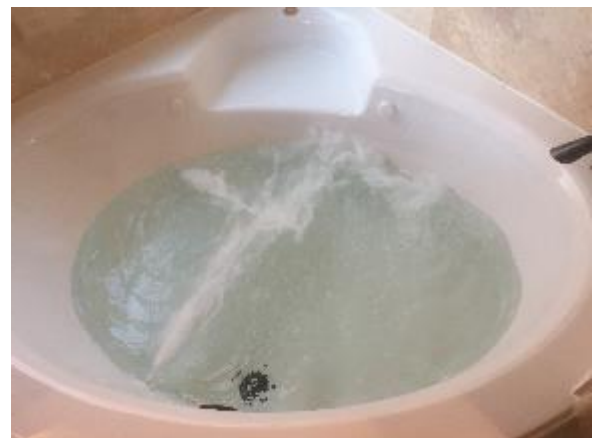
The trap area of the whirlpool tub was not accessible, and was not viewed. The trap area was walled in, and no access has been provided to the pump.

Locations included: the master bathroom

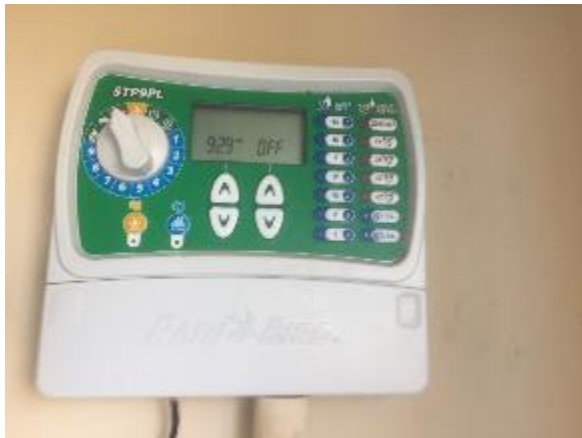
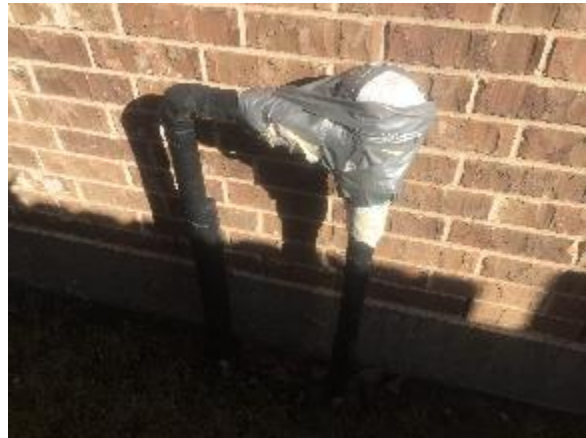
The water was turned off to the sprinkler system and the system appeared to be winterized. The sprinkler system was not operationally checked at the time of the inspection. **Further investigation is recommended.**
