Wood Destroying Insect Report

Inspection Performed by Juan Mireles TPCL #838092 7/7/2021

201 Vanderpool Ln. #13

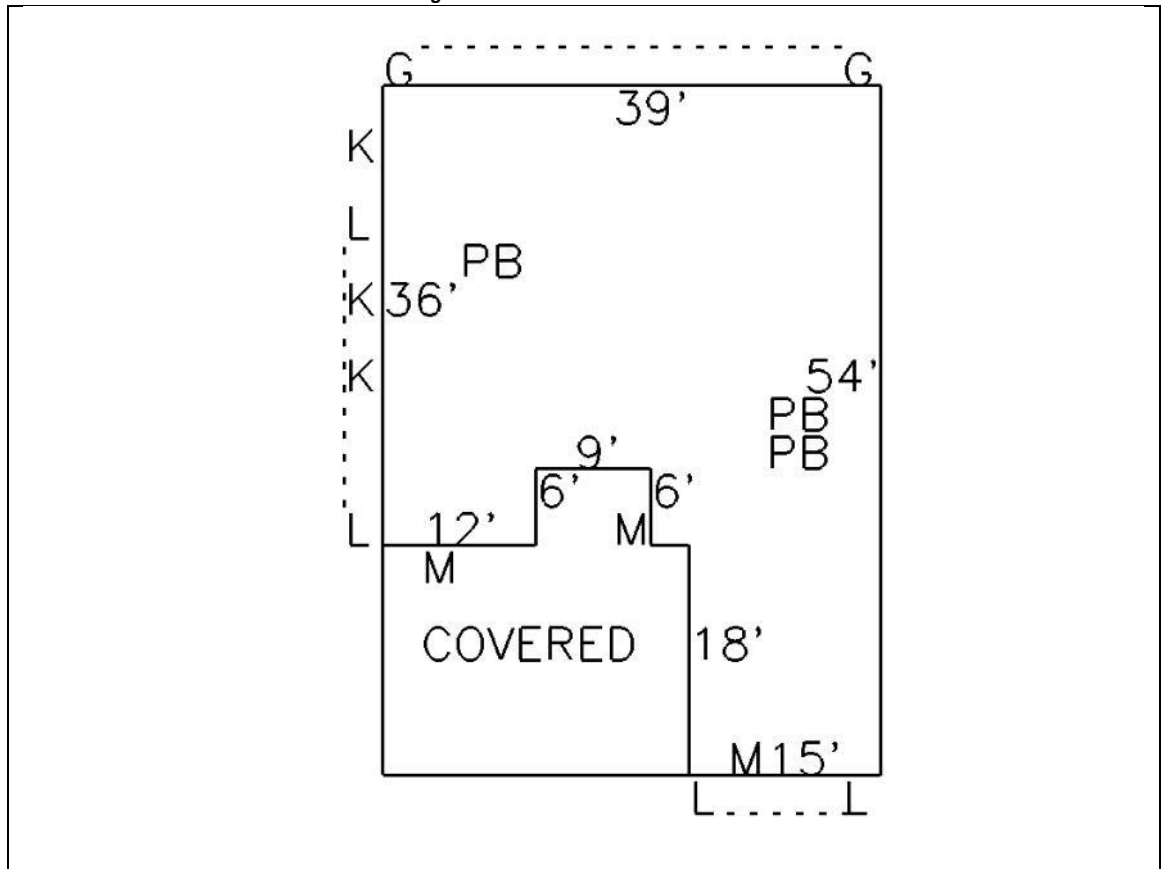
Additional Comments: **(L) High Soil - Soil should be lowered to below the top of the foundation.**

(M) Wood Rot - All damaged or affected wood materials should be properly repaired or replaced.

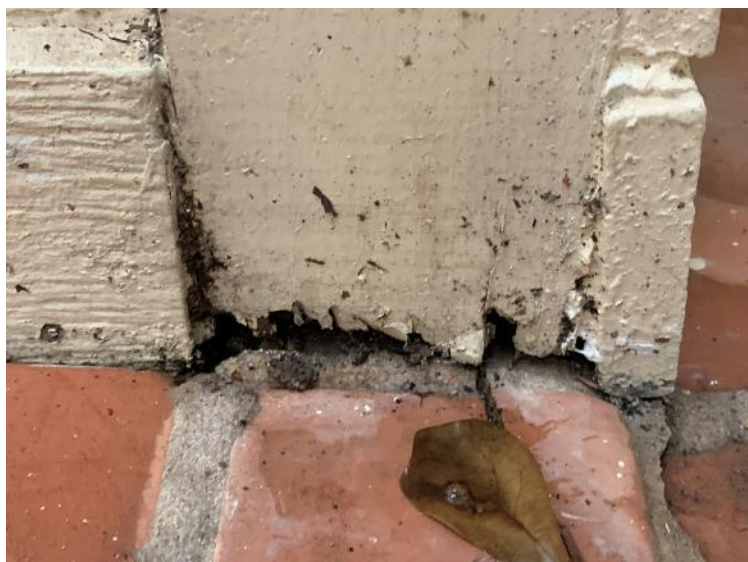
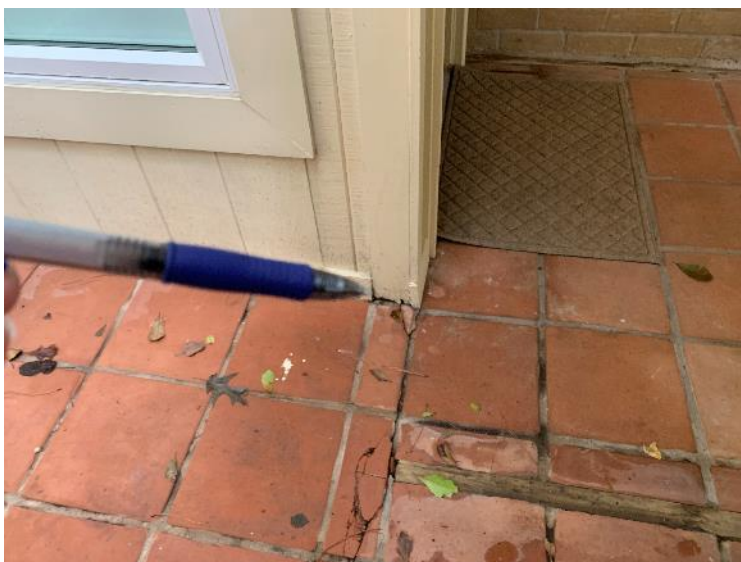
Wood Rot
