STRUCTURAL INSPECTION

201 Vanderpool Ln #13
Houston TX 77024

JULY 7, 2021

REF: CONDITION OF PROPERTY SURVEY

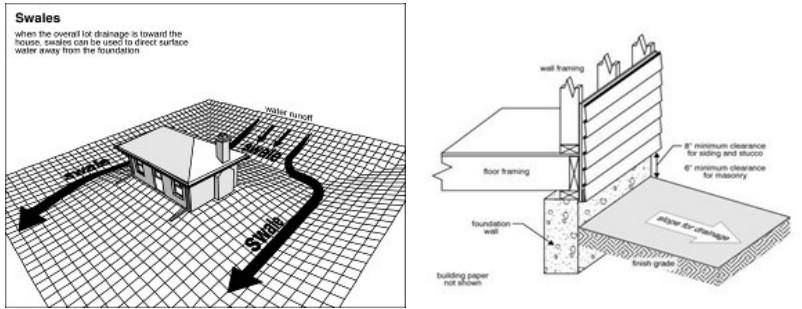
Perimeter Grading/Drainage: Appeared Adequate

The perimeter drainage around the property appeared to generally be adequate. It could not be determined with certainty if water would pool at any localized low areas around the property. Further investigation with the homeowner is recommended to determine if there are any drainage problems or water that ponds on the property after a rain.

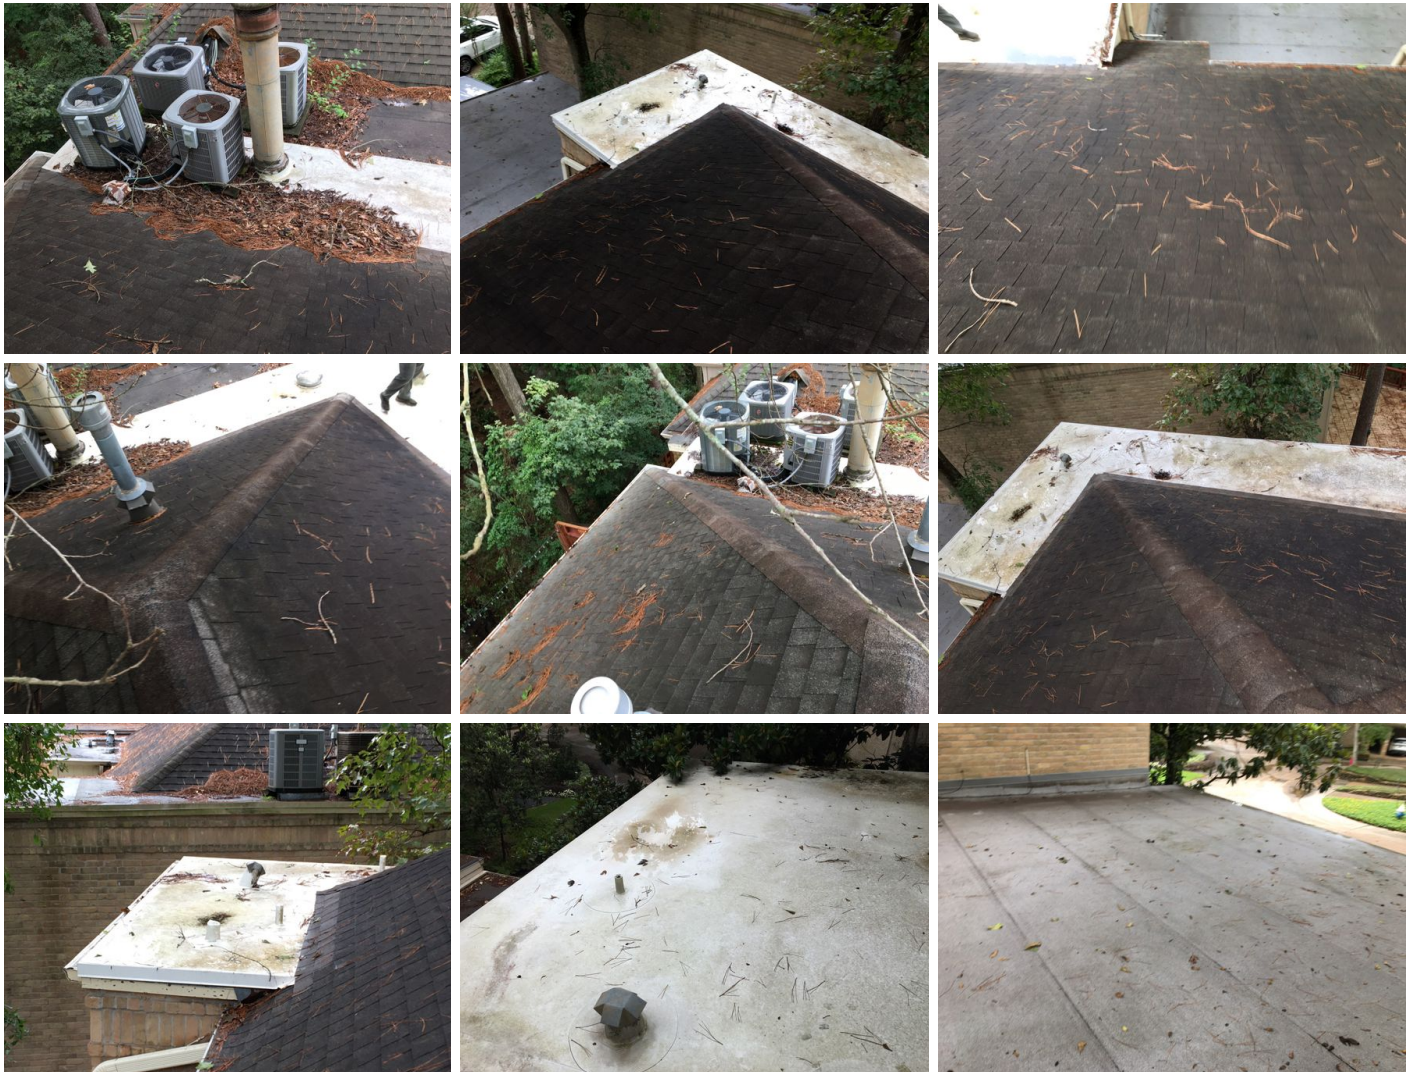
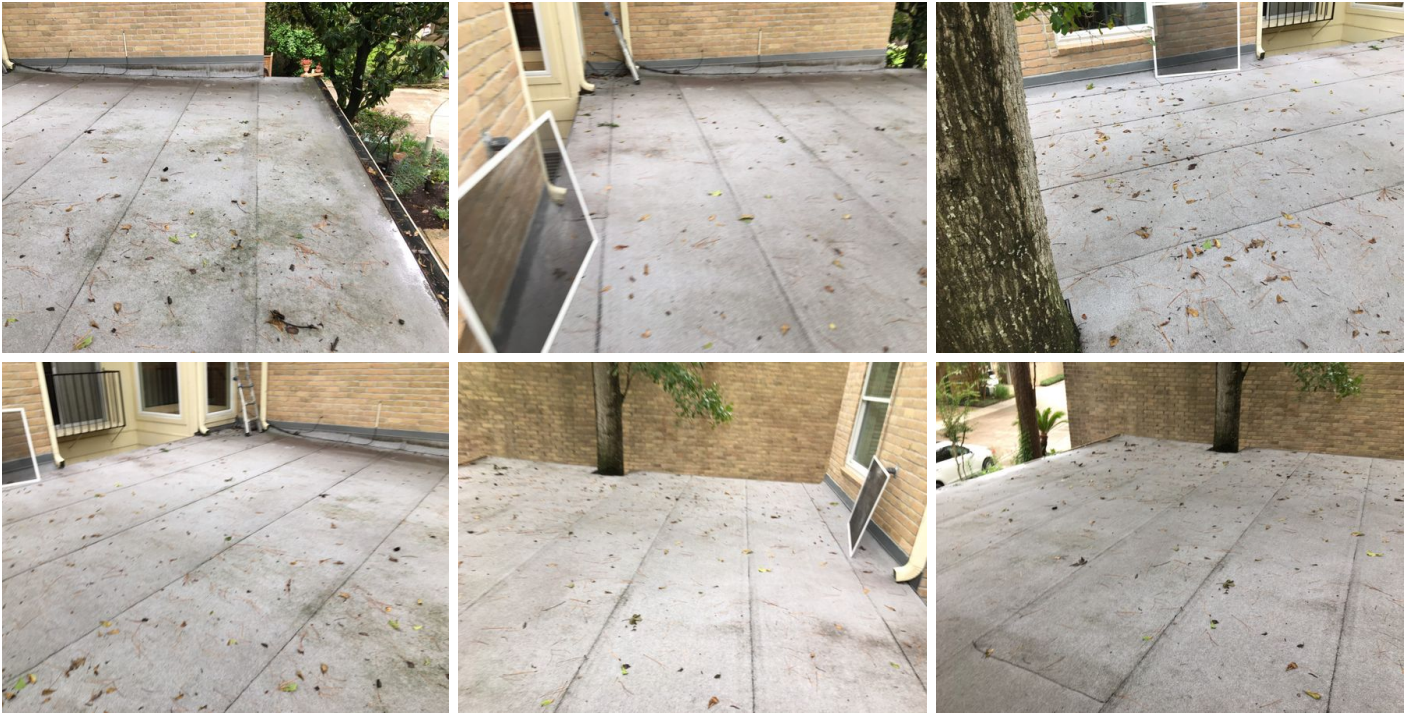
Roof Descriptions: Composition Shingles, single ply membrane, and Modified bitumen

The pitched roof surface was constructed of composition shingles, and the low-sloped portion of the roof was covered by a single ply membrane roof. The carport roof surface was covered by a modified bitumen roofing system. The life expectancy of a composition shingle roof has been observed to vary from 15 to 20 years, with most requiring replacement at about 17-20 years. The life expectancy of a single ply membrane roof has been observed to vary from approximately 15-20 years, depending on the type and thickness of the membrane. The life expectancy of a modified bitumen roof is estimated to be approximately 15 years.

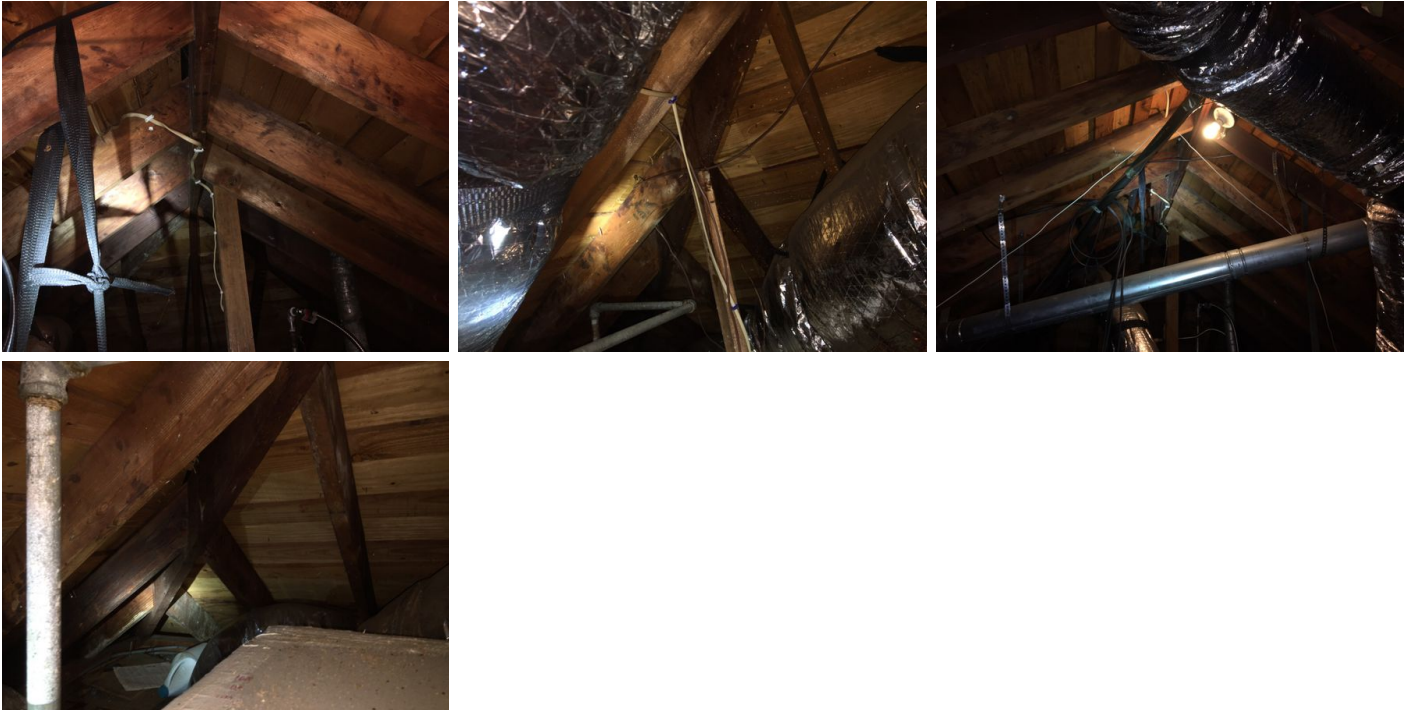
Attic Framing: Viewed from attic access walkway

The attic space was viewed only from the areas determined by the inspector to be safely accessible from the access walkway.

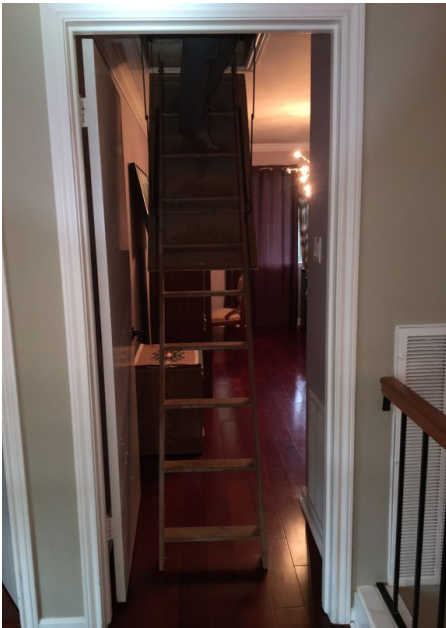
Ladder: Original ladder - Not rated

The access ladder into the attic appeared to be the original installation ladder, and the ladder was not labeled to indicate the rated capacity of the ladder. The ladder does not meet current code requirements for ladders into attics. Consideration should be given to replacing the ladder with a ladder that meets current code requirements.

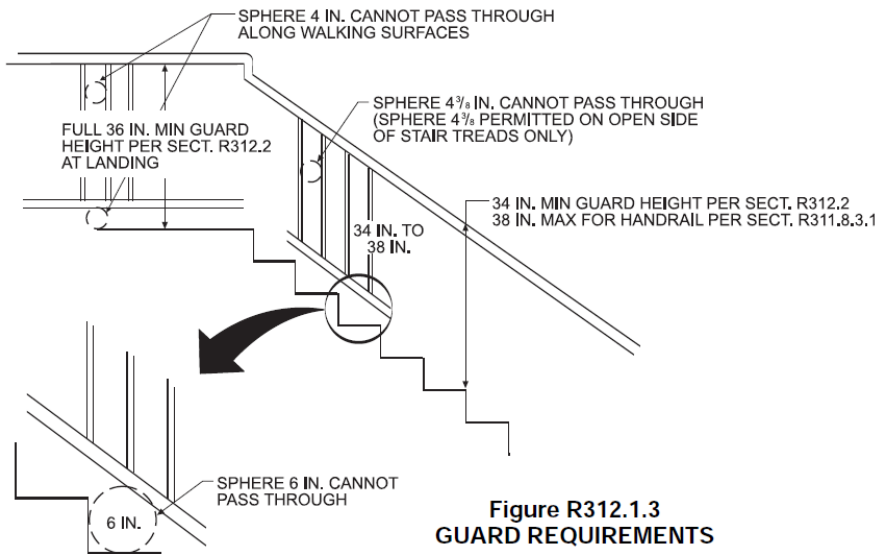
Figure R312.1.3 GUARD REQUIREMENTS

The handrail was not constructed according to the current building code standards (obviously, given the age of the house). Therefore, the width between the balusters is greater than four inches. If this condition is of a concern to you, then further investigation with a contractor is recommended.

Obtain Cost Estimate
