PROPERTY INSPECTION REPORT

“AROUND THE HOUSE” HOME INSPECTIONS

Concerning: 38 Twin Valley Drive, Sugar Land, TX 77479

By: David J. Stiles Inspector Lic. #7308 8/11/2020

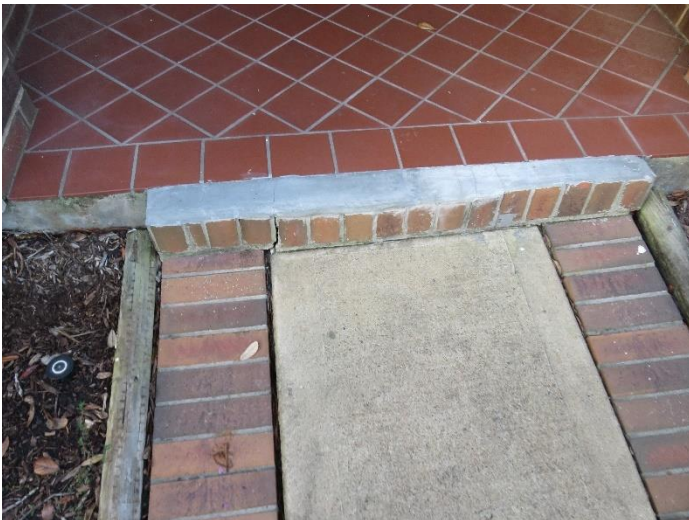
- *It has been stated that...*Previous foundation repairs/adjustments have been made to this home. A transferrable warranty may be available from the current owner and repair company. It may be beneficial to have the foundation company evaluate the foundation during the option period.
- The front porch step edge is damaged with failing brick structure.

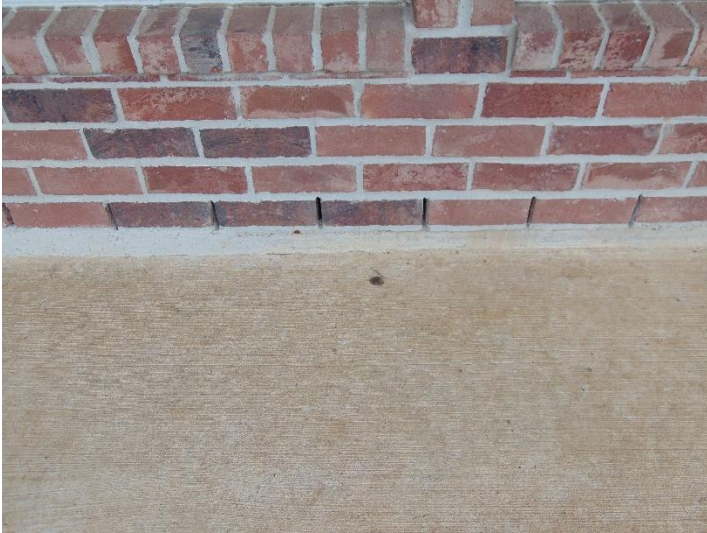
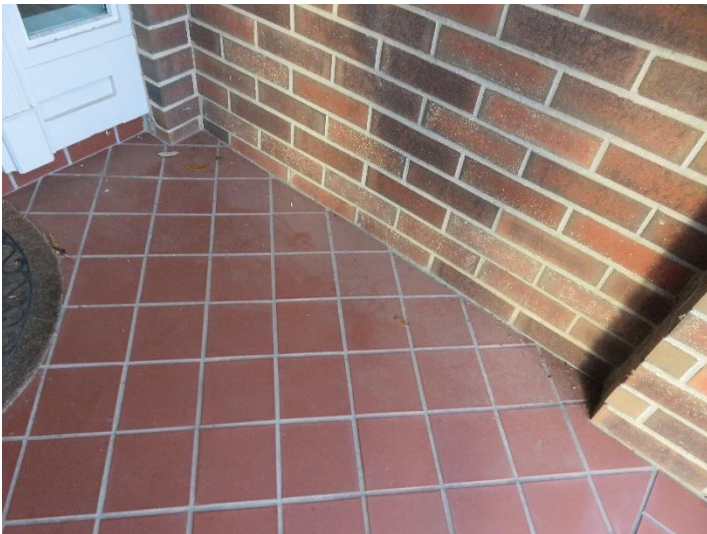
Required example and current installations

- The front porch lacks weep holes at the wall/foundation.

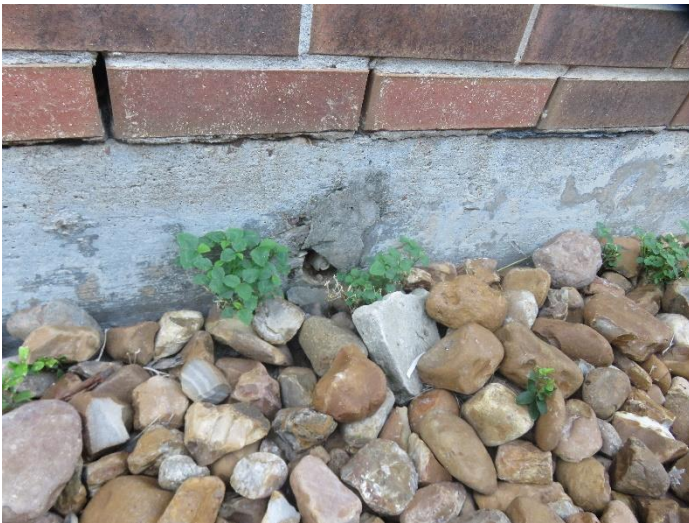
Example at the right rear foundation

- A post tension foundation cable end is exposed. Allowing this cable end(s) to remain exposed to moisture and weather elements could eventually cause the cable to weaken and possibly lose strength. Evaluation by a professional foundation contractor familiar with decay of post tensions cables may be required. All exposed cable ends should be properly covered/protected to prevent further deterioration. Coverings should extend outward from the foundation by 5/8”.

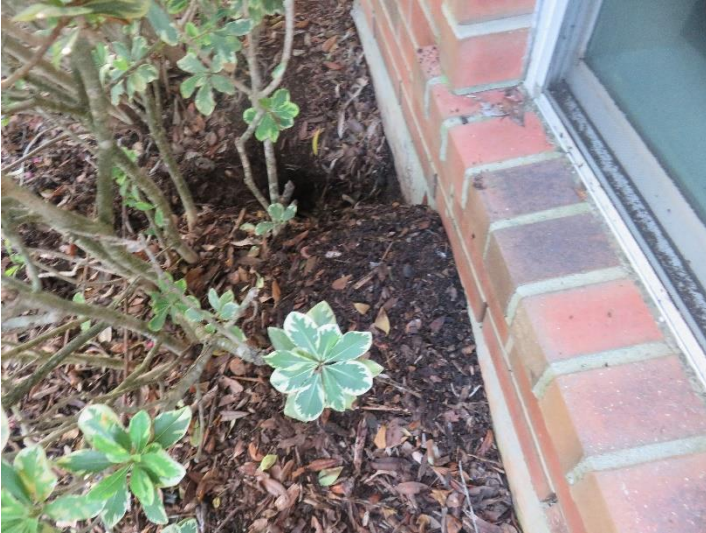
- At the front left flower beds a borrowing animal has dug a hole/home.

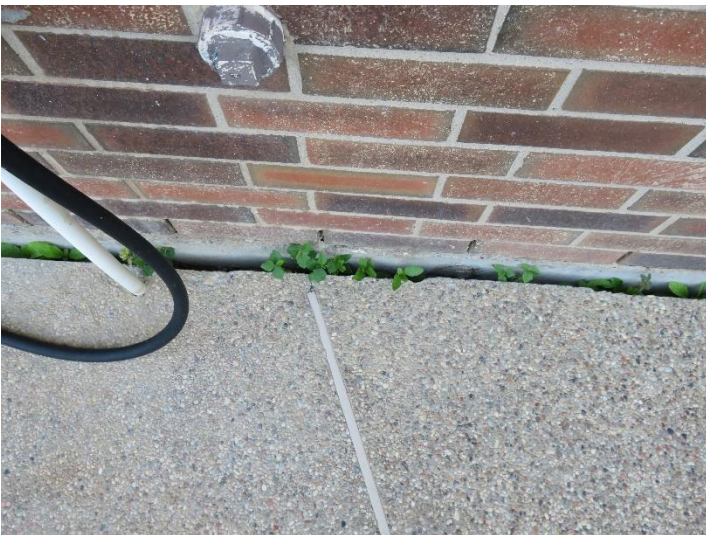
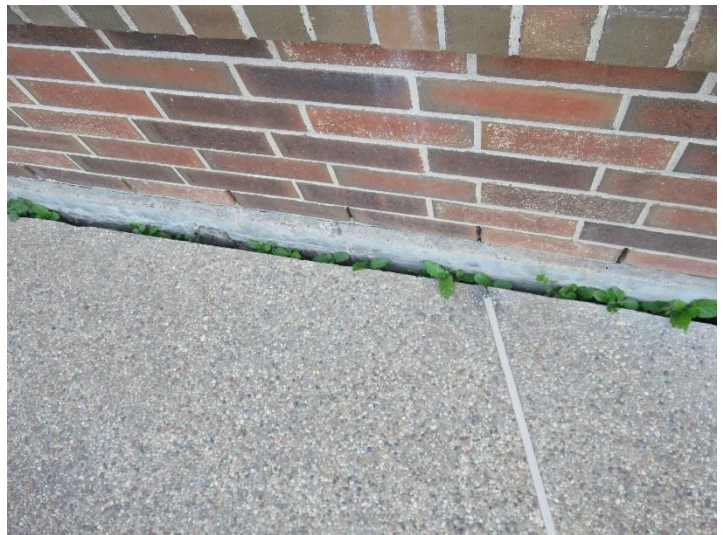
- Along the rear wall of the house, the gap between the pool deck and house should be properly encapsulated.

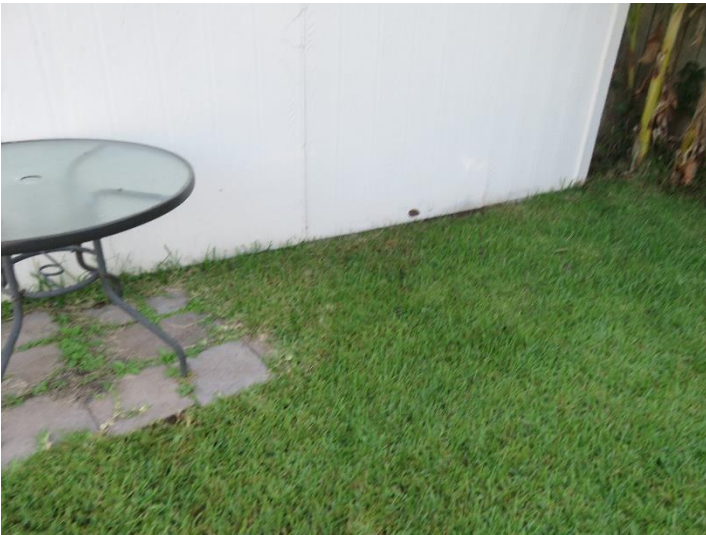
- At the rear of the garage soils are installed too high against the rear framing and wall surfaces. Dirt and moisture is penetrating into the garage.

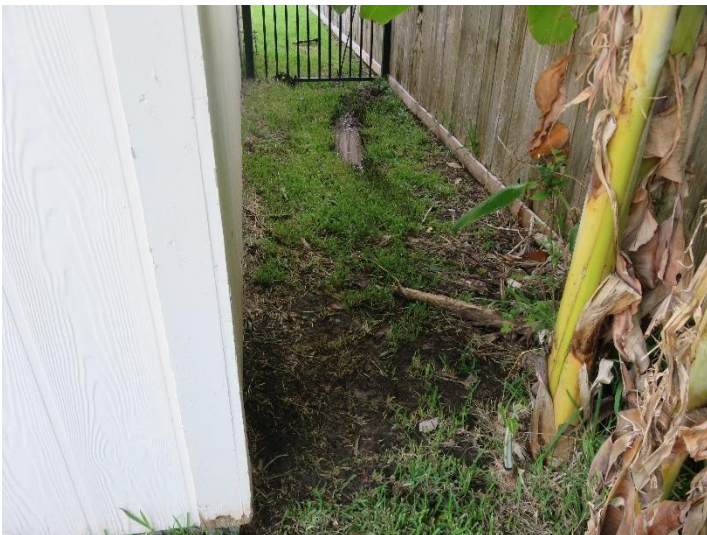
➤ Drainage at the left side of the garage requires improvement.

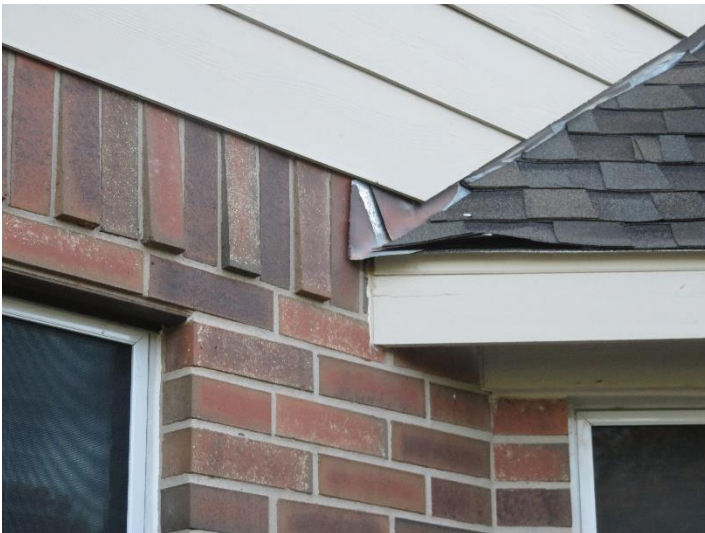
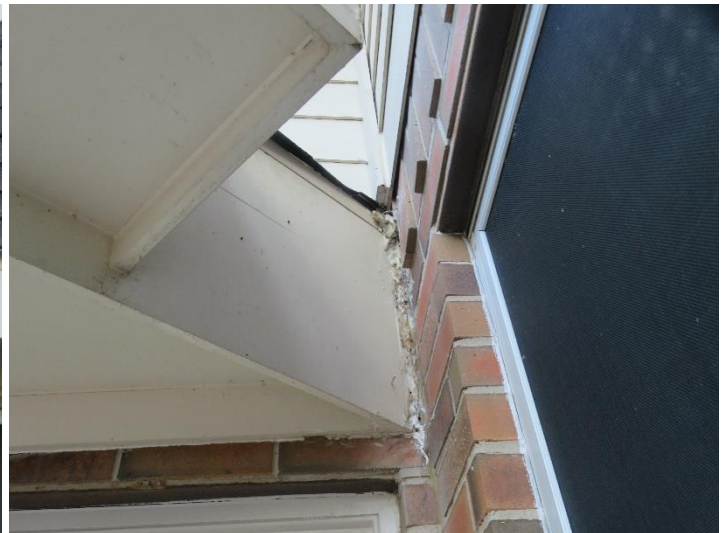
Current installation examples at the rear of the home

- Kick-out flashing is required at the lower run of rain gutters to divert water away from the wall at the rain gutter/end of the roof.

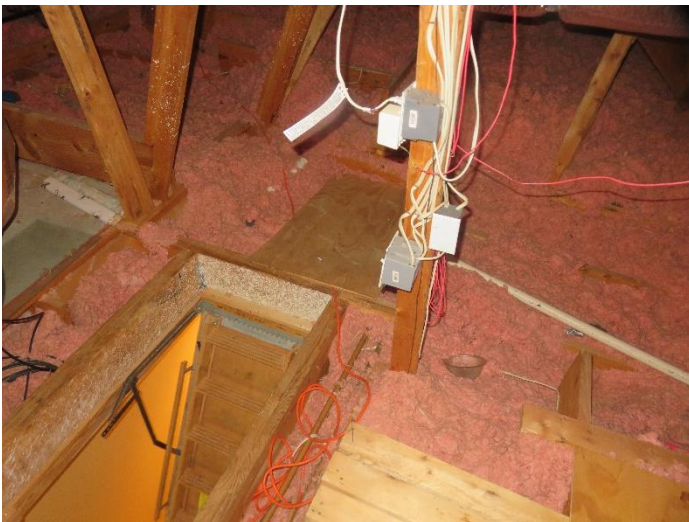
- Access to the attic from the stairs is unsafe lacking a platform and walkway conducive to safe passage.

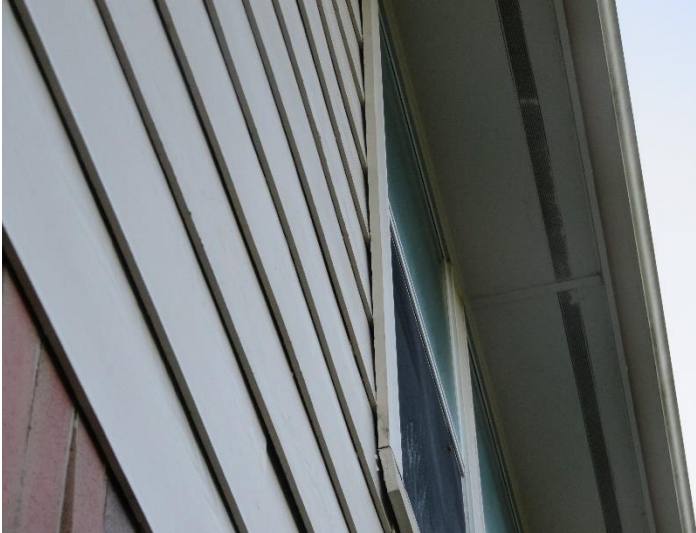
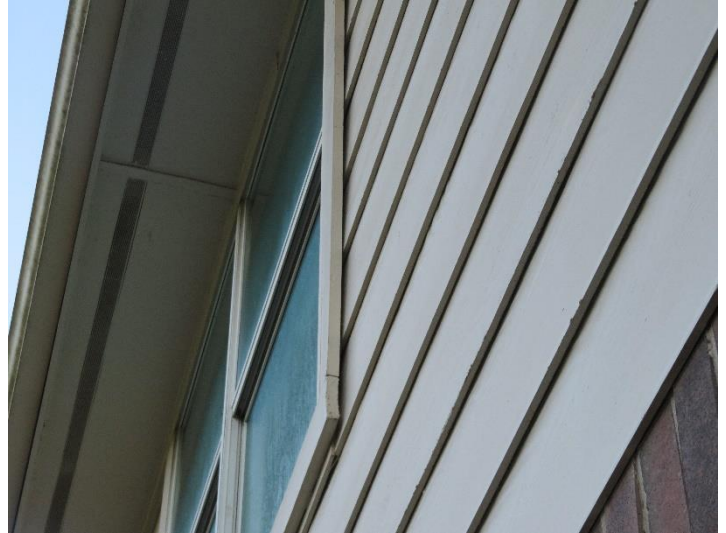
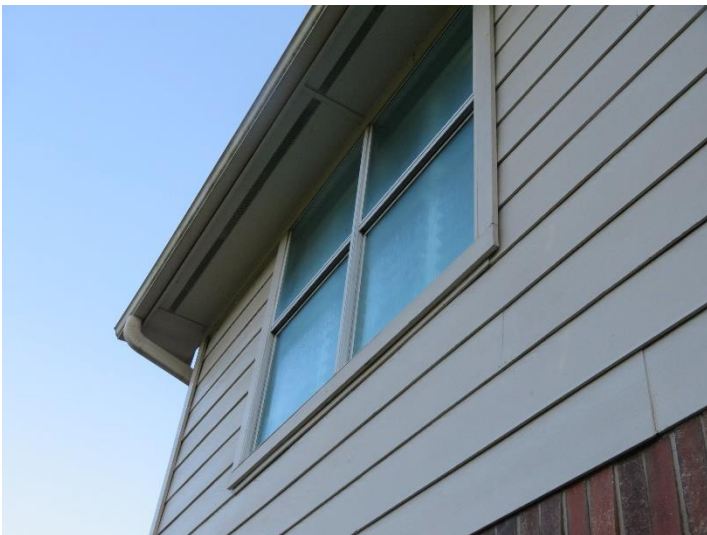
Current installation examples

- Exterior door/window/siding trim is required to be flashed with overhanging flashing at the top and mid-trim (if present) and caulked along the sides or butt-framed into the siding and caulked.

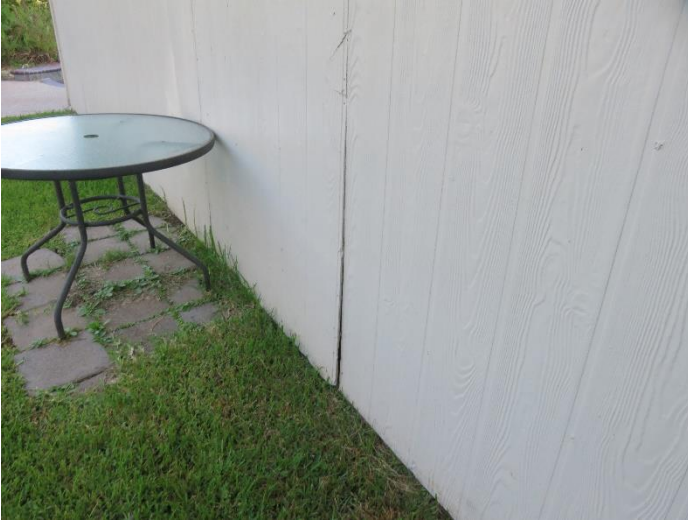
- Siding at the rear of the garage displays separation.

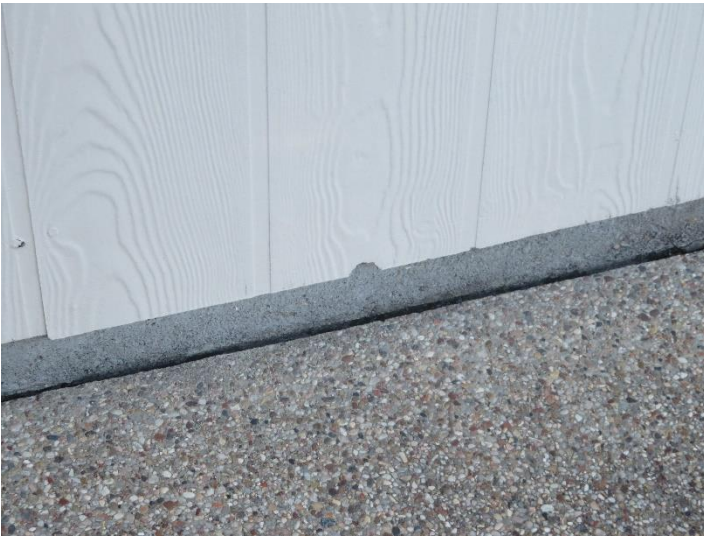
Examples

- Siding at the garage displays damage.

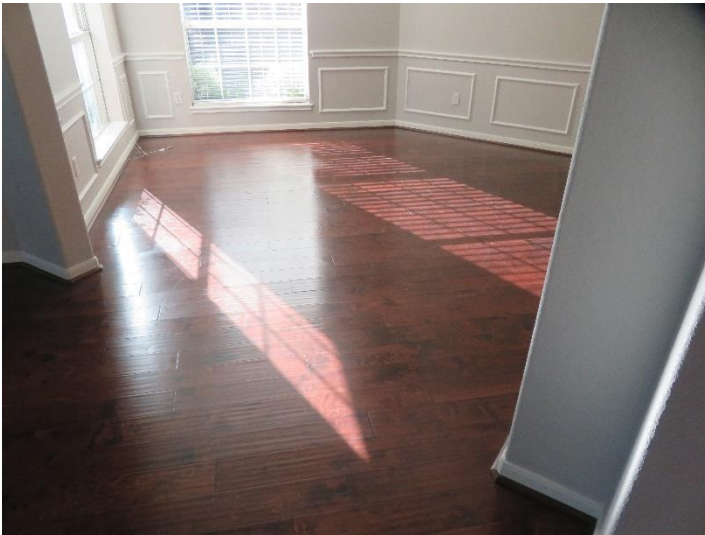
- The ceiling between the kitchen and 1st floor family room displays a ridge.
- Wood flooring in the front left and center 1st floor rooms creak under foot.

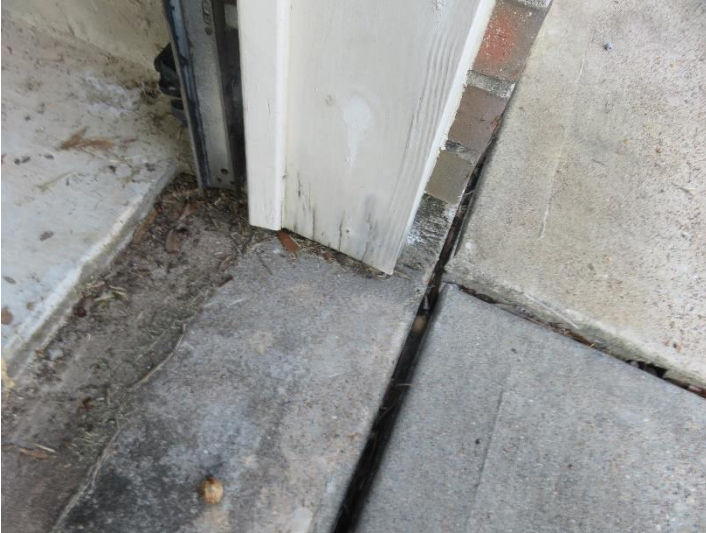
- The right garage door trim displays deterioration.

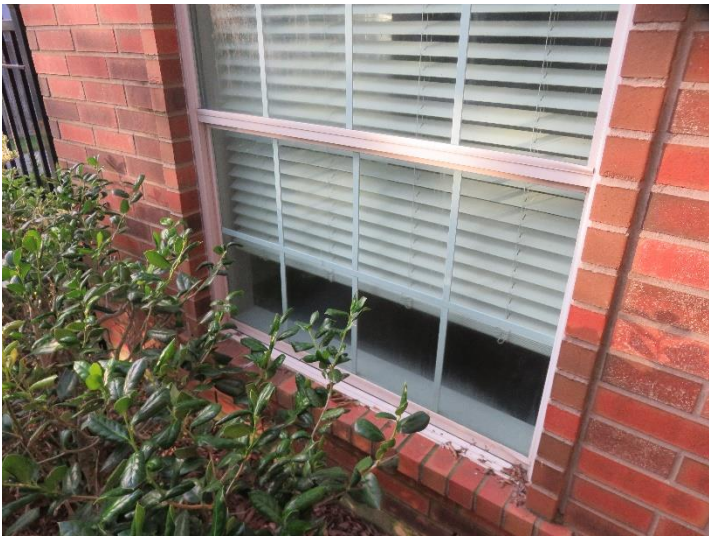
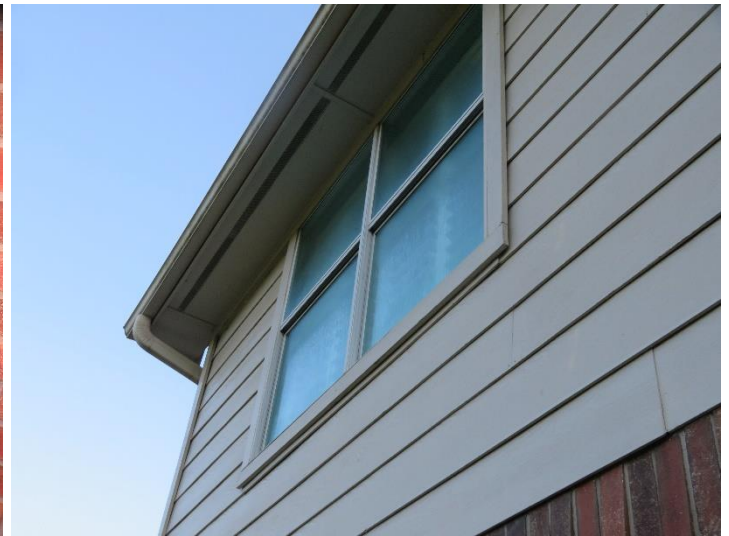
Examples

➤ Several windows lack screens.

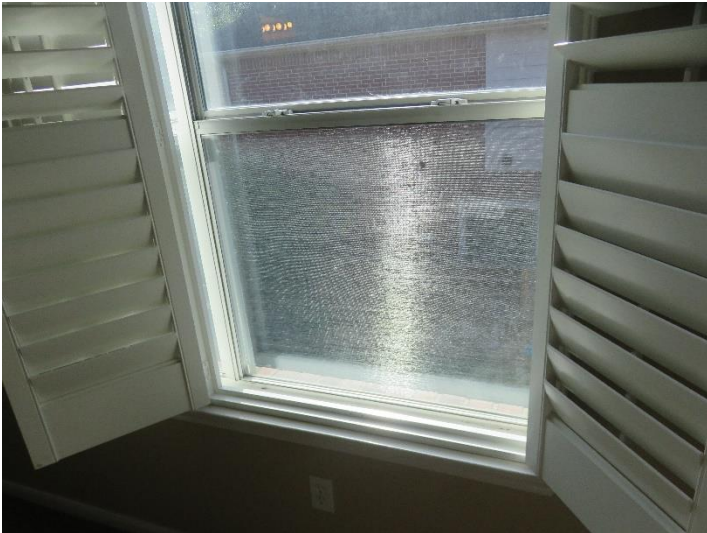
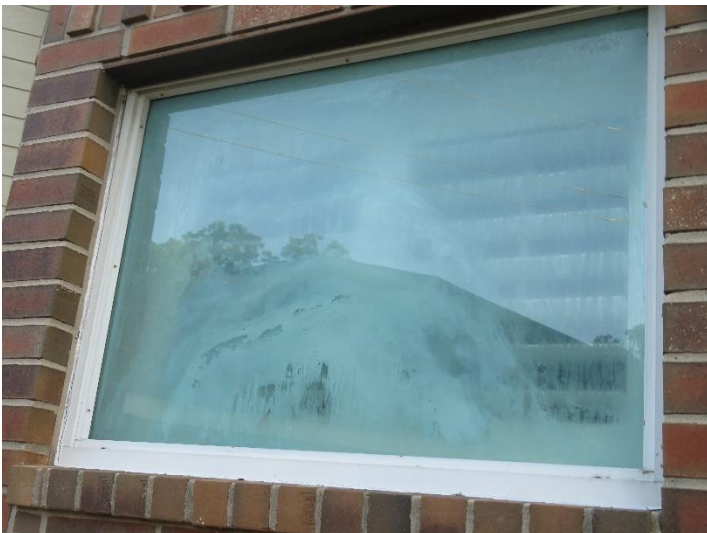
Examples

- Several windows in the home displayed broken insulating seals and condensate that has formed/stained the area of glass between window panes.

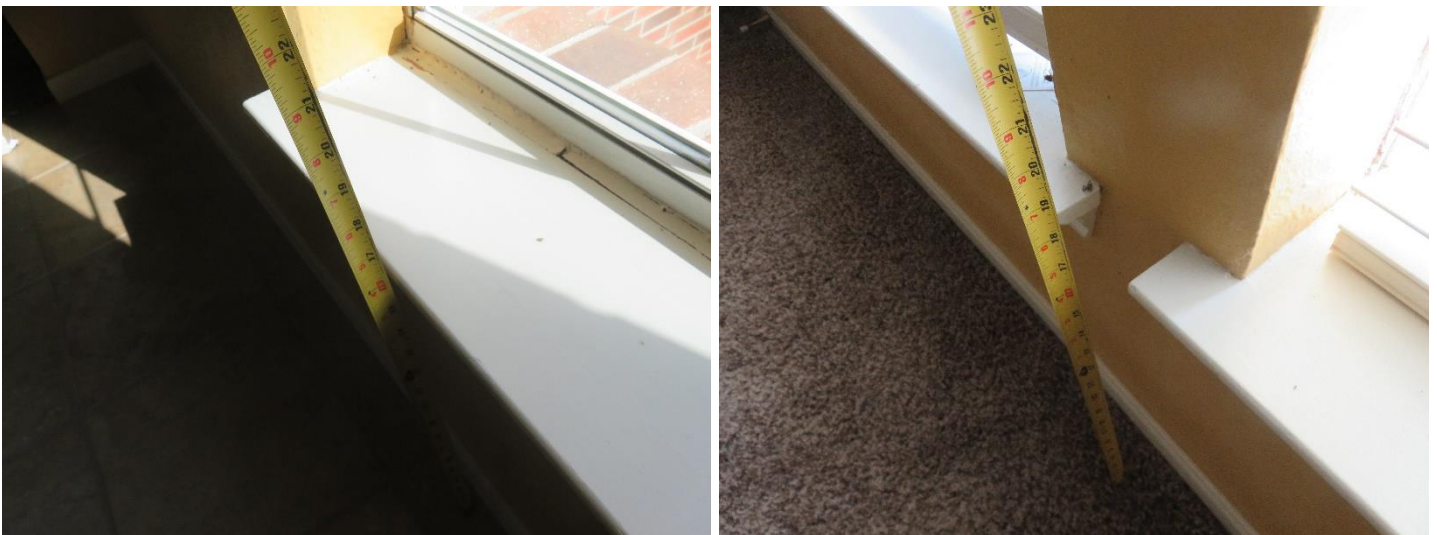
Current installations lacking height off the finished floor and/or safety apparatus

- Some windows were unable to be opened and/or were not able to be opened to the 24" required for minimum emergency egress.
- Windows >72" above the exterior finished grade are required, at sill height, to be a minimum of 24" above the finished floor for child fall safety precautions. IRC {612.2}. The only exceptions include (1) windows that do not open in excess of 4" sphere, (2) windows that are equipped with fall protection devices per ASTM F 2090 and (3) approved window opening limiting devices.

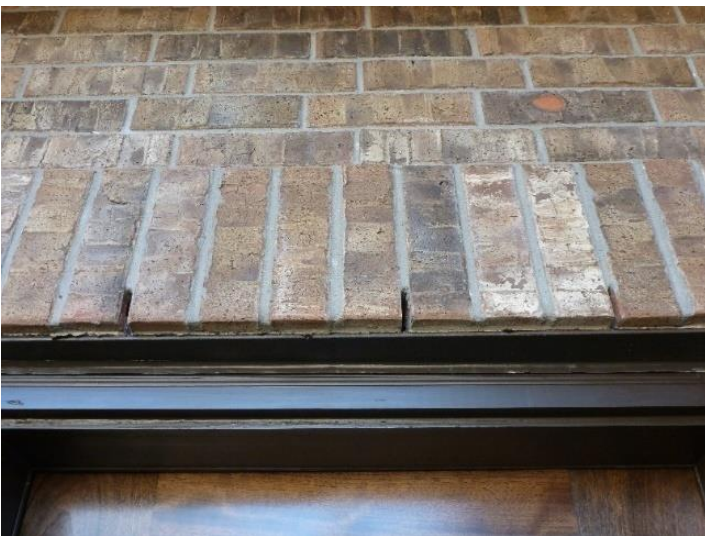
Weep hole example and current installation examples

- Windows with brick walls supported by steel lintels will rust if condensation/water is allowed to accumulate or penetrate behind the wall of brick. The top of the lintel should be installed with flashing between the bottom of the first row of brick and the lintel. [IRC - 703.7.5]. It could not be ascertained to what degree, if any, flashing is installed in this manner. Weep holes can be provided by drilling/removing a portion of the mortar between bricks at the top of the lintel. Weep holes are required to be 3/16" in width and installed in pairs above a window and/or at least within 33" of each other. [IRC - 703.7.6]. Already rusting lintels should be scraped and painted with a rust preventing paint.

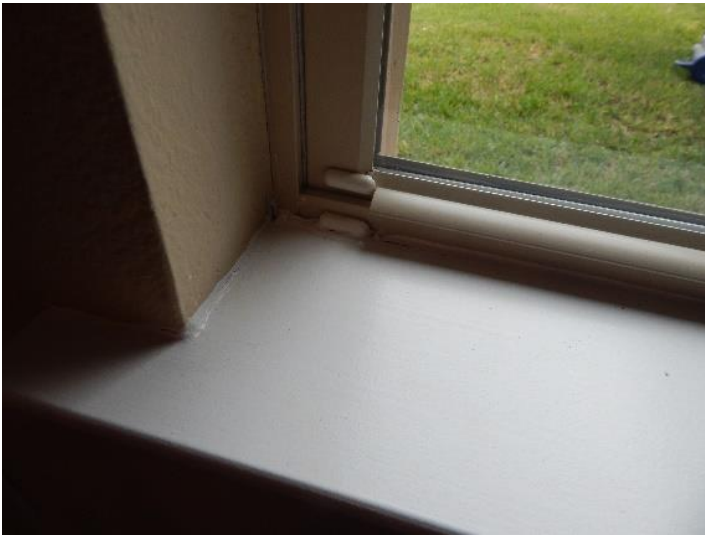
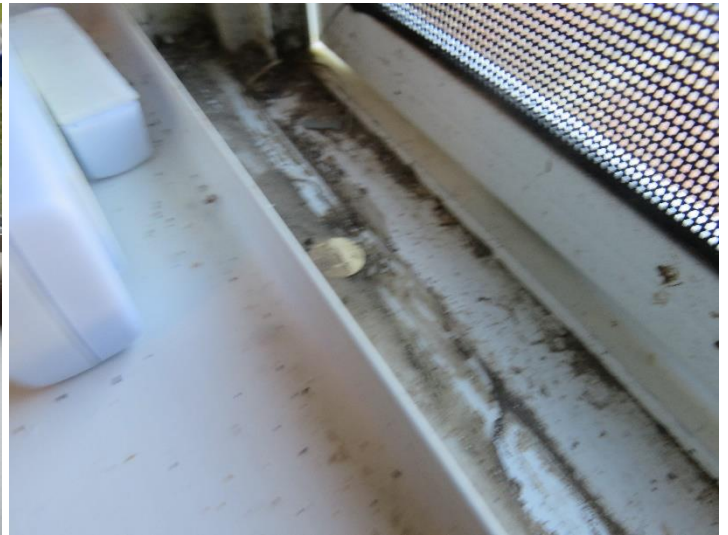
Example and current installation example

- Windows that have had its frame bored for the insertion of a security alarm contact or other apparatus effectively negates the manufacturers window warranty. Side mounted contacts glued to the window are preferred. Maintain contacts with full sealant.

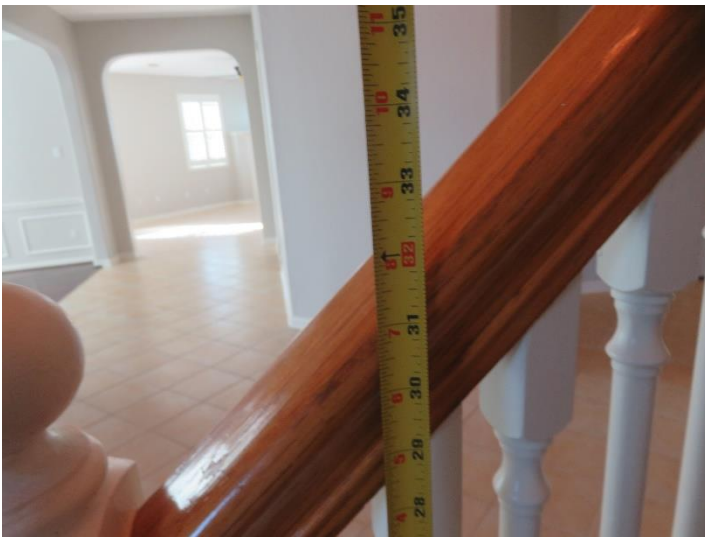
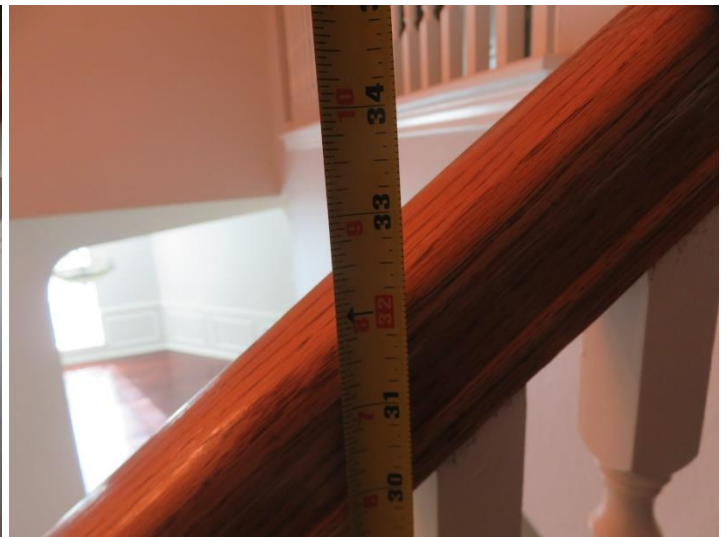
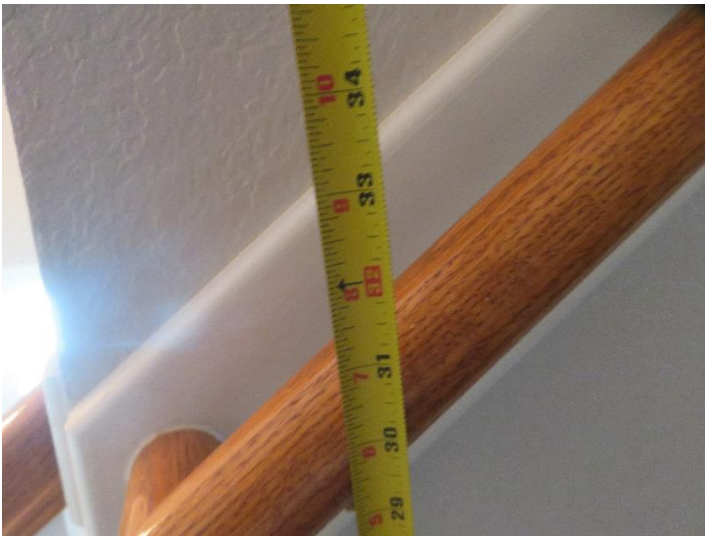
Examples at the main staircase

- Handrail height, measured vertically from the slope plane adjoining the tread nosing or finish surface of ramp slope, shall not be less than 34" and not more than 38". {IRC311.7.7}

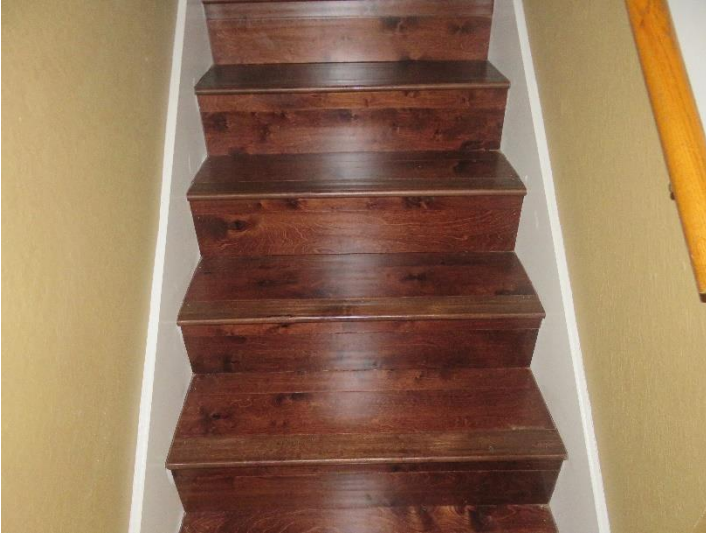
- The stair treads at the rear staircase are loose.

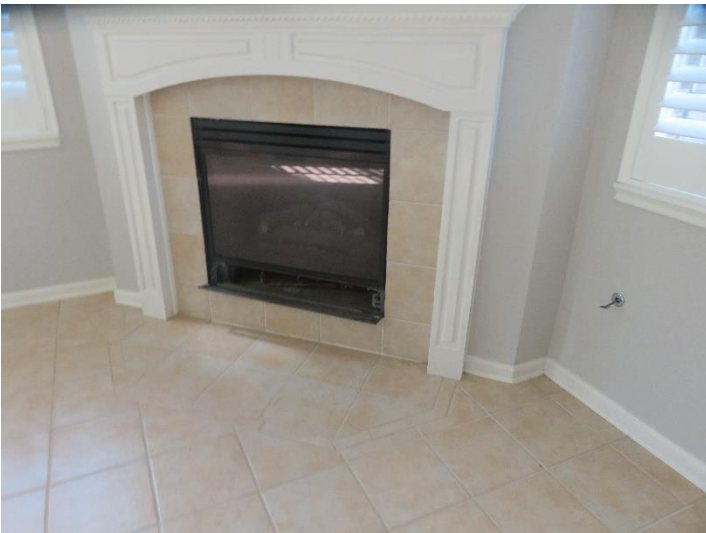
- The fireplace in the family room is a sealed natural gas assisted appliance having its emergency gas valve to the right on the adjacent wall. The fireplace was unable to be tested/operated due to the lack of a remote-control device to turn the appliance ON and OFF.

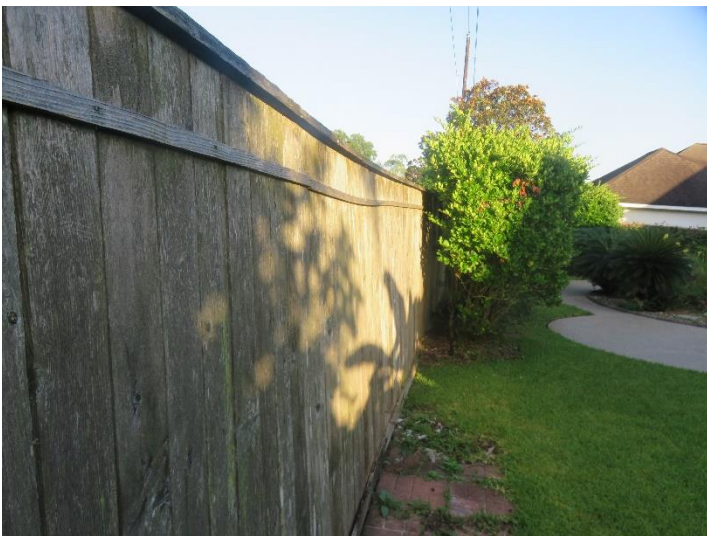
- The rear fence displays leaning.

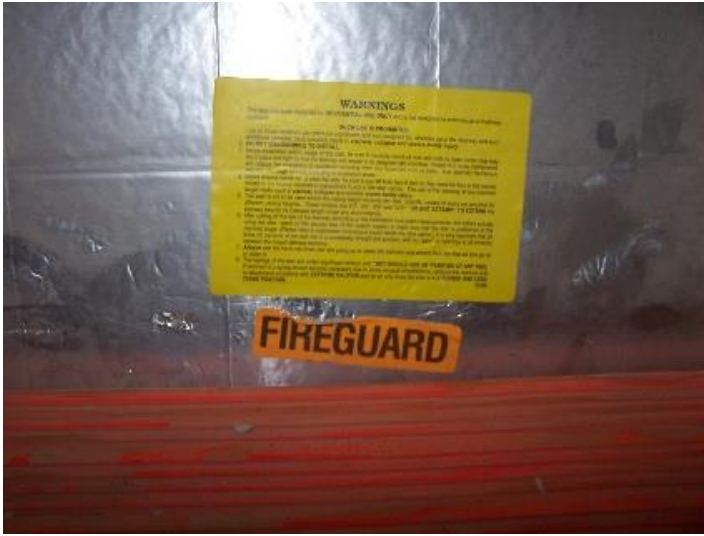
Example of a fire rated/insulated attic pull down stairs include and current installation

- Pull down attic stairs in the home are required to be clad with insulation to form a barrier between the attic and living area of at least R-30 equal to the rating of currently required attic insulation at living area attic fronting ceilings. It is advisable to install fire rated stairs to provide a fire barrier between the attic and living space.

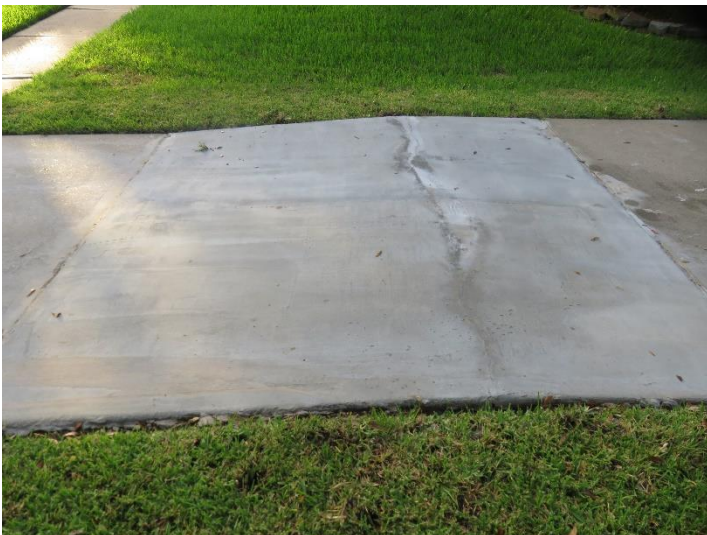
- The driveway displays a section recently improved by arched and cracked as well as cracks in the upper pads.

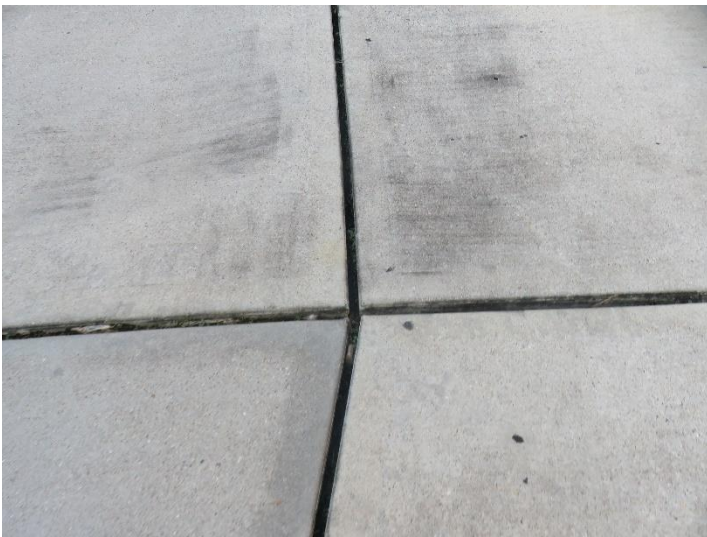
- The driveway has lost its expansion joint material.

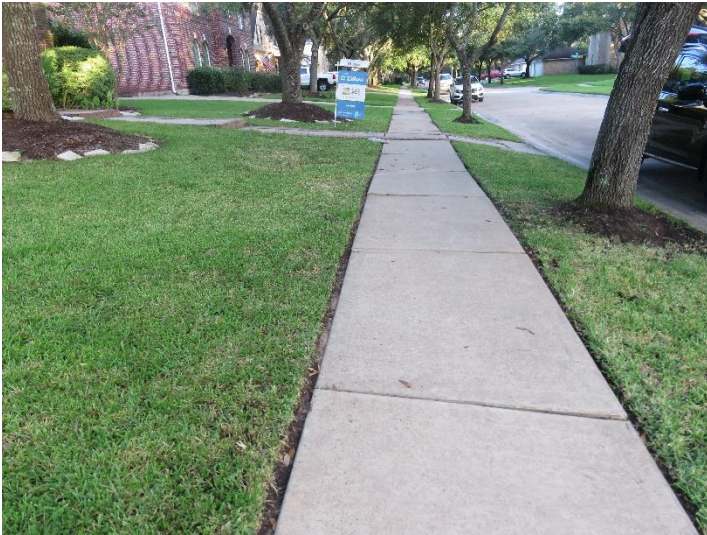
- The front walkway displays tilting and uneven surfaces.

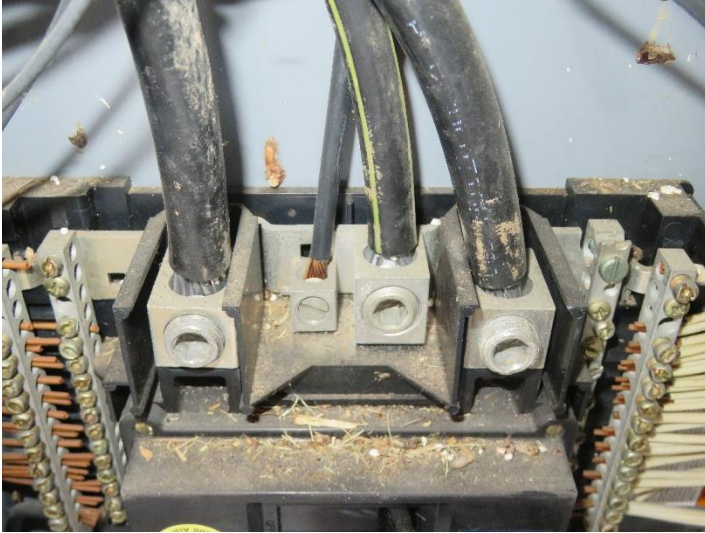
Current and required installation

- Aluminum service wiring requires anti-oxidizing agent at entry points to the main breaker and neutral bar.

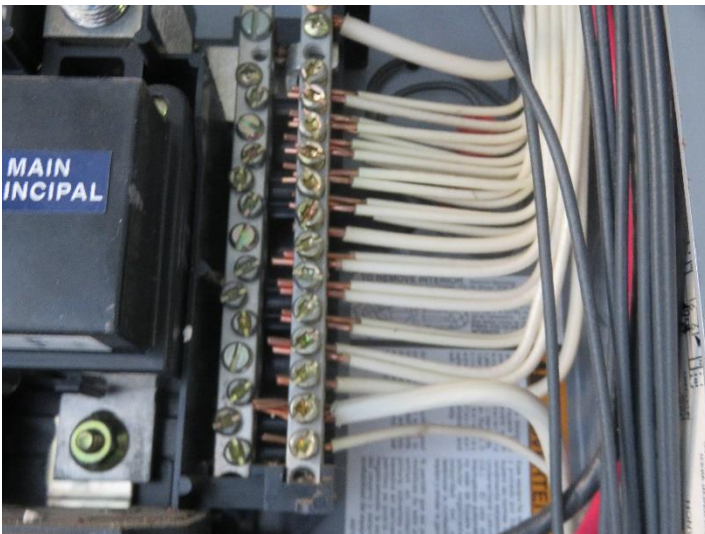
- The Main service entrance exhibits Neutral wires that have been double lugged (connected together) at the Neutral bar. This installation can cause an overheating condition between the two or more wires. Each Neutral wire should be separated and assigned its own lug for connection.

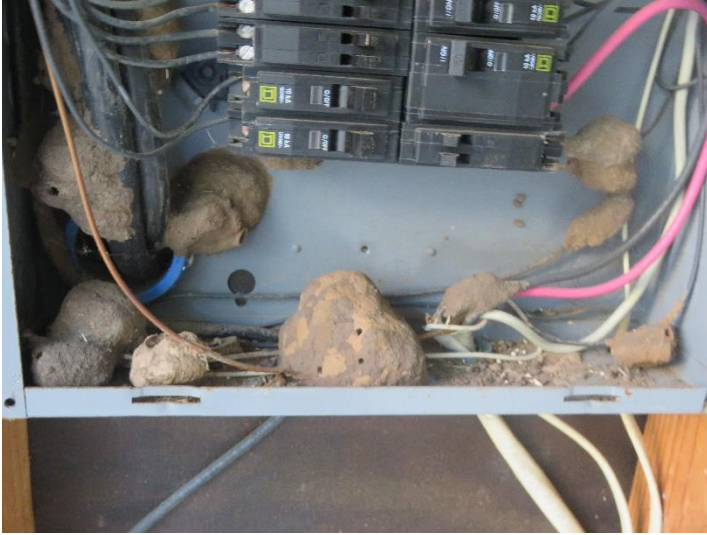
- The panel interior requires cleaning.

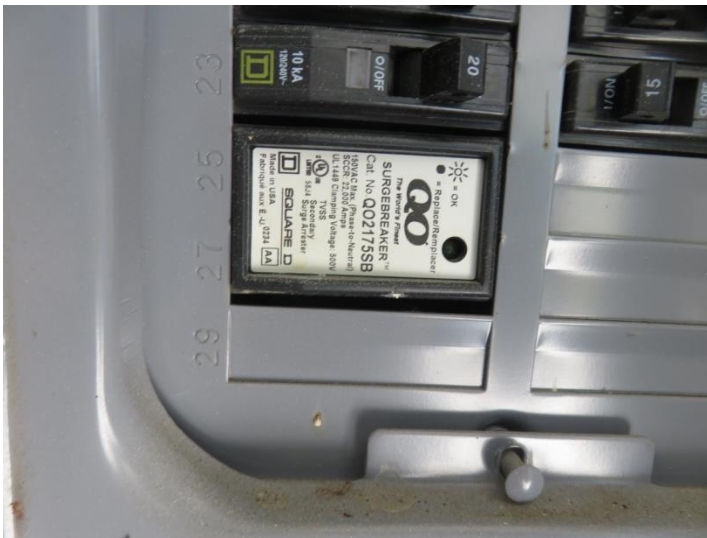
Example

- It is beneficial to have a whole-house surge protector in the panel.

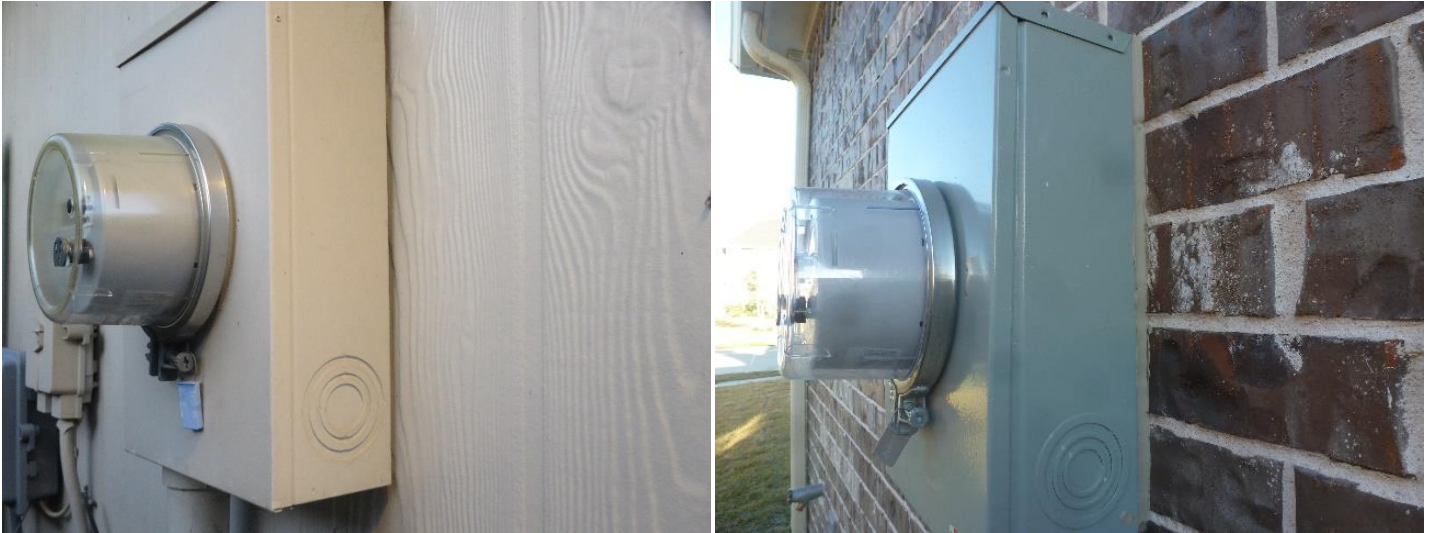
Current installation and example of recommended caulking

- The electric panel box(s) should be caulked around its perimeter (including between panels) to assist in preventing water from accumulating behind the box at the porous wall substrate creating the potential for wall damage.

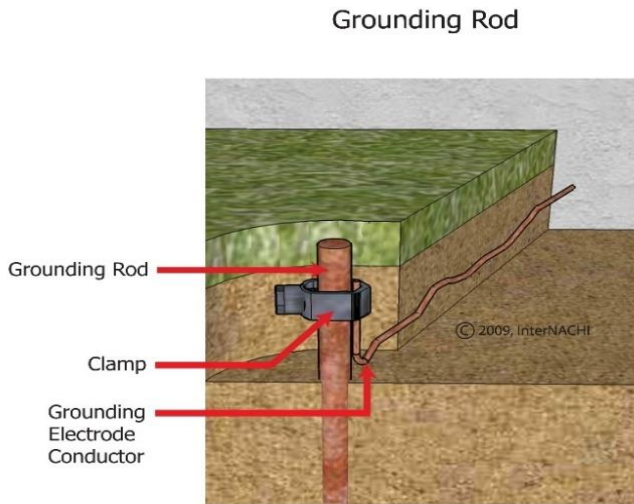
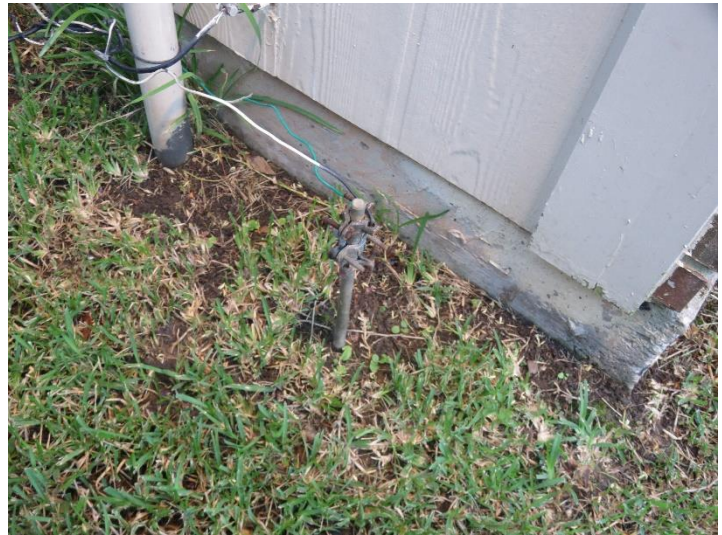
Illustration and current installation

- The electric system grounding rod is required to be 8' long (not verified) and should be fully driven into the ground to provide optimum grounding connection to earth and to prevent it being accidentally damaged or personal injury result from contact.

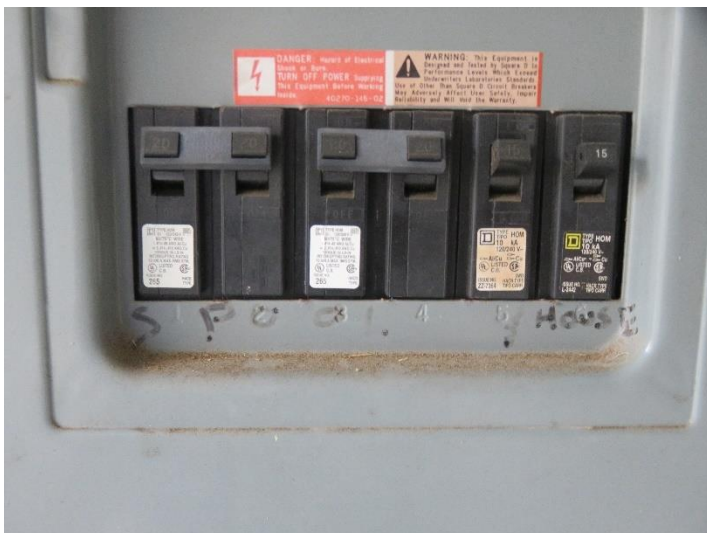
Example at pool sub-panel

- Individual circuit breakers for the home are not labeled in the service entrance panel for specific areas, fixtures and/or appliance as required. General labeling is prohibited. The purpose of an accurate and legible circuit breaker directory is to provide clear identification of the breakers that may need to be operated by service personnel or others who may need to operate a breaker in an emergency. (NEC 408.4)

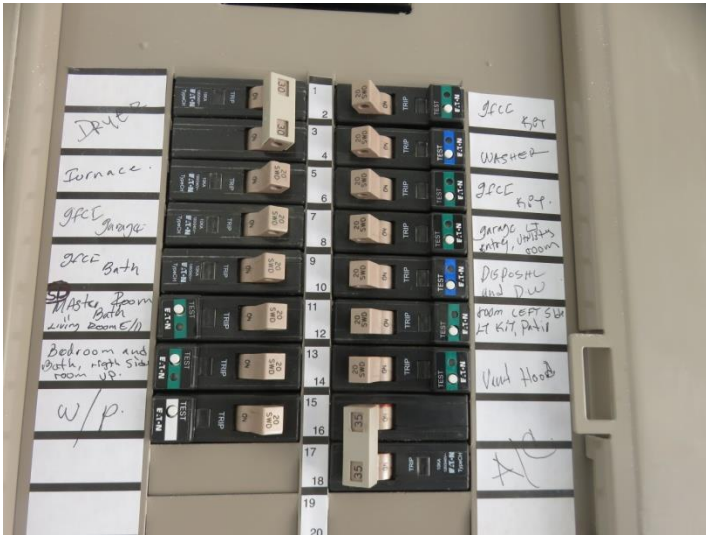
Example

- As of approximately 1/1/2014, 15 and 20 AMP branch circuit outlets in the laundry room, the dishwasher and disposal in the kitchen are required to be wired to a combination AFCI/GFCI circuit breaker.

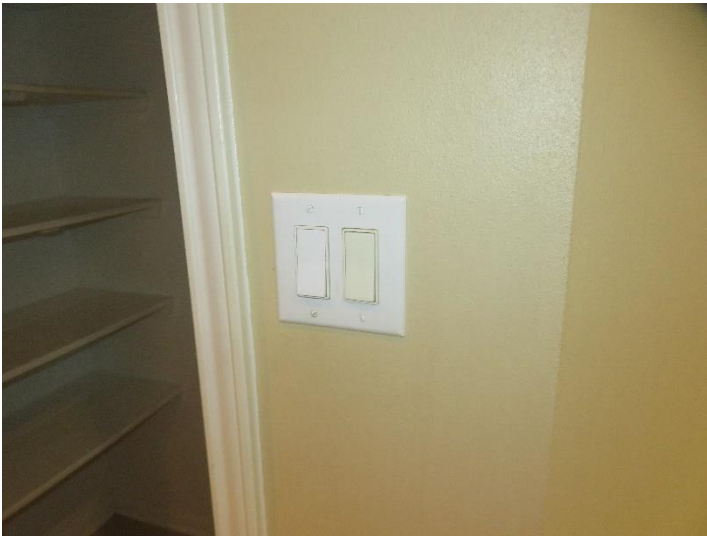
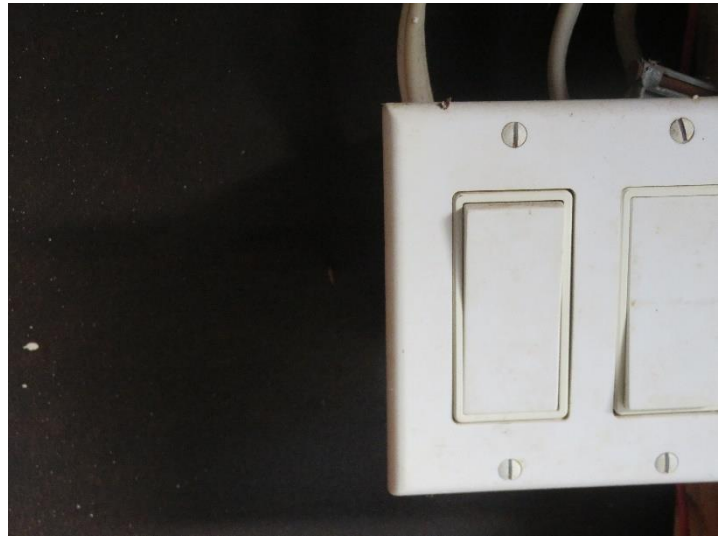
Examples at the kitchen and garage – left switches

- Some switches were unable to be determined for use/purpose.

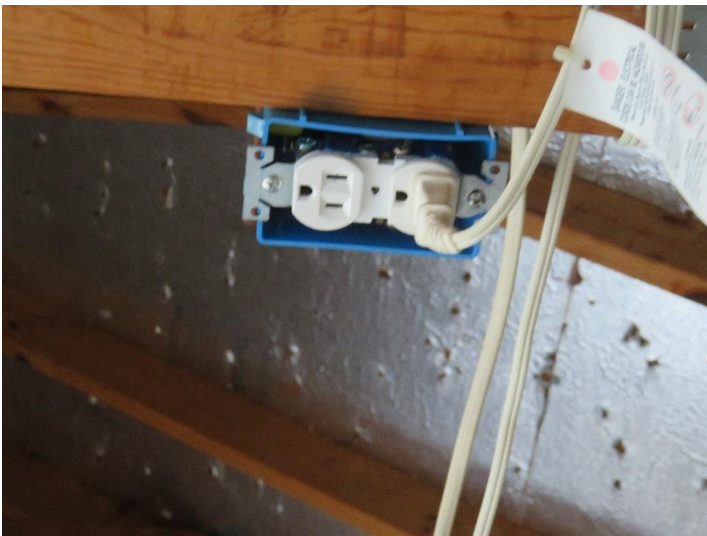
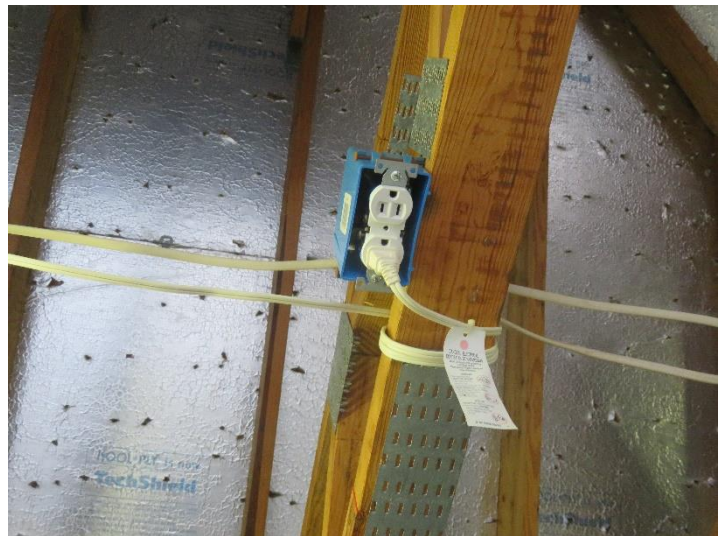
Examples in the garage

- All light switches and outlets are required to be provided safety cover plates.

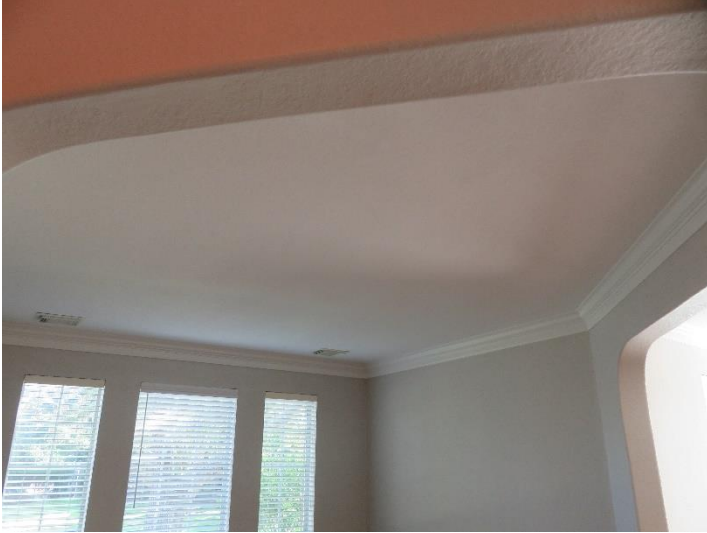
- All living areas are required to have permanently installed lighting fixtures for illumination and safety. The 1st floor center room lacks this accommodation.

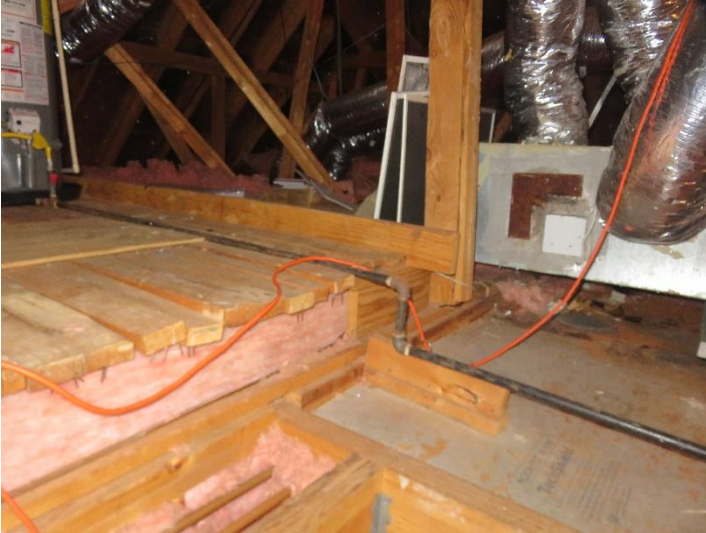
Example in attic

- Extension cords are intended for use as temporary devices. The use of temporary cords as permanent fixtures is a safety hazard. The use of extension cords as a permanent electrical accommodation in the garage or elsewhere should be avoided. Especially important is to remove electrical cords from natural gas piping contact.
