PROPERTY INSPECTION REPORT

“AROUND THE HOUSE” HOME INSPECTIONS

Concerning: 38 Twin Valley Drive, Sugar Land, TX 77479

By: David J. Stiles Inspector Lic. #7308 8/11/2020

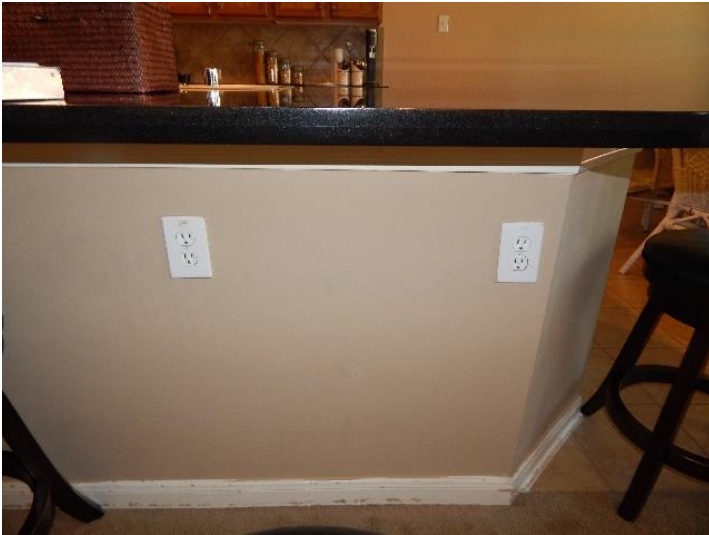
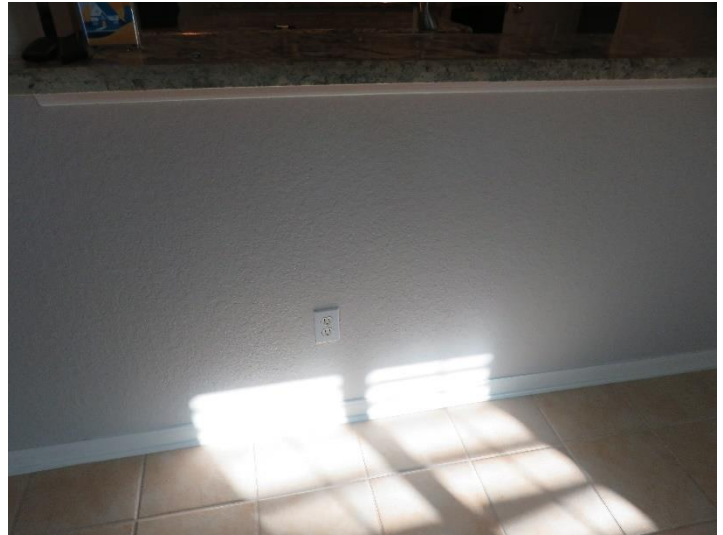
Required and current installation

- The outlet(s) on the family room side/dining side of the kitchen sink countertop are required to be GFCI safety rated and no lower than 12” beneath the countertop for safety of crawling toddlers and smaller children. (IRC 3901.4.5X). While not specifically intended for use at the countertop the outlet is GFCI protected and would undoubtedly be used at the countertop and electrical cords may not reach the outlet of an appliance creating a safety hazard.

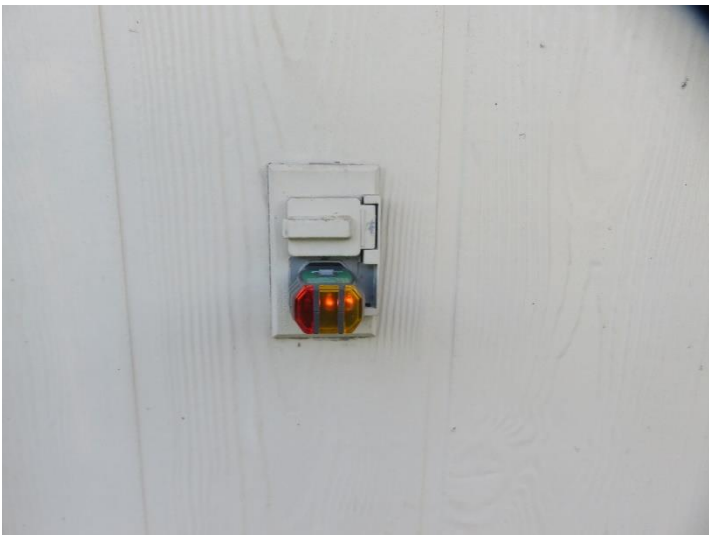
- The outlet at the rear exterior wall of the garage, controlled by a light switch in the garage, lacks GFCI safety protection.

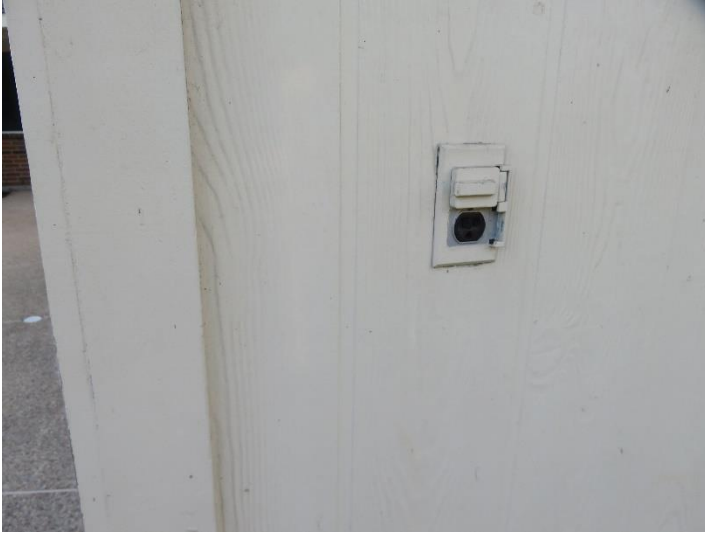
- All exterior outlets are required to be protected from weather elements with an approved cover and/or junction box.

Example of a weatherproof exterior receptacle cover and outlet at the rear exterior wall of the garage

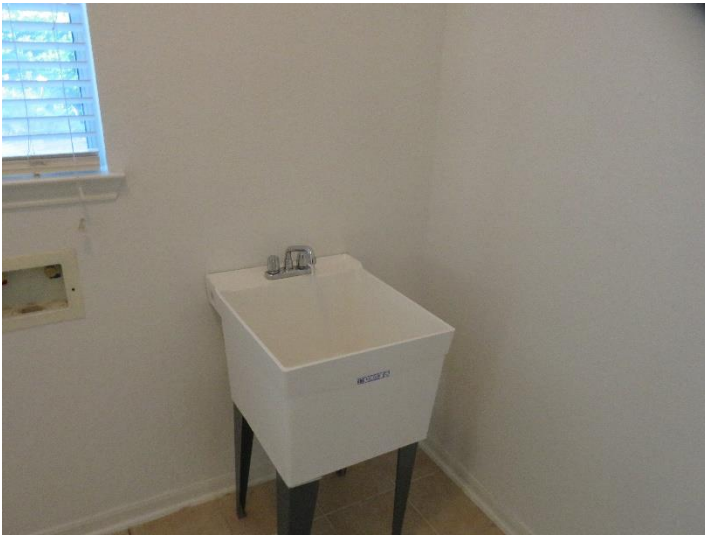
- The wet sink in the laundry room is required to have an electrical outlet that is GFCI safety rated adjacent to the sink.

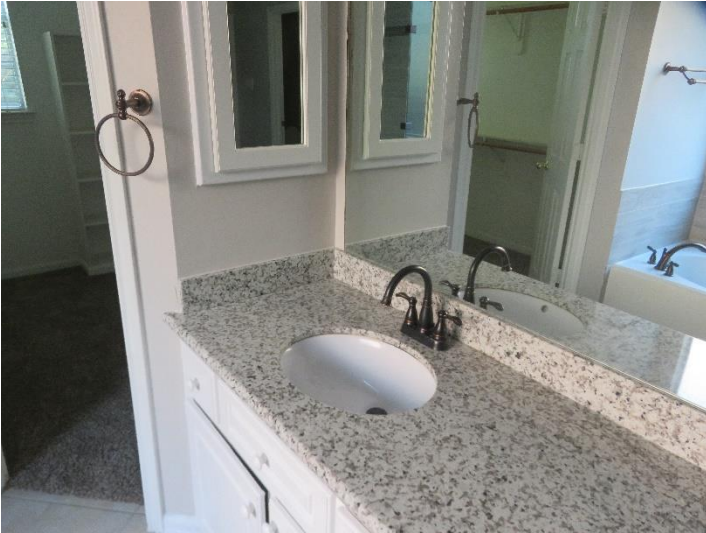
- All bathroom sink outlets are required to be GFCI (Ground Fault Circuit Interrupt) safety rated and installed within 3' of the sink edge. The left sink in the Primary bathroom lacks an outlet.

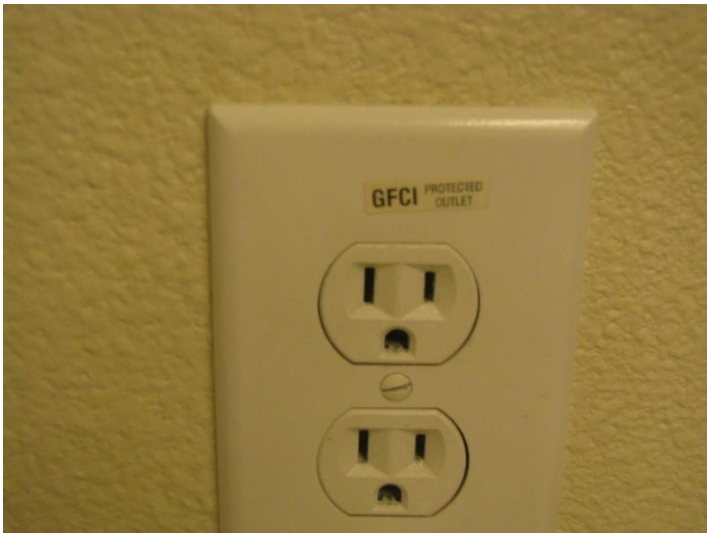
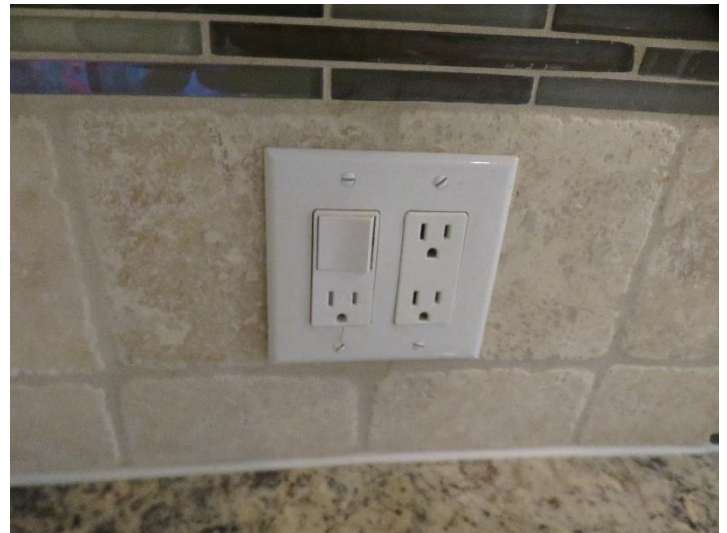
- All GFCI safety outlets should be labeled/marked with the familiar GFCI safety documentation. All garage, kitchen countertop, bathroom and exterior outlets are required to be GFCI safety rated and labeled for identification.

Example of a labeled outlet and installation examples in the kitchen and bathroom lacking labeling

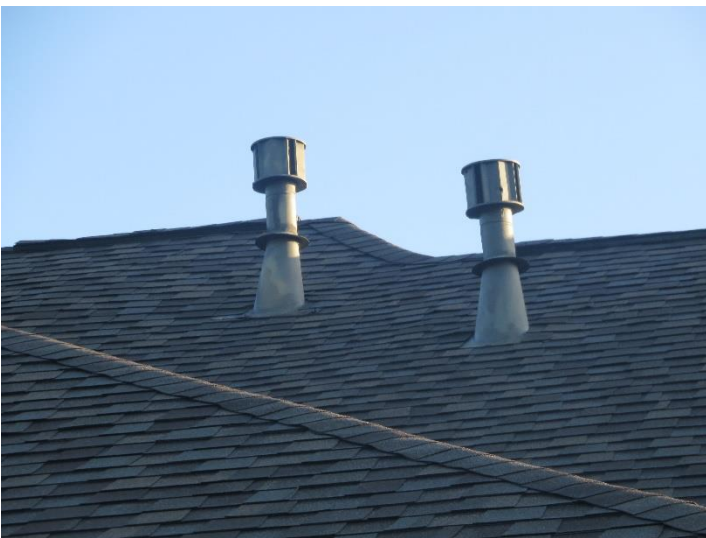
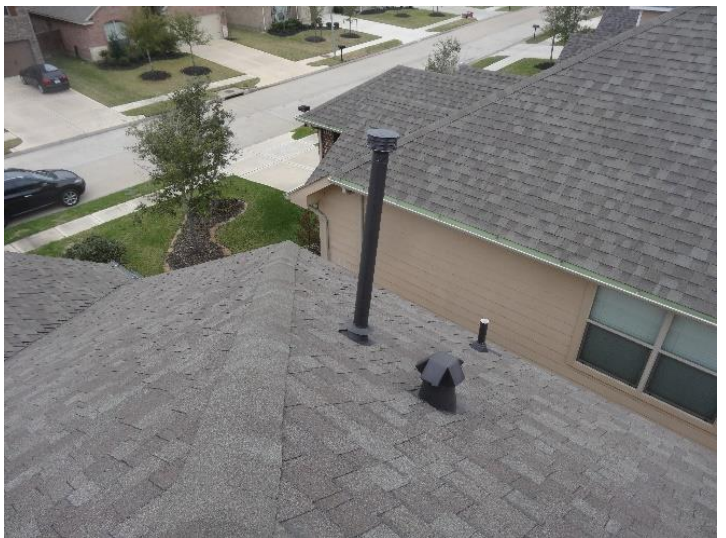
Current installations and required example

- The bottom of the “B” vent exhaust hood for the appliance(s) is required to be at least 24” above the roof deck anywhere within 10’ of any combustible materials and the roof deck. This installation also provides a preventative measure for backflow of gases back to the attic.

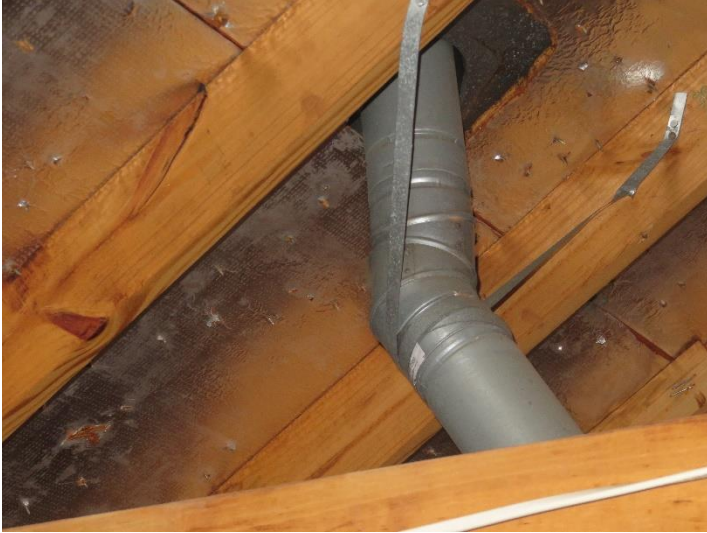
- An exhaust flue in the attic is too close to the combustible materials of the roof deck creating a fire hazard.

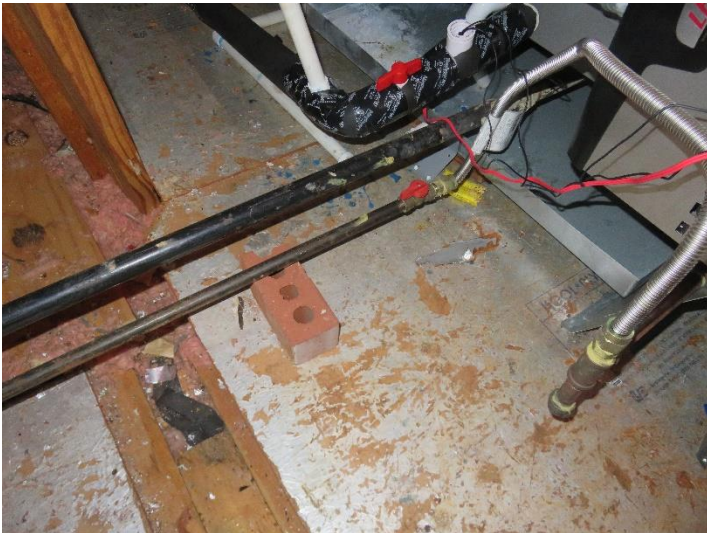
- The natural gas line for the appliance(s) is required to be secured within 12" of the shut-off valve.

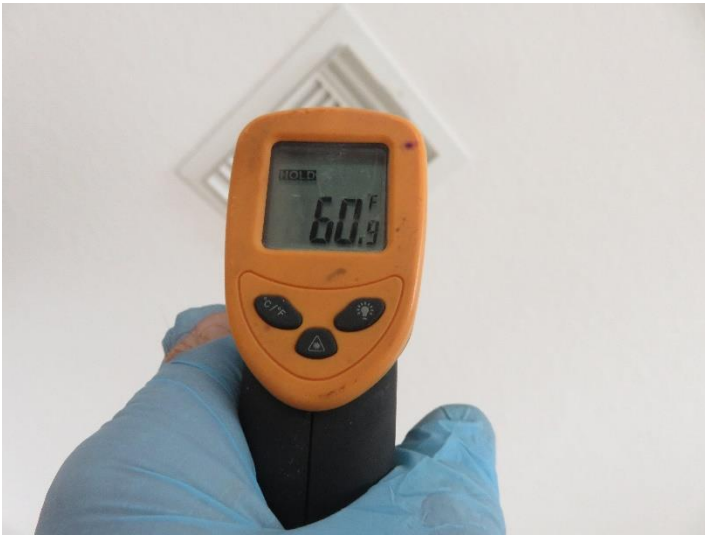
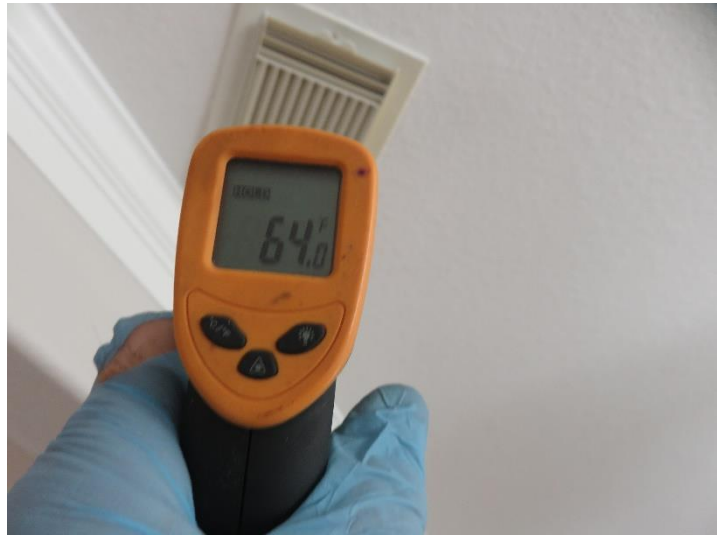
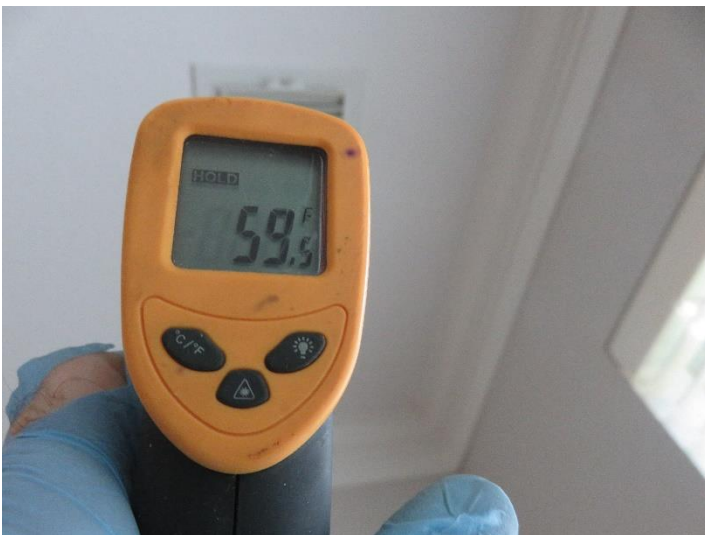
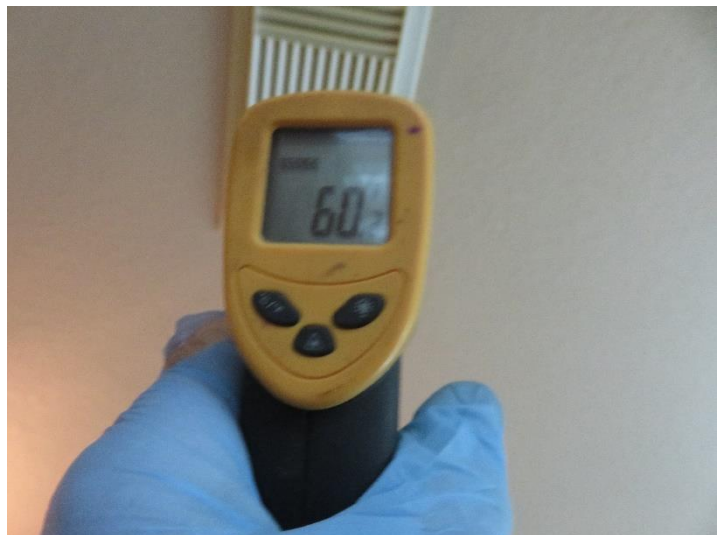
When operationally tested, the temperature differential between supply (conditioned air) and return air measured approximately 8°F to 13°F on the 1st floor and 17°F to 20°F on the 2nd floor. The measurement for the 1st floor was outside the acceptable range of temperature differential of 16°F to 21°F and the units appeared to be installed and functioning as intended at the time of the inspection except as noted by example(s):

- Supply and return temperatures on the 1st floor (8°F to 13°F temperature differential)

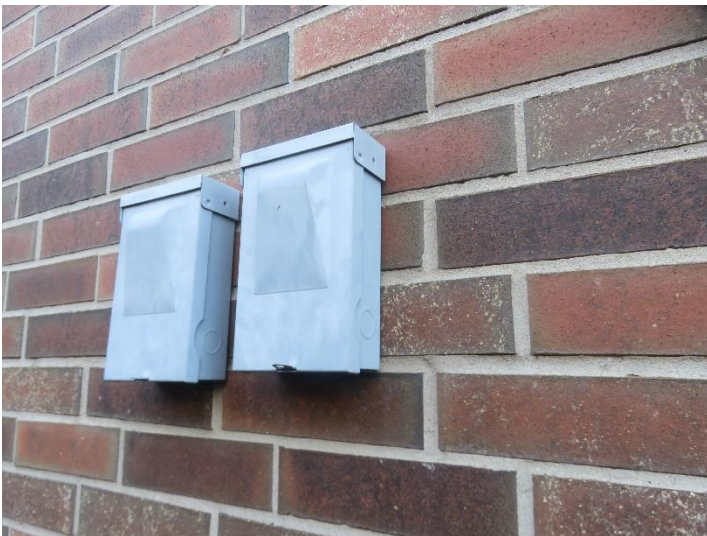
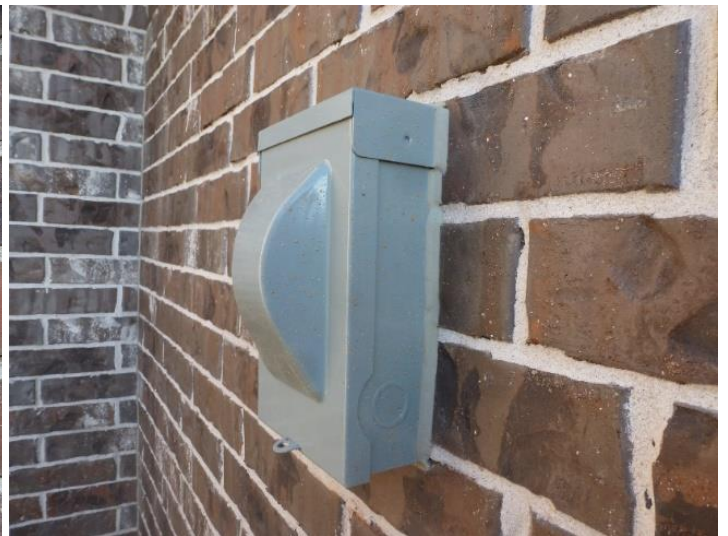
Current and recommended installation

- The mechanic disconnect breaker panel(s) should be caulked around its/their perimeter to prevent water and insect penetration into the wall cavity behind the box(s).

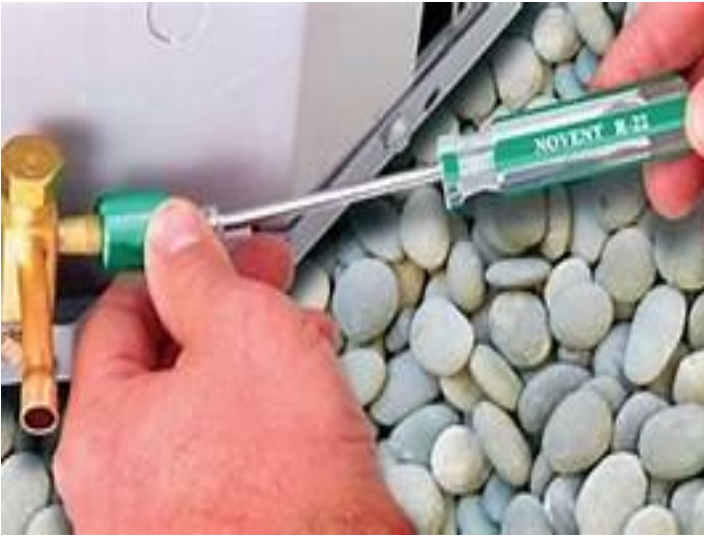
- As of 2009, locking caps for HVAC Freon ports are required and only a licensed HVAC company/contractor can install and/or remove.

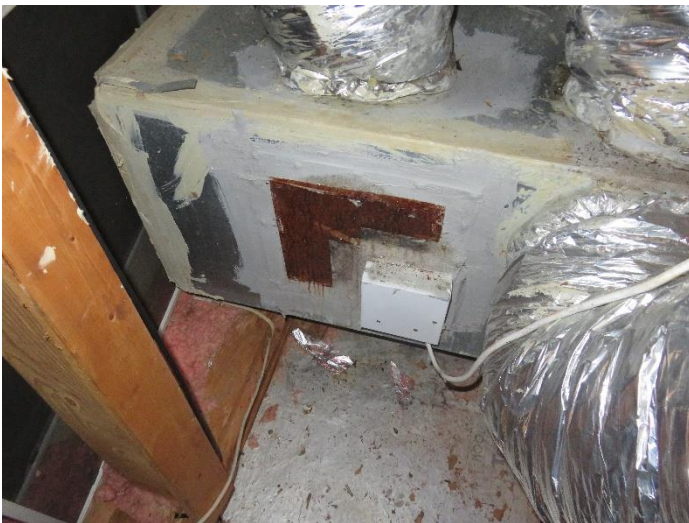
- A unit evaporator coil plenum displays rusting and condensate.

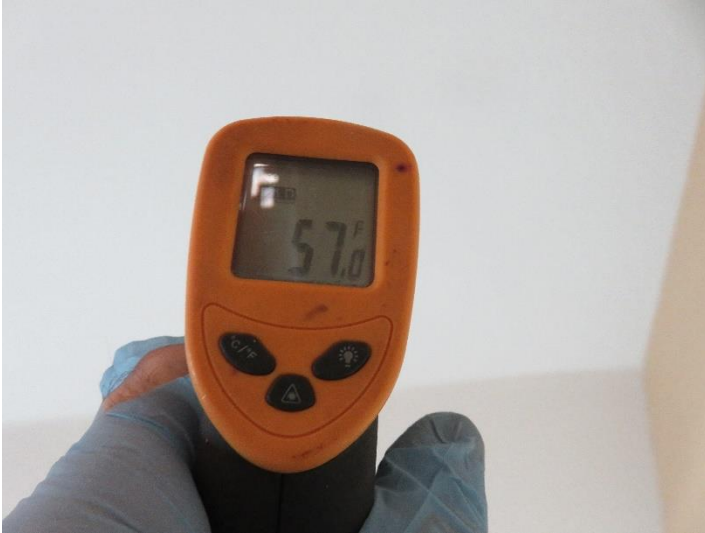
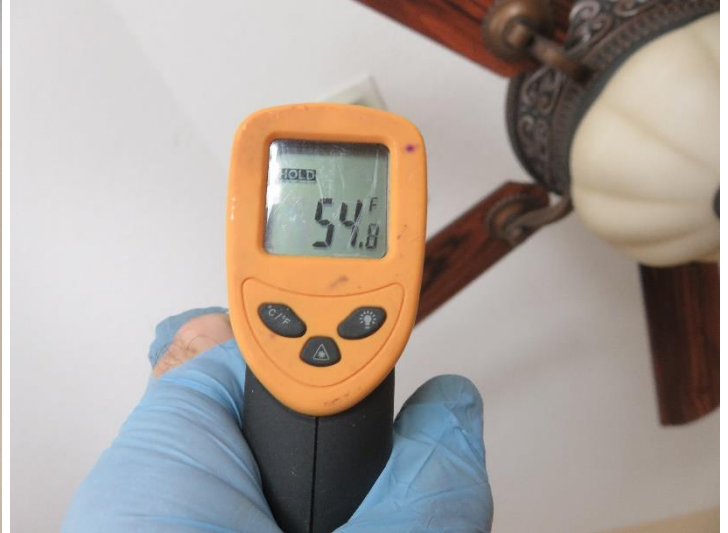
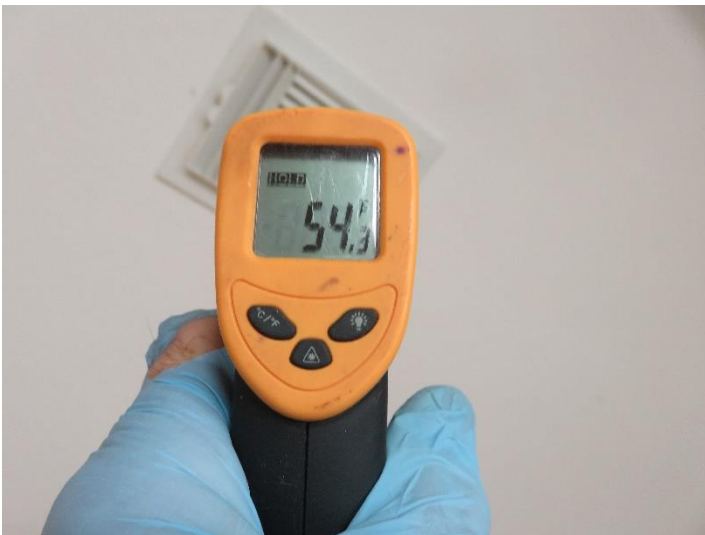
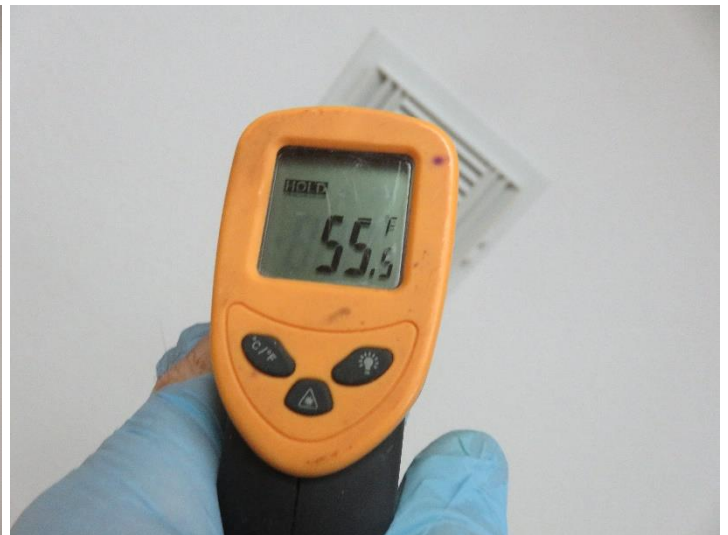
✚ Supply (4) and return temperature examples on the 2nd floor (17°F* to 20°F temperature differential)

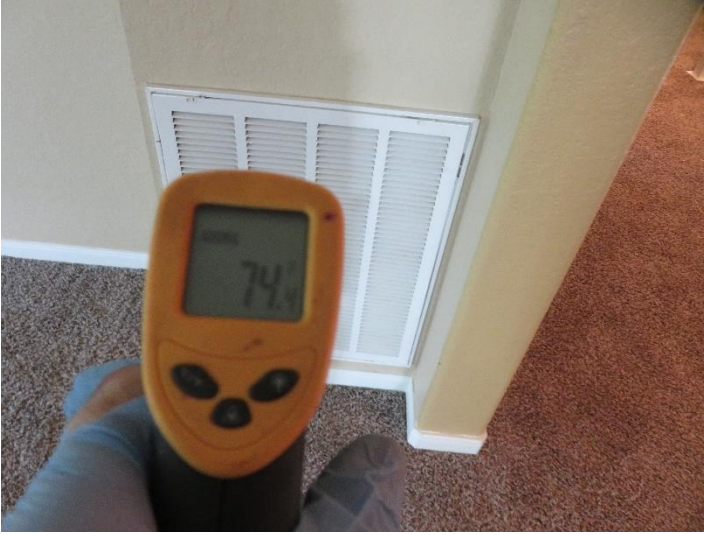
- Due to design, the evaporator coils were not able to be viewed and/or inspected. It is recommended that you have a HVAC contractor fully inspect and report on the internal condition of the evaporator coils prior to the end of the option/discovery period.

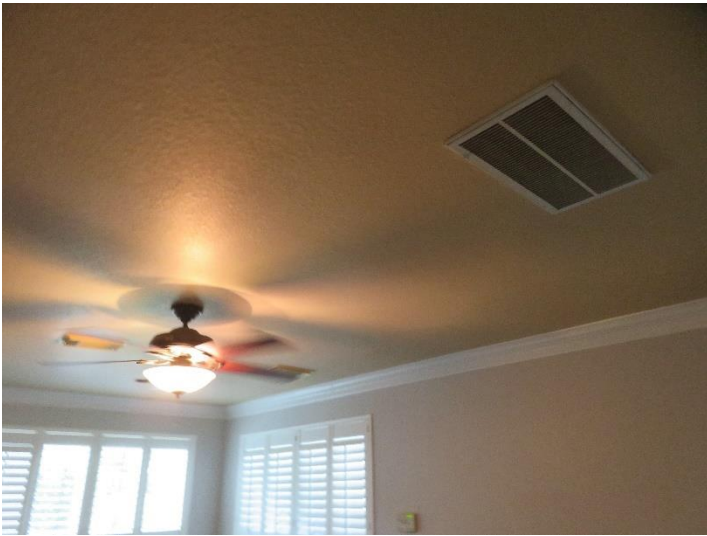
Example in the Primary bedroom

- By current Code, each living area room (common areas and bedrooms) are required to have a source of return air to the furnace/AC coil in the attic. Bedrooms, othe than the Primary, lack this accommodation.

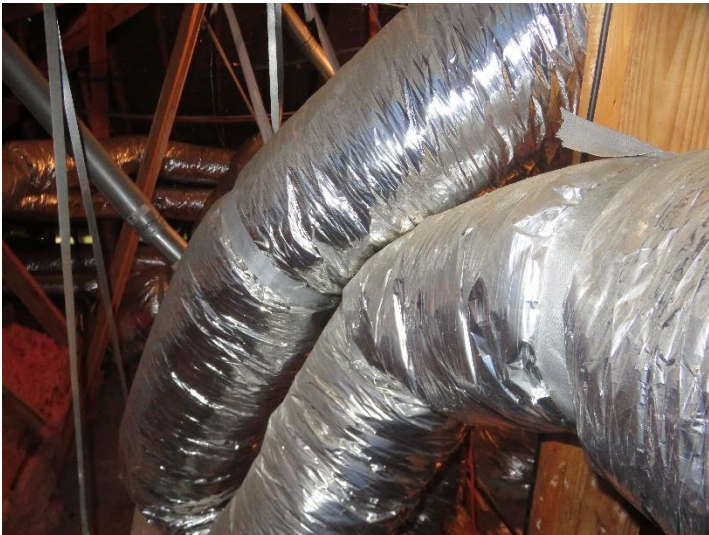
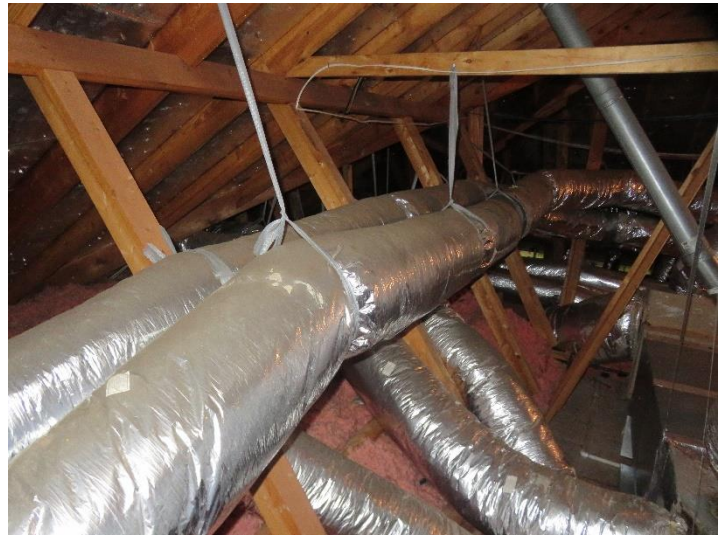
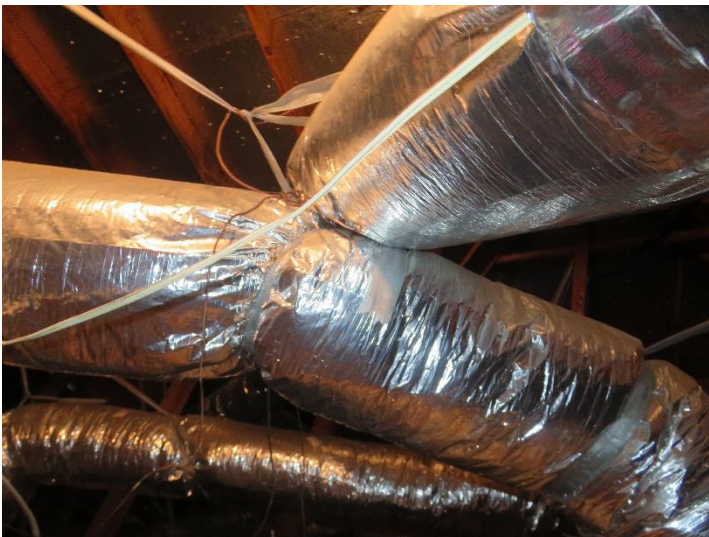
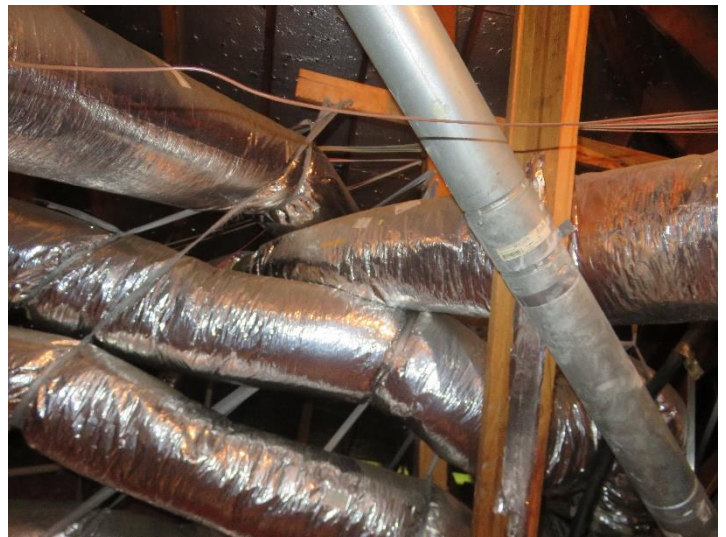
Examples

- Attic ductwork in general is prohibited from touching/coming into contact with other ductwork or installed lying on the attic floor. Insulation placed between sections is not a remedy. Damaging condensation can result.

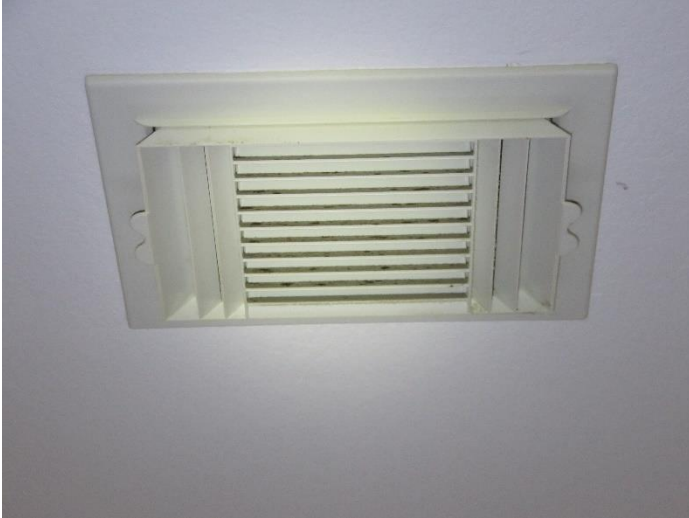
- Some supply registers display significant dirt and dust from previous use. It would be suggested that the return and supply registers as well as the ductwork be inspected by a professional company and cleaned and sanitized.

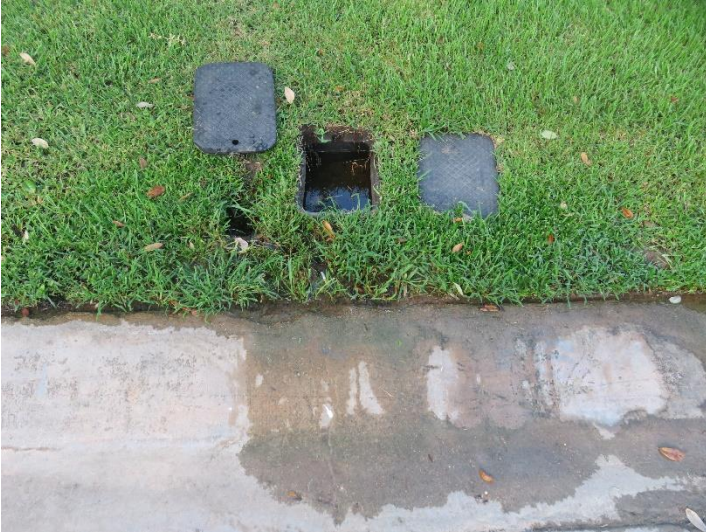
- The water meter(s) appear to be leaking.

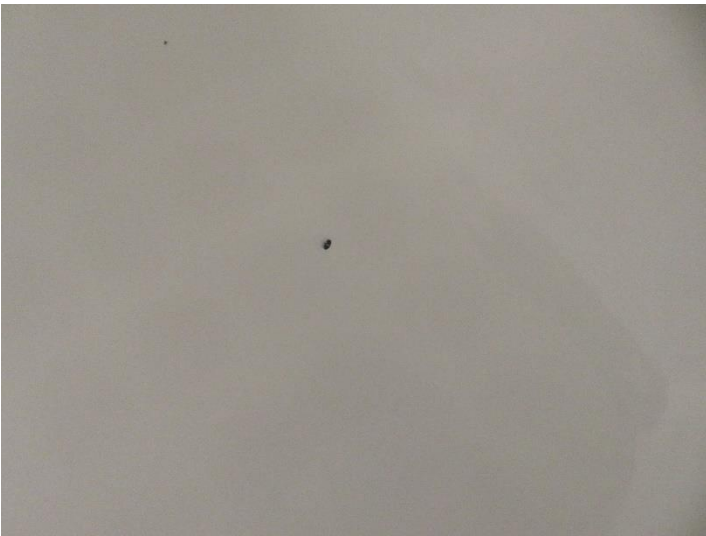
- A 2nd floor guest bathtub displays a chip in its surface.

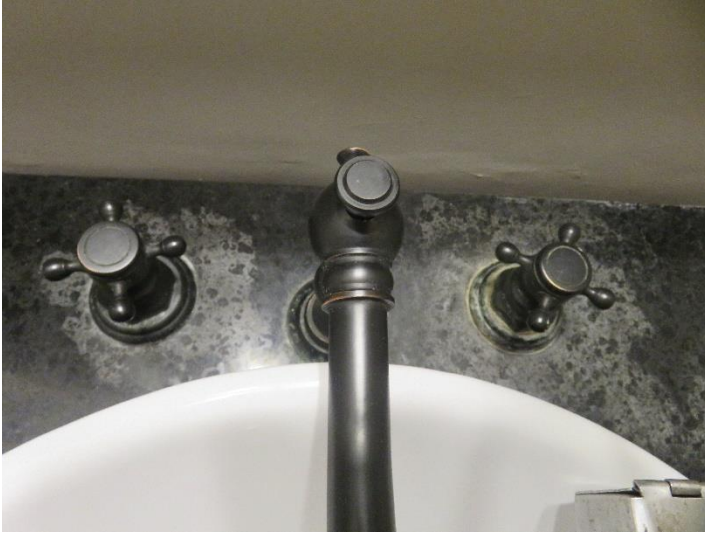
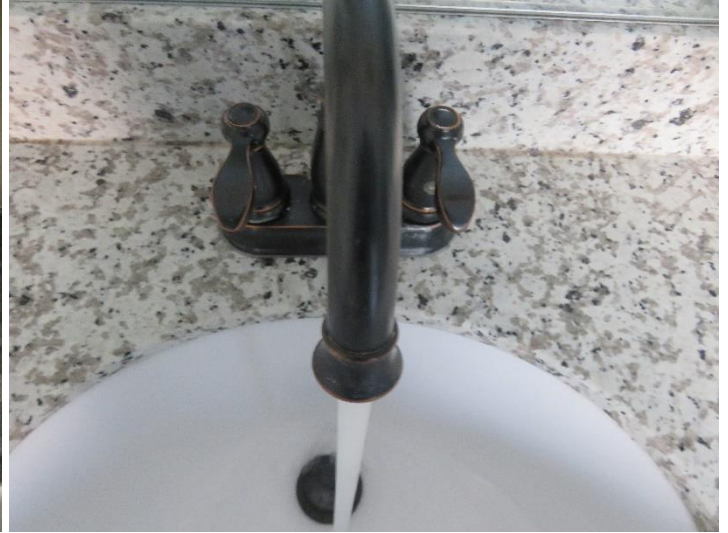
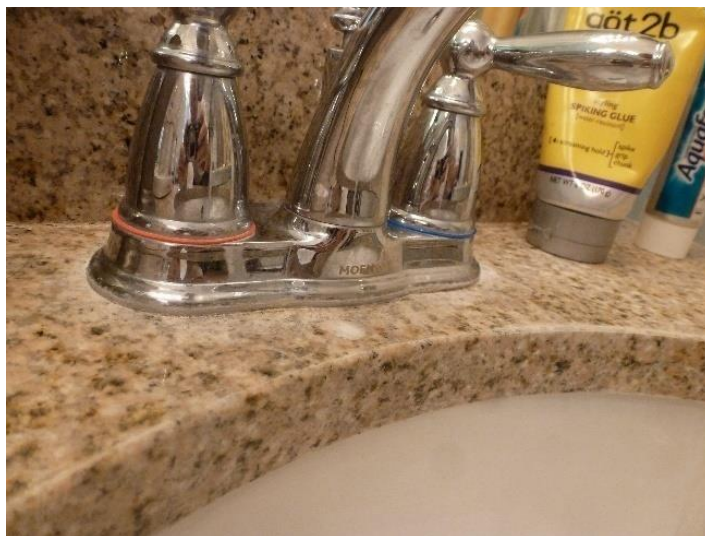
Current installations and example of labeling

- All water supply faucets should be marked by color coding, engraving or other means to identify each handle for water temperature orientation. This includes the washing machine faucets handles.

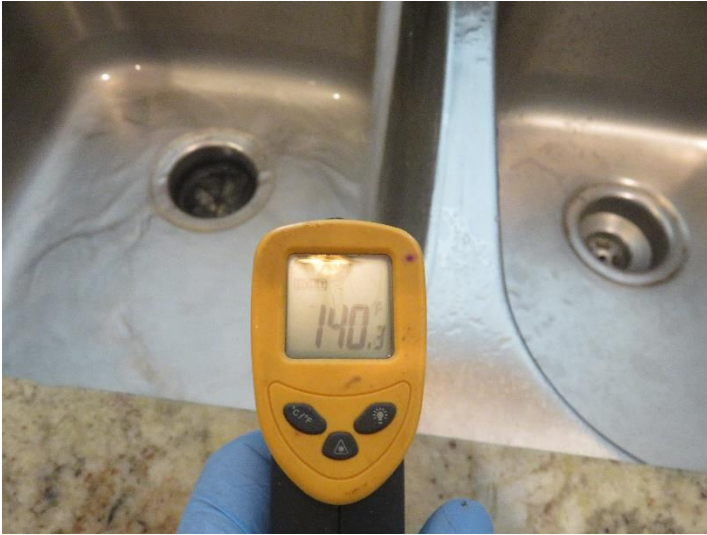
- The water temperature as recorded at sinks was too hot. Temperatures in excess of 120°F can cause severe burns and scalding.

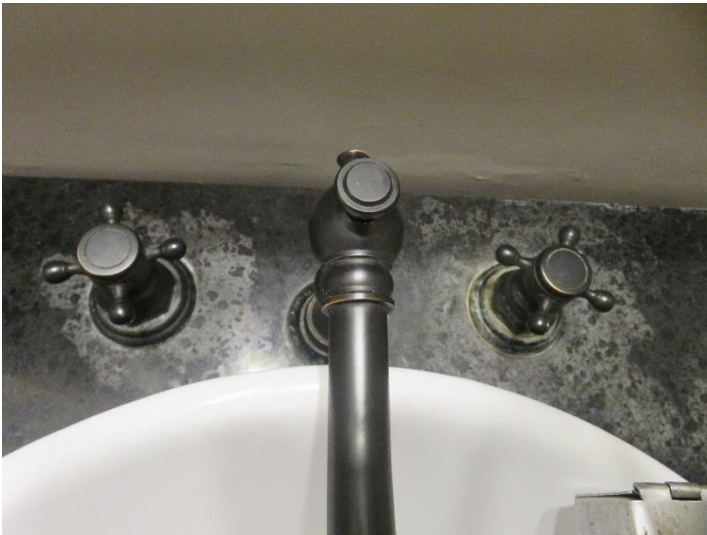
- Water pressure at the 1st floor half-bath lacked adequate water pressure and the hot water handle is loose/wobbly.

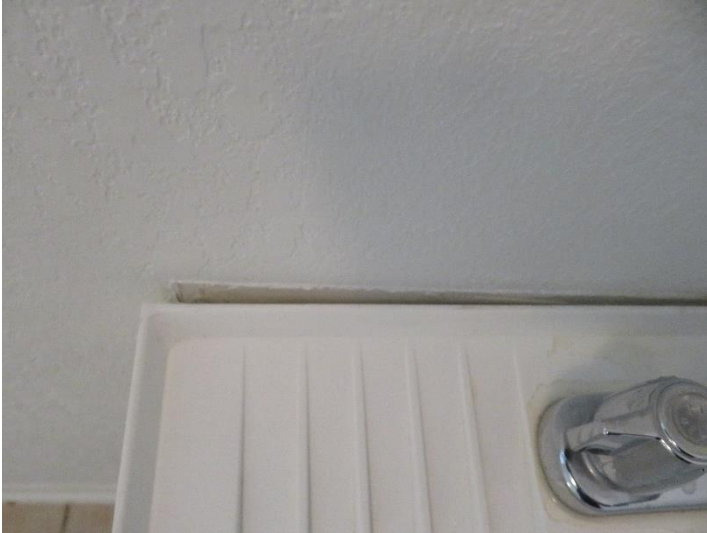
- The laundry room sink is not secure.

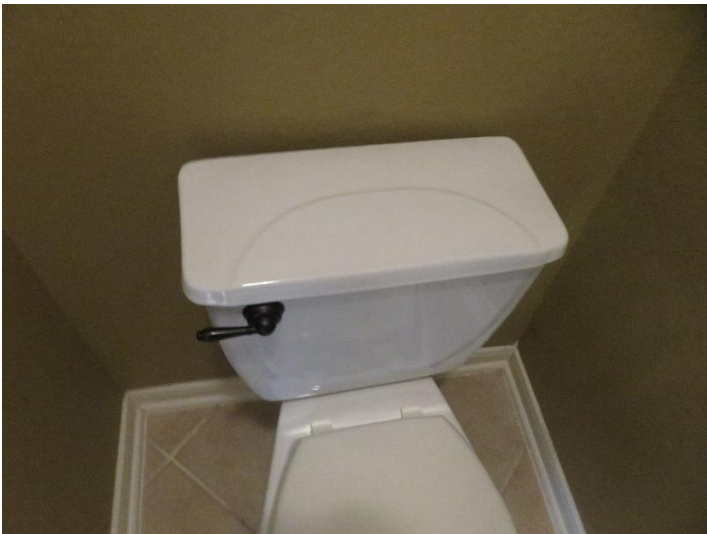
- The Primary bathroom toilet tank is loose.

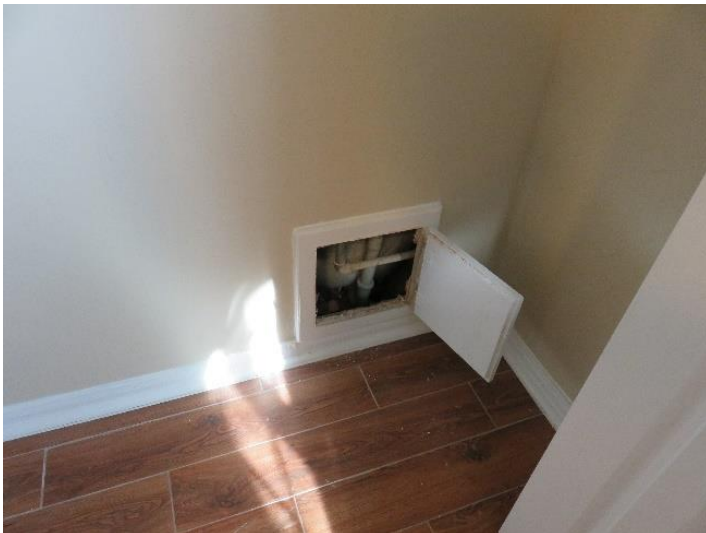
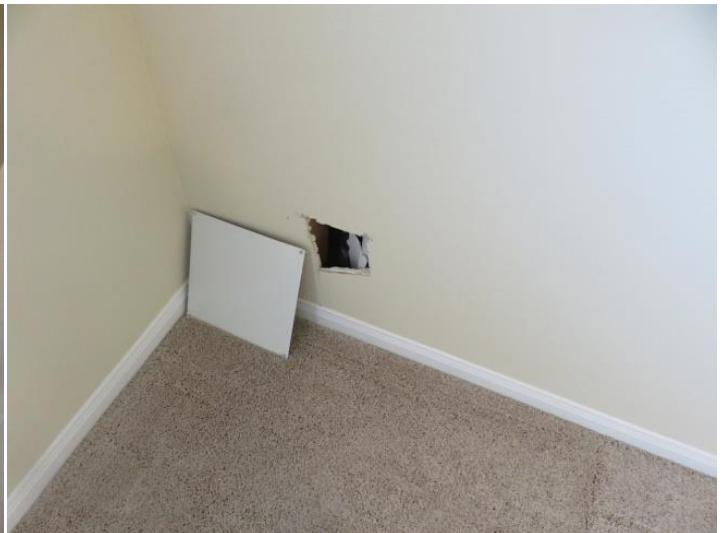
Examples of opening for drain and plumbing inspection

- To readily access plumbing connections in bathrooms for showers and bathtubs it is a required procedure to have access openings installed in walls adjacent to/behind in-wall plumbing fixtures. An access opening at least 12" X 12" is required for repair or replacement of concealed slip joints. The opening can be a ceiling or a wall. {IRC 33201.1} (UPC 404.2)

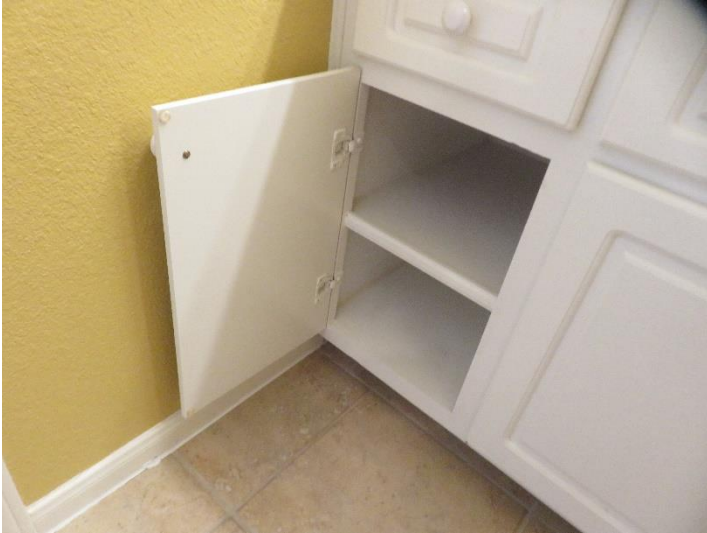
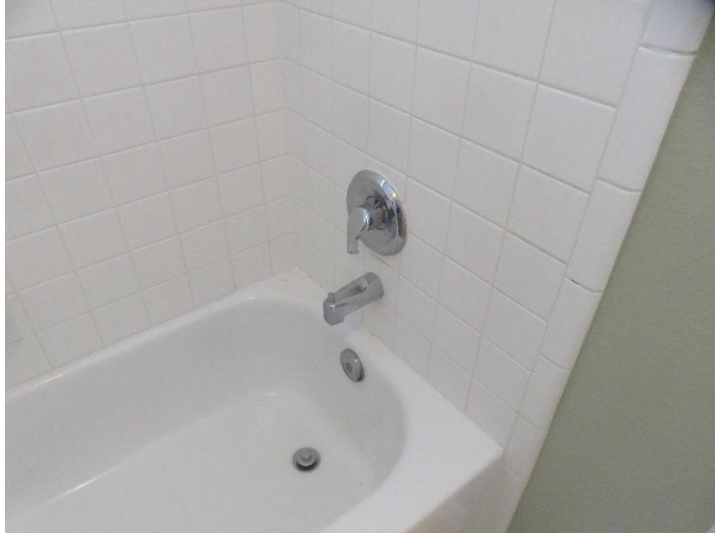
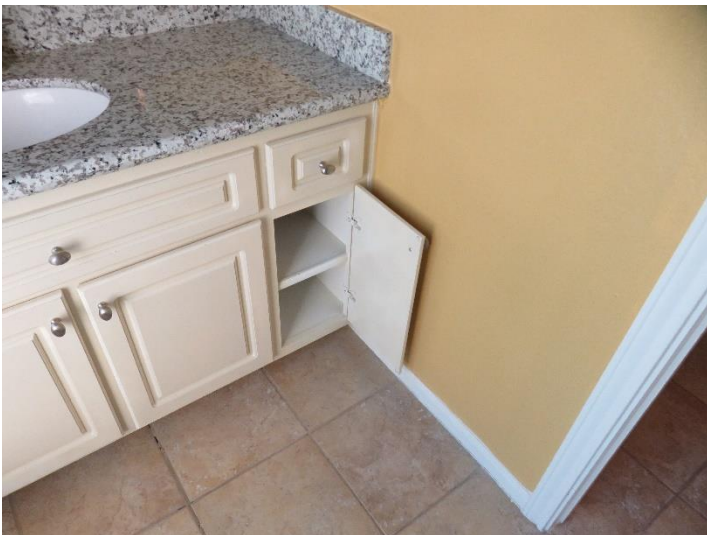
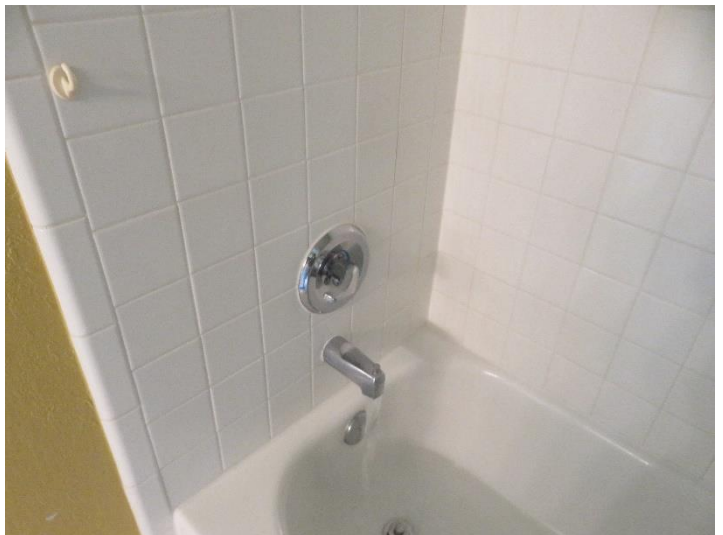
Examples on the 2nd floor at bathtubs lacking ready access

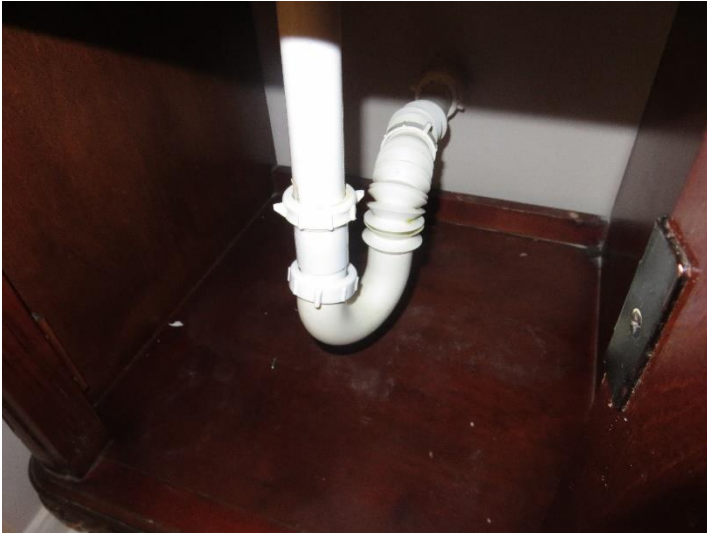
- The 1st floor half-bath sink drain piping is ribbed. Ribbed drain piping should be avoided as they will tend to collect dirt and clog drains.

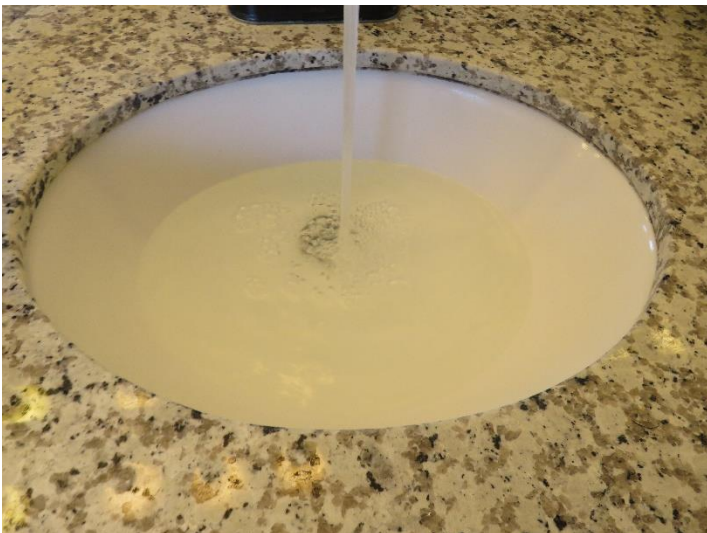
- The right sink in the Primary bathroom does not readily drain.

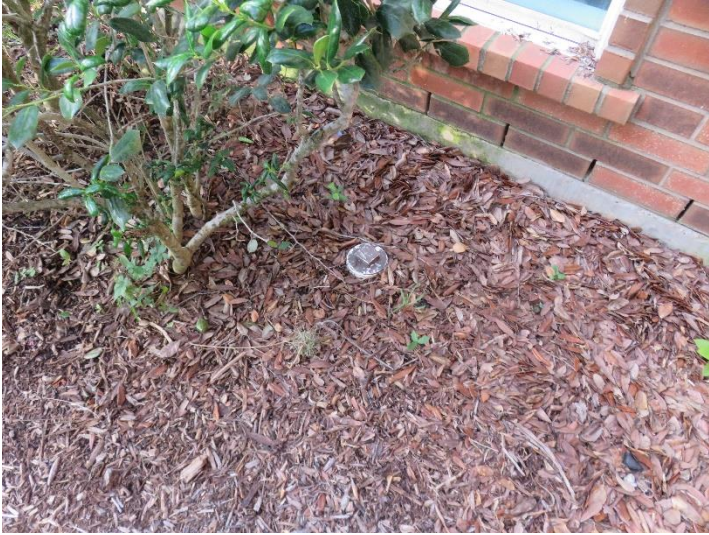
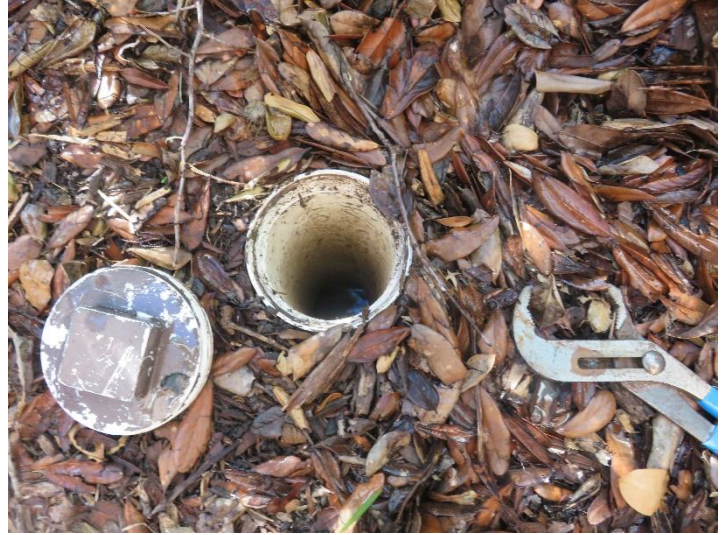
✚ The main drain clean-out for the home is located at the left front flower beds.

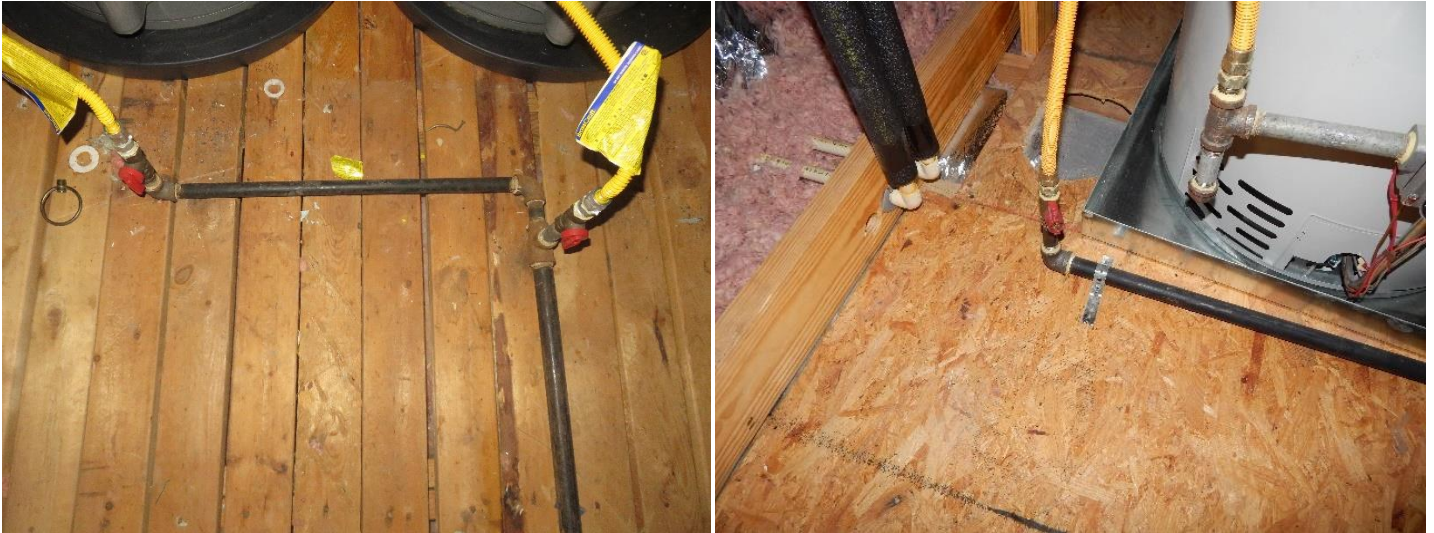
Current installation and example of a secured gas supply line

- The natural gas line for the appliance(s) is required to be secured within 12” of the shut-off valve.

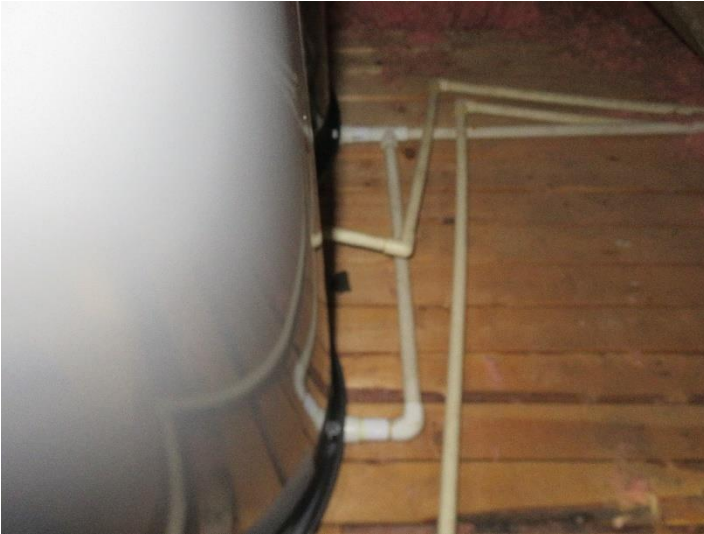
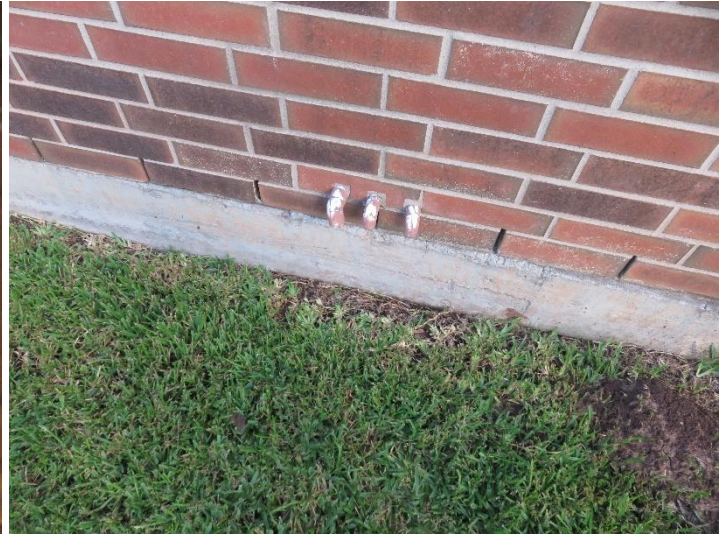
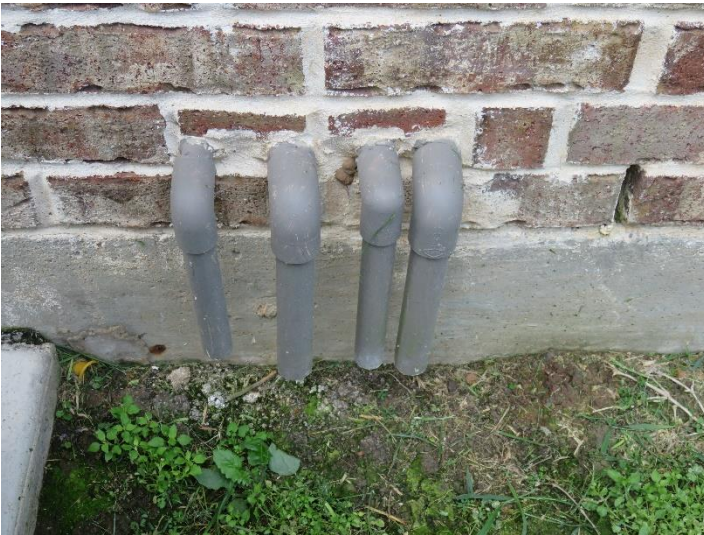
Current with drain pan drain lines connected and required installation

- Each T&P safety relief valve should have its own drain line as well as each drip pan beneath each water heaters should be individual to each appliance. There should be four (4) drain lines for the water heaters. The pan drain lines are combined in the attic.

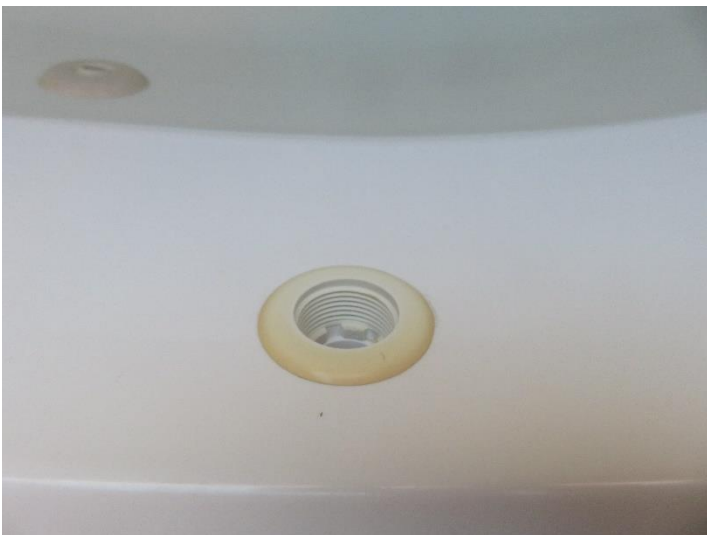
- The near side air volume dial has been removed.
