PROPERTY INSPECTION REPORT

“AROUND THE HOUSE” HOME INSPECTIONS

Concerning: 38 Twin Valley Drive, Sugar Land, TX 77479

By: David J. Stiles Inspector Lic. #7308 8/11/2020

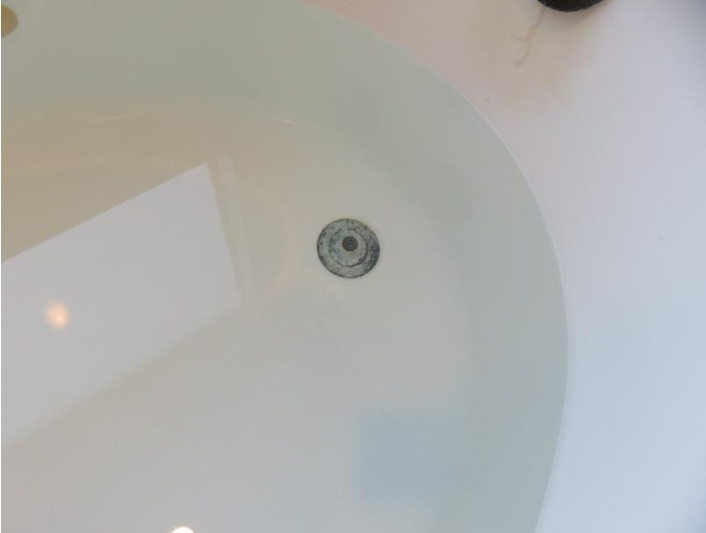
- The drain stopper does not hold water in the tub.

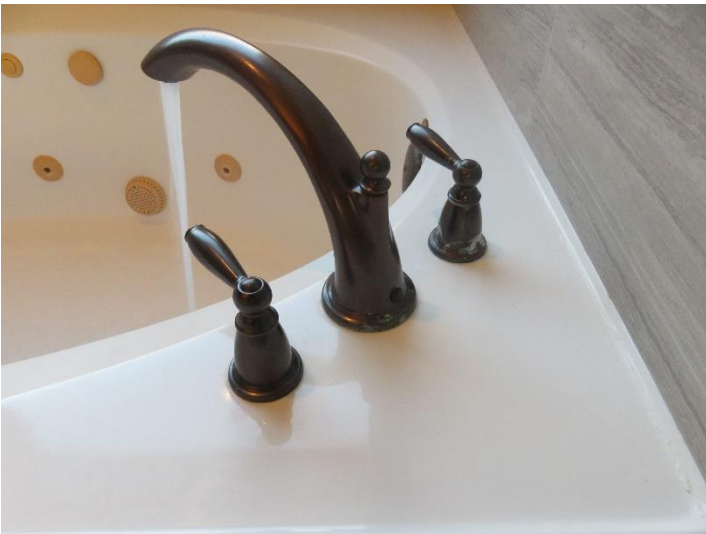
- The faucets handles should be accurately labeled for hot and cold water temperature orientation.

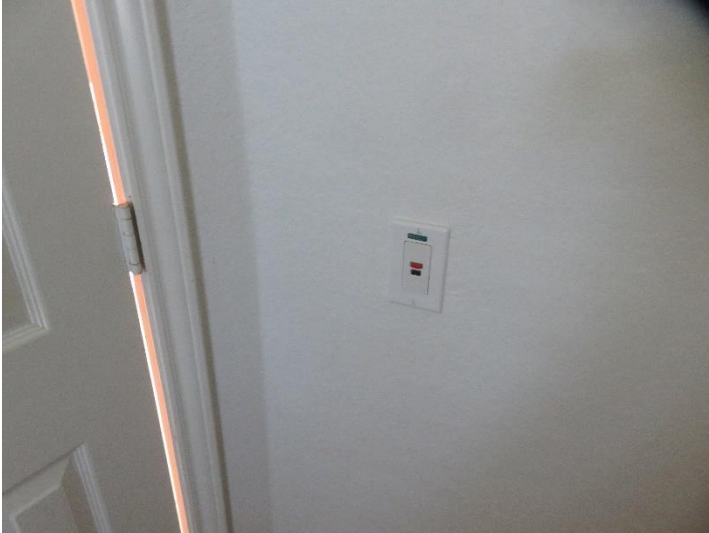
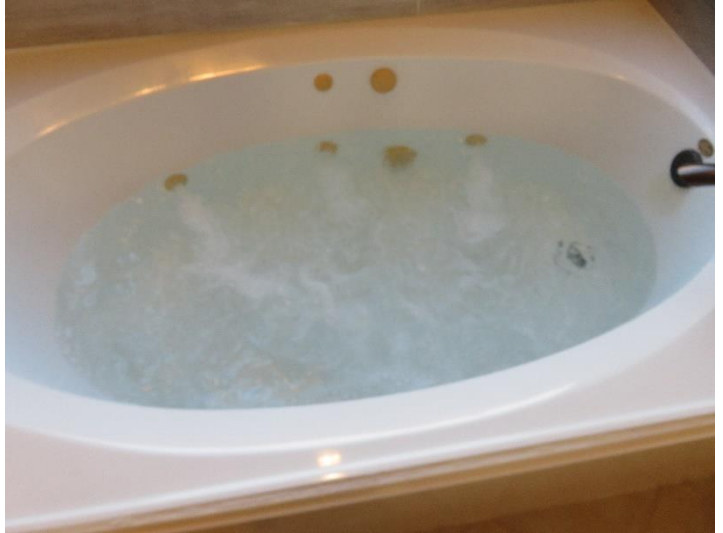
✚ The Jacuzzi is equipped with a GFCI safety outlet located in the bathroom closet.

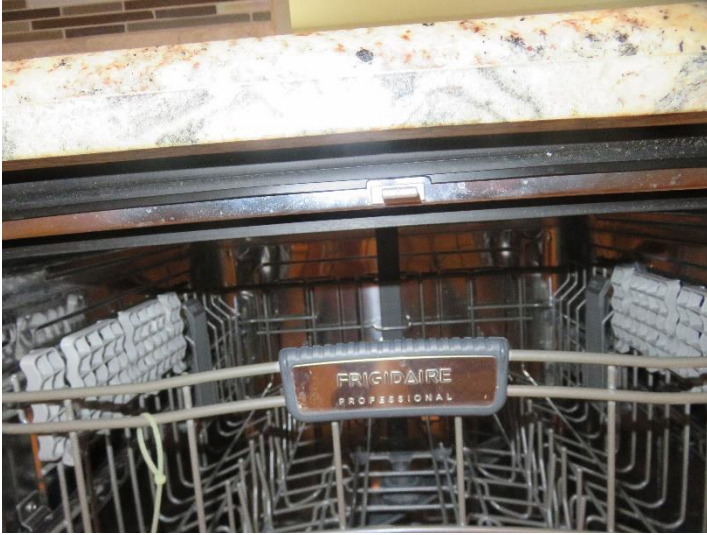
- The appliance is not secure beneath the countertop. It can easily tip forward.

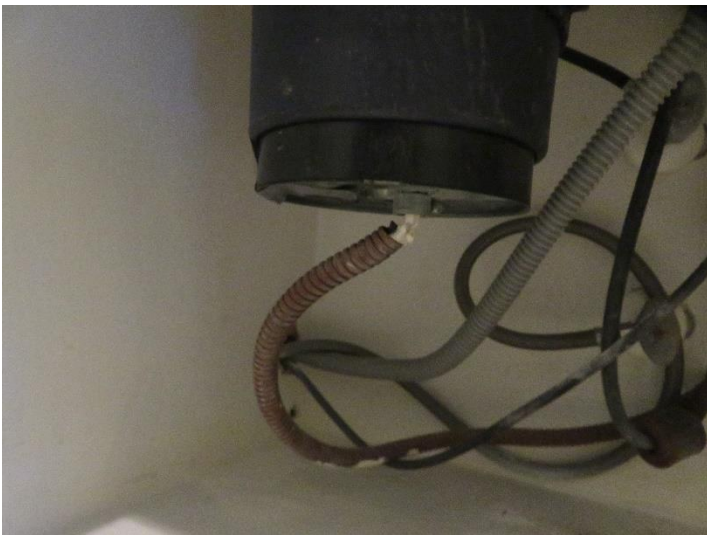
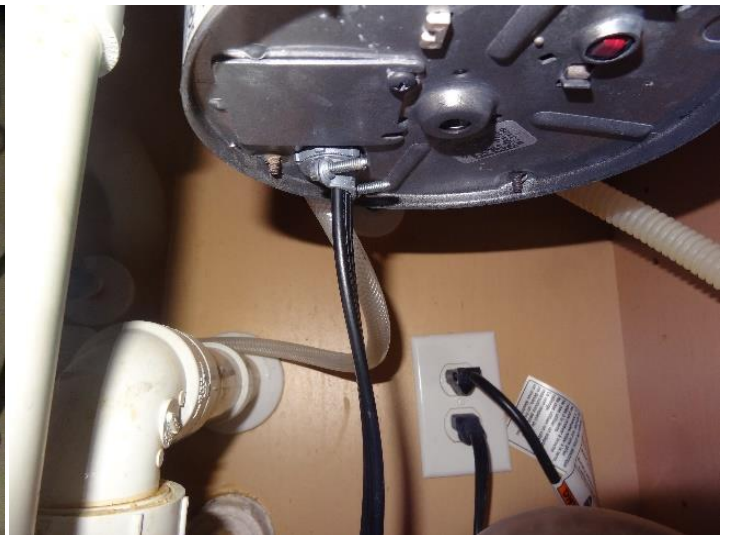
Current installation and example of required wire protection

- The wiring penetrating the bottom of the appliance lacks the protective grommet required to assist in preventing the wire from being damaged by the sharp edges of the housing.

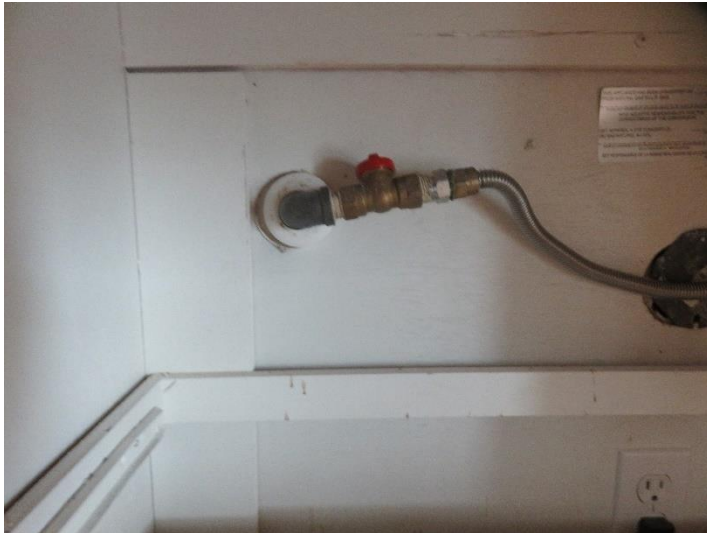
- Following the completion of operating the cook top a strong aroma of natural gas was present. The valve was turned OFF but should be inspected by a licensed plumber for proper installation.

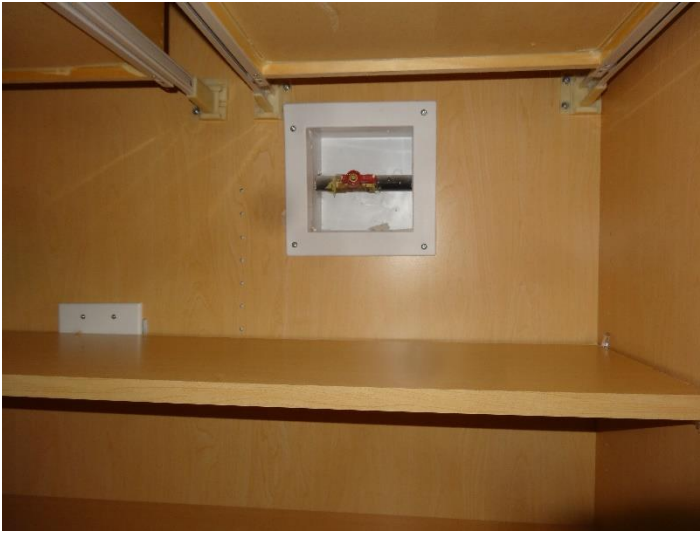
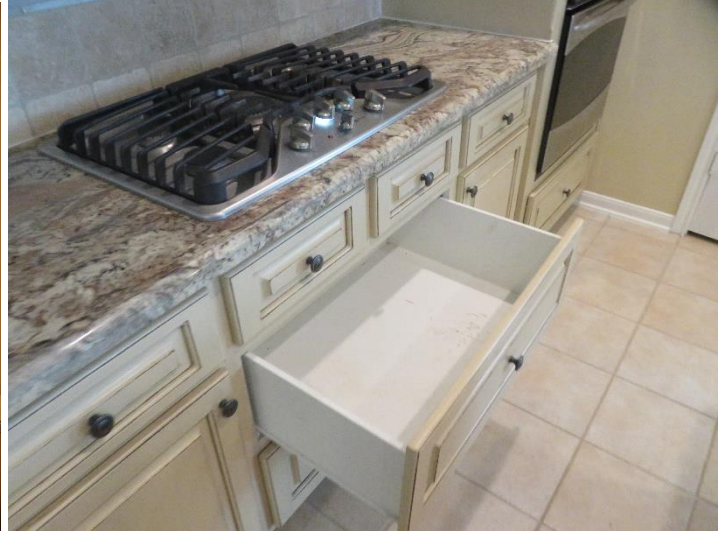
Example in a lower cabinet to the side of an appliance and current installation behind pull out drawer

- The emergency gas shut-off valve for the cook top is located directly to the rear of the appliance. It is neither visible nor accessible. In the event of an emergency and the need to cut the flow of natural gas to the appliance it is preferred that the shut-off valve be located in the lower cabinet to the right or left of the appliance. In the interest of safety, the emergency gas valve is required to be relocated.

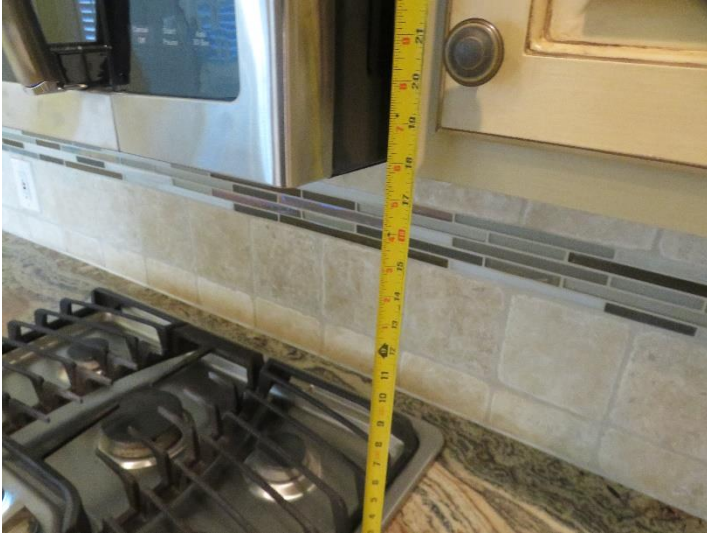
⚠ Be mindful of the limited distance between the natural gas cook top and bottom of the microwave oven.

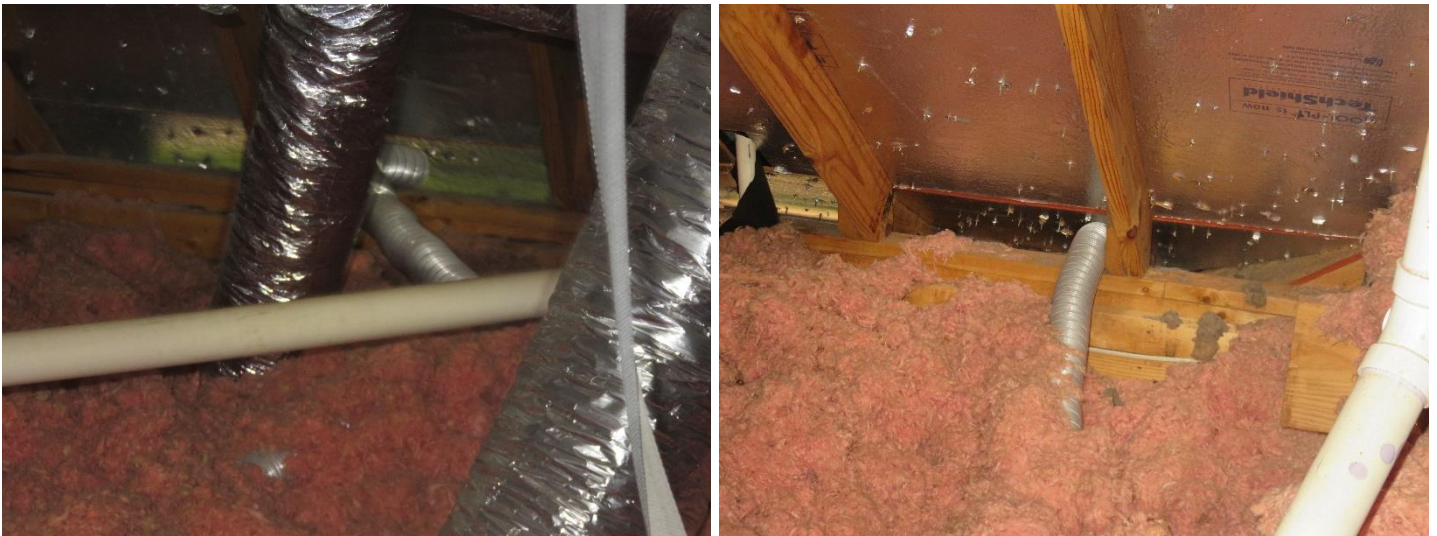
Examples of bathroom ductwork extending through the attic to the roof edge soffits

- Bathroom and laundry room (lacking openable windows) exhaust ductwork is required to exit outside the home to fresh air either through a hood at the sidewall of the home or directly through the roof with approved hoods. Attic exhaust ducts terminate at the soffit roof edge where hot, humid air can deteriorate roof decking and soffits. Air must be exhausted directly to the outside – 2006 IRC [303.3X]. May not discharge to crawlspace or attic – 2006 IRC [1506.2]

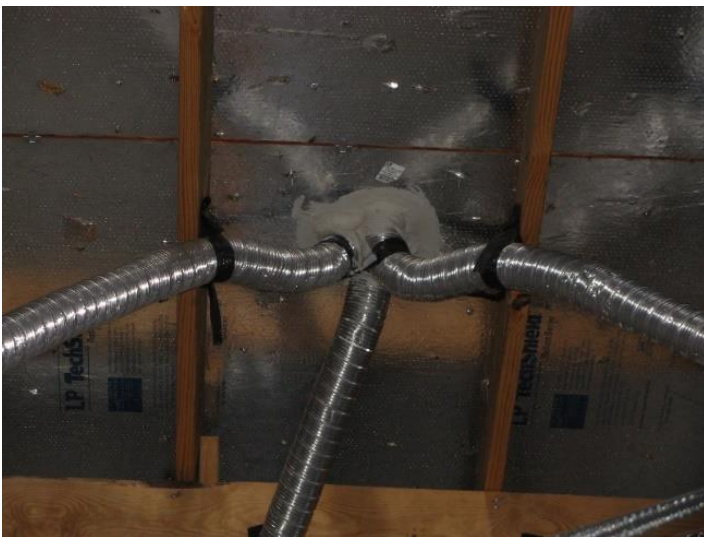
Example of sealed ductwork

- Exhaust fan ductwork in the attic rising through the roof deck should be sealed.

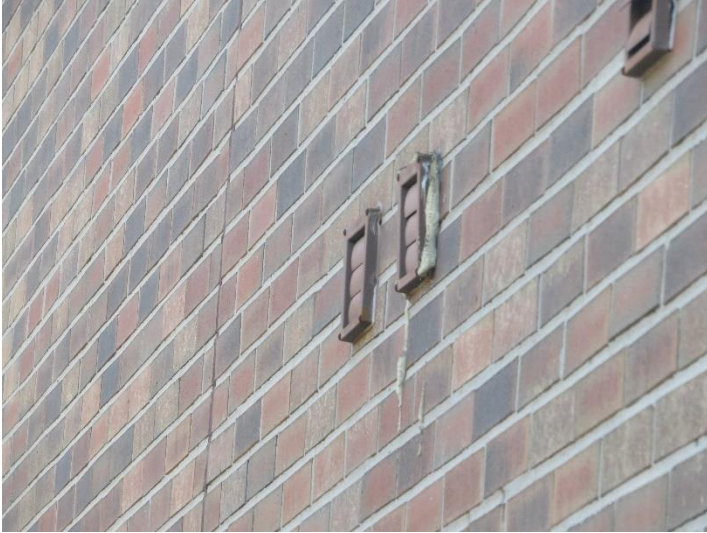
- The Primary bathroom toilet (center hood with foam) area exhaust fan did not open the louvered hood when in operation.

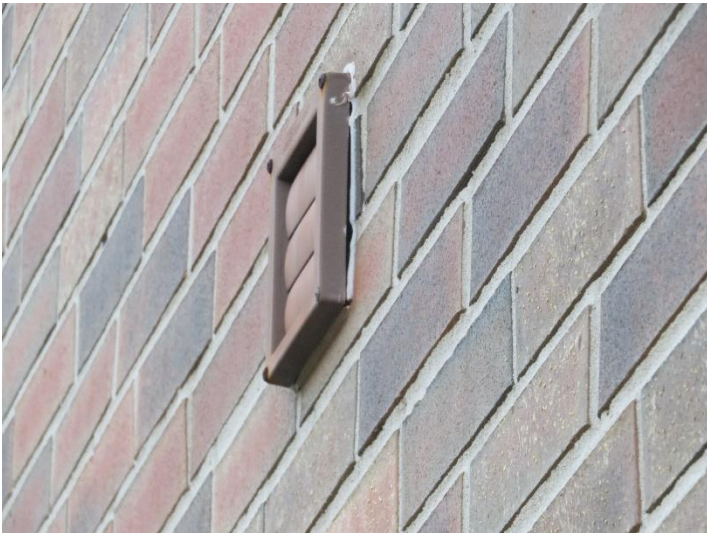
- All exterior hoods should be fully caulked around their perimeter.

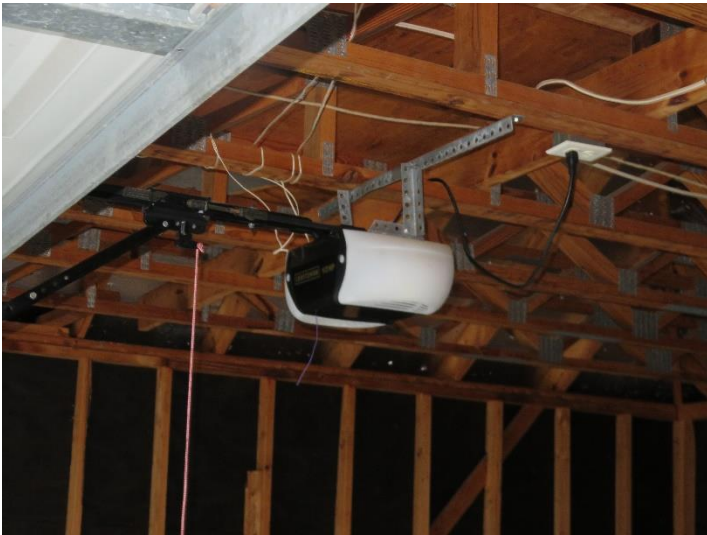
- The garage panel light did not illuminate.

- The ground level safety beam/eyes should trigger the panel lighting when the beam is broken for safety at night or during dark periods.

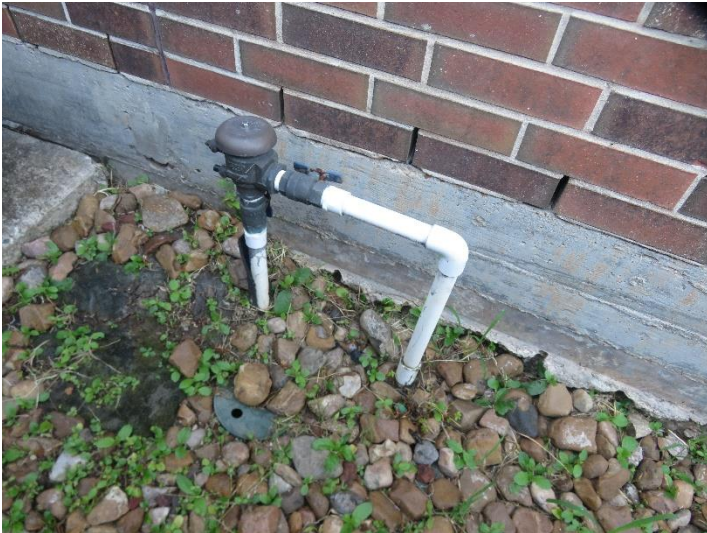
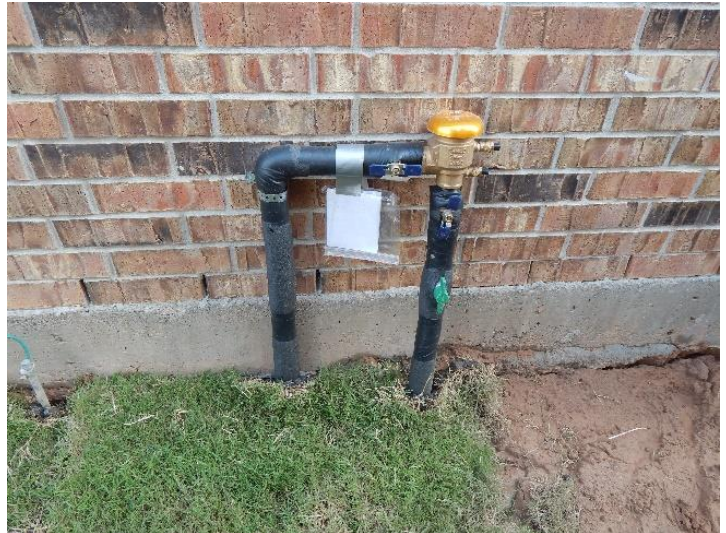
Current and recommended installation

- The backflow preventer should be secured to the structure to prevent accidental movement and damage and the exposed piping of the sprinkler system should be insulated against winter cold weather.

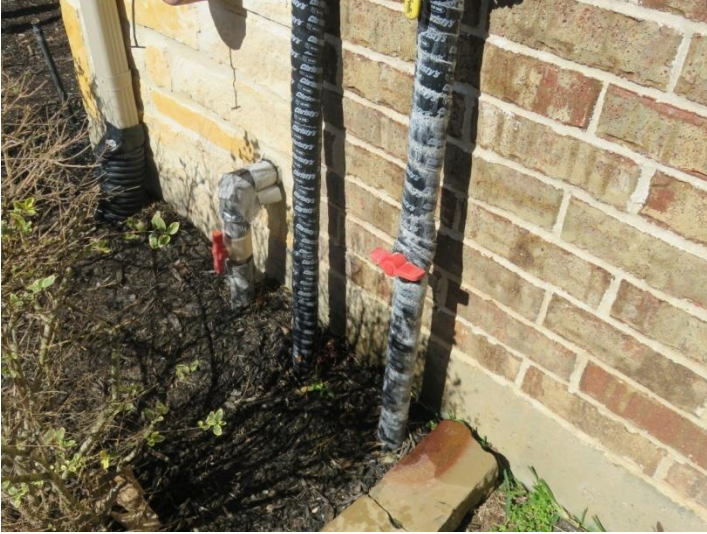
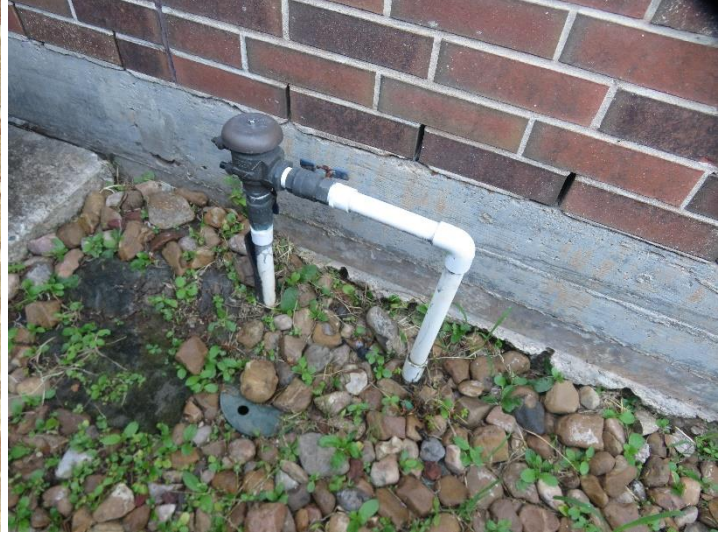
Example and current installation

- The backflow preventer should have an intermediate shut off valve on the supply side.

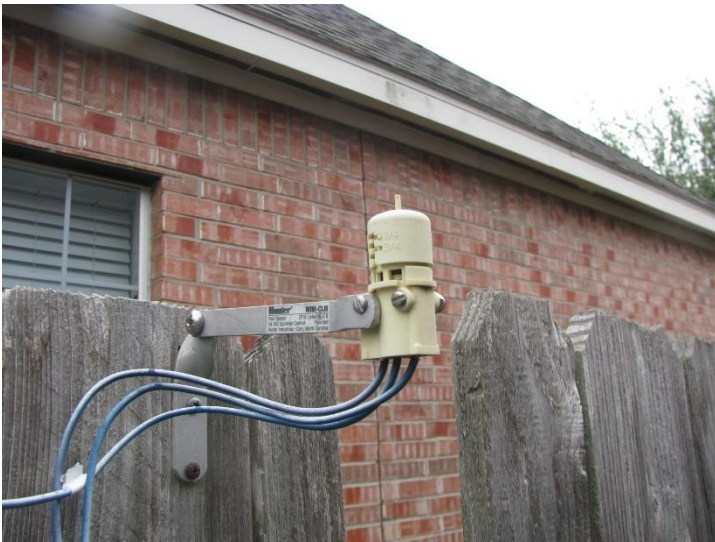
Example of a rain sensor

- The sprinkler system appears to lack a rain sensor that acts as an automatic shut-off during rainy and wet periods.

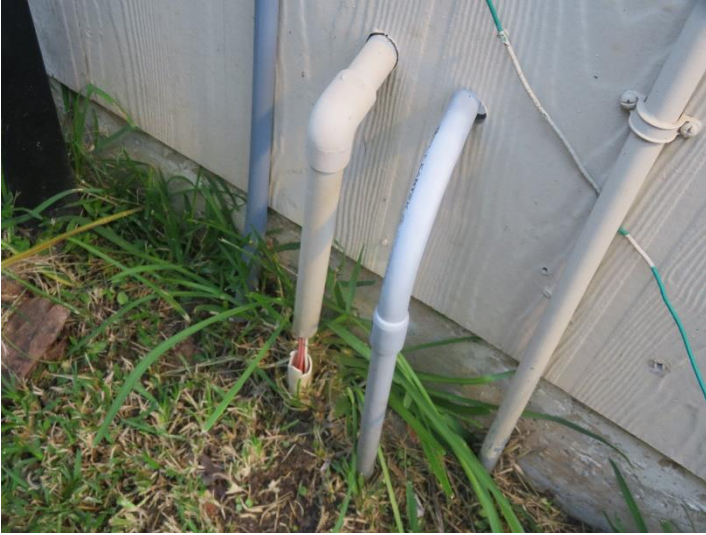
- Conduit installed to protect the wiring of the sprinkler system is separated exposing the wires and creating an opening where water and insect penetration can penetrate into the home. Conduit is also noted as damaged.

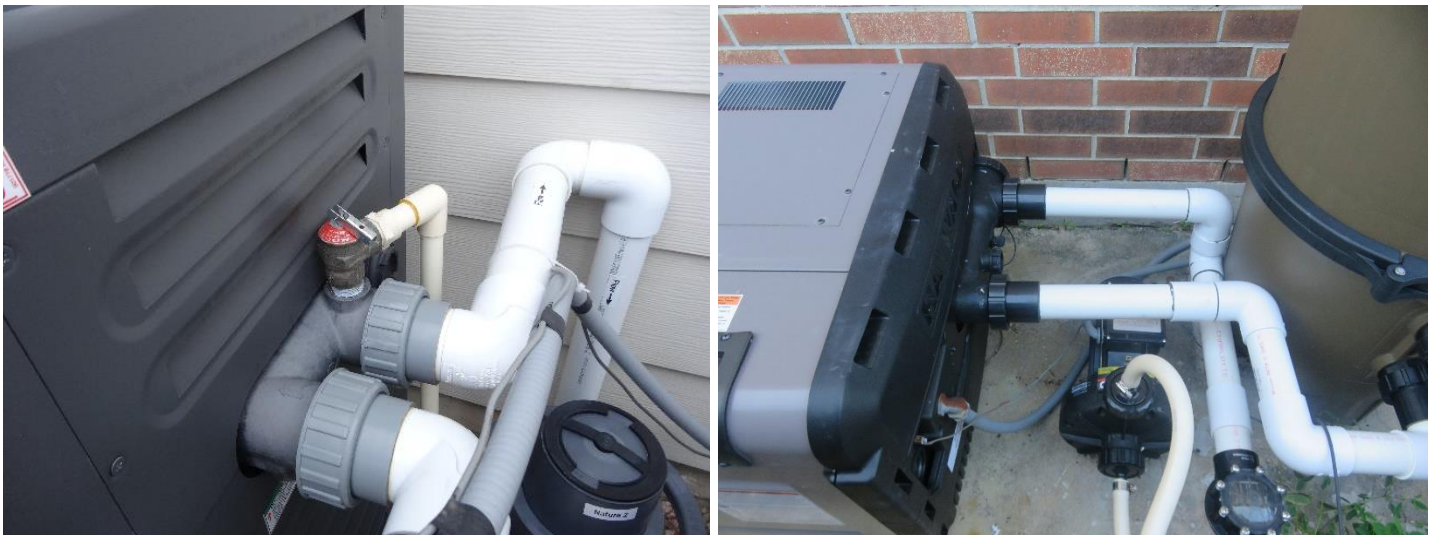
Example of a T&P safety relief valve and current installation

- The pool heater is required to have the ability to automatically shut down if the filter loses power.
- Pool heater natural gas lines are required to have a sediment trap at the gas supply line and a T&P safety relief valve for hot water release similar to a water heater installation.

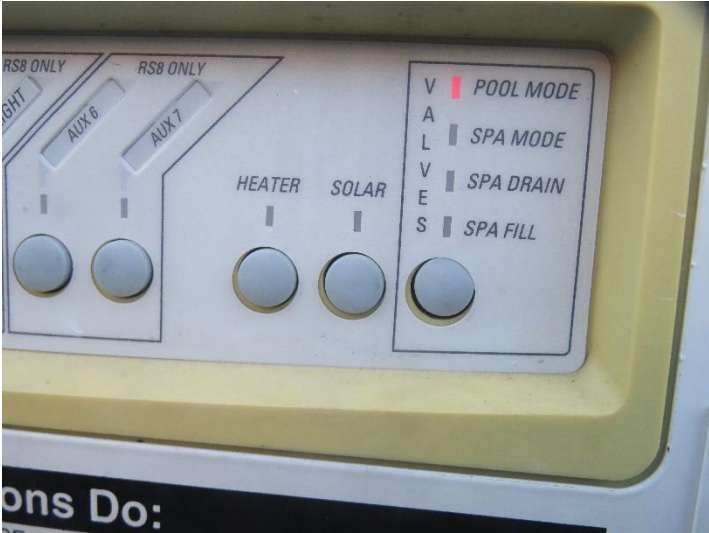
- The heater was not able to be operated. The heater push button was not operable and the “mode” setting button was not able to be moved to the spa.

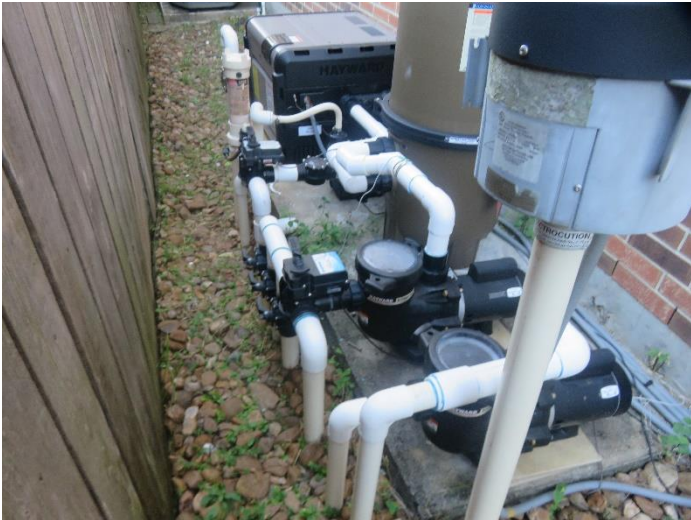
- Plastic plumbing pipes at the pool equipment are required to be painted to protect it from sunlight/ultraviolet light that will cause degradation of the piping.

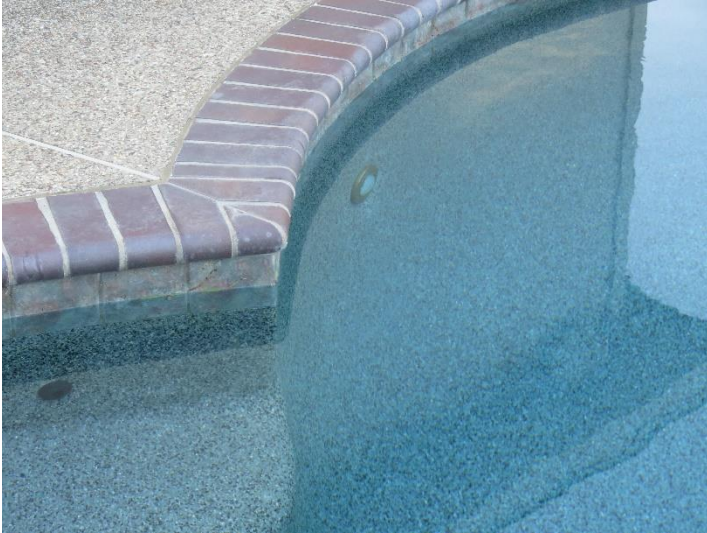
- The left side pool light did not illuminate.

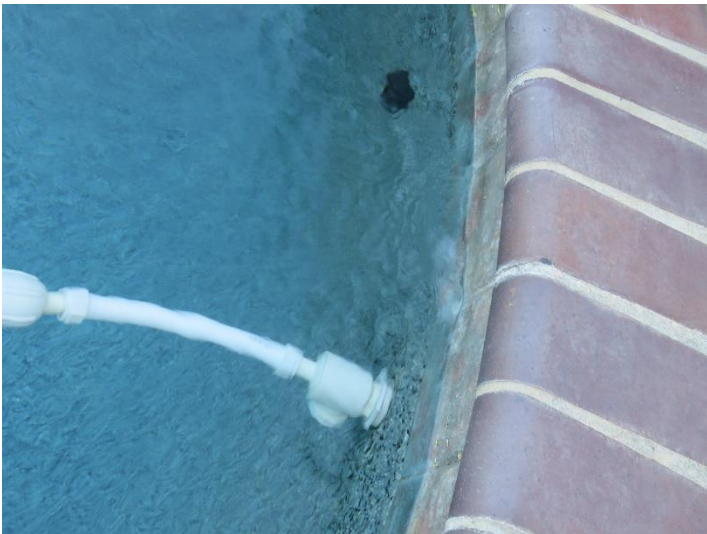
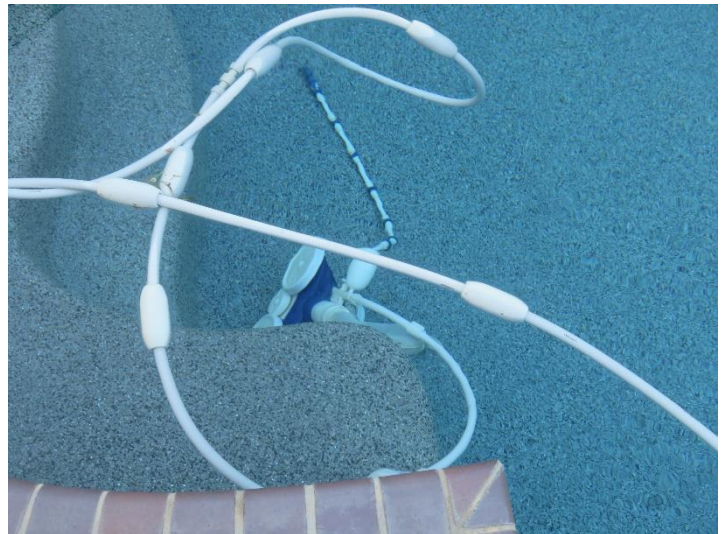
- The Polaris pool cleaner was not functioning.

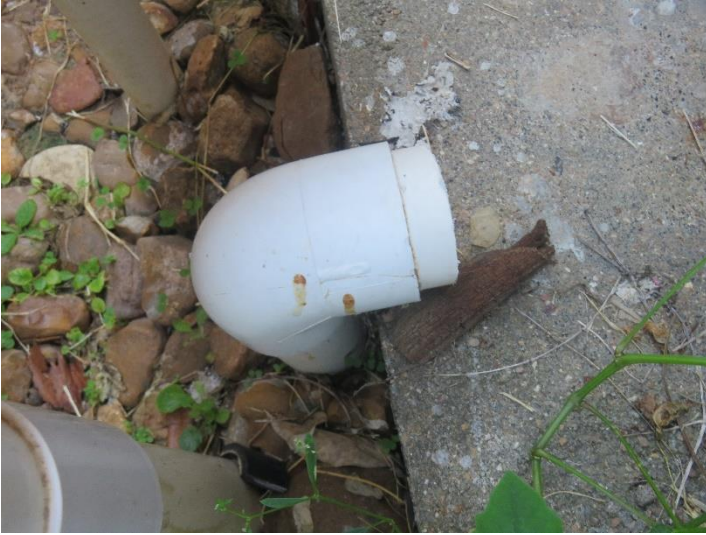
- A pipe, possibly a drain pipe for the pool and spa, has been cut/disconnected.

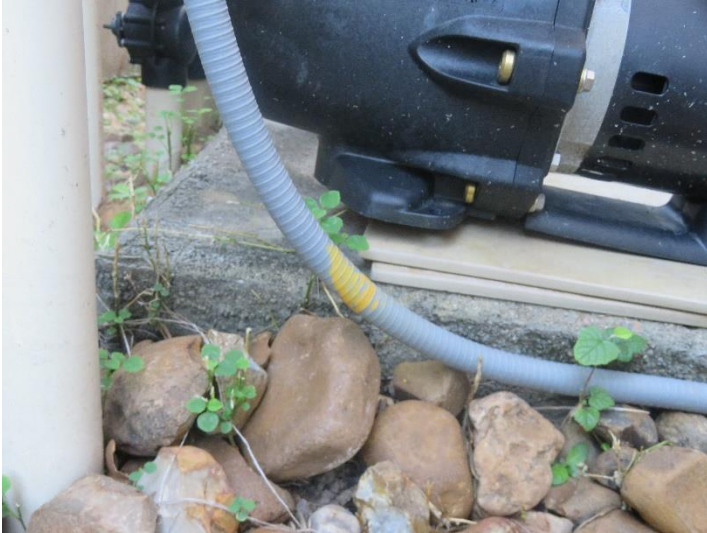
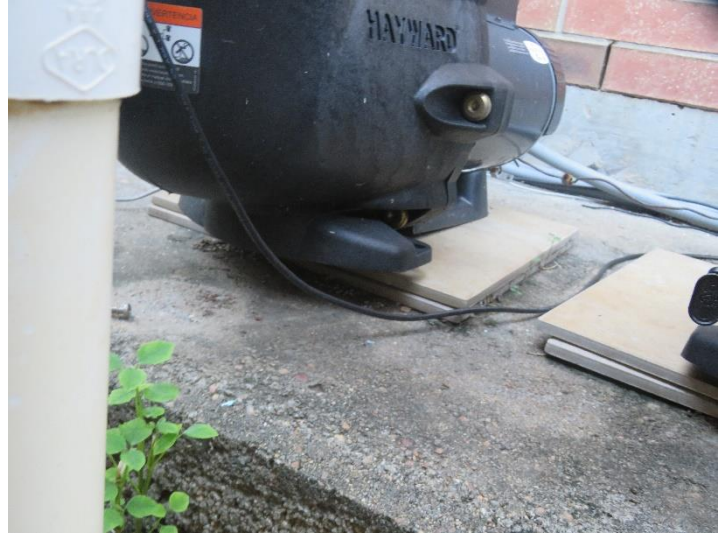
- The pumps are elevated off the ground by plumbing that is under pressure to support the pump.
