PROPERTY INSPECTION REPORT

Concerning: 1148 Arlington St, Houston, TX 77008
(Address or Other Identification of Inspected Property)

By: Scott Osborne, Lic #20555 12/30/2019
(Name and License Number of Inspector) (Date)

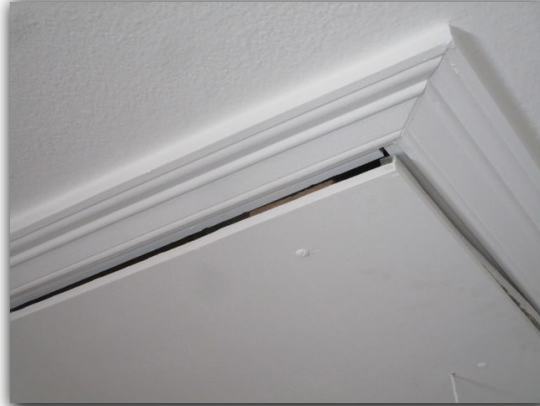
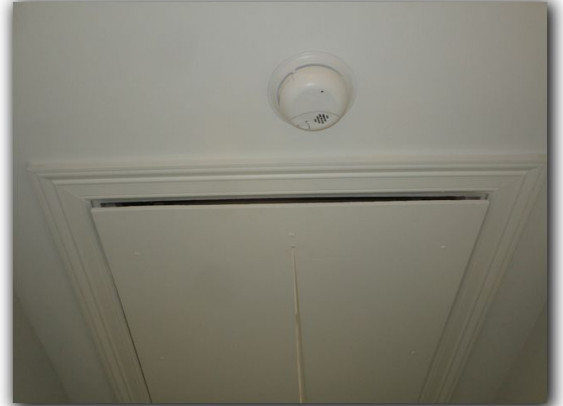
The strong back has been cut in the attic above the garage apartment to make room for the attic ladder.

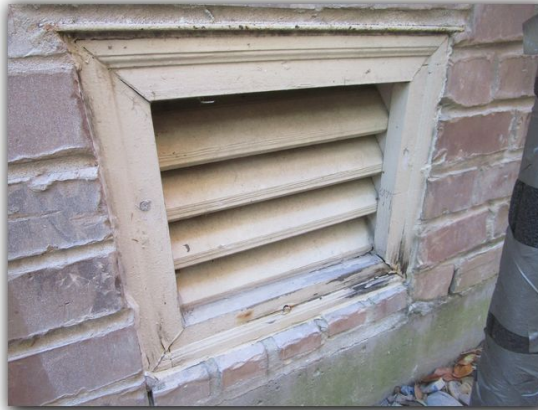
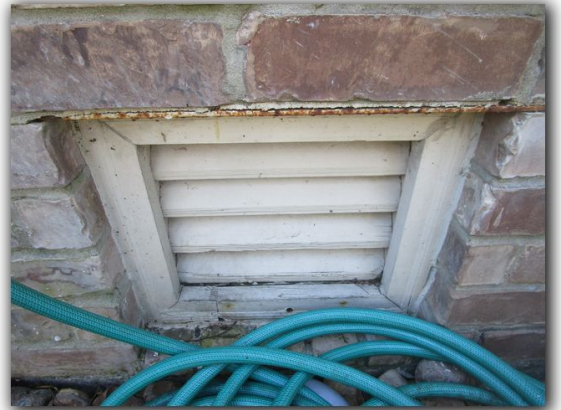
There is evidence of rotting wood at the crawl space ventilation covers including at the front right and front left corners (and along the sides of the home).

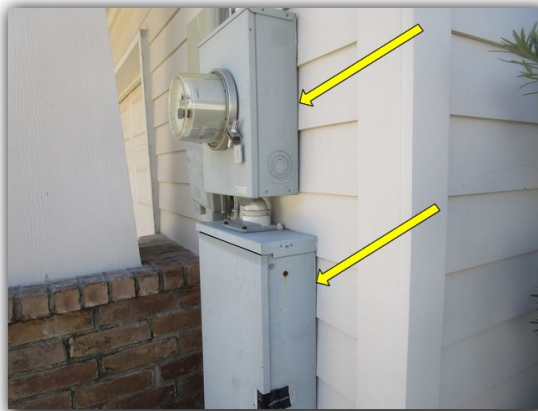
The electric meter and service panels are not properly weather sealed on the exterior wall.

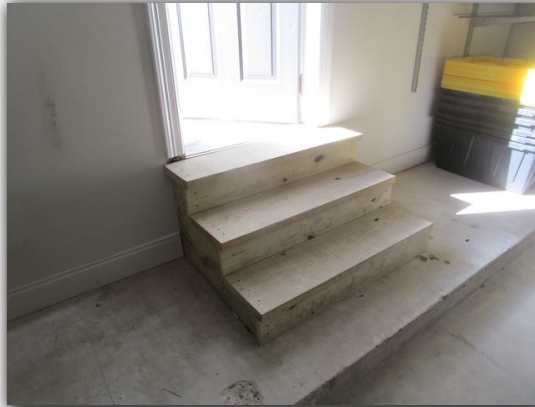
Where there are three or more stairs, a handrail is required. This requirement is not being met at the garage entry stairs, or along the left side of the stairs in the home. This may pose a potential safety hazard.

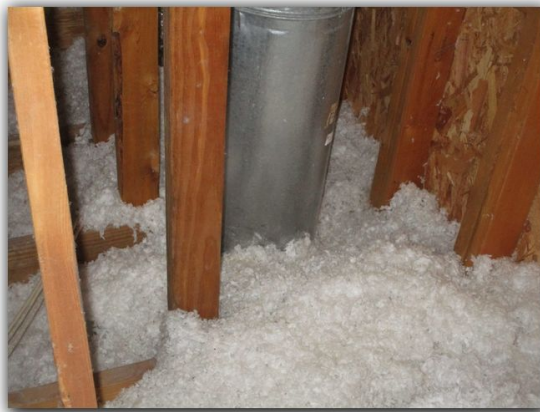
The chimney vent pipe does not have proper clearance from combustible materials including insulation in the attic.

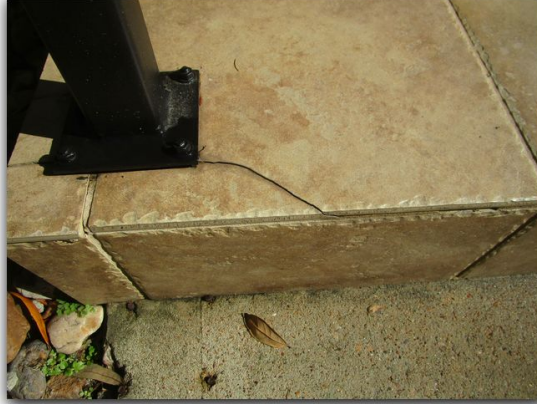
There is a cracked tile at the front entry steps.

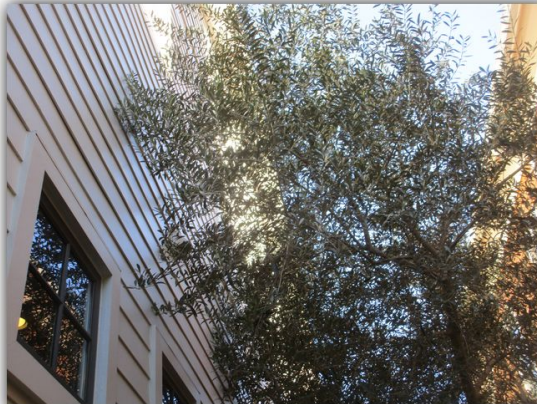
There is a tree touching the right side of the home. I recommend trimming the branches away from the home.

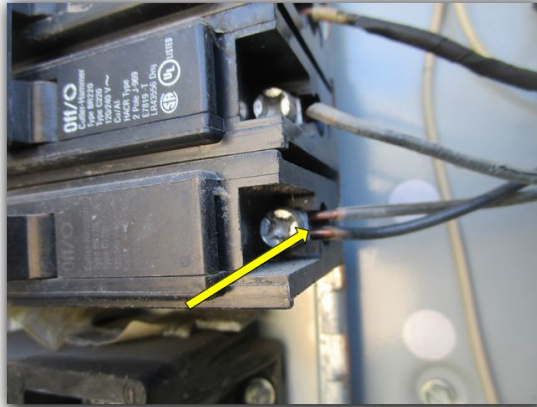
There are wires that are double tapped in the outside panel at the lower right breaker.

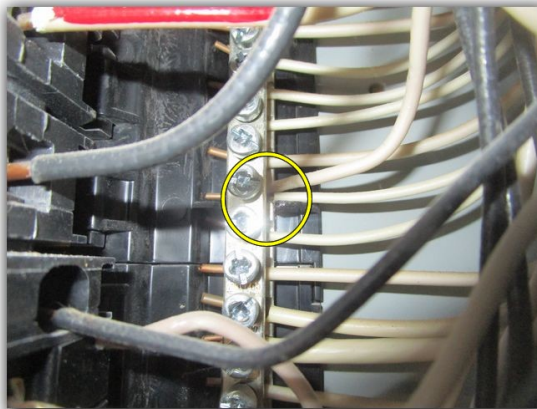
There are neutral wires that are double tapped in the garage panel. Each neutral wire should be under its own lug.

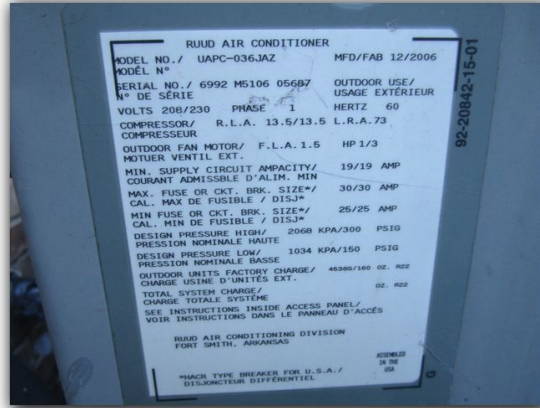
NOTE: Due to the age of the unit, I recommend having the unit serviced by a licensed HVAC technician.

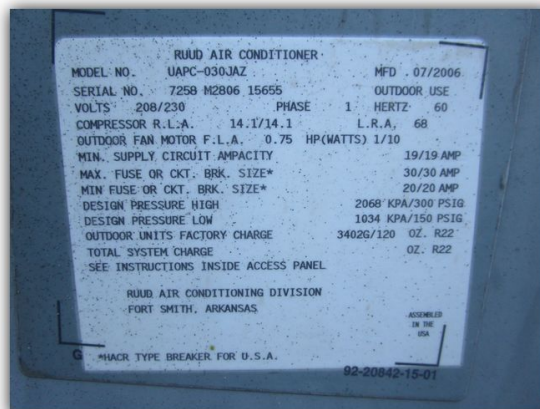
NOTE: The ambient temperature is near 60 degrees. This may make the differential readings inaccurate.

NOTE: Due to the age of the unit, I recommend having the unit serviced by a licensed HVAC technician.

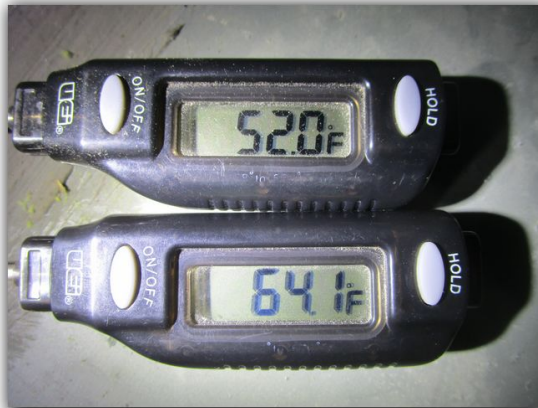
The evaporator coils unit in the attic vibrates during operation. The temperature differential between the supply and return registers should be at least 15 degrees. The unit did not produce a temperature differential that meets this minimum requirement. This could be symptomatic of other issues inside the system.

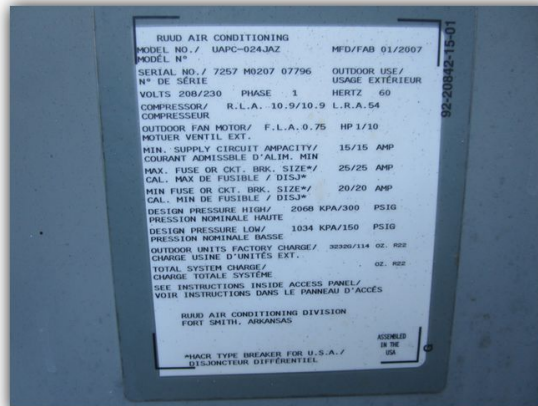
NOTE: The ambient temperature is near 60 degrees. This may make the differential readings inaccurate.

NOTE: Due to the age of the unit, I recommend having the unit serviced by a licensed HVAC technician.

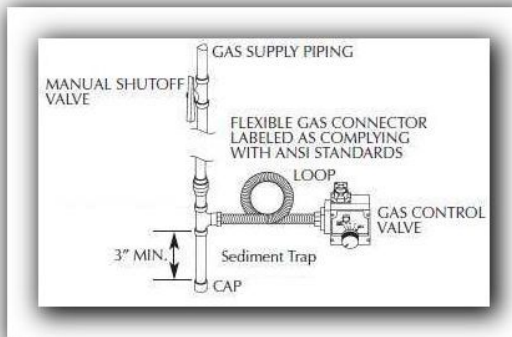
NOTE: The TPR (temperature and pressure relief valve) was not operationally checked at the time of the inspection. If the water heater is not maintained annually, the valve may not seat properly when it is operated, which causes the valve to leak. It is best to replace a TPR valve every 3 years to prevent it from getting clogged with mineral deposits. It is also recommended to open / close the valve at least twice per year as a form of maintenance. There is no sediment trap on the gas supply line. The below diagram is an example of a sediment trap.

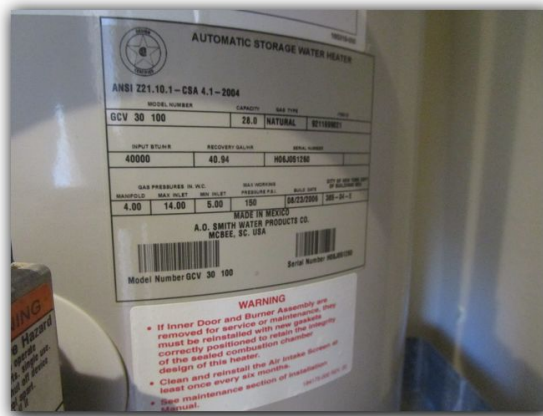
NOTE: Due to the age of the unit, I recommend having the unit serviced and cleaned by a licensed plumber and I recommend routine monitoring for any signs of deterioration.

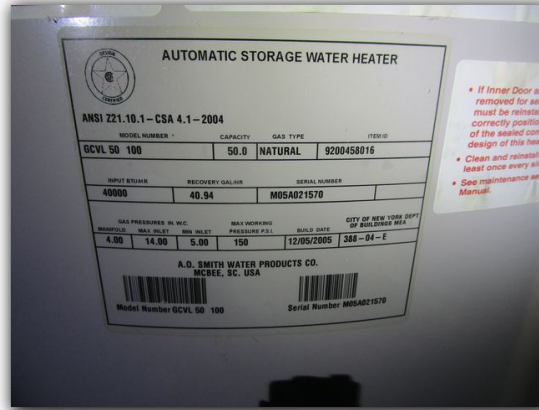
NOTE: Due to the age of the unit, I recommend having the unit serviced and cleaned by a licensed plumber and I recommend routine monitoring for any signs of deterioration.

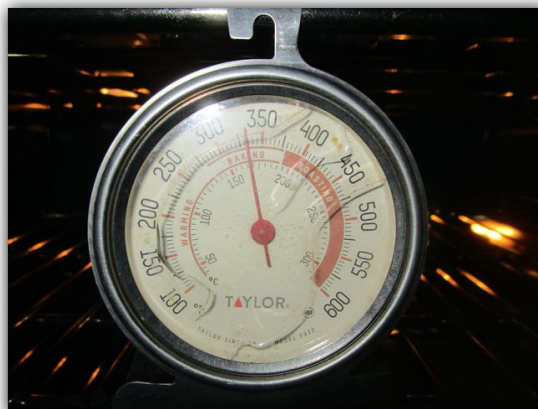
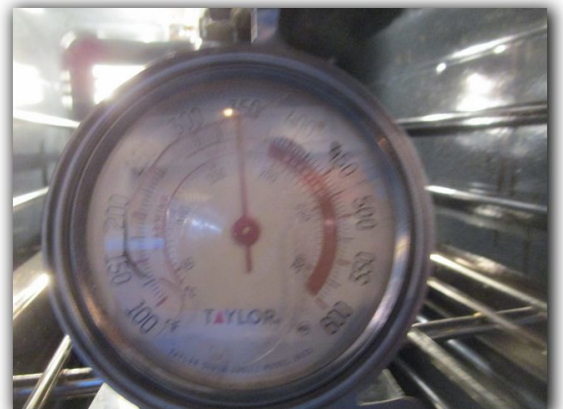
The gas supply shut off valve is located behind the unit (in both locations). The gas supply shutoff valve should be readily accessible in case of an emergency.

The anti tip device is missing.

The apartment oven was set to 350 degrees for the duration of the inspection. During that time, the oven achieved a temperature of 380 degrees. The oven is 30 degrees high and may need to be recalibrated.

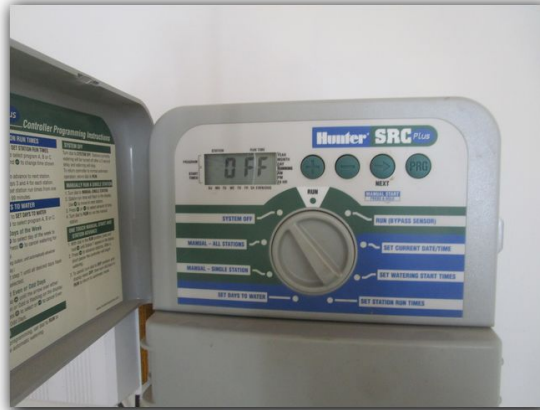
NOTE: The unit was off at the control panel. I turned it on to test it, then off again when I was finished.
