PROPERTY INSPECTION REPORT

Prepared For: Andrew Michon
(Name of Client) File Name CS-8917

Concerning: 24722 Double Lake Dr., Missouri City TX 77459
(Address or Other Identification of Inspected Property)

By: Clint Simon TREC 5550 2-27-2020
(Name and License Number of Inspector) (Date)

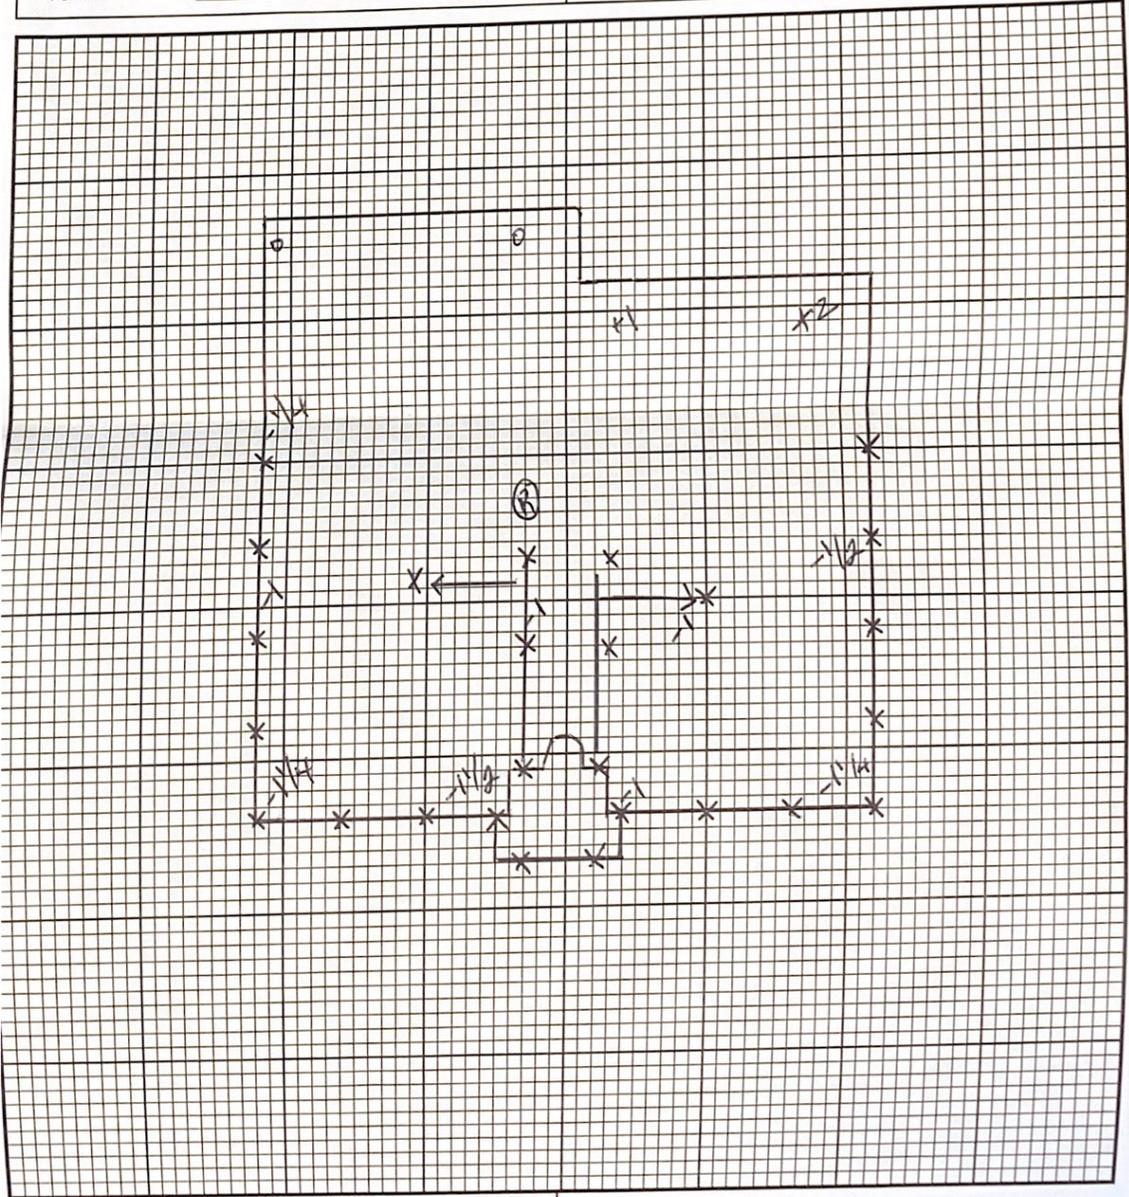
FOUNDATION REPAIR / DRAIN / P+B HOUSE REPAIRS

Total Job Cost \$ 9,700 ⁰⁰

# Piles Thru Dirt	<u>18</u>	@	<u>250</u>	=	<u>4500</u>
# Piles Thru Concrete	<u>2</u>	@	<u>350</u>	=	<u>700</u>
# Interior Piles	<u>30</u>	@	<u>140</u>	=	<u>4200</u>
# Tunnel (ft)	<u>20</u>	@	<u>150</u>	=	<u>300</u>
Permit

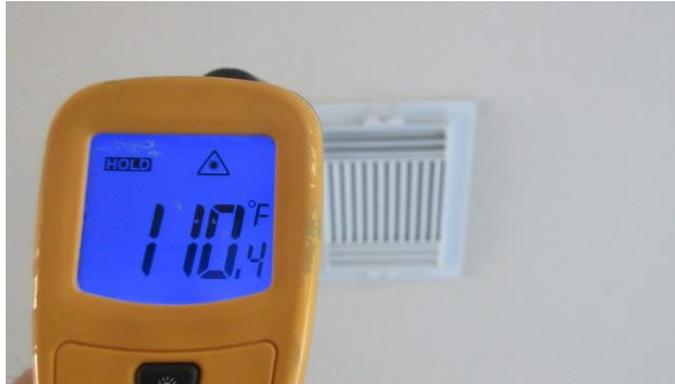
Upstairs Unit:

- Rust in burner compartment noted, recommend repairs, service, and a complete inspection of the Heating System / **exchanger** by a licensed Heating & Cooling service.
- Heating Unit appeared to be functioning as intended at the time of the inspection.
- Observed 117 degrees at supply registers.

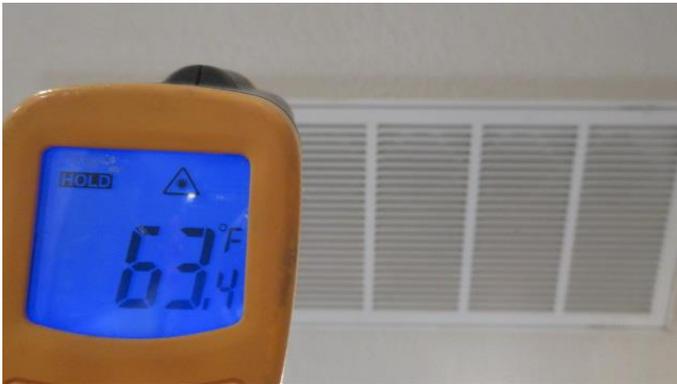
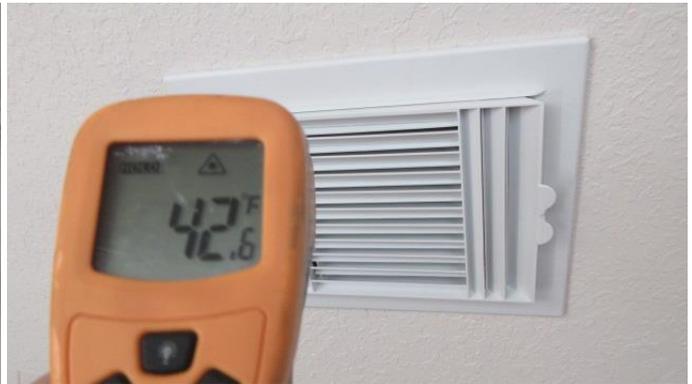
Downstairs Unit:

- A/C is working efficiently as evidence by a 21 degree drop between return air and supply register.
- Observed 63 degrees at return air chase and 42 degrees at supply register.

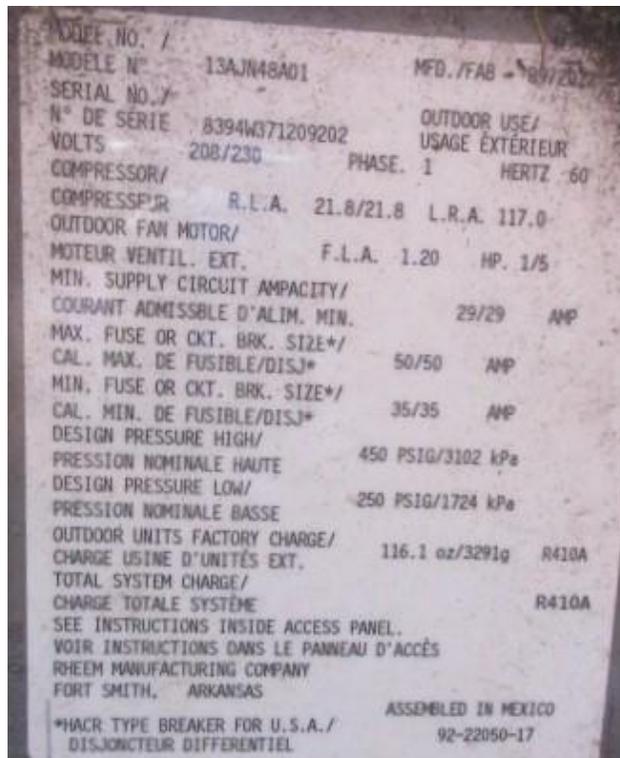
- Cooling System appeared to be functioning as intended at the time of the inspection.
- Observed 4 Ton Condenser (Max 50 amp) and Evaporator Coil.

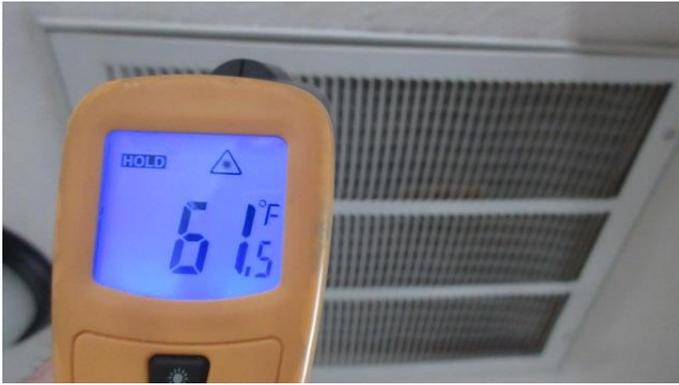
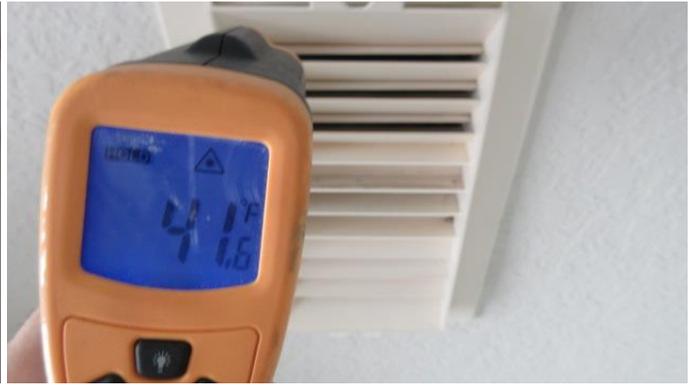
Upstairs Unit:

- A/C is working efficiently as evidence by a 20 degree drop between return air and supply register.
- Observed 61 degrees at return air chase and 41 degrees at supply register.

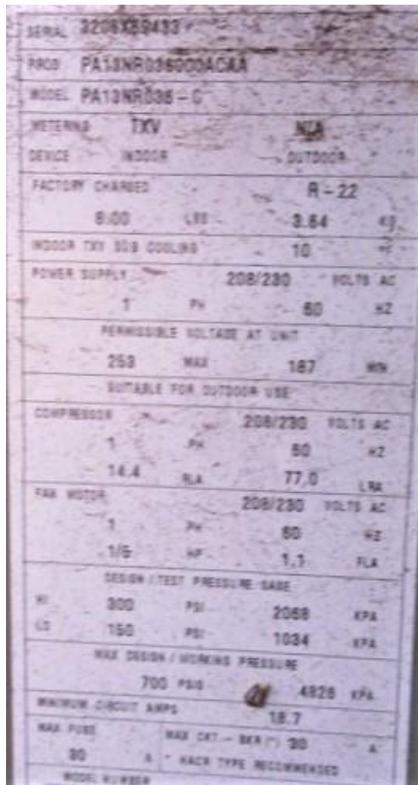
- Cooling System appeared to be functioning as intended at the time of the inspection.
- Observed 3 Ton Condenser (Max 30 amp) and Evaporator Coil.
