## RESIDENTIAL INSPECTION REPORT

2380 Marina View Way  
League City TX 77573

# PROPERTY INSPECTION REPORT

Concerning: 2380 Marina View Way, League City TX 77573

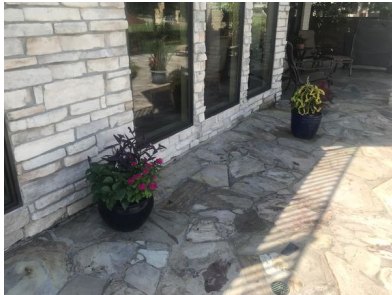
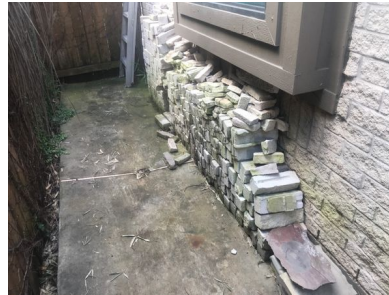
**1: Slab: Exposed Post Tension Cables**

Post tension cable(s) exposed along the perimeter of the foundation. Remedy as needed.

Recommendation: Contact a qualified professional.

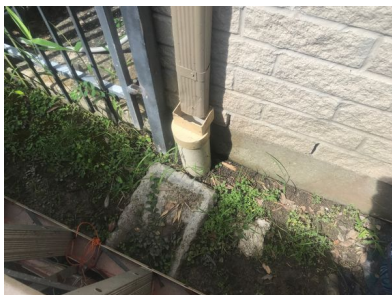
**1: Grading & Drainage: Inadequate**

Low spots, ruts, and/or damaged sod were present at the time of inspection. Regrading by a qualified landscaping contractor or foundation contractor so that water flows away from the home is recommended.

Recommendation: Contact a qualified landscaping contractor

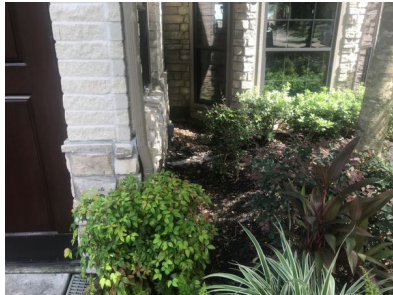
## 2: Grading & Drainage: Negative Grading

Grading was sloping towards the home in some areas. This can lead to water intrusion and foundation issues. Regrading by a qualified landscaping contractor or foundation contractor so that water flows away from the home is recommended.

Recommendation: Contact a qualified landscaping contractor

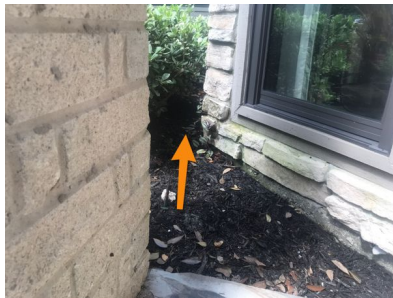
## 3: Gutters & Downspouts: Clogged

Clear gutters of debris to improve drainage. Badly clogged gutters can cause water to back up under the roof covering and cause damage.

Recommendation: Contact a qualified landscaping contractor

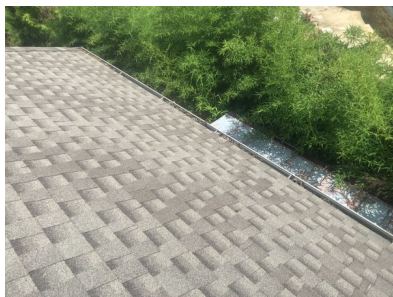
## 4: Gutters & Downspouts: Damaged

Further evaluation of the gutter and drainage system is recommended.

Recommendation: Contact a qualified landscaping contractor

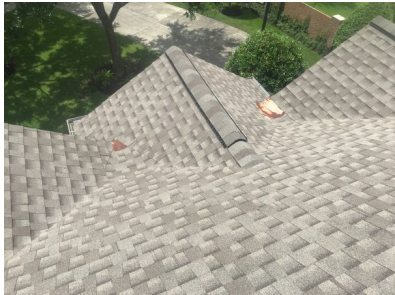
**1: Flashing: Rusted flashings**

Rusted flashings were present. Remedy as needed.

Recommendation: Contact a qualified roofing professional.

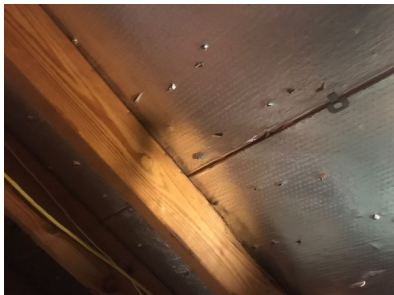
**1: Sheathing: Evidence of Prior Moisture**  
➔Recommendation  
Evidence of prior moisture intrusion was observed. Evaluate and remedy as needed.  
Recommendation: Contact a qualified roofing professional.

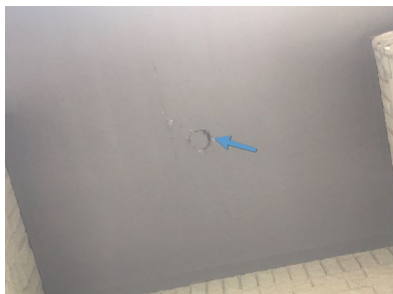
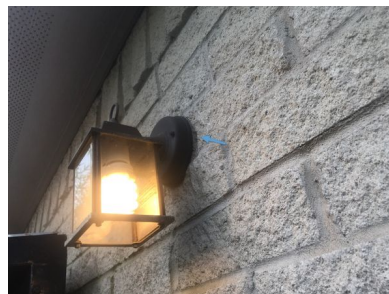
#### **2: Exterior Masonry: Minor Brick Cracks**

Cosmetic hairline cracks were observed in the masonry siding. Hairline cracks may be a result of thermal expansion of the veneer and/or normal structural movement. Monitoring is recommended.

Recommendation: Recommended DIY Project

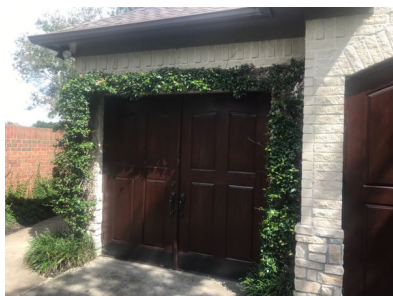
Foliage that is too close to siding materials can cause moisture buildup and deterioration.

Recommendation: Contact a qualified professional.

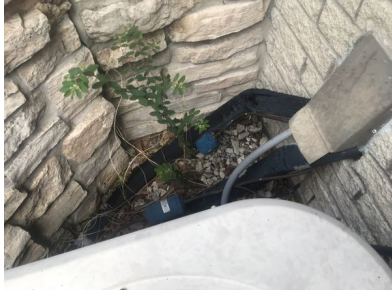
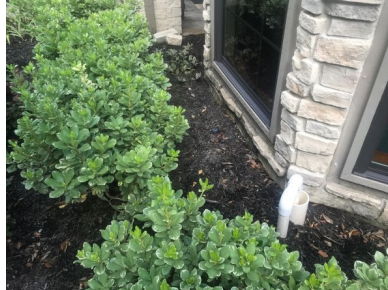
A high soil level was observed. The foundation should have at least 4 inches of exposure. Remedy as needed.

Recommendation: Contact a qualified landscaping contractor

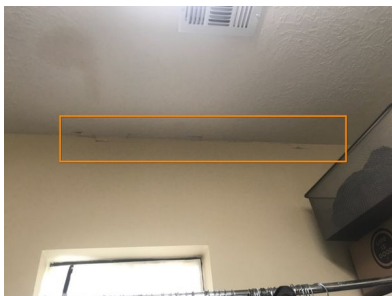
**6: Interior: Wrinkled Tape Joint**

Wrinkled tape joint can be evidence of current and/or previous structural movement.

Recommendation: Contact a qualified professional.

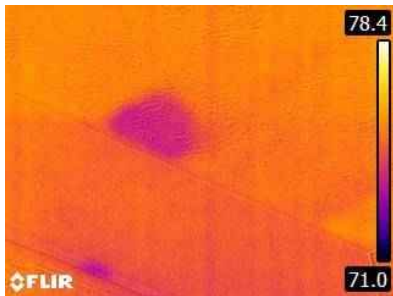
#### 1: Ceiling: Evidence of Active Moisture Contact

Wall structure showed signs of water intrusion. Tested positive for moisture at the time of the inspection. Evaluate and remedy as needed.

Recommendation: Contact a qualified professional.

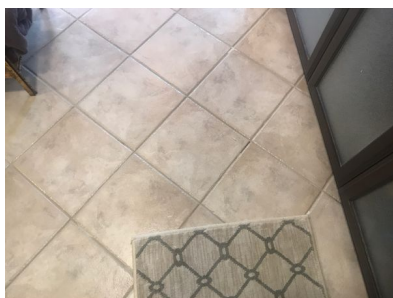
Grout between floor tiles is deteriorating. Remedy as needed.

Recommendation: Contact a qualified professional.

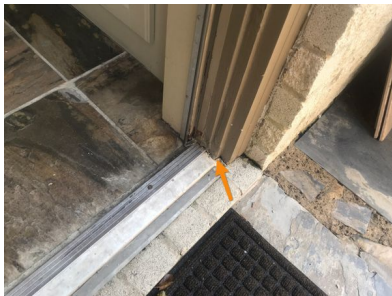
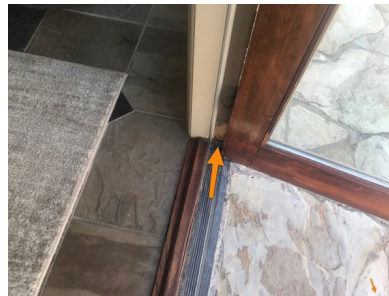
### 1: Door: Wood Rot at Base of Frame

Wood rot was observed at the base of a door frame. Remedy as needed.

Recommendation: Contact a qualified handyman.

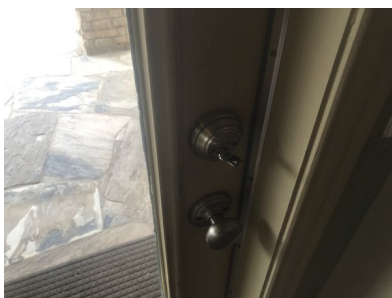
### 2: Door: Keyed Deadbolt

Double cylinder deadbolts are generally prohibited due to fire-code restrictions. Essentially, people can be entrapped in a house in the event of an emergency if they don't have the keys to double cylinder deadbolts. Evaluation and remediation by a qualified professional is recommended.

Recommendation: Contact a qualified professional.

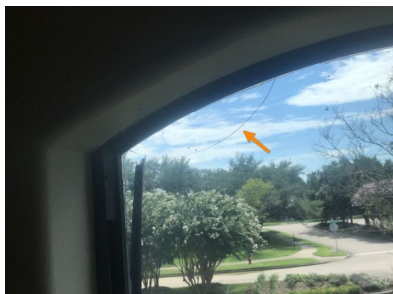
**1: Cracked/Broken Glass Panes**

Cracked or broken glass panes were present. Remedy as needed.

Recommendation: Contact a qualified window repair/installation contractor.

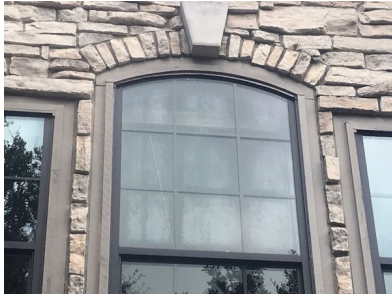
**2: Low-e coating imperfections**

**Note:** *This condition primarily affects window clarity. It can appear as streaks on the glass or as bronze colored flecks and can (but not necessarily) be indicative of a failed seal.*

Recommendation: Recommend monitoring.

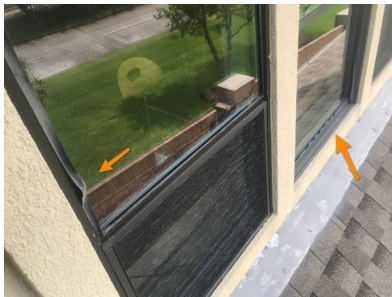
**3: Plastic trim is damaged/missing**

Plastic trim around windows is either damaged or missing. Remedy as needed.

Recommendation: Contact a qualified window repair/installation contractor.

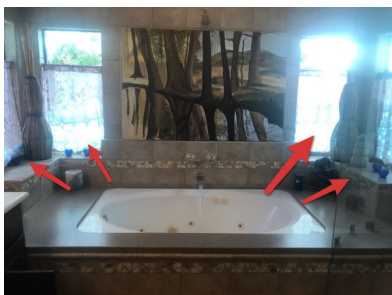
**4: Safety Glass not Installed**

Safety glass with a tempered stamp should be installed in all hazardous locations, such as:

- within 24 inches of doors
- within 60 inches of the floor of a tub
- within 60 inches of a stair landing
- within 60 inches vertically and 60 inches horizontally of a pool
- at door glazing

Recommendation: Contact a qualified professional.

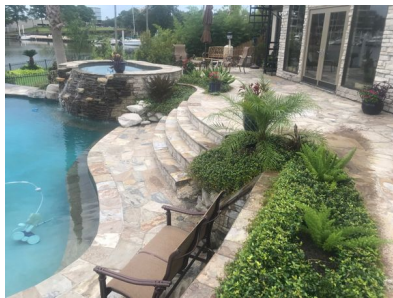
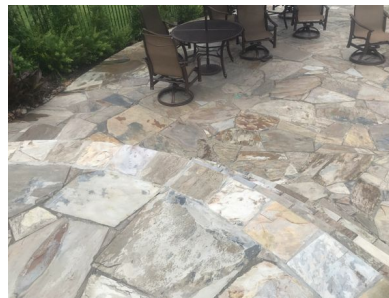
**1: Handrails/Guardrails: Missing**

Staircase had no handrails and/or a guardrail was missing. This is a safety hazard. Installation of a handrail or guardrail by a qualified professional is recommended.

Recommendation: Contact a qualified professional.

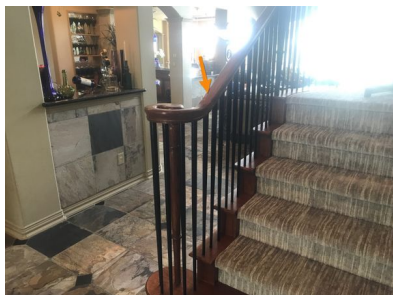
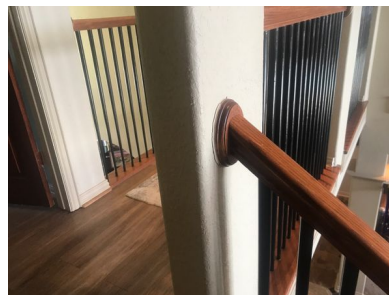
**2: Handrails/Guardrails: Loose**

Handrails/Guardrails were loose. This could pose a safety hazard. Evaluation and fastening by a qualified professional is recommended.

Recommendation: Contact a qualified professional.

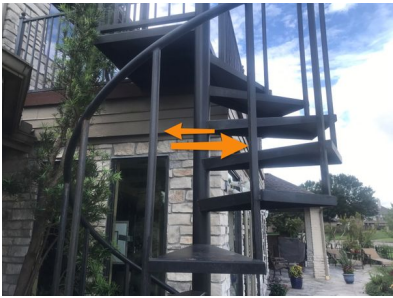
**3: Handrail/Guardrails: Baluster Gap Too Wide**

The baluster space was not up to modern safety standards. The space between balusters in a handrail should not allow passage of a 4 3/8-inch sphere for child safety. The space between balusters in a guardrail should not allow passage of a 4 inch sphere for child safety. Evaluation by a qualified professional is recommended. /Guardrails

Recommendation: Contact a qualified professional.

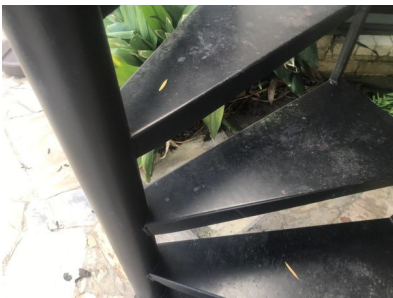
**4: Stair Tread Issues**

Too Narrow -  
Stair treads exhibit conditions that do not appear to meet current building standards. Evaluation by a qualified contractor is recommended for safety.

Recommendation: Contact a qualified professional.

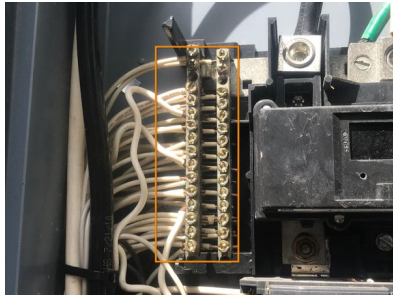
### 1: Double Lugged Neutral Wires

Double lugged neutral wires were on the neutral bus bar inside the distribution panel. One neutral wire per lug is recommended. Remedy as needed.

Recommendation: Contact a qualified electrical contractor.

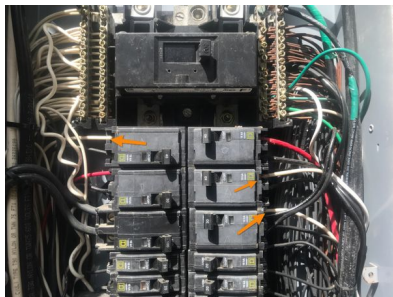
## 2: White Wires Not Marked

White wires connected to breakers are not marked with black or red electrical tape to indicate that they are "hot". Remedy as needed.

Recommendation: Contact a qualified electrical contractor.

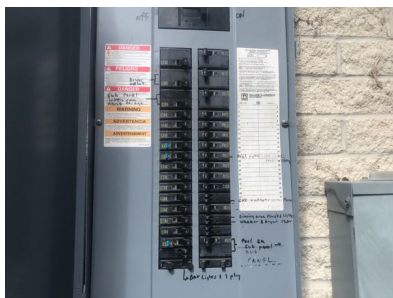
## 3: Circuits Not Labeled

Circuits in the distribution panel were not properly labeled. Remedy as needed.

Recommendation: Contact a qualified electrical contractor.

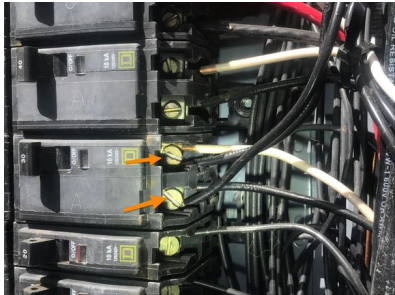
## 4: Double Lugged Breaker

Two or more wires are attached to a single breaker. Most terminals are not designed for two wires, and is a poor installation practice. Further evaluation by a licensed electrician is recommended.

Recommendation: Contact a qualified electrical contractor.

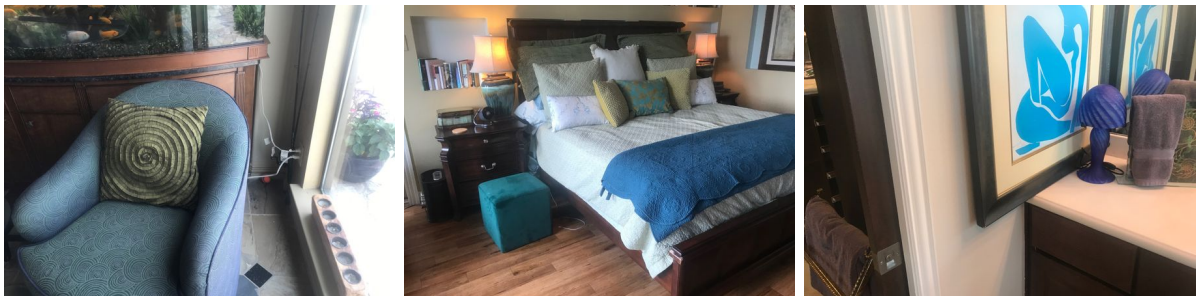
**1: Ceiling Fan Defects**  
👉Recommendation  
Multiple Locations  
Out of balance, Light out -  
Further evaluation is recommended.

Recommendation: Contact a qualified professional.

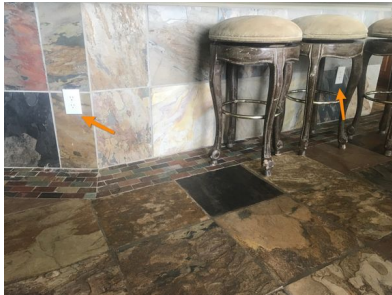
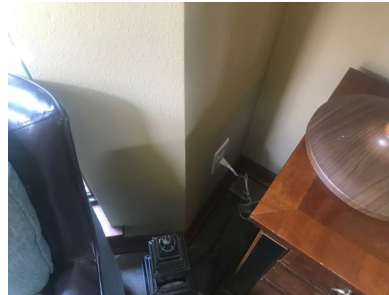
## 4: Receptacles: Loose

One or more receptacles were loose at the time of inspection. Evaluate and remedy as needed.

Recommendation: Contact a qualified professional.

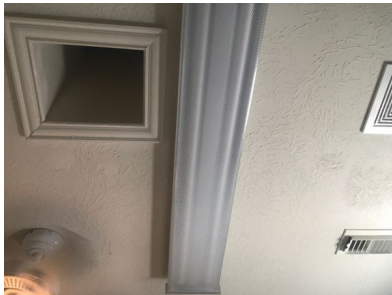
**5: Light: Inoperable**

One or more light fixtures were not operating at time of inspection. Cause was not determined. Remedy as needed.

Recommendation: Contact a qualified electrical contractor.

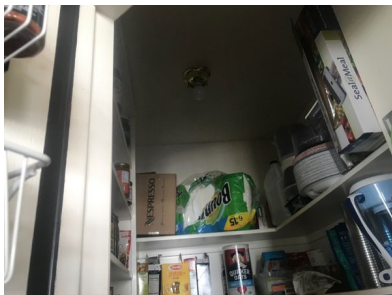
**6: Light: Globe Damaged/Missing**

Missing/damaged light globe was observed. Remedy as needed.

Recommendation: Recommended DIY Project

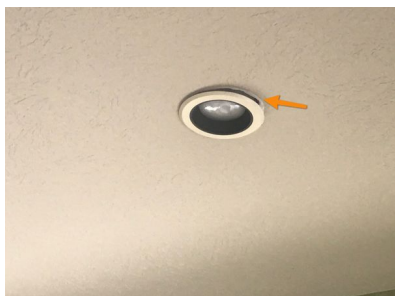
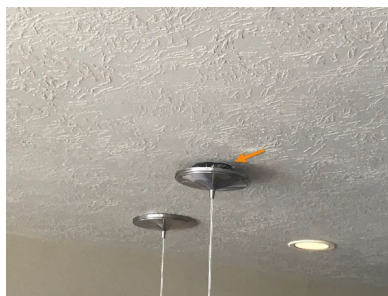
**8: Light: Fixture is Loose**

Fixture should be secured or repaired as needed.

Recommendation: Contact a qualified electrical contractor.

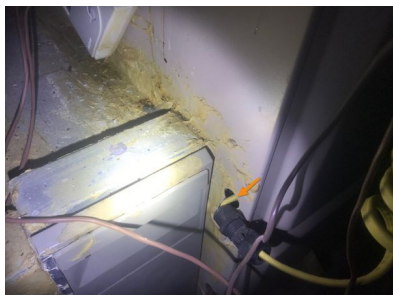
No bushing was present to protect wiring entering the unit. Remedy as needed.

Recommendation: Contact a qualified professional.

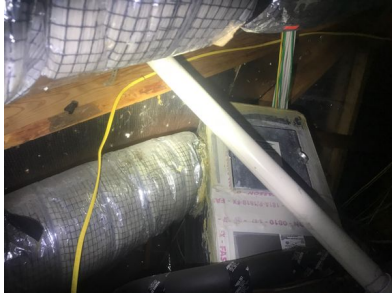
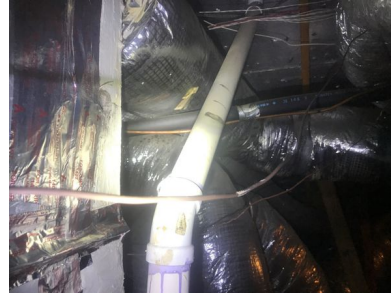
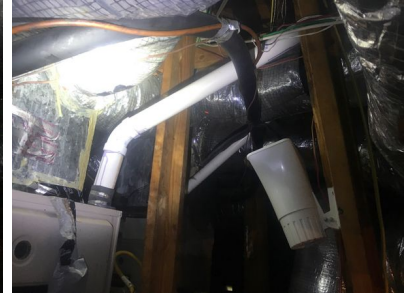
**2: Venting: Schedule 40 PVC Used for Furnace Vent**

**Note:** Vent pipe observed for heater is made of schedule 40 PVC. This is correct for heating units rated at a 90% efficiency. Determination of the efficiency of a heating unit is beyond the scope of this inspection. For further evaluation, a qualified HVAC Technician should be contacted.

Recommendation: Contact a qualified professional.

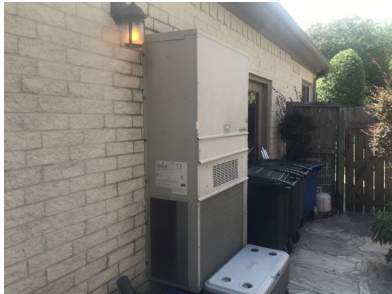
### 1: Functionality: System Not Operating As Intended

The HVAC system was not operating as intended. Evaluation and remediation by a licensed HVAC contractor is recommended.

Recommendation: Contact a qualified HVAC professional.

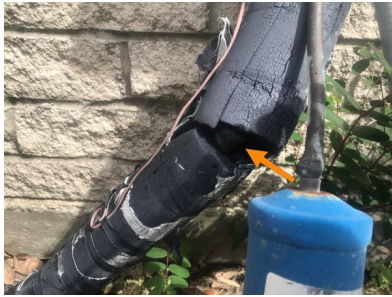
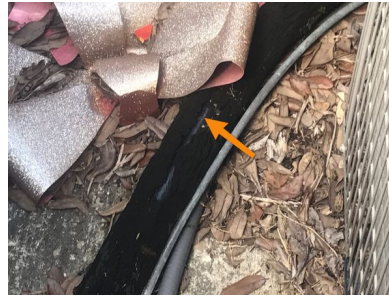
### 2: Condenser: Insulation Missing or Damaged on Refrigerant Lines

Missing or damaged insulation on refrigerant line can cause energy loss and condensation. Remedy as needed.

Recommendation: Contact a qualified HVAC professional.

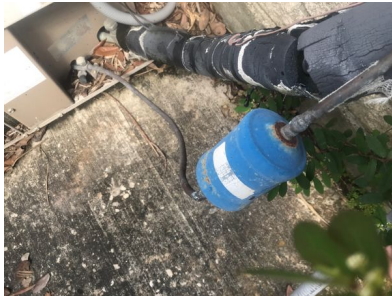
### 3: Condenser: Rusty Filter Drier

The filter drier was rusted. Evaluation and remediation by a licensed HVAC contractor is recommended.

Recommendation: Contact a qualified HVAC professional.

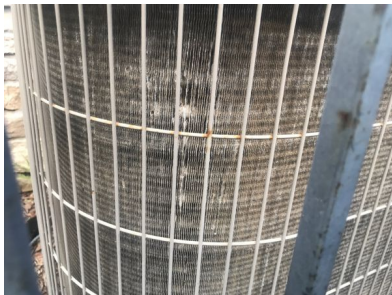
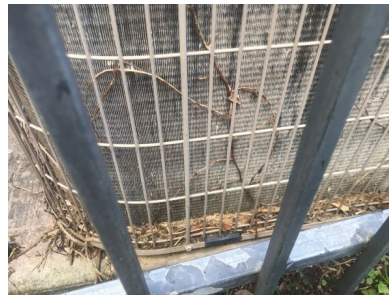
### 4: Condenser: Damaged Fins

External fins on the condensing unit were damaged. Evaluation and remediation by a licensed HVAC contractor is recommended.

Recommendation: Contact a qualified HVAC professional.

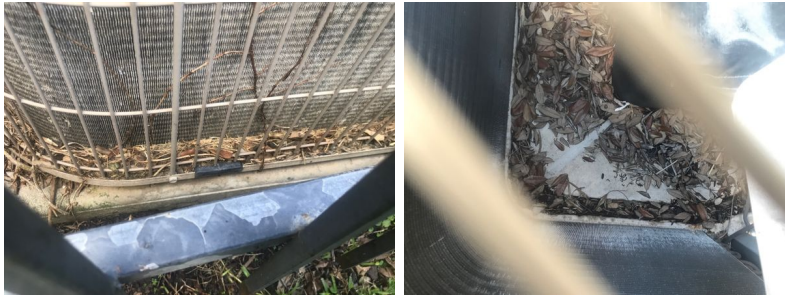
### 5: Condenser: Dirty

The condensing unit was dirty. Servicing by a licensed HVAC contractor is recommended.

Recommendation: Contact a qualified HVAC professional.

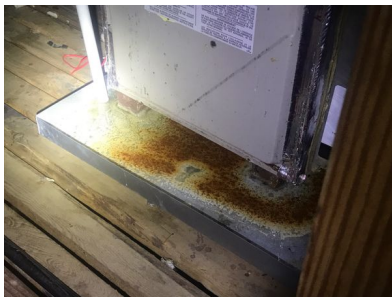
**6: Condensate system: Standing water in overflow pan**

Standing water was present in the A/C emergency overflow pan. This can indicate a dirty or restricted condensate system. Servicing by a licensed HVAC contractor is recommended.

Recommendation: Contact a qualified HVAC professional.

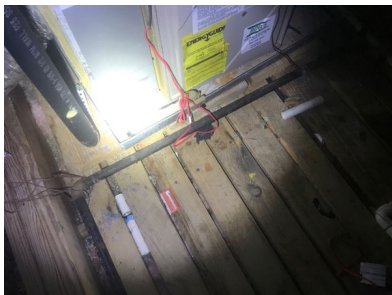
**7: Condensate System: Discoloration Under or Around HVAC Equipment**

Discoloration under or around HVAC equipment indicates prior moisture contact. Cause was not determined.

Recommendation: Contact a qualified HVAC professional.

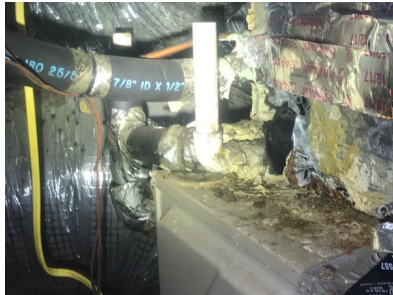
**8: Condensate System: Discoloration on HVAC Equipment**

Discoloration on HVAC equipment indicates prior moisture contact or excessive condensation.

Recommendation: Contact a qualified HVAC professional.

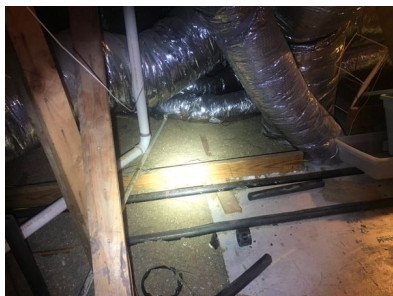
**1: Ducts: Ducts on attic floor**

Sections of ducting were resting on the attic floor. Evaluate and remedy as needed.

Recommendation: Contact a qualified HVAC professional.

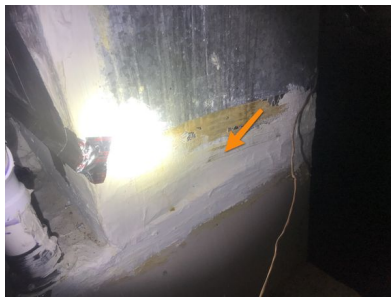
### 3: Ducts: Leaking

The air supply duct was leaking air. Evaluation and remediation by a licensed HVAC contractor is recommended.

Recommendation: Contact a qualified HVAC professional.

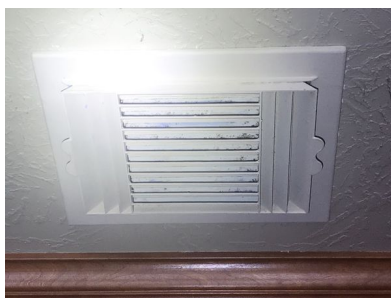
### 4: Visible substance observed on Supply Register

A dark substance was observed on an air supply register in the home. Servicing and cleaning of the system by a qualified HVAC contractor is recommended, as this can be a result of excessive water vapor/humidity in the conditioned air.

*Unless otherwise contracted, the Inspector does not test these areas to determine the presence of microbial growth.*

Recommendation: Contact a qualified HVAC professional.

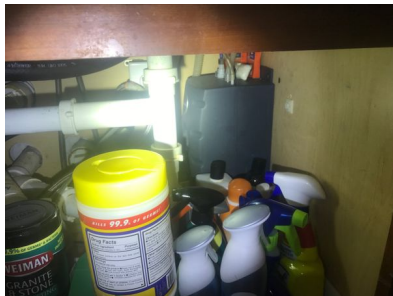
*Water Treatment Equipment:*

Water treatment equipment is not covered under the scope of this inspection. For further evaluation, contact the installer or manufacturer of the equipment.

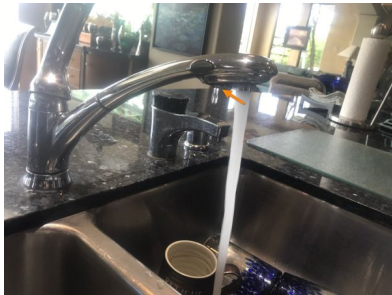
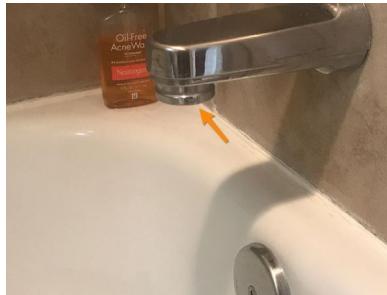
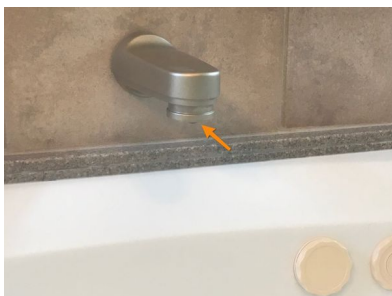
A faucet was dripping. Evaluation and/or repair by a qualified handyman or licensed plumber is recommended. Fixtures:

Recommendation: Contact a qualified plumbing contractor.

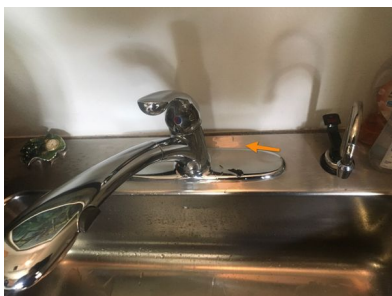
### 2: Fixtures: Stem Leaking

The faucet stem leaked when operated. Remedy as needed.

Recommendation: Contact a qualified plumbing contractor.

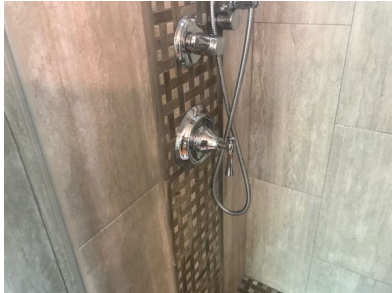
The faucet handle rotated 360. It can be difficult to determine if the faucet is completely shut off. Remedy as needed.

Recommendation: Contact a qualified plumbing contractor.

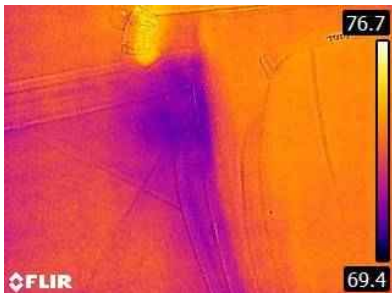
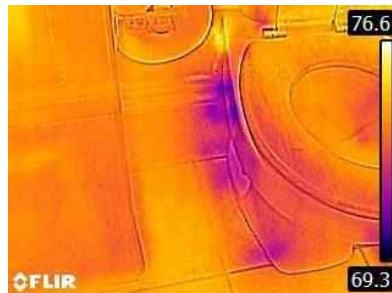
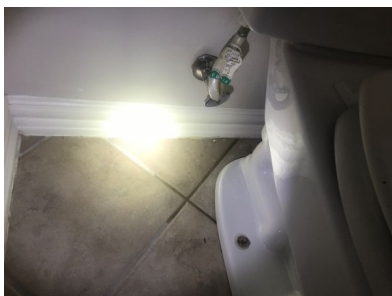
**5: Toilet: Leaking**

Toilet is leaking. Evaluation and/or repair by a qualified handyman or licensed plumber is recommended.

Recommendation: Contact a qualified plumbing contractor.

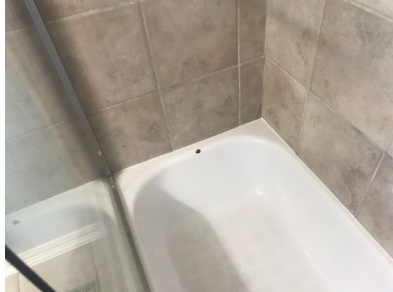
**6: Tub: Surface Defects**

Defects were observed on the tub surface. Remedy as needed.

Recommendation: Contact a qualified professional.

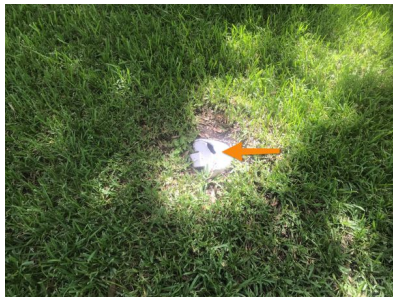
**1: Drain piping: Clean-out cap damaged/missing**

A clean-out cap was damaged or missing. Remedy as needed.

Recommendation: Contact a qualified plumbing contractor.

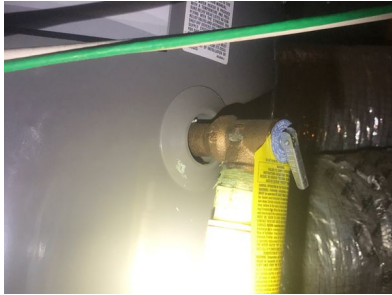
**2: TPR Valve Note: Replacement may be needed**

The manufacturer recommends replacement of the pressure relief valve every three years to ensure proper emergency function. The inspector does not test TPR valves due to safety hazard or possible damage to unit.

Recommendation: Contact a qualified professional.

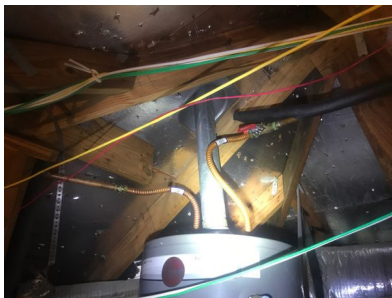
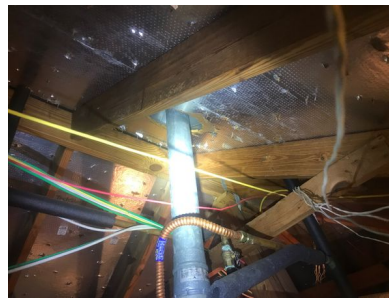
### **3: Venting system: Missing vent pipe strap**

The water heater combustion vent pipe was not properly supported/secured with strapping. Remedy as needed.

Recommendation: Contact a qualified professional.

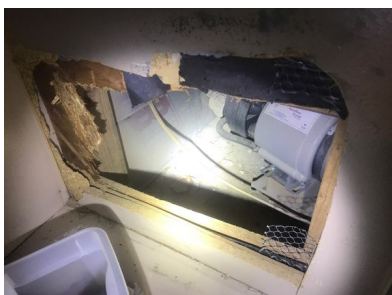
Limited access to the area under the tub limited visibility of all under-tub components.

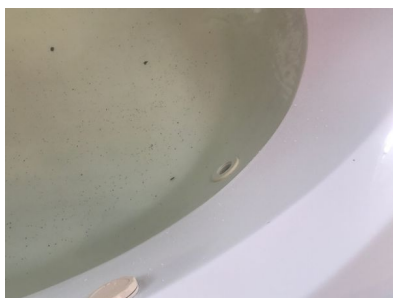
**3: Damaged Ports**

Water ports on the tub walls were damaged or missing. Remedy as needed.

Recommendation: Contact a qualified professional.

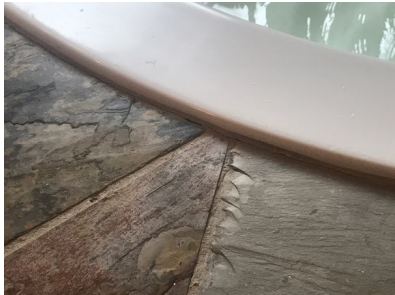
**4: Gaps in Grout**

Grout was missing or damaged around whirlpool. Repair is recommended to prevent moisture intrusion.

Recommendation: Contact a qualified professional.

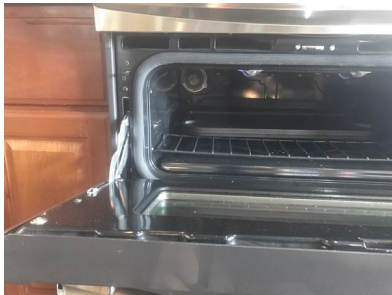
**1: Oven Light Inoperable**

Oven light did not come on when tested. This may be the result of a bad bulb. Evaluate and remedy as needed.

Recommendation: Contact a qualified professional.

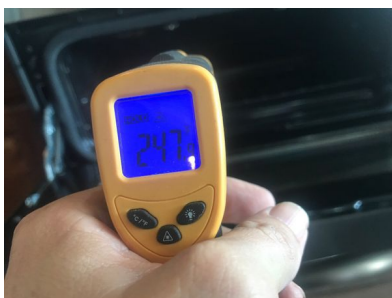
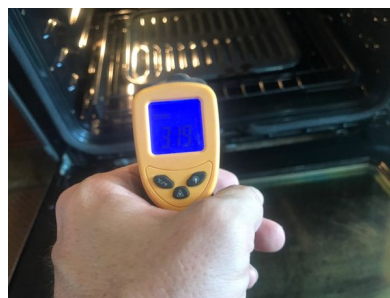
**2: Oven Temperature is Inaccurate**

The oven thermostat is inaccurate. A variance of more than 25 degrees F was noted when set at 350F. Evaluate and remedy as needed.

Recommendation: Contact a qualified professional.

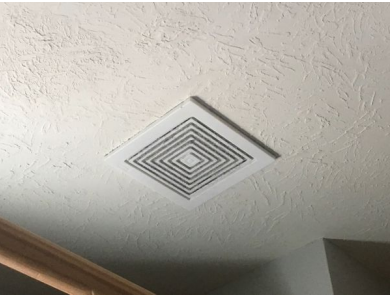
Cleaning of the exhaust vent cover is needed to ensure unrestricted air flow.

Recommendation: Contact a qualified professional.

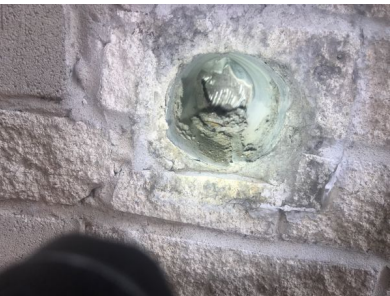
**1: Cleaning Vent Recommended**

Cleaning of the dryer exhaust vent is recommended as normal maintenance and to prevent excessive lint build-up in the line.

Recommendation: Contact a qualified professional.

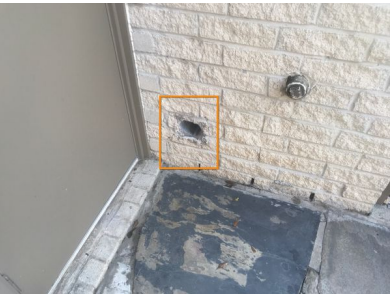
**2: Damaged Cover**

The dryer exhaust cover was damaged.

Recommendation: Contact a qualified professional.

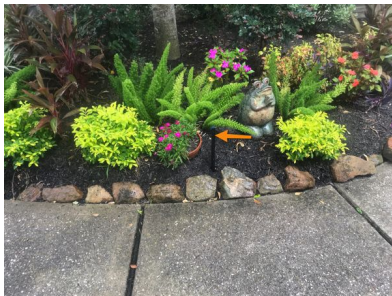
## 2: Broken Sprinkler Heads

One or more sprinkler heads were broken. Replacement is recommended.

Recommendation: Contact a qualified professional.

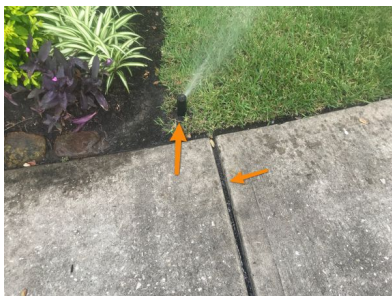
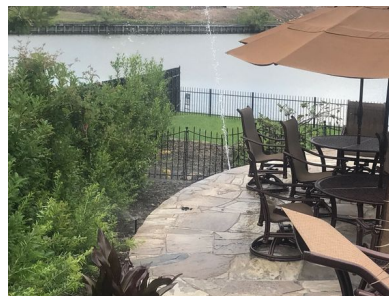
## 3: Leaks

Components of the irrigation system leaked. Further evaluation is recommended.

Recommendation: Contact a qualified professional.

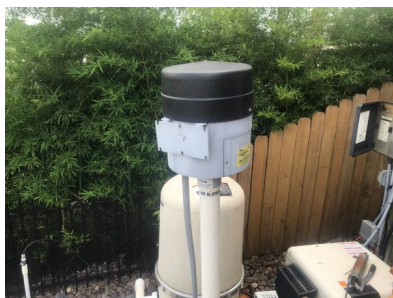
The spa air injection or "bubbler" was not working properly and should be repaired or replaced as needed.

Recommendation: Contact a qualified Swimming Pool Contractor

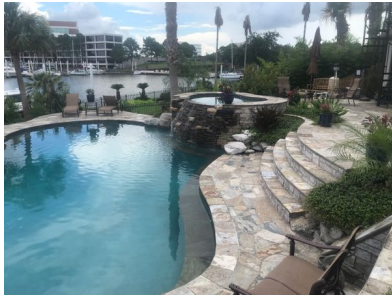
**7: Inadequate Perimeter Gates**

The perimeter gates that provide access to the pool/spa area should be self-closing, self-latching, and open away from the pool area.

Recommendation: Contact a qualified professional.

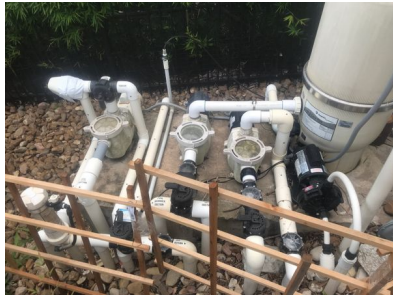
**9: PVC Piping Not Painted**

PVC piping was not painted. PVC can be damaged by sunlight and should be painted or coated for UV protection.

Recommendation: Contact a handyman or DIY project

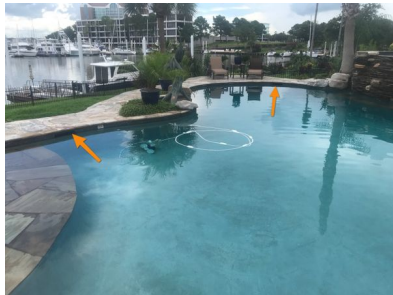
#### 10: Skimmer Weir Missing

Skimmer weir was missing

**Note:** *The weir has a dual function of regulating the amount of water entering the skimmer and preventing excessive debris from clogging the skimmer.*

Recommendation: Contact a qualified Swimming Pool Contractor

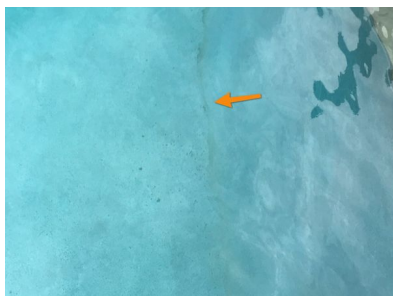
#### 11: Stains Noted

The pool walls were stained. This could be from a high mineral level or chemical imbalance. Recommend testing pH or having pool professional evaluate.

Recommendation: Contact a qualified professional.

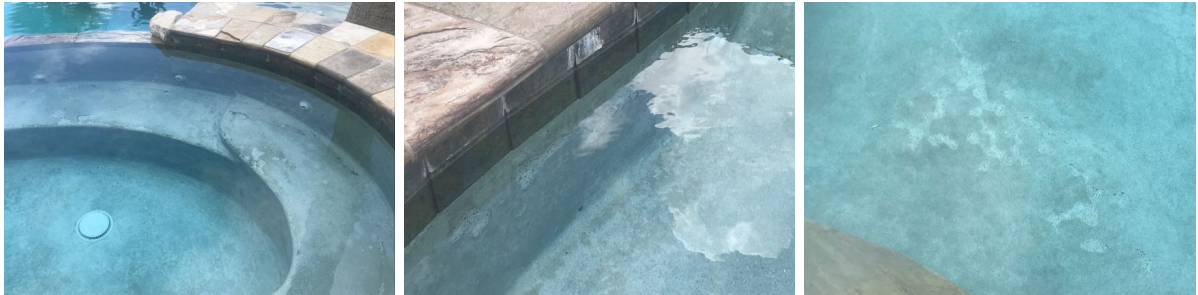
#### 12: Surface Defects Present

Visible defects were noted on the pool surface material. Contact a qualified swimming pool repair company if resurfacing estimates are desired.

Recommendation: Contact a qualified Swimming Pool Contractor
