A & L PROFESSIONAL  
HOME INSPECTIONS, PLLC  
TREC LICENSE# 21647  
HOME INSPECTION REPORT

**11723 Dorrance Ln, Meadows Place, TX 77477**

7/22/2021

# PROPERTY INSPECTION REPORT

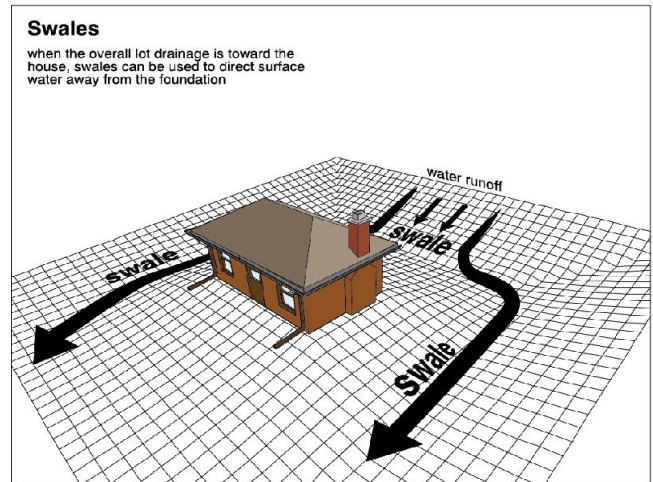
This exaggerated illustration shows how a property should be graded to promote the flow of storm water runoff away from the foundation and off the property.

A negative slope flowing towards the foundation was observed at the back of the home. Grading Improvement should be performed to promote the flow of stormwater runoff away from the foundation. The grade should slope away from the foundation at a rate of six inches in the first ten feet or to a swale designed to drain the water off of the property.

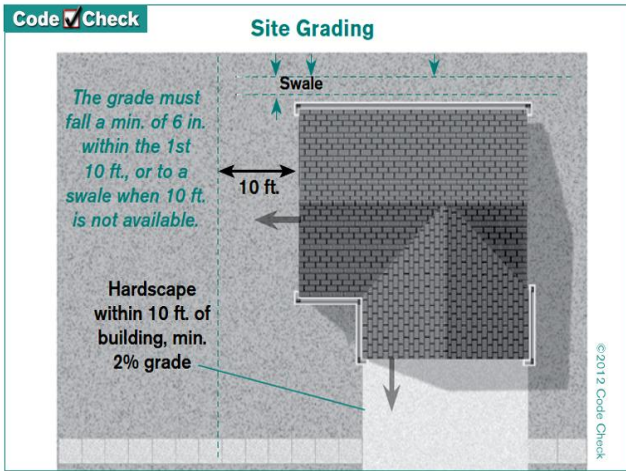
This illustration shows the proper dimensions to grade a property to promote the flow of storm water runoff away from the foundation.

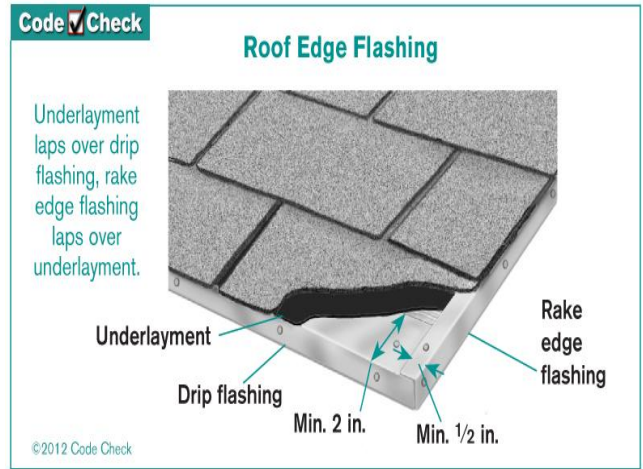
There is no drip / rake edge flashing installed around the west side of the roofs edge. See the comments above and the following illustration.

This illustration shows properly installed drip / rake edge flashing around a roof's edge.

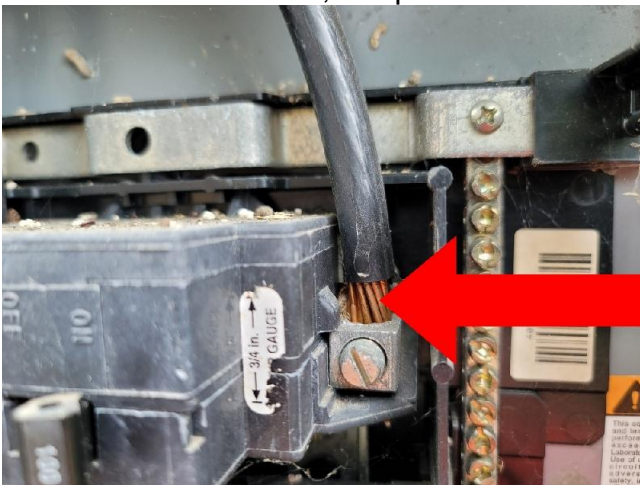
This Photograph confirms the statement above that these are copper service connectors.

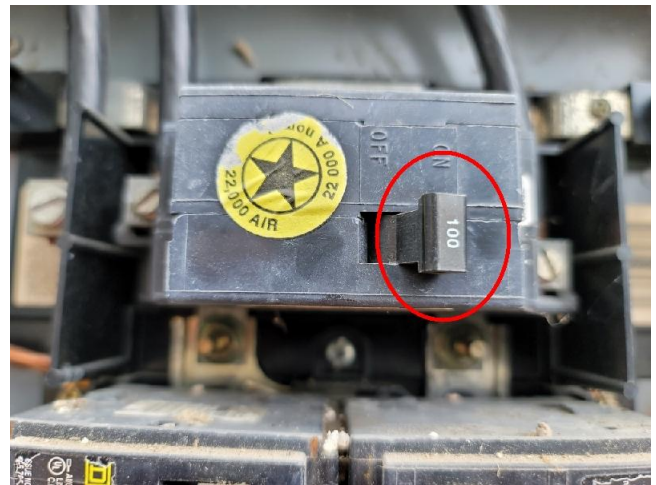
This Photograph confirms the statement above that this is a 100-amp service.

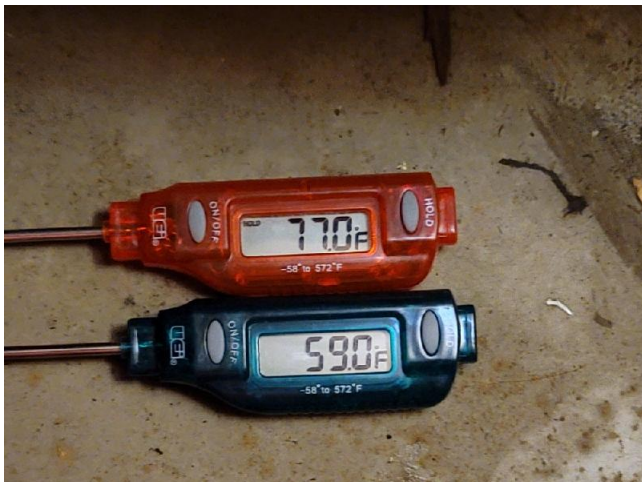
The temperature drop across the coil of the AC unit at the time of this inspection was 18 degrees. This is considered acceptable.

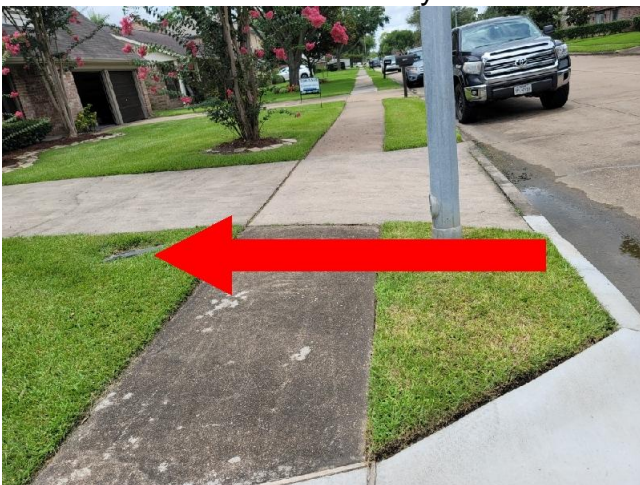
This Photograph confirms the location of the water meter within about 10" feet of the front curb.

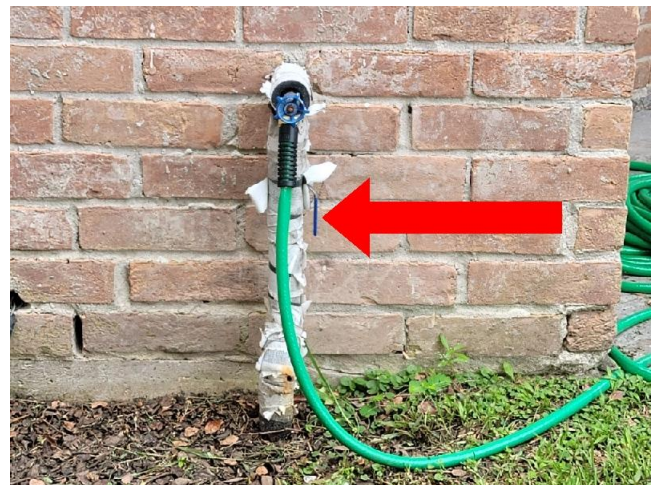
This Photograph shows the location of the main water supply shut off valve located on the exterior wall at the northeast corner of the home.

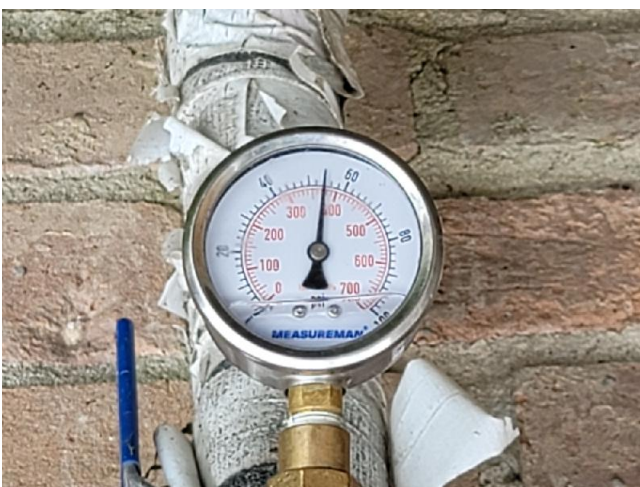
54 PSI main water supply pressure is considered acceptable.

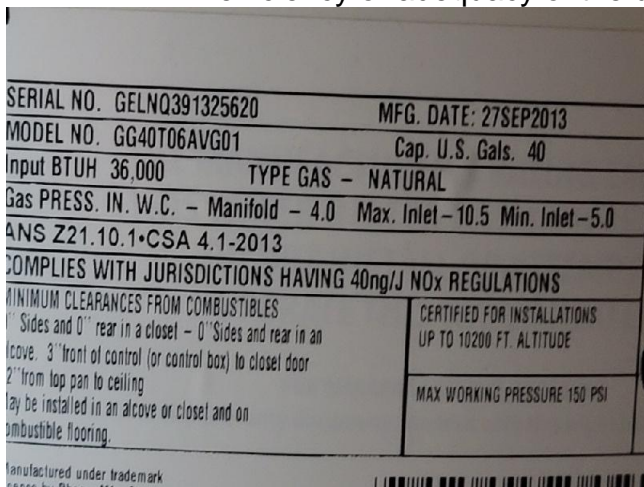
This water heater was manufactured on September 27th of 2013.

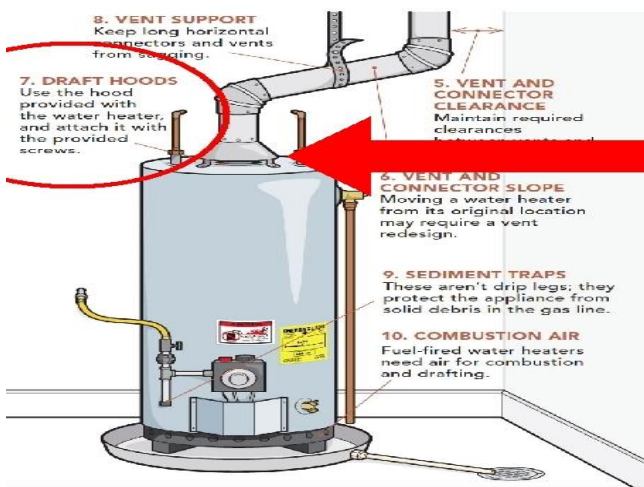
There is no draft hood installed on the exhaust vent on top of the water heater.

This illustration shows a properly installed draft hood on top of a gas water heater.

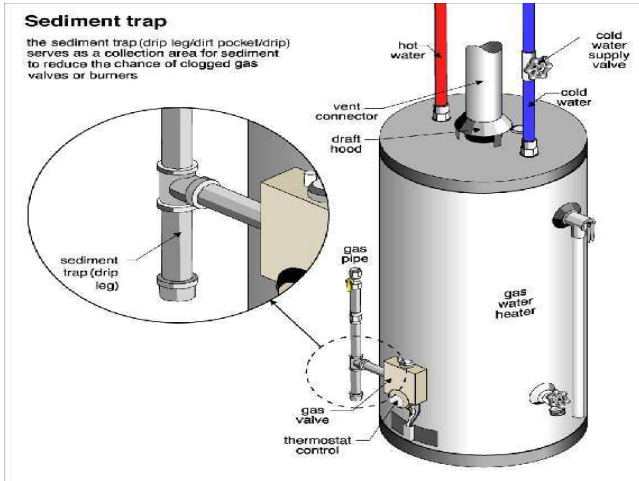
The Sediment trap on the gas supply line to the water heater as required by today's standards is missing. The sediment trap is designed to trap sediment in the gas line before it enters the orifice on the water heater. Recommend a plumber evaluate and Service as necessary.

There is no sediment trap installed on a gas supply line to the water heater. See the comments above and the following illustration.

This illustration shows a properly installed sediment trap on the gas supply line to a gas water heater.
