PROPERTY INSPECTION REPORT

Prepared For: Shane Lampard and Candise Juarez
(Name of Client)

Concerning: 2421 Parkview Dr. Pearland, TX 77581
(Address or Other Identification of Inspected Property):

By: Giovanni Angel, 22909 3/10/2019
(Name and License Number of Inspector) (Date)

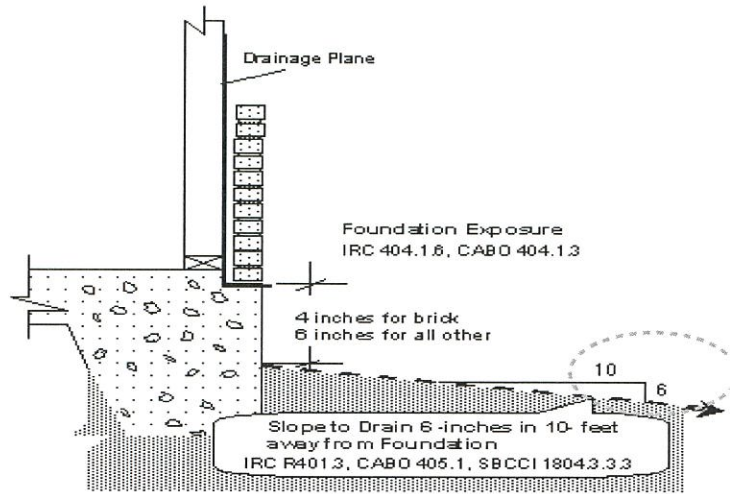
Grade clearance and sloping standard

- The soil level was high on the front side of the house. When soil levels and vegetation are high against the face of the foundation it promotes water penetration, siding rot and insect infestation. Brick veneer wall cladding should have about *4" of clearance between the soil and the first of bricks*, and other materials should have *6" of clearance between other materials and the soil*. We recommend lowering the grade. See illustration in this document's Addendum
- Soil overall is of reverse grade (low spots, negative slope, etc), creating vulnerability to the accumulation of standing water at the foundation wall, a condition known to be a factor in foundation failure. Re-grading is required for a more positive drainage

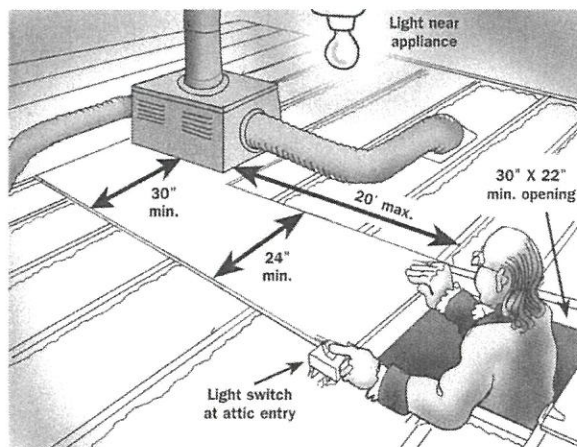
Fig. 4 • Attic Furnace

- Inadequate attic walkway/platform to mechanical equipment. Standards require 30" head clearance and a minimum of 24" wide solid with no gaps or obstructions

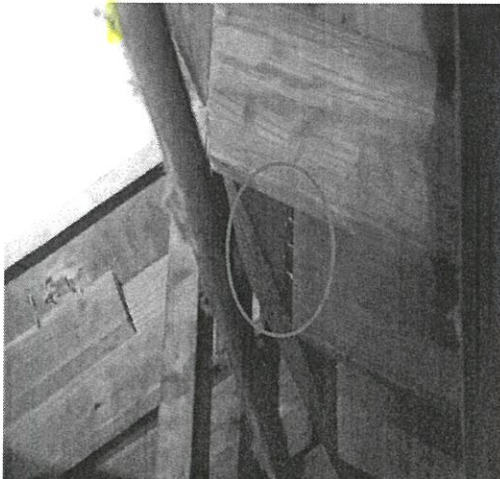
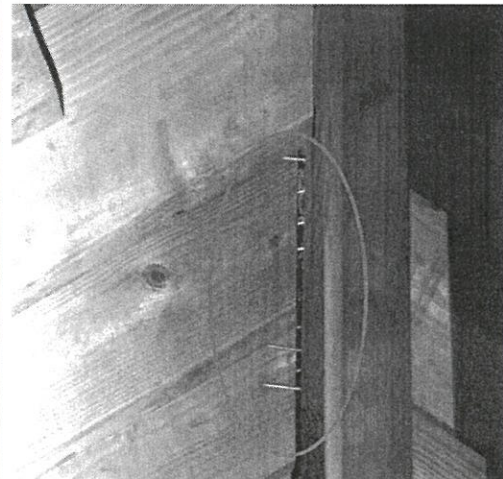
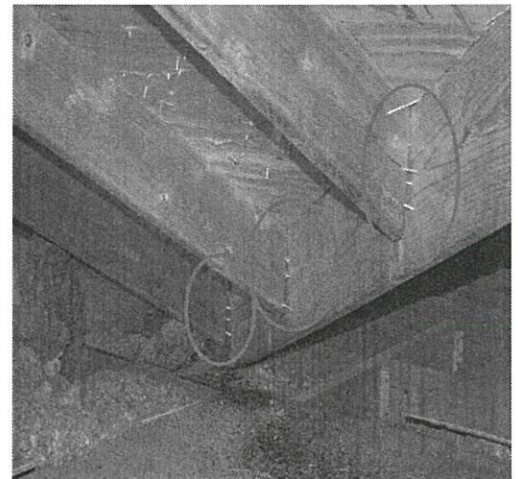
- Several roof structure rafters were observed to be poorly attached to the ridge and hip boards. Recommend repair by a qualified roofing contractor as needed. Samples below.

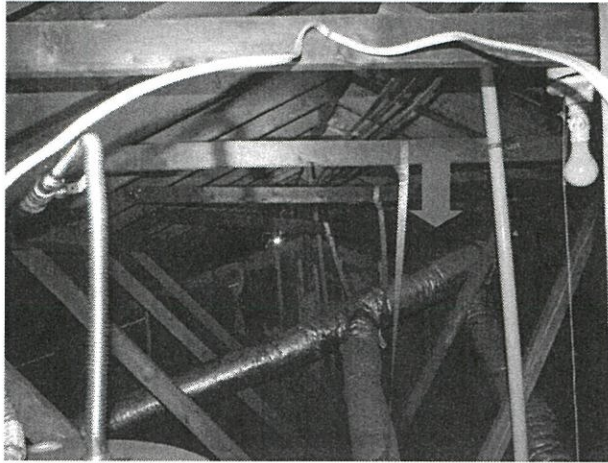
- Collar tie visible through the garage attic access is not attached to the rafter. In need of repair.

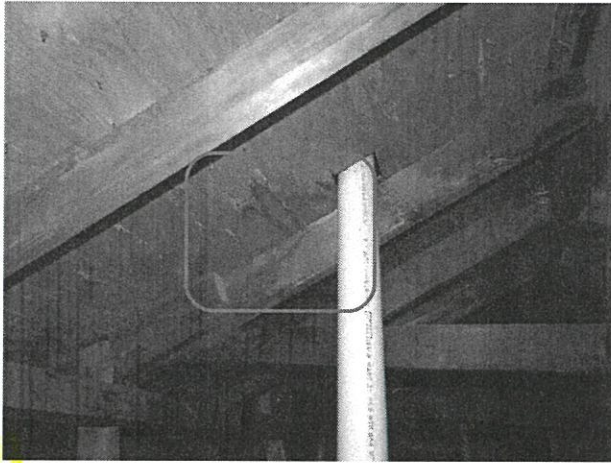
- There is evidence of previous water intrusion at plumbing vent penetrations visible through the garage attic access. Stains appear to be prior to installation of existing shingles. Further investigate condition as needed.

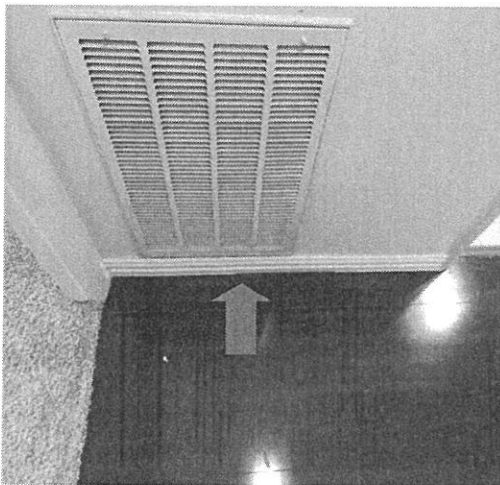
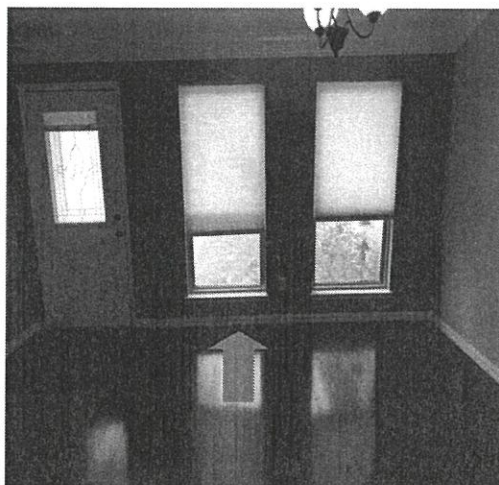
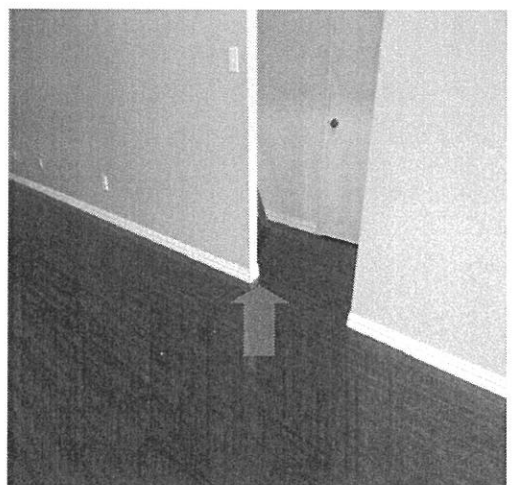
- Baseboards are pulling loose from multiple walls. Recommend proper repair.

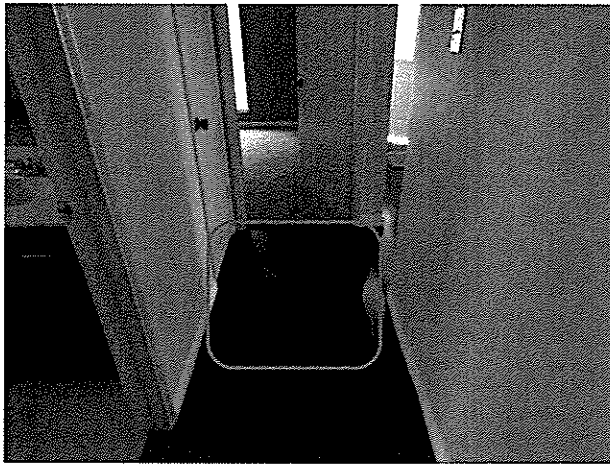
- Lifting flooring in front of the front right bedroom and also noted possible evidence of water damage on flooring at the entrance door. Repair as needed.

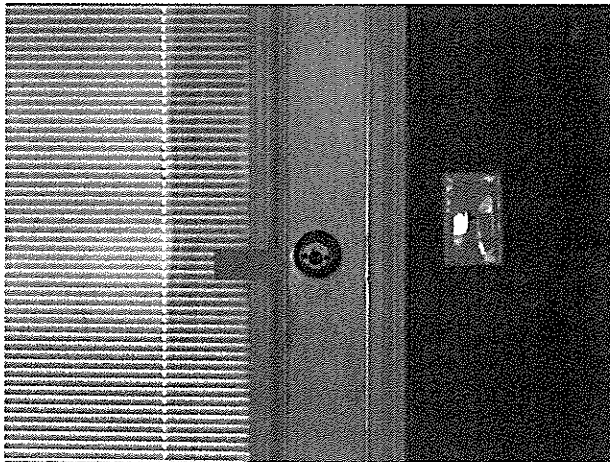
- Double key deadbolt observed at the front and rear exterior doors. **Note:** while this feature improves security, it may also hinder access/egress in an emergency. Recommend single key deadbolt for safety
- Observed daylight on rear exterior door. Properly seal for energy efficiency

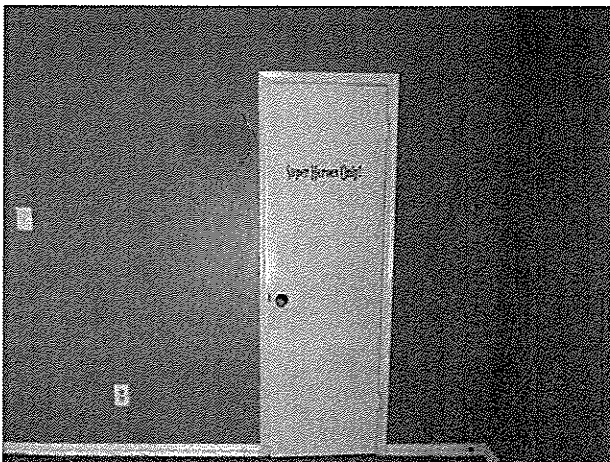
- Front right bedroom door sticks and garage door trim is damaged. Repair as needed.

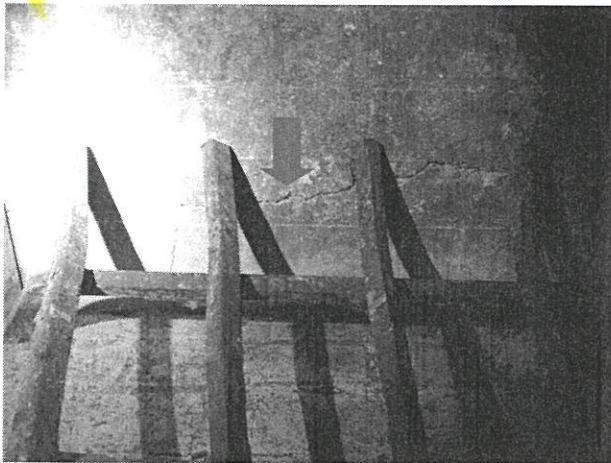
- Repair cracks in the firebox to prevent the escape of gases/ashes into the cavity.
- Chimney cricket is missing. **Note:** Chimneys shall be provided with crickets where the dimension parallel to the ridge line is greater than 30 inches. Repair as needed.

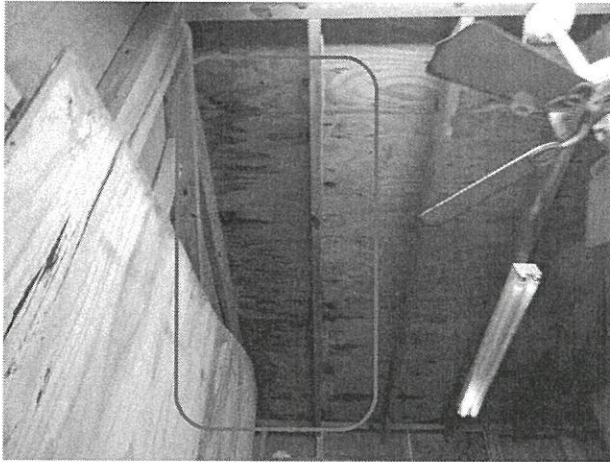
- Water damaged noted on storage shed roof structure and walls. Investigate root cause and repair as needed. Samples below.

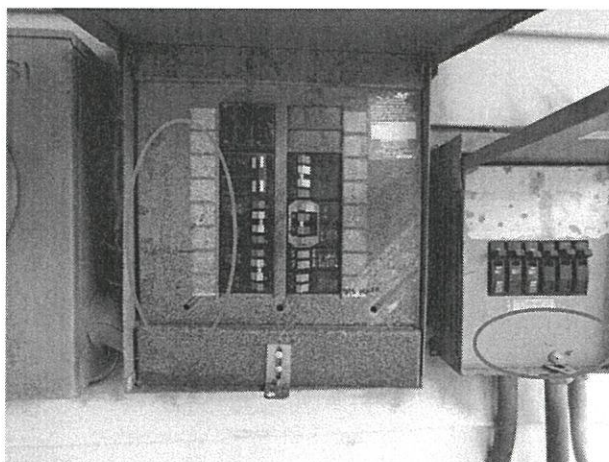
- Noted corrosion on the dead front cover. Recommend repair/replacement of same.
- Missing circuit breakers ID labels. Accurately identify each breaker according to their function

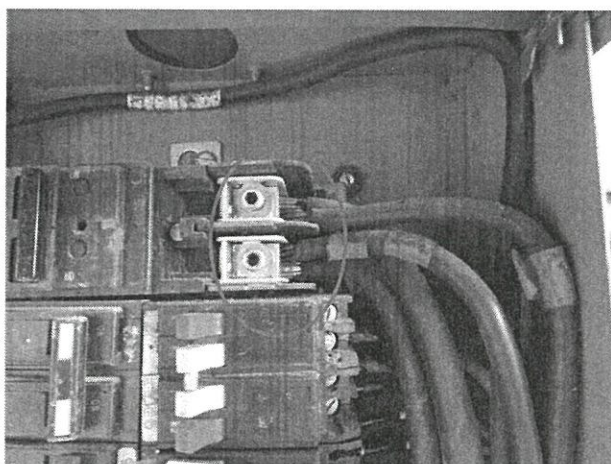
- Main feeder and sub panel feeder cables are double tapped. This condition is hazardous and may cause overheating. Consult with a licensed electrician for proper repairs for safety.
- No anti-oxidant compound on feeder aluminum cables. As oxide builds and continues to build on aluminum wires, it also builds up resistance. Recommend Alnox or Penetrox A13k
- Branch conductors were bundled and pass through a single penetration in the panel cabinet. Such constriction of conductors may generate excessive heat and de-rate the amperage of the cables.

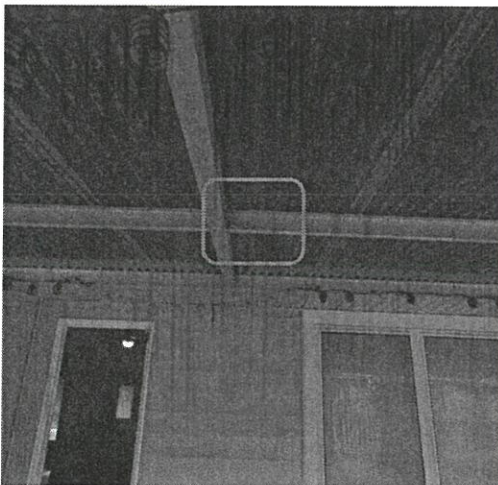
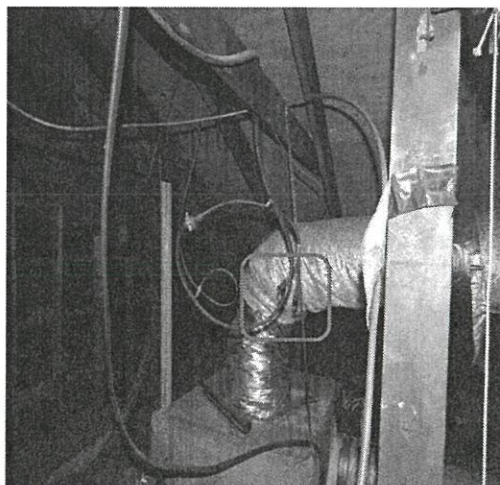
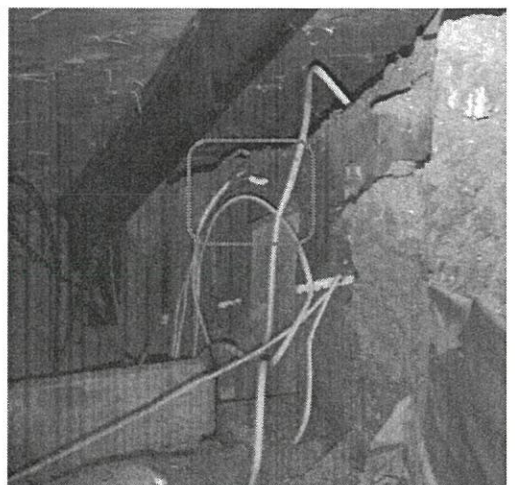
- Observed spliced wires on the rear side of the house and the right attic access. **Note:** All spliced wires should be placed inside a junction box. Properly repair for safety.

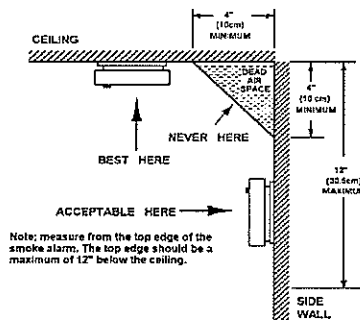
- Install missing smoke alarms and/or carbon monoxide alarms at each required location: **Smoke alarms should be installed at each sleeping area , outside each sleeping area and on each level of the dwelling. Install smoke alarms for the safety of the occupant**

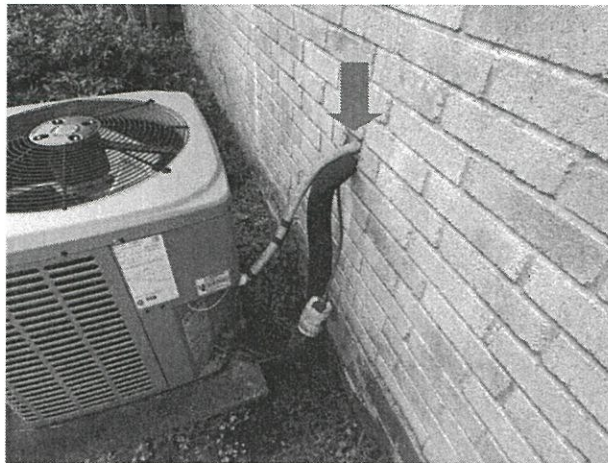
- Properly secure condenser unit to mounting pad to prevent damage from excessive vibration/movement.
- Corrosion-resistive flashing required at the penetrations utilized by the A/C refrigerant lines was not evident. Such flashing should be provided in the exterior wall envelope in such a manner as to prevent entry of water into the wall cavity or penetration of water to the building structural components. The flashing should extend to the *surface of the exterior wall finish* and should be installed to prevent water from reentering the exterior wall envelope.

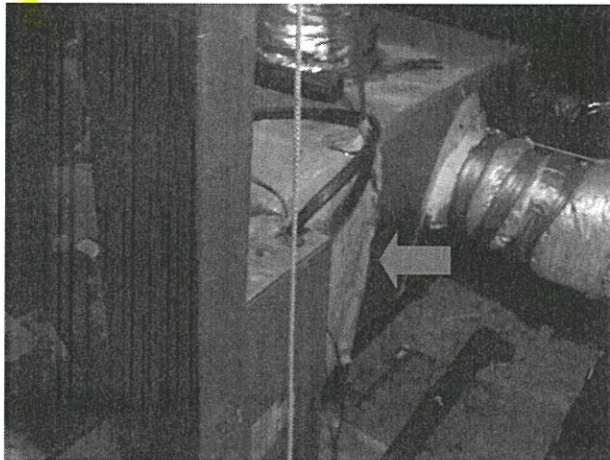
- Air leaking from plenum. Properly seal to prevent the escape of air/moisture.
- Recommend to unplug secondary drain line and elbow it down to drain pan using pvc.

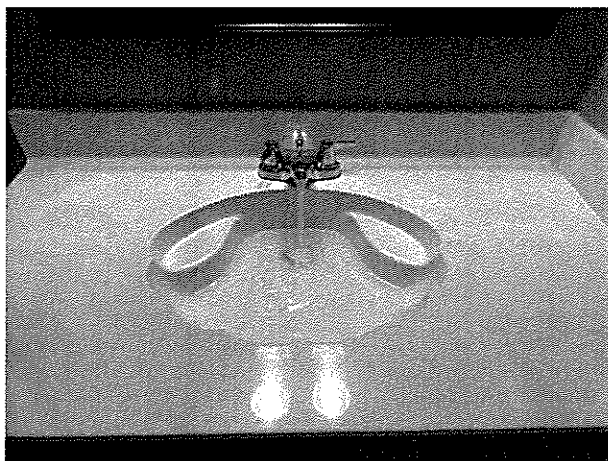
- Slow drain in the hallway bathroom. Further investigate root cause and properly repair as needed.

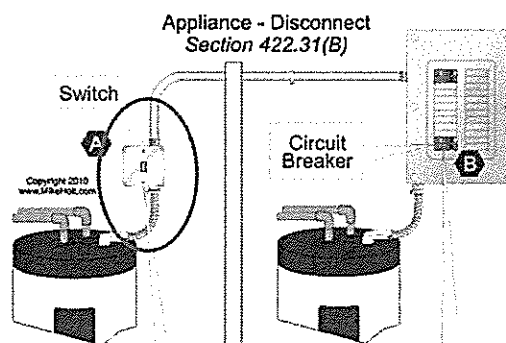
- Inspector was not able to verify bonding of the metal water supply piping. **Note:** The metal gas water supply piping should be grounded or bonded to the electrical system. Recommend verification and/or installation of same for safety precautions.
- The temperature/pressure relief discharge pipe should be as short and as straight as possible so as to avoid undue stress on the valve and be installed so as to drain by flow of gravity. In need of repair.
- The water heating equipment is missing the required in-sight direct disconnect or lockable switch. Install same for safety precautions.

The disconnect must be within sight of the appliance, or it must be capable of being locked in the open position, and the provision for locking remains in place whether locked or unlocked.

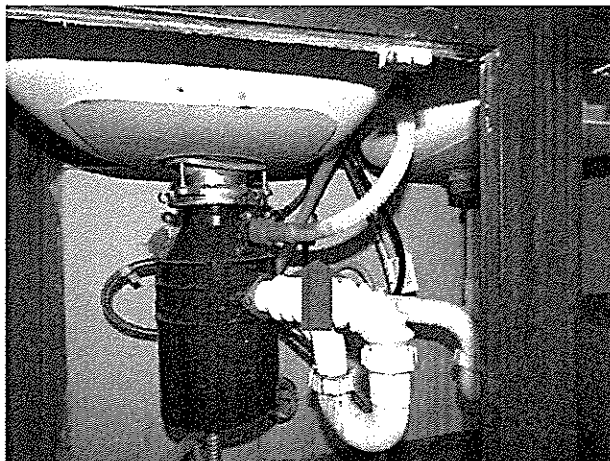
- Debris noted in the dishwasher drain line. Note: Maintain drain line free of debris to prevent blockage of drain line.
