BRUCE ' S

Date: 07/16/2020 Report Number 2020-Ashford Meadow-Goldman-82

Address: , Houston, TX 77082

PROPERTY INSPECTION REPORT

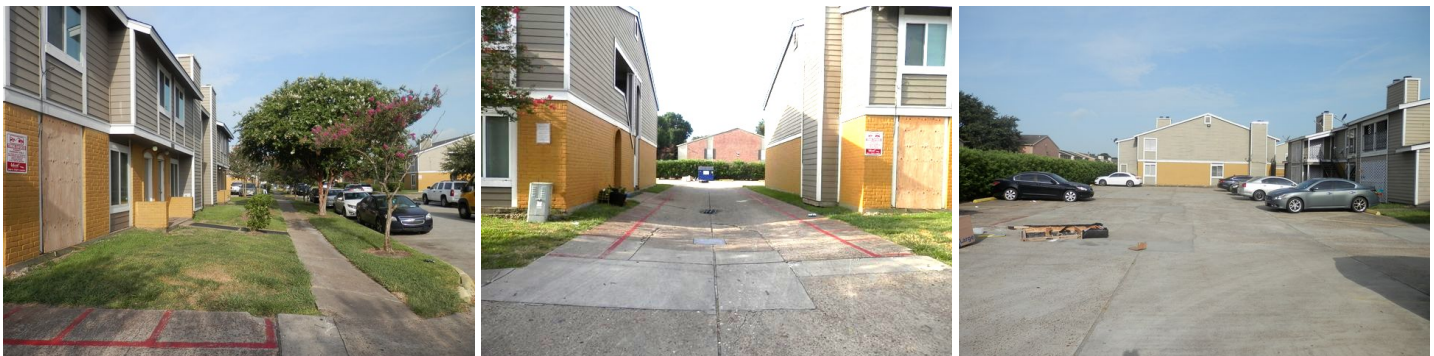
General view of the outside at the front, common drive way and the parking area at the back. There was no indication of ponding or low areas to be a drainage issue.

general view drain path at the front, left (driveway)

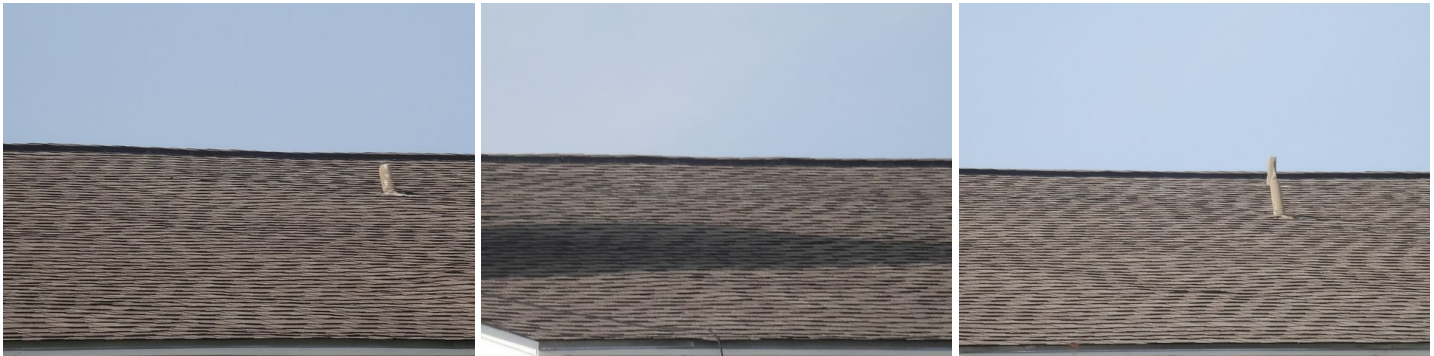
general view of the roof covering as seen from the ground at the front of the property

This is a design of the manufacture, generally referred to as " sluff" or drop off granules. Granules play an integral role in protecting the roof shingles from UV light. Once granules begin to fall from the roof due to age and wear, the UV light will begin to degrade the shingle surface and eventual failure will occur. I am unable to determine the remaining life expectancy of the roof covering.

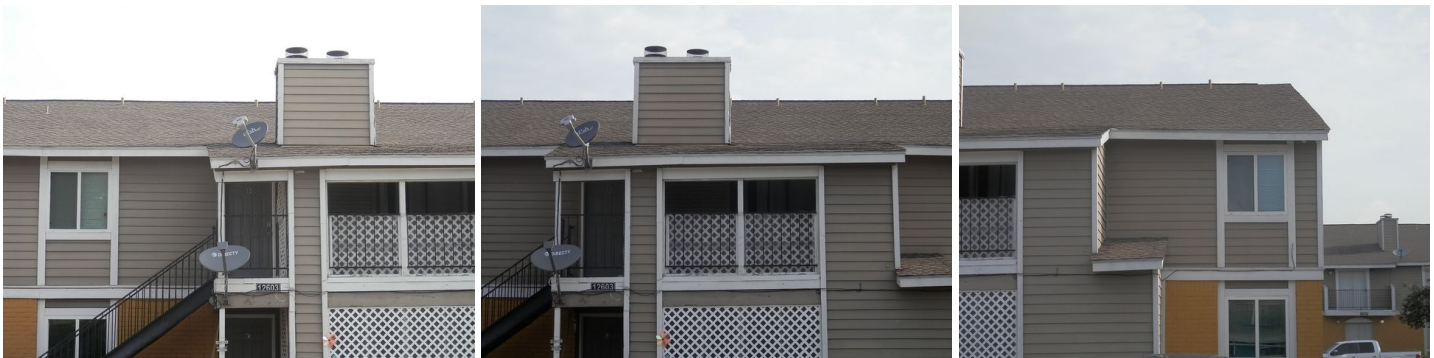
general view of the roof covering as seen from the ground at the back of the property

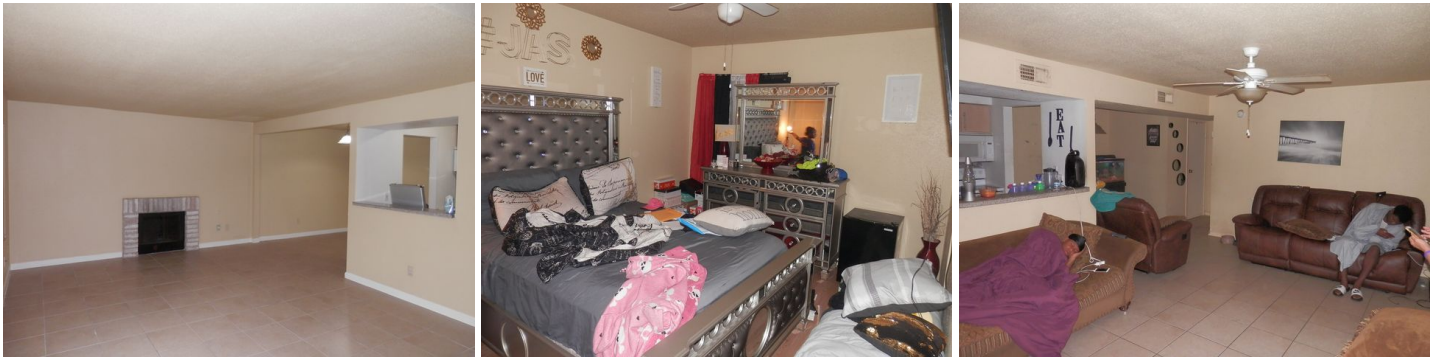
Interior: Observation of the interior gypsum board (Sheetrock) wall and ceiling surface revealed standard workmanship for a structure of this age. This type of construction generally reflects most frame movement and/or foundation movement by cracking and/or causing joint distortions at the surface.

general view of the inside walls at unit A, B & C

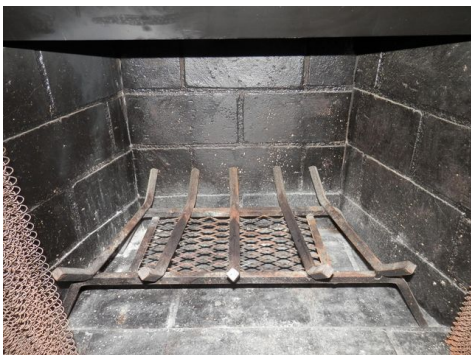
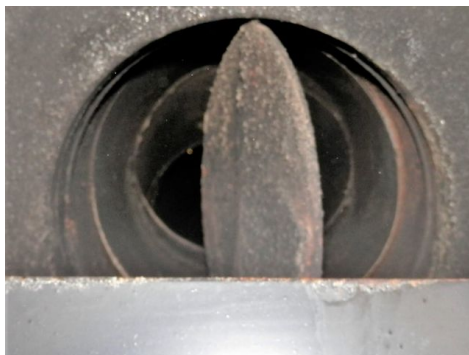
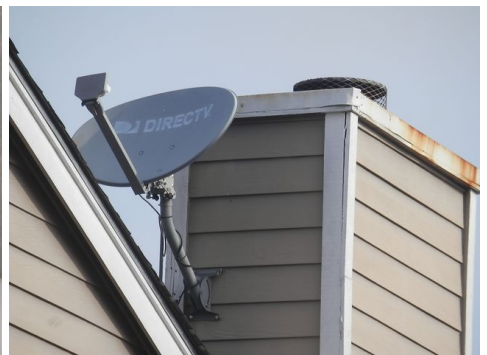
sample view of a fire box and up the fireplace flue - satellite dish attached to the chimney housing at the left

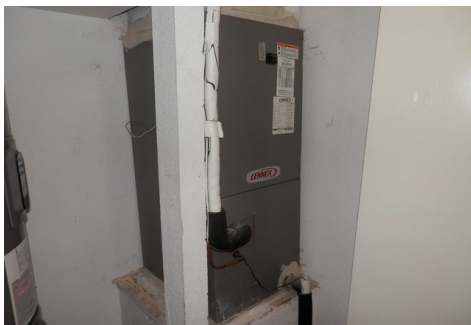
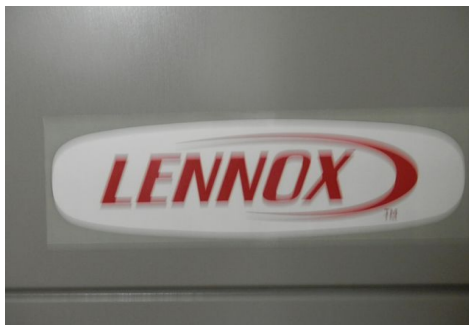
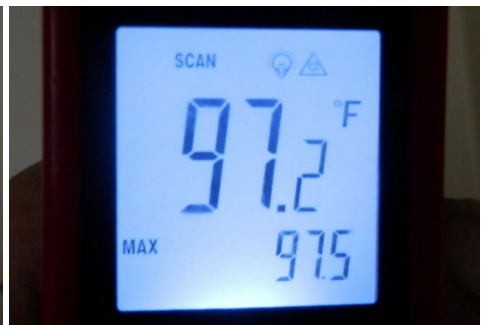
Unit A, B, C, and D: **Functioning:** The unit appeared to function in an acceptable manner. The heating and cooling system is the workhorse of you indoor climate system. Have your local heating/cooling contractor tune up your system annually for comfort, safety and most economical operation.

typical HVAC unit in the utility closet - checking heat output temperature in the test cycle (typical of all units)

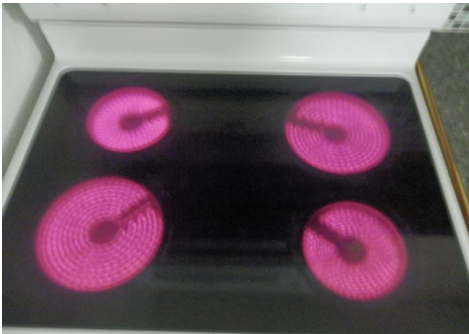
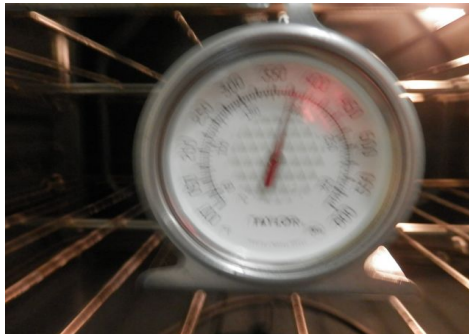
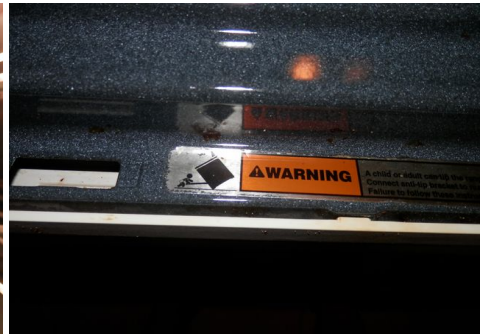
sample of cooktop and ovens in test mode - manufactures placard calling for an anti-tip device

Newer models will have a sign or placard at the inside of the oven. To check to see if the anti-tip bracket installation is proper, use both arms, grasp the rear edge of the range back. Carefully attempt to tilt range forward. The range should not tilt forward. Refer to the anti-tip bracket installation instructions supplied with your range for proper installation. Consult manufacture for additional questions.

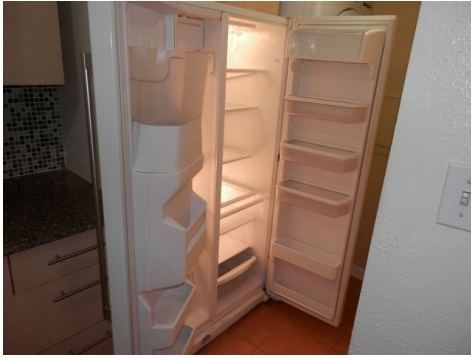
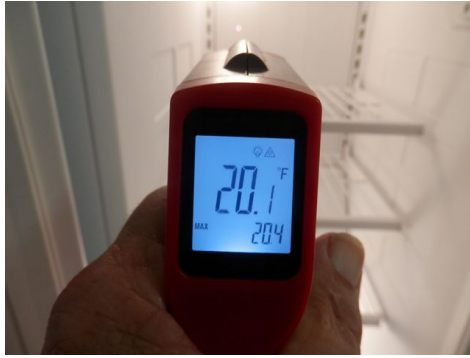
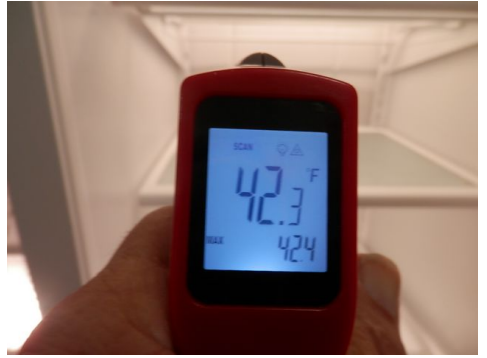
refrigerator in unit A appeared to function (no ice in the container)

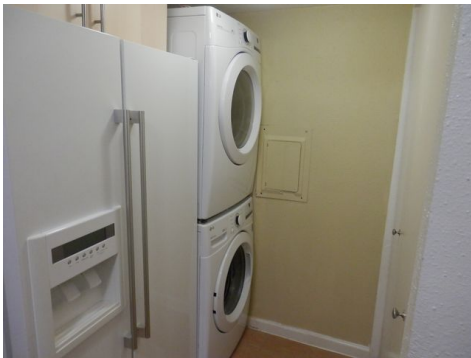
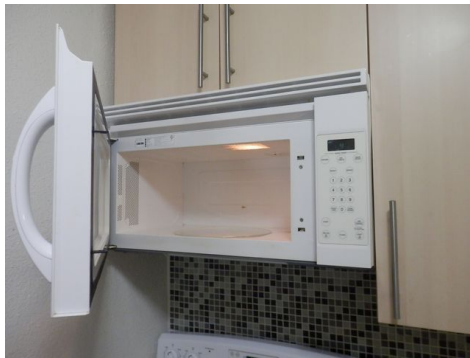
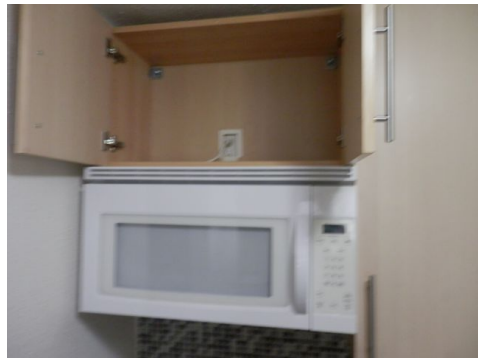
typical utility appliance installation - microwave with a recirculation type vent
