PROPERTY INSPECTION REPORT

Concerning: 5115 White Manor Drive , Pasadena, TX 77505
(Address or Other Identification of Inspected Property)

By: Mike Ash Lic.#: TREC 24404 08/24/2021
(Name and License Number of Inspector) (Date)

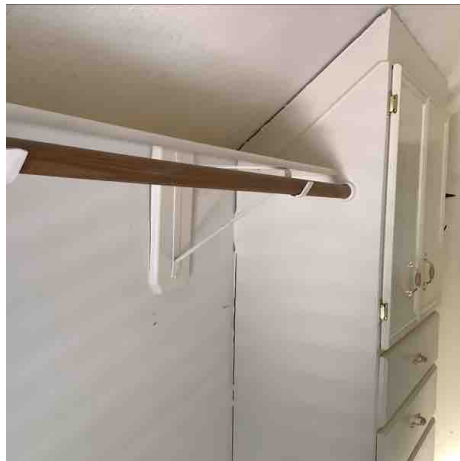
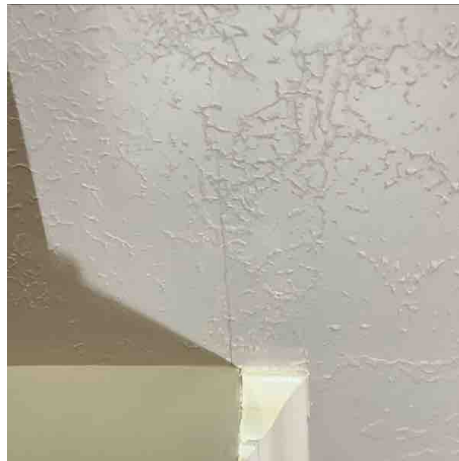
• Water stain was noticed in master bathroom closet ceiling. Area was tested with a moisture meter and no moisture was detected at the time of inspection.

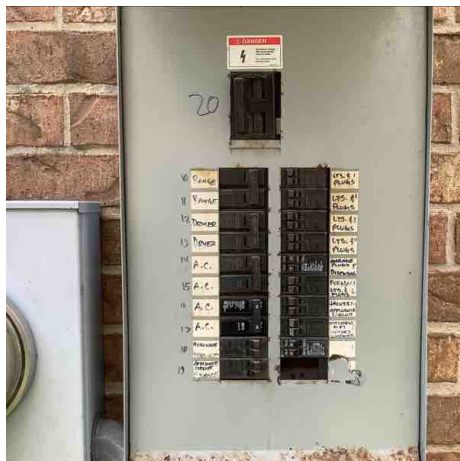
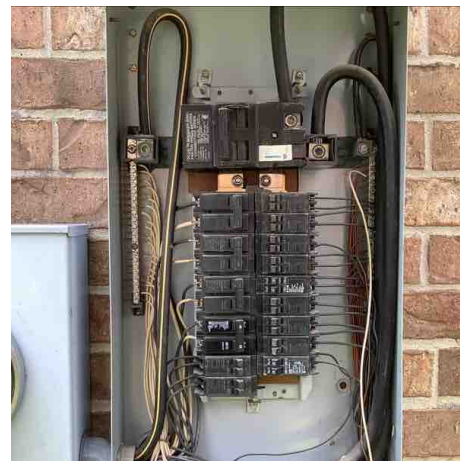
- Breaker panel is rated for 200 max amps and has a 200 amp main circuit breaker, 120/240 single phase service. Panel appears to be working properly at the time of inspection.

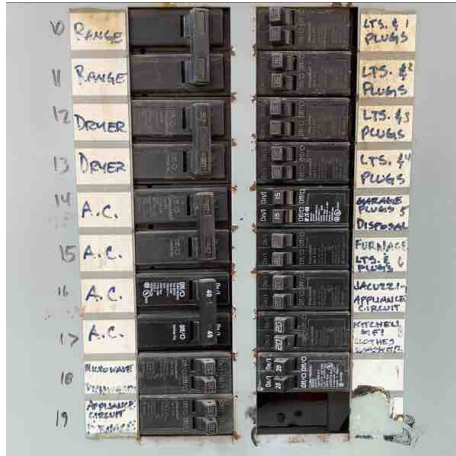
- Opening observed in the cover of the service panel. Breaker cover plate should be installed to cover the openings.

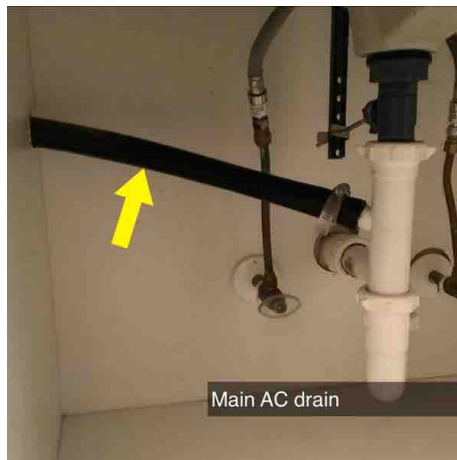
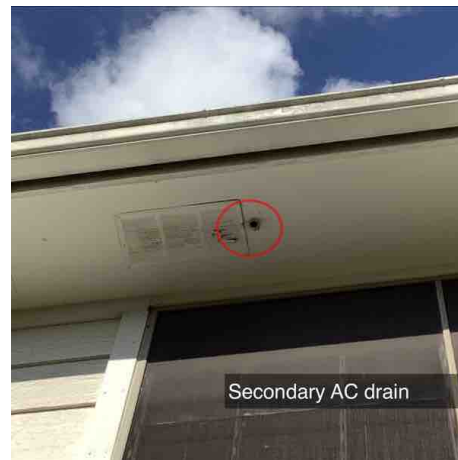
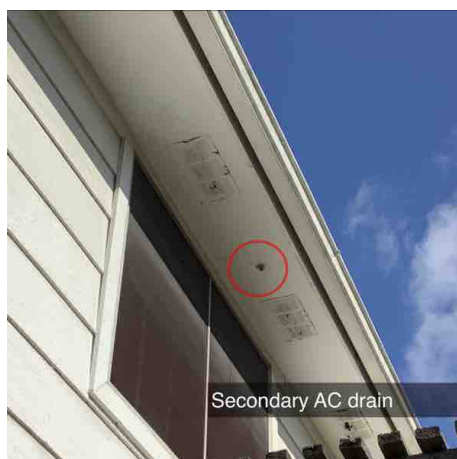
The main AC condensation drains terminate under the upstairs guest bathroom sink. While this is correct, note that in the event this sink drain is blocked this will also block the AC drain.

The secondary AC condensation drains terminate on the east side of the home. In the event water drains from this/these pipe(s) contact a HVAC professional to service the system.

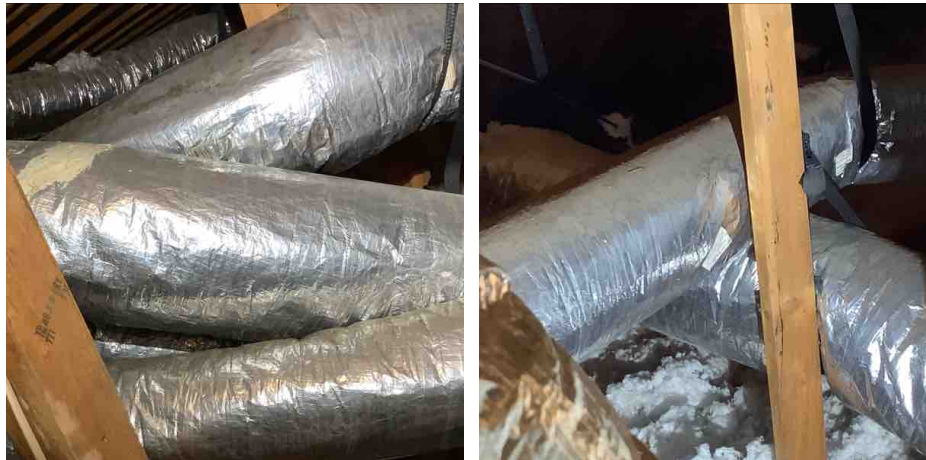
- Multiple ducts do not have proper clearance between each other. There should be a 1" air gap between the ducts to prevent possible condensation from forming.
