Report Prepared For:
Mary Sharkey

5410 Navarro
Houston, Texas 77056
September 12, 2017

Stucco Inspection Report

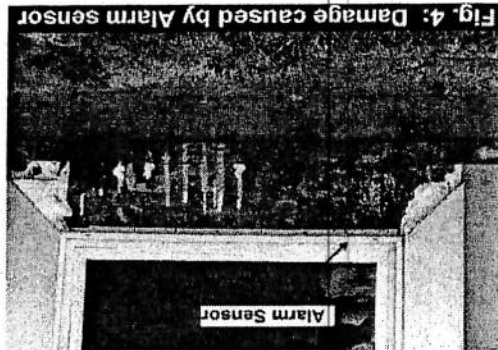
Fig. 4: Damage caused by Alarm sensor

Punctured window tracks or frames from security system installation. This may also void your window warranty. Sealing these penetrations will many times correct the leakage.

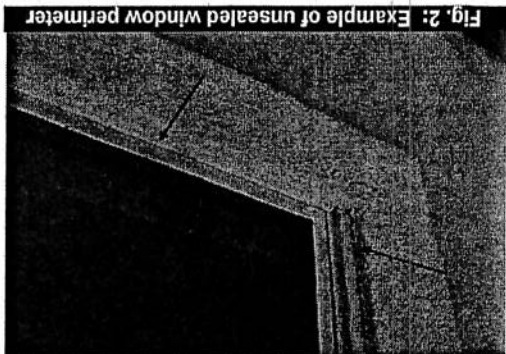
Fig. 2: Example of unsealed window perimeter

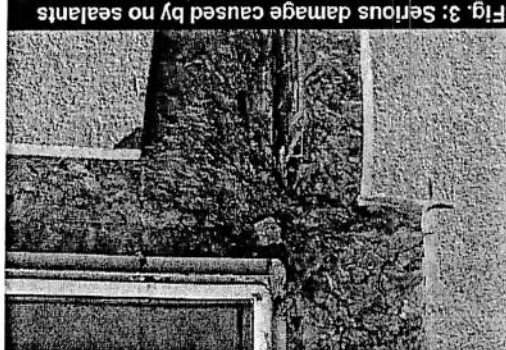
Fig. 3: Serious damage caused by no sealants

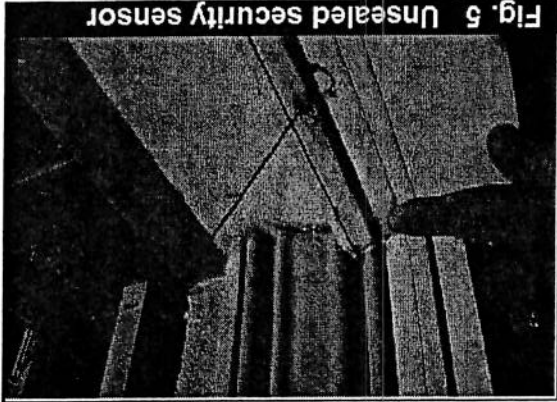
Fig. 5 Unsealed security sensor

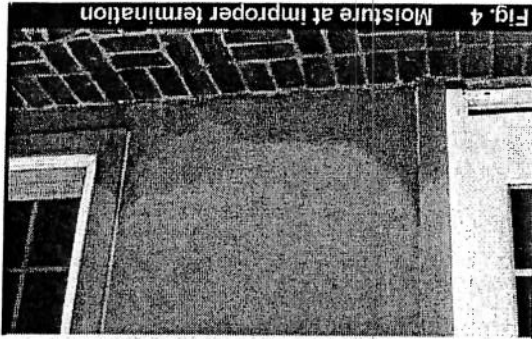
Fig. 4 Moisture at improper termination

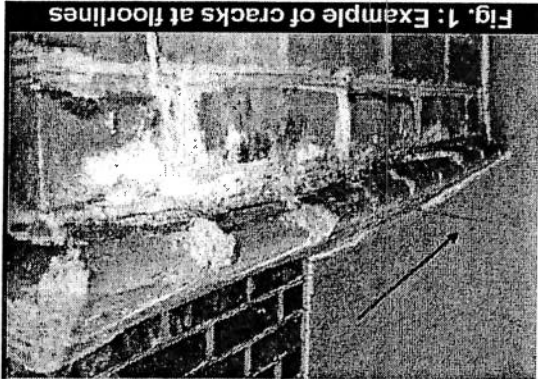
Fig. 1: Example of cracks at floorlines

It does not take a very big crack to allow water intrusion. In fact, a crack as small as 1/16" of an inch wide can permit water to enter behind the stucco, especially with a stucco system that has no moisture barrier. All cracks 1/16" wide or larger and all damaged areas of stucco should be properly repaired as per manufacturers guidelines. Many times the patched areas will still be slightly noticeable even with a good repair application. Extreme cracking will sometimes require the reapplication of EIFS base, mesh, and finish to prevent more cracking and provide a consistent appearance. Cracking is common in hard coat stucco systems, therefore expansion joints are called for every 144 sq. ft. as well as between floorlines and extending vertically from window and door corners to help control cracking.

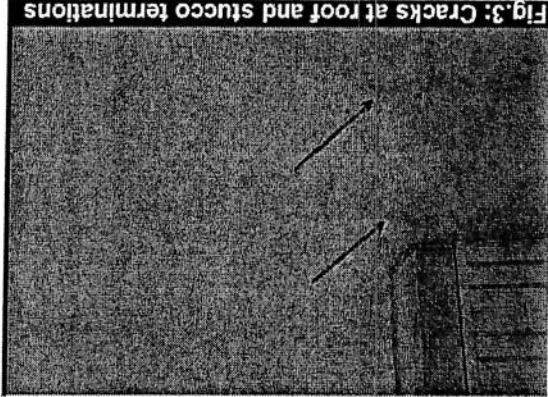
Fig. 3: Cracks at roof and stucco terminations

The most common areas that experience cracking in EIFS are at the corners of windows or roof terminations as seen in Figures 2 and 3. To prevent cracking in this area, most manufacturer and EIMA details specify that an additional layer of reinforcement mesh be applied diagonally at the corners of all windows, doors and other openings. This is called "butterfly" mesh.

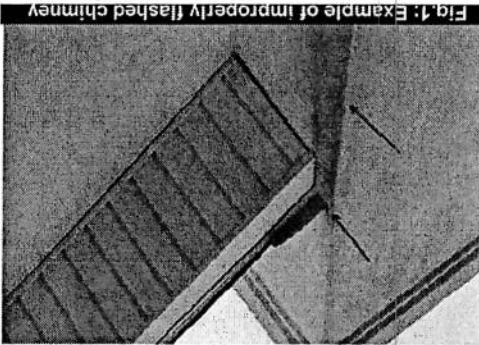
Figure 1 shows a chimney that was not properly flashed (sidewall and kickoff flashing see section 3.4) which resulted in wood rot and termite infestation. Figure 2 shows a chimney coping that was not sealed to the stucco which has now separated and will allow water into the chimney chase.

Fig. 1: Example of improperly flashed chimney

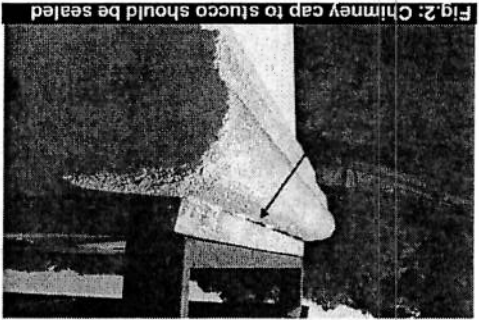
Fig. 2: Chimney cap to stucco should be sealed

A properly designed chimney cap (coping) will shed water away from the stucco to metal joint (Figure 2) and help prevent leaks in this area. The flue should be properly sealed to the "storm flashing" and the chimney cap (coping) sealed to the stucco.
