PROPERTY INSPECTION REPORT

217 11th Ave N
Texas City TX 77590

Prepared For: Robert Orfino
(Name of Clients)

Concerning: 217 11th Ave N, Texas City TX 77590
John Rugg - TREC #24488, TPCL FIRM #2017015000 (Inspector)
FIRM #ACO1162, LEAD FIRM #2110697, ASBESTOS
By: AGENCY #100576, TPCL FIRM #0761253 08/07/2021 9:30 am
(Name and License Number of Inspector) (Date)

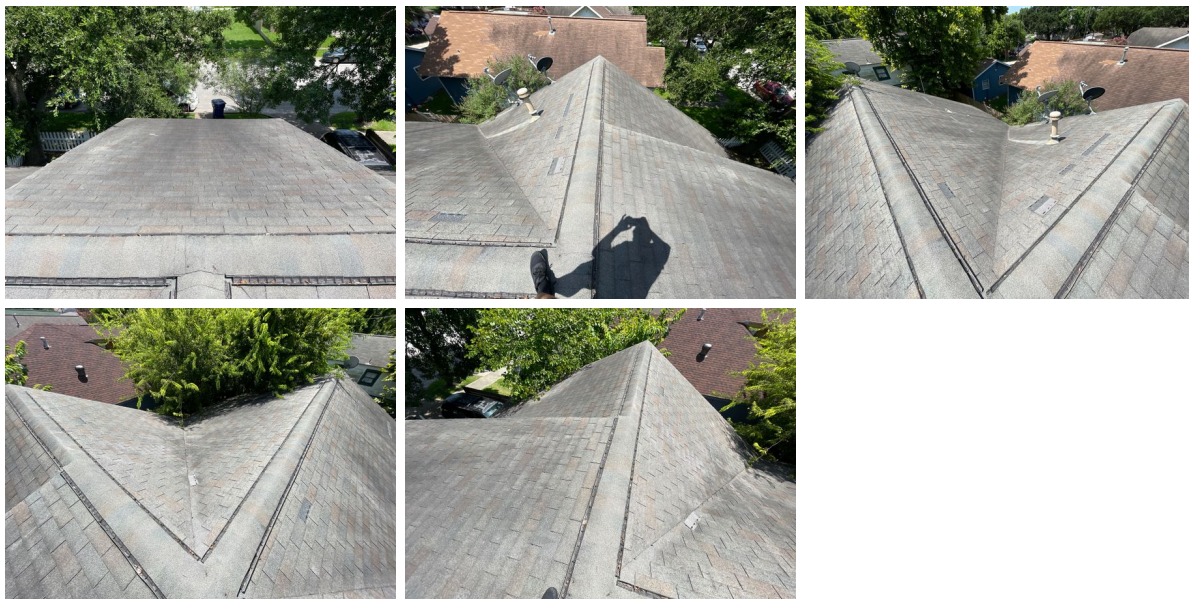
General Roof Photos:

The roof on both structures are nearing the end of their lifespan and should be replaced soon.

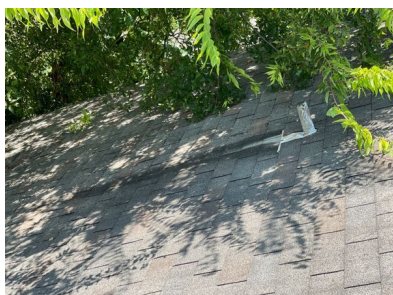
[Here is a helpful article](#) on common roof stains.

Recommendation: Contact a qualified roofing professional.

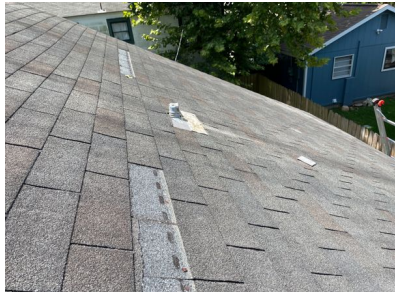
Not all of the vent stacks are high enough; they should terminate a minimum of 6" above the roof.

Recommendation: Contact a qualified professional.

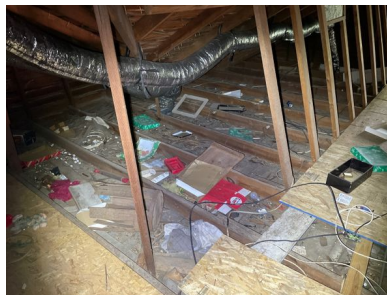
There were areas of missing insulation in the attic area. The Department of Energy currently recommends an insulation value of R-30 to R-49 for the attic area.

Recommendation: Contact a qualified insulation contractor.

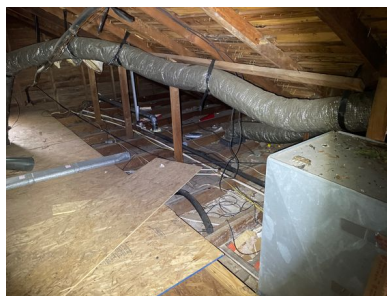
There were missing purlin supports.

Recommendation: Contact a qualified professional.

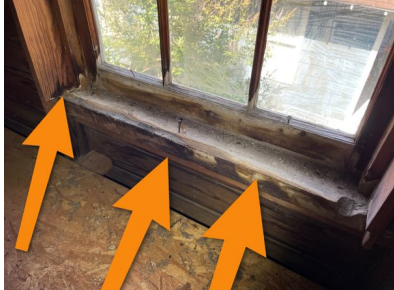
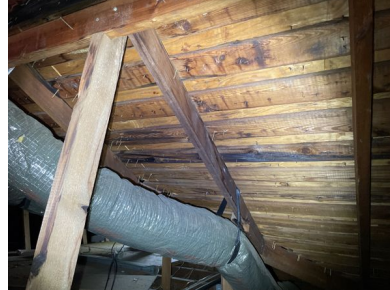
Areas of water damage and staining were noted on the roof decking and structural members in the attic.

Recommendation: Contact a qualified professional.

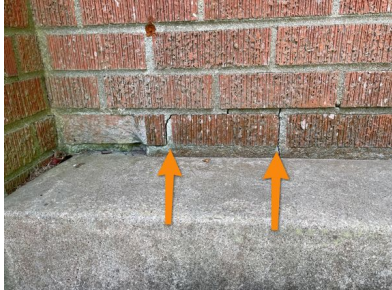
Brick and mortar separation was observed at the exterior walls.

Recommendation: Contact a qualified masonry professional.

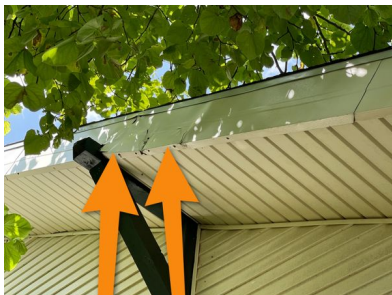
There were areas of damaged siding and trim materials.

Recommendation: Contact a qualified professional.

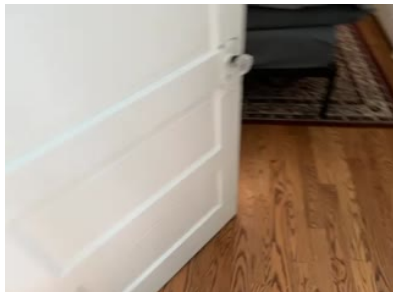
There were doors within the home that open/close when left in a fixed position.

Recommendation: Contact a qualified door repair/installation contractor.

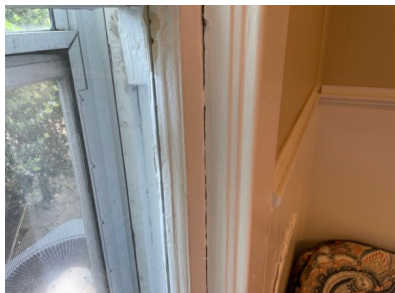
Windows have been painted shut and could not be operated or tested. These limit the ability to inspect the window opening function and inhibit egress in case of emergency.

Recommendation: Contact a qualified window repair/installation contractor.

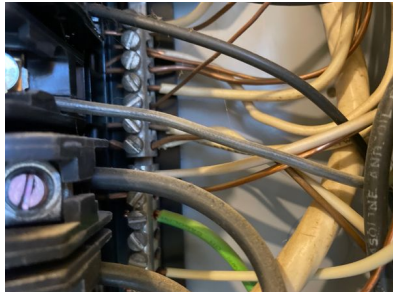
Double lugging was present at the neutral bar at the time of inspection.

Recommendation: Contact a qualified electrical contractor.

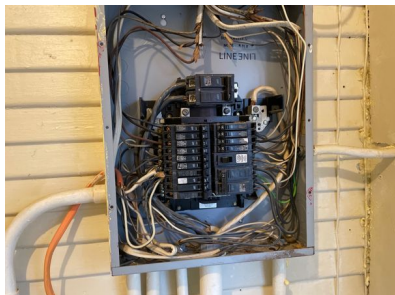
There are no Arc Fault Circuit Interrupt (AFCI) breakers present as called for by recent TREC reporting standards. AFCI breakers are used to protect living area branch circuits that are not GFCI (Ground Fault Circuit Interrupt) protected. These were not part of the building standards at the time of construction.

Recommendation: Contact a qualified electrical contractor.

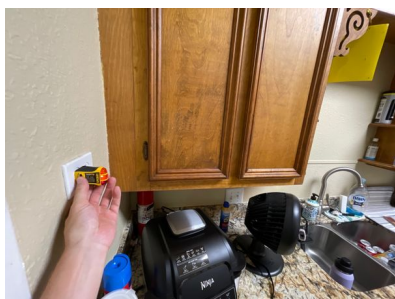
Not all TREC required areas were GFCI protected. Required areas include but not limited to the Kitchen, all Bathroom/Restrooms, Garage, Exterior, Crawlspace, Unfinished Basements, Laundry Rooms, and Bar areas.

Recommendation: Contact a qualified electrical contractor.

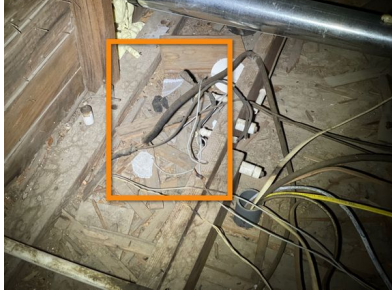
Observed wire splices that were not protected in junction boxes.

Recommendation: Contact a qualified electrical contractor.

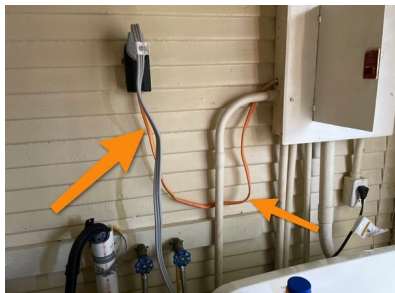
The exposed interior wiring should be relocated behind gypsum board or should be in protective electrical conduit.

Recommendation: Contact a qualified electrical contractor.

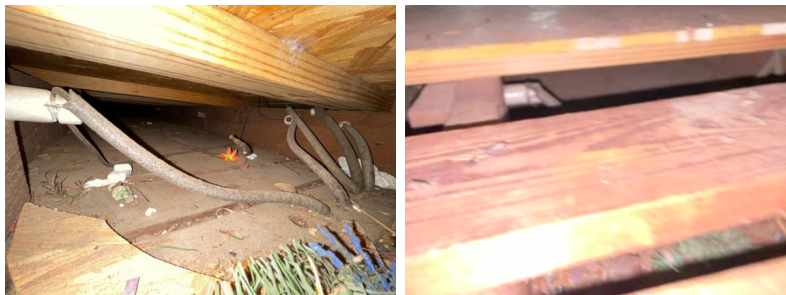
There was knob and tube wiring observed within the attic and it was determined to be live. Evaluation by a licensed electrician is recommended.

Recommendation: Contact a qualified electrical contractor.

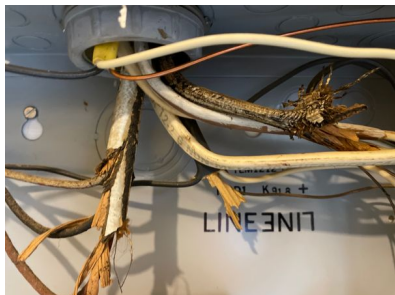
There was cloth wrapped wiring observed within the property. Cloth wiring is an antiquated type of wire that can become unraveled and damaged over time. Parts or all of the wiring may need replacement as it continues to age.

Recommendation: Contact a qualified electrical contractor.

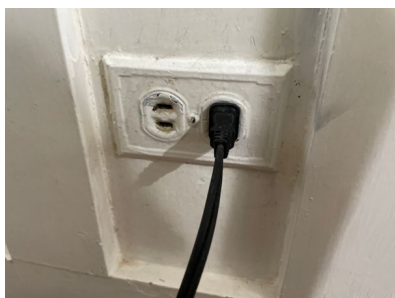
Two prong outlets were present within the home. These older antiquated outlets do not have a grounding wire present. Without a ground wire, there is no protection from short circuits and high voltage. Modern codes and electronics require grounded three wire outlets for best protection against shock and damage.

Recommendation: Contact a qualified electrical contractor.

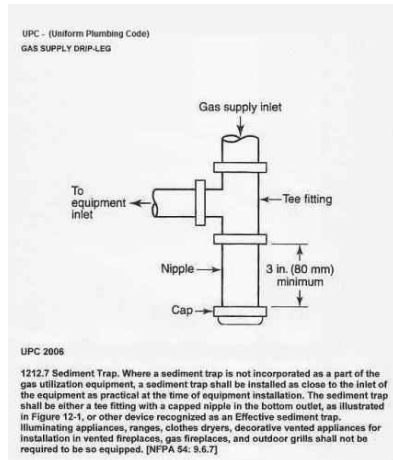
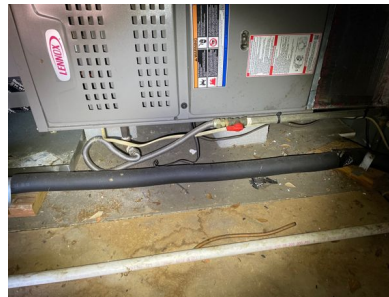
A drip leg or sediment trap was not observed on the gas line at the unit.

Recommendation: Contact a qualified professional.

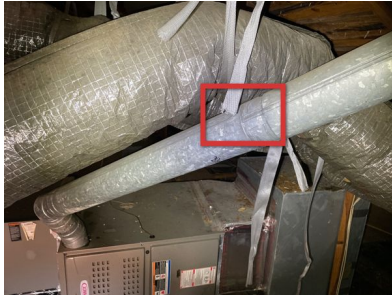
The flue pipe serving the gas furnace does not have sufficient clearance from combustible materials. Normally, a clearance of at least 1" is required. This situation may result in pyrolysis, which can possibly lower the auto-ignition temperature of the surrounding materials. This condition should be improved for safety reasons.

Recommendation: Contact a qualified HVAC professional.

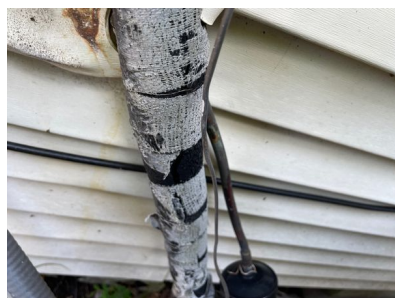
1: Condensation Line Insulation - Exterior Damage

Insulation is damaged and separating on the large Freon suction line at the air conditioning compressor.

Recommendation: Contact a qualified heating and cooling contractor

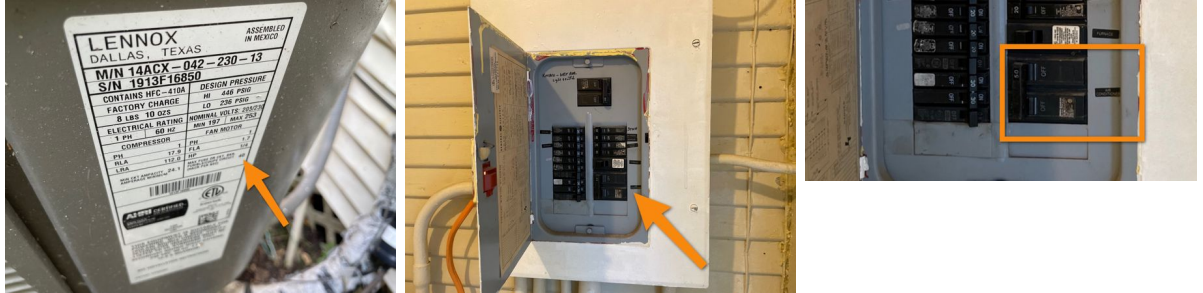
The condensing unit breaker size does not match the recommended size per manufacturer's label.

Recommendation: Contact a qualified electrical contractor.

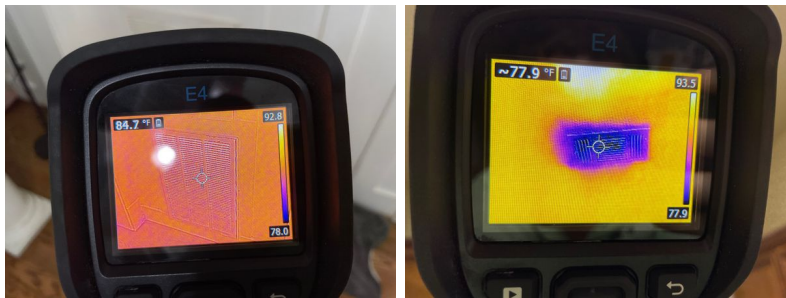
3: Insufficient Differential

The temperature differentials indicate a problem with the cooling system or system ducting. A differential of 15°F or higher indicates proper cooling. This system should be inspected and repaired by a licensed H.V.A.C. professional.

Recommendation: Contact a qualified HVAC professional.

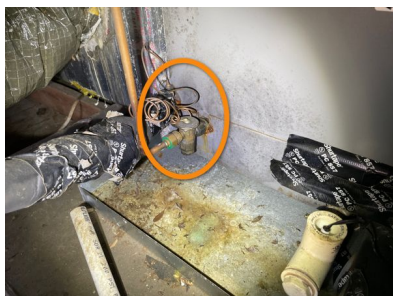
4: Evaporator Unit - Air Leak

The evaporator unit in the attic had an air leak from the plenum at the time of inspection. This has caused condensation to build up on the unit.

Recommendation: Contact a qualified HVAC professional.

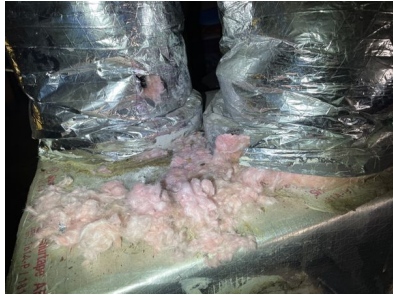
1: Ducts - Damaged - Dust Cover - Deteriorated

The dust cover has deteriorated on some of the ducts in the attic. The dust cover prevents moisture from saturating the insulation and keeps the insulation from opening up and exposing the conditioned air to attic temperatures.

Recommendation: Contact a qualified heating and cooling contractor

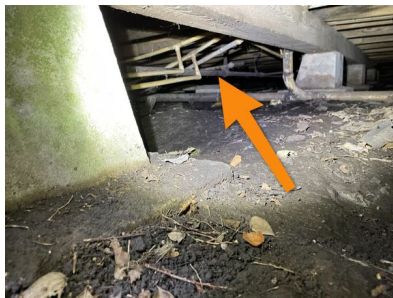
Home has original galvanized supply lines. Lines of this age are known to develop leaks and clogs overtime. Supply problems may not be detectable until they actually fail. Consider updating these supply lines. Consult with licensed plumber for options and pricing.

Recommendation: Contact a qualified plumbing contractor.

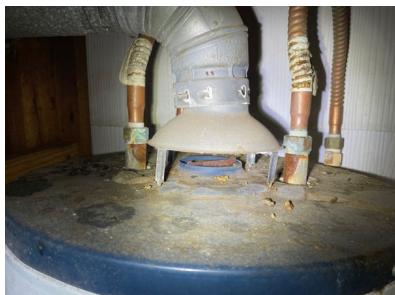
1: Corrosion - Valves/Fittings

There is corrosion on the valves and fittings at the water heater. Corrosion is prone to water leaking and corroded areas should be replaced as needed.

Recommendation: Contact a qualified plumbing contractor.

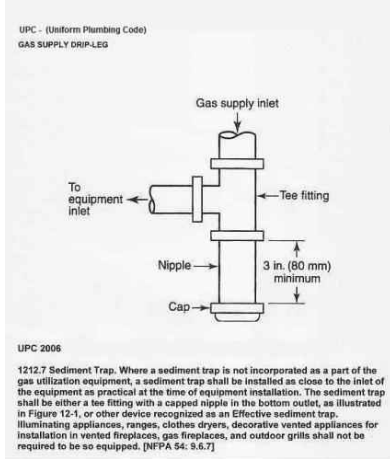
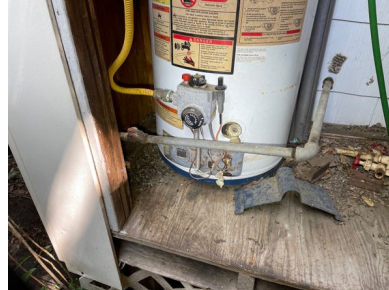
Drip leg or sediment trap was not observed on the gas line at the unit.

Recommendation: Contact a qualified plumbing contractor.

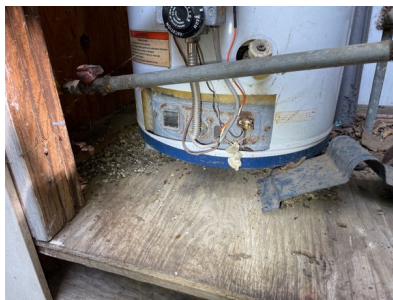
3: Outer Blast Shield Missing

The outer blast shield is missing to the gas water heater.

Recommendation: Contact a qualified plumbing contractor.

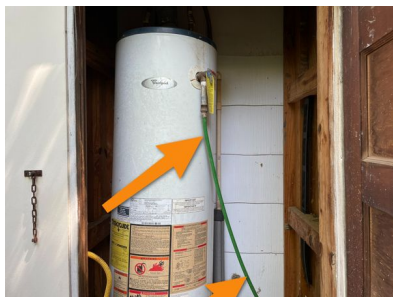
4: TPR Made Of Water hose

The Temperature and Pressure Relief (TPR) Valve drain line is not made out of ideal materials. A TPR Valve is designed to open when the water in a tank reaches 150 PSI and/or 210 degrees F.

Recommendation: Contact a qualified plumbing contractor.

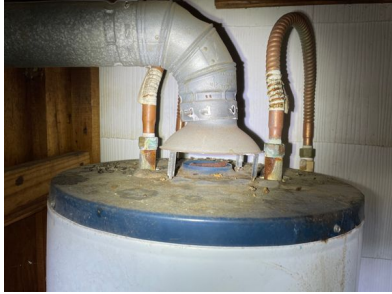
5: Improper Flue Installation

The natural gas fueled water heater is improperly vented, lacking the recommended minimum 12" of vertical rise before the elbow and vented directly into a large masonry flue where it cannot develop adequate draft. This heater installation may be unsafe.

Recommendation: Contact a qualified professional.

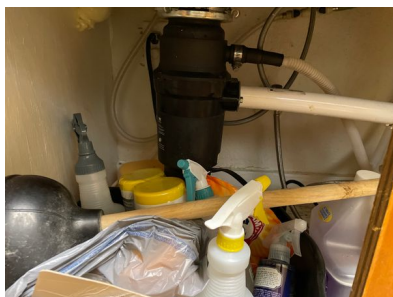
1: Not Respond

Unit did not respond to testing at time of inspection.

Recommendation: Contact a qualified appliance repair professional.

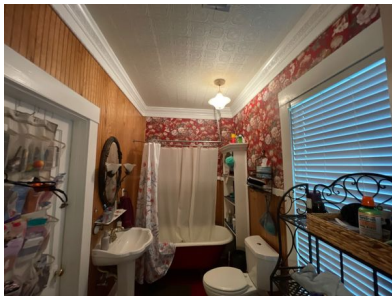
1: Missing Exhaust Fans - Bathroom

An exhaust fan or operable window was not installed in the bathroom. Window has been painted shut.

Recommendation: Contact a qualified professional.

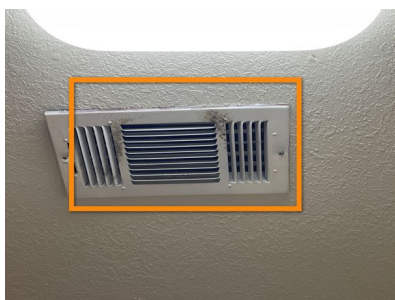
There was assumed mold growth observed within the home. It is recommended that these areas be further sampled and analyzed and remediated as necessary.

Recommendation: Contact a qualified mold inspection professional.

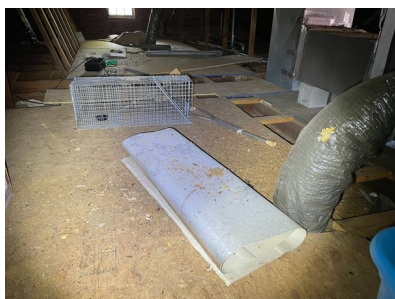
2: Rodent Bait/Traps Present

Rodent bait/traps were observed at the home. This may indicate previous infestation, active infestation, or preventative measures. Continuing of the service by a pest control professional is highly recommended.

Recommendation: Contact a qualified pest control specialist.

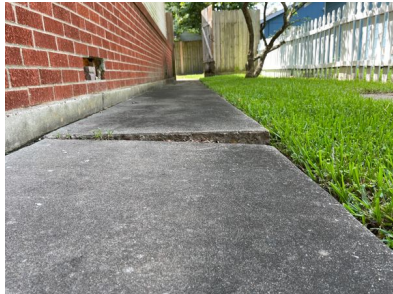
3: Sidewalk Cracks

Cracking, damage, or uplift was noted at the sidewalk. Recommend a qualified professional evaluate and repair.

Recommendation: Contact a qualified professional.

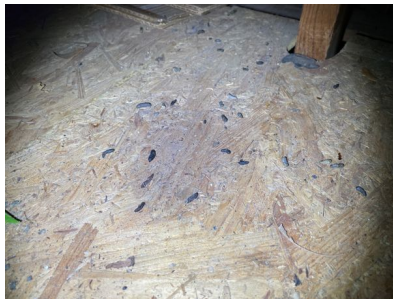
4: Varmint/Vermin Feces

There was fecal matter noted in the attic area that appeared to be from varmints/vermin.

Recommendation: Contact a qualified professional.
