DUPLEX INSPECTION REPORT

217 11th Ave N
Texas City TX 77590

PROPERTY INSPECTION REPORT

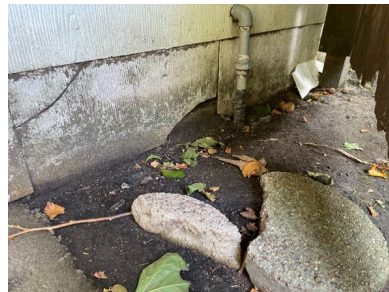
There were areas of damaged siding and trim materials.

Recommendation: Contact a qualified professional.

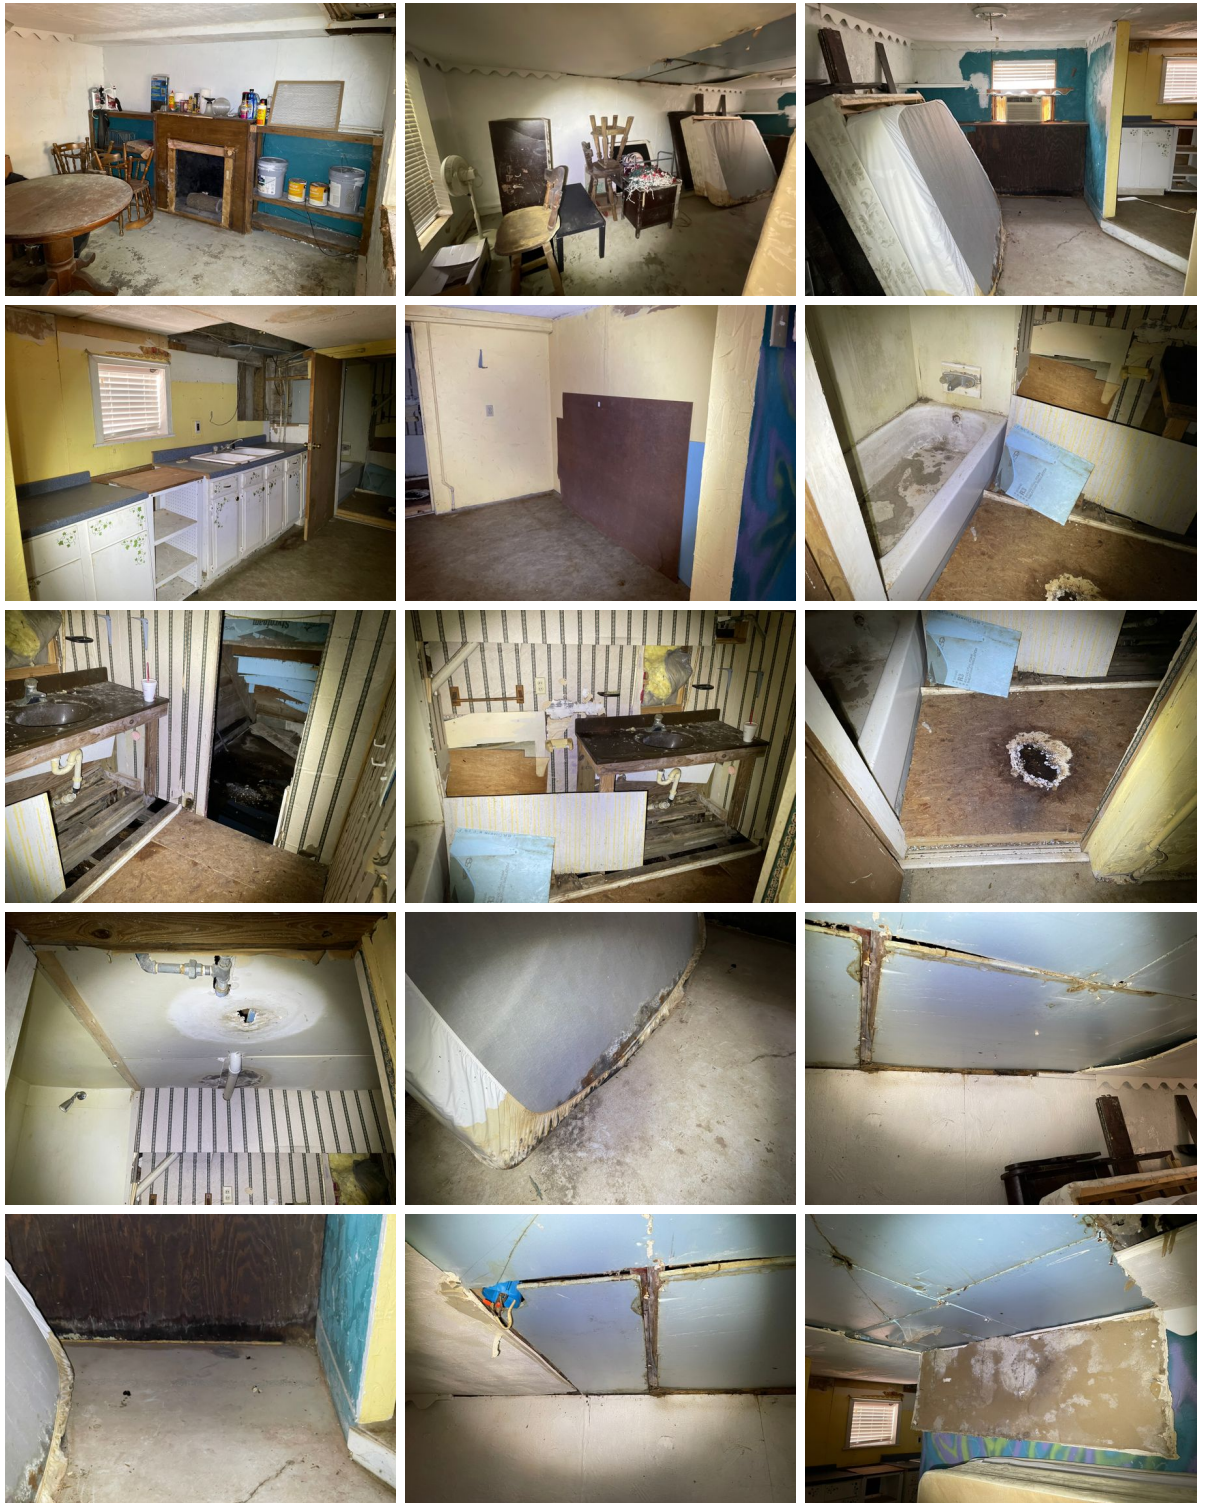
Interior Photos - Downstairs :

The downstairs portion of the structure was a very limited inspection due to numerous water leaks, broken pipes, holes in wall, rotten wood, mold, insects and personal belongings.

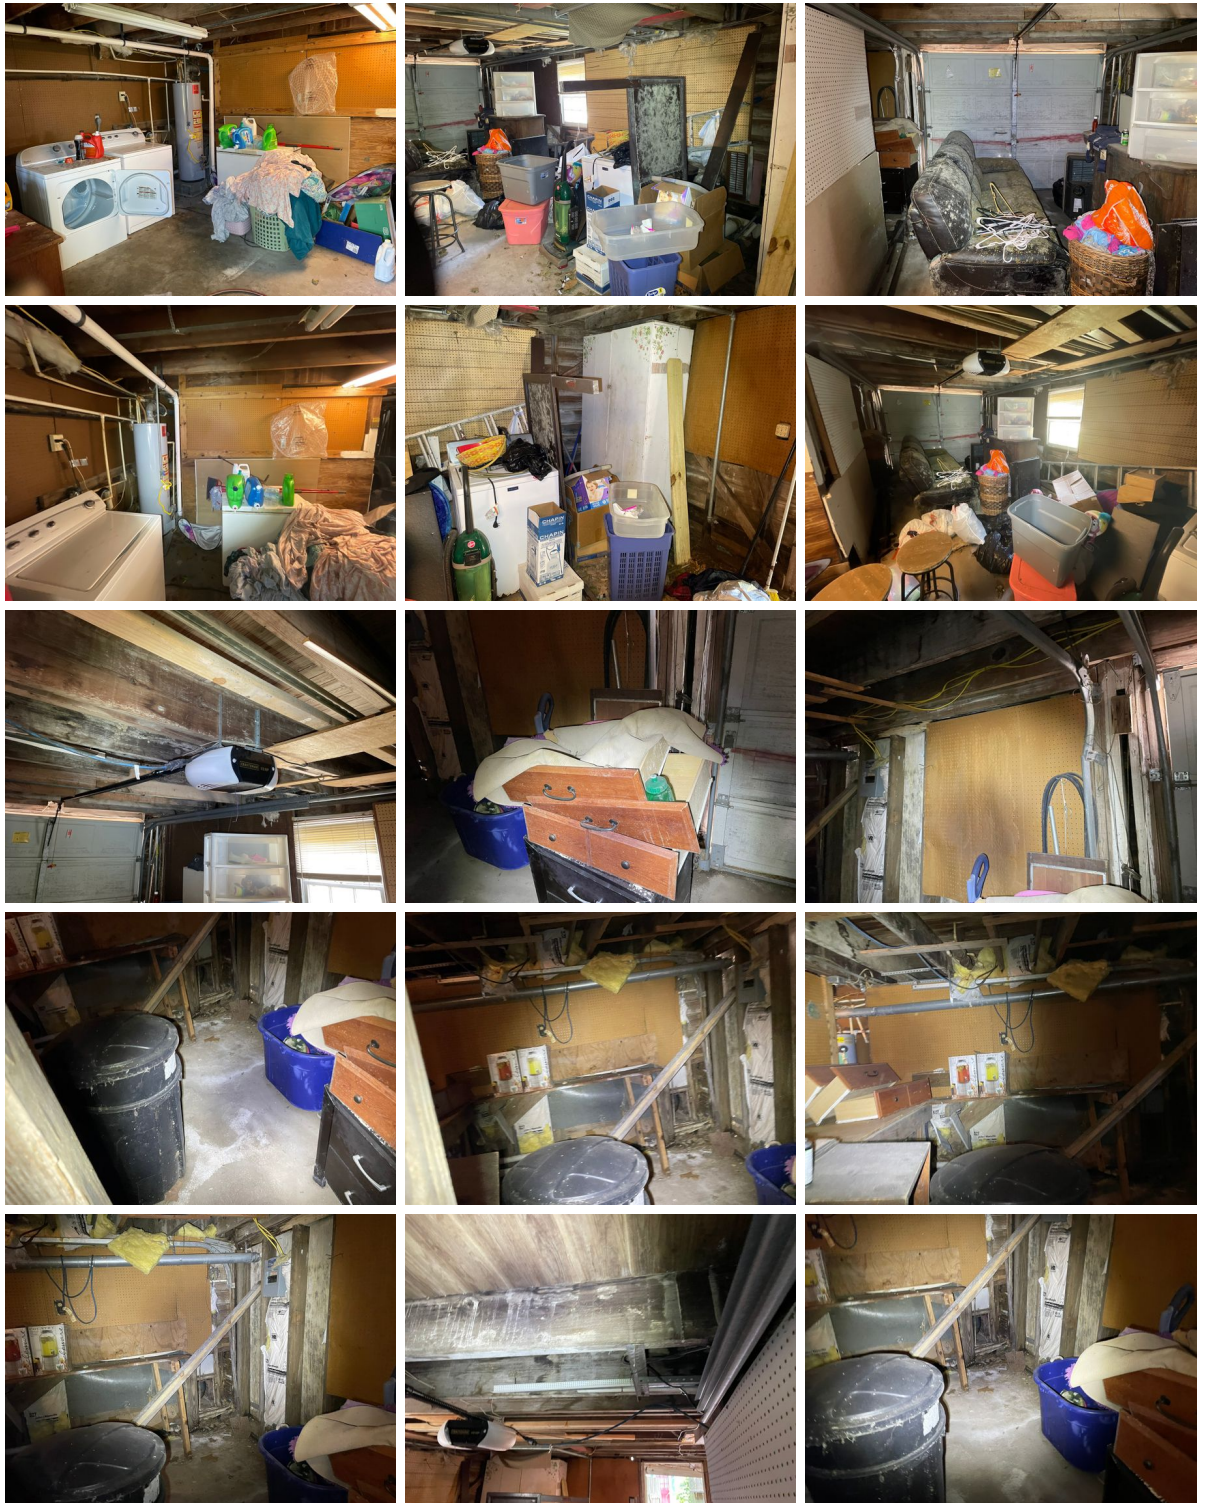
Interior Photos- Downstairs Side B:

The downstairs portion of the structure was a very limited inspection due to numerous water leaks, broken pipes, holes in wall, rotten wood, mold, insects and personal belongings.

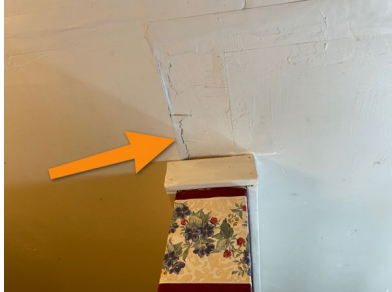
2: Cracking/Separation - Wall/Ceiling

There were cracks at the ceilings.

Recommendation: Contact a qualified professional.

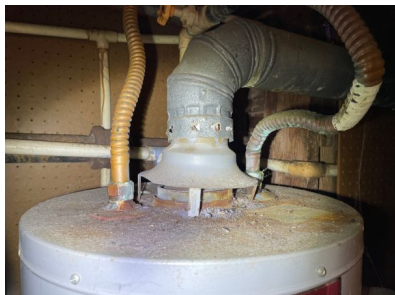
3: Improper Flue Installation

The natural gas fueled water heater is improperly vented, lacking the recommended minimum 12" of vertical rise before the elbow and vented directly into a large masonry flue where it cannot develop adequate draft. This heater installation may be unsafe.

Recommendation: Contact a qualified professional.

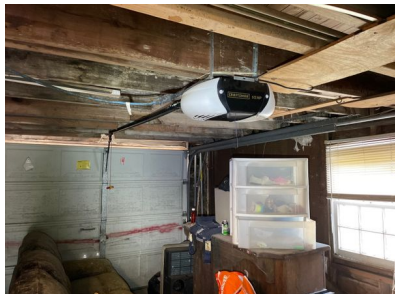
Unit did not respond to testing at time of inspection.

Recommendation: Contact a qualified garage door contractor.
