# PROPERTY INSPECTION REPORT

Concerning: 6511 Misty Creek, Missouri City, TX, 77459

By: Ning Xue 04/30/2021

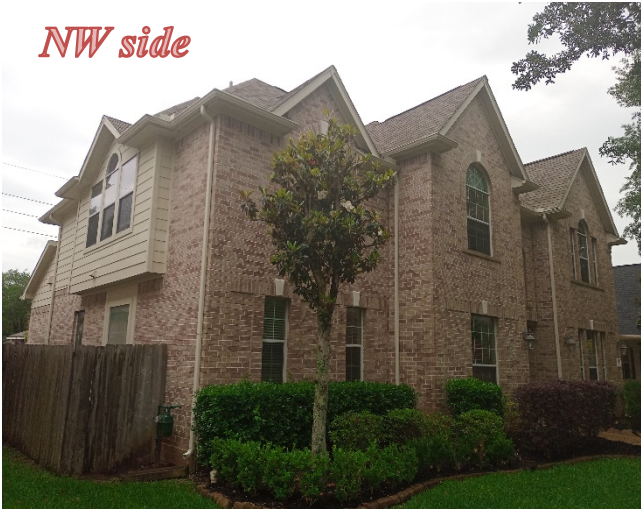
*NW side*

- a. The finish grade slopes away from the house to provide positive drainage along all three sides of the property where the finish grade of the backyard seems to be fairly flat and no defined drainage pattern can be identified;

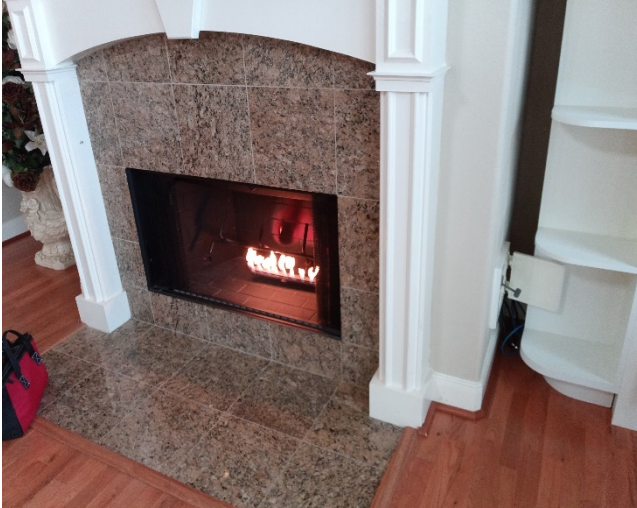
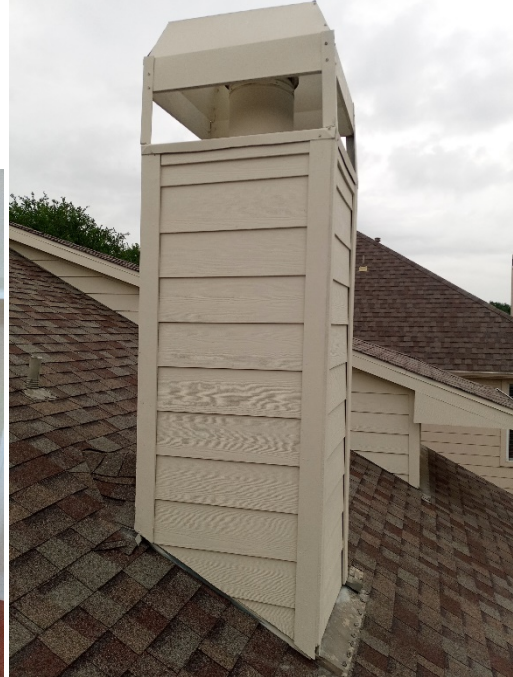
*Comments/Limitations:* Fireplace is prefabricated unit with gas log lighter; gas valve is located on the right side of the fireplace. Only visible portions of the mantel, hearth, hearth extension, venting system, flue and/or chimney is inspected for proper connectivity, installation and termination; The inspector will not inspect or comment on the adequacy of the draft or performance of a chimney. An open flame is not required to be used to test a gas appliance. Fireplaces that are sealed or have glass installed over the opening are not inspected internally as this would require removing components and other items, which could result in damage to the property. These fireplaces are inspected from the exterior and readily accessible areas.

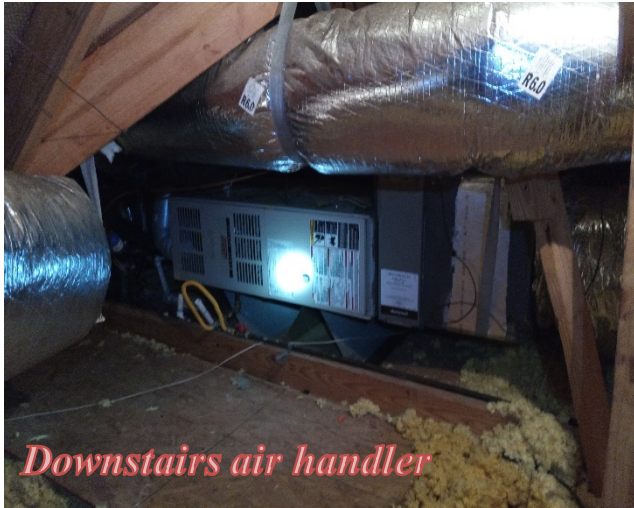
*Downstairs air handler*

*Comments:* **Full evaluation of the integrity of a heat exchanger requires dismantling of the furnace and is beyond the scope of a visual inspection.**

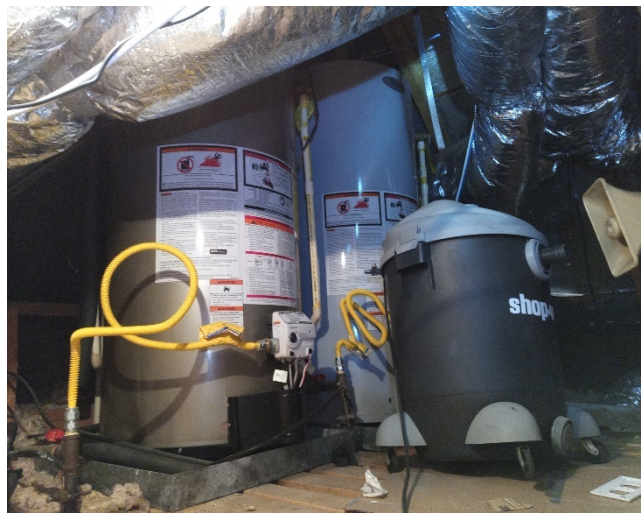
**C. Water Heating Equipment**  
*Energy Sources: 2 x gas water heaters manufactured by Craftmaster Water Heater Company in 2017;*  
*Capacity: 40 gal./each*  
*Comments: Located in the attic;*

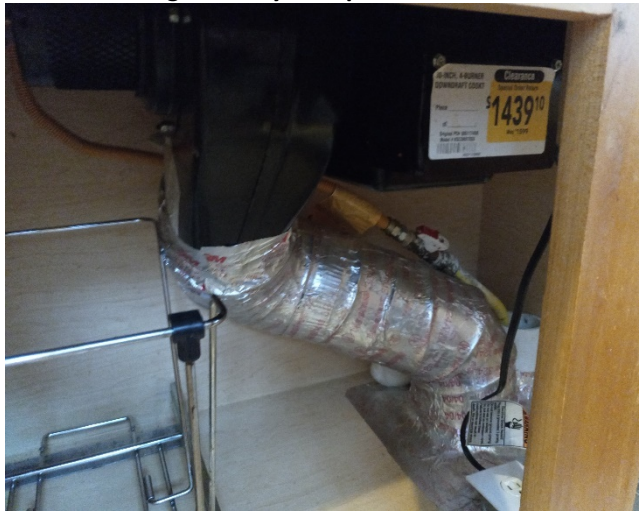
*Comments: A downdraft range hood system present;*
