## **Property Inspection Report**

**27815 Dewy Meadow Run Ct., Spring, TX, 77386**

INSPECTION PREPARED FOR: James Andrew Marr  
AGENT: Woody Marr - Team Marr Coldwell Banker  
Date of Inspection: 7/17/2020

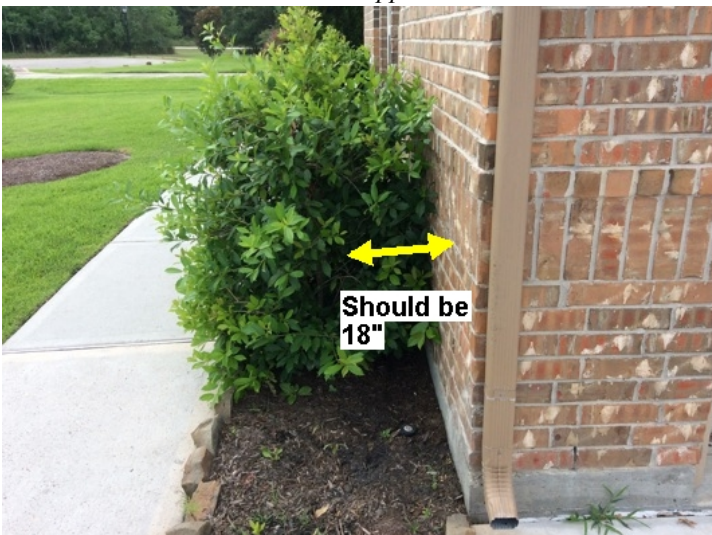
- The building site was relatively level and flat.
- There is at least one location where a gutter drains directly downward onto shingles below. This condition may cause premature failure of the roof shingles by washing the granular particulate material away from the shingle. This condition could potentially jeopardize the manufacturer's warranty. During this inspection, the shingle manufacturer could not be determined. Recommend referral to a roofing contractor for a determination if the manufacturer's warranty has been jeopardized.
- Vegetation too close to structure

Vegetation and shrubbery is too close to the house

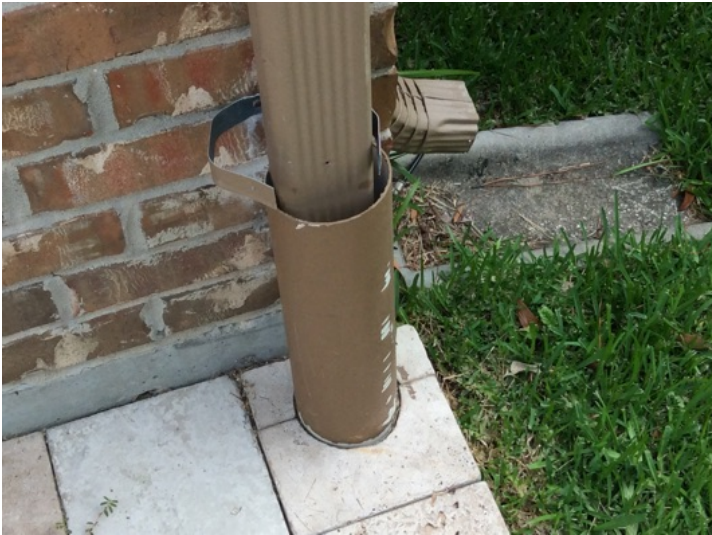
*A strapping system for securing the downspouts to the underground drainage*

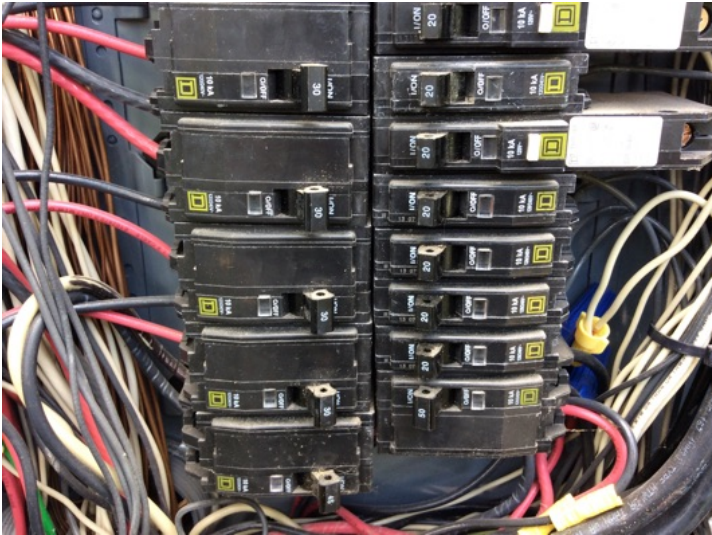
- The service panel is NOT completely and/or properly labeled. All breakers must be specifically identified as to appliances, lighting and receptacles

Square D, 200 amp, electric service panel

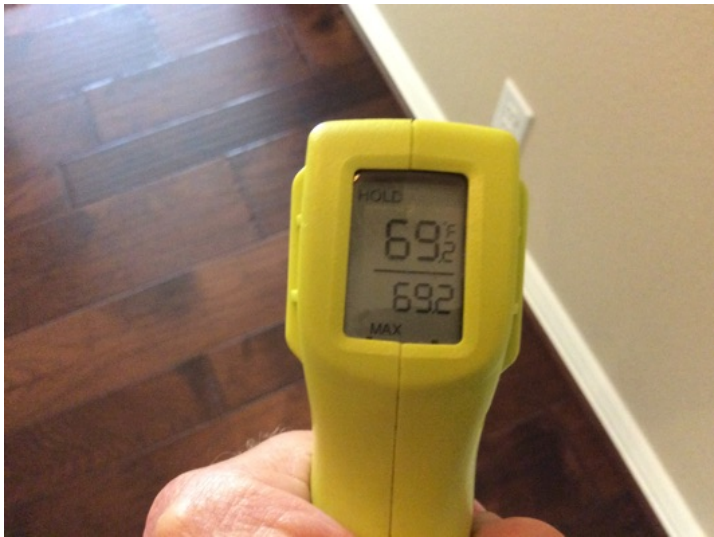
- The unit appeared to be functioning as intended at the time of the inspection
- The Downstairs heating differential calculations were recorded as follows: 69° Heating return temperature, 119° heating supply temperature, = Calculated heating differential 50°. Differential temperature readings are only intended as representative of the general operating conditions of the HVAC system. By taking comparative reading both at the return and supply registers, a general assessment of the operation can be made. It is always recommended for more precise evaluation information, a licensed professional HVAC technician should be consulted.

*Downstairs heating return temperature 69°*

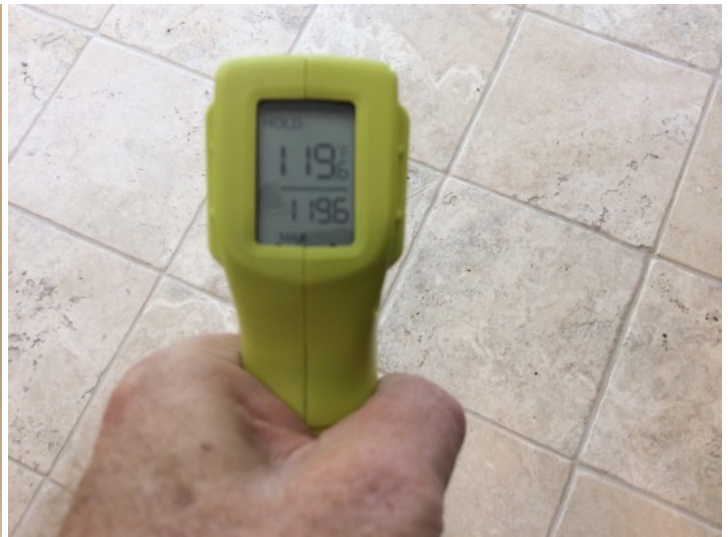
*Downstairs heating supply temperature 119°*

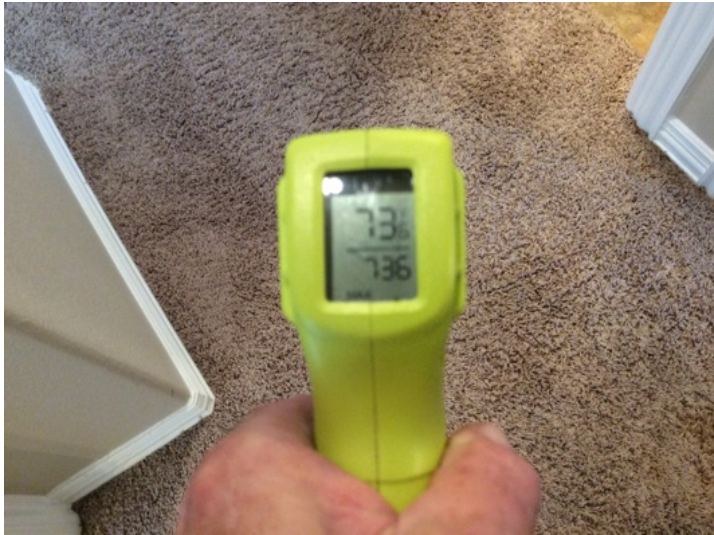
- The Upstairs heating differential calculations were recorded as follows: 73° Heating return temperature, 103° heating supply temperature, = Calculated heating differential 30°. Differential temperature readings are only intended as representative of the general operating conditions of the HVAC system. By taking comparative reading both at the return and supply registers, a general assessment of the operation can be made. It is always recommended for more precise evaluation information, a licensed professional HVAC technician should be consulted.

*Upstairs heating return temperature 73°*

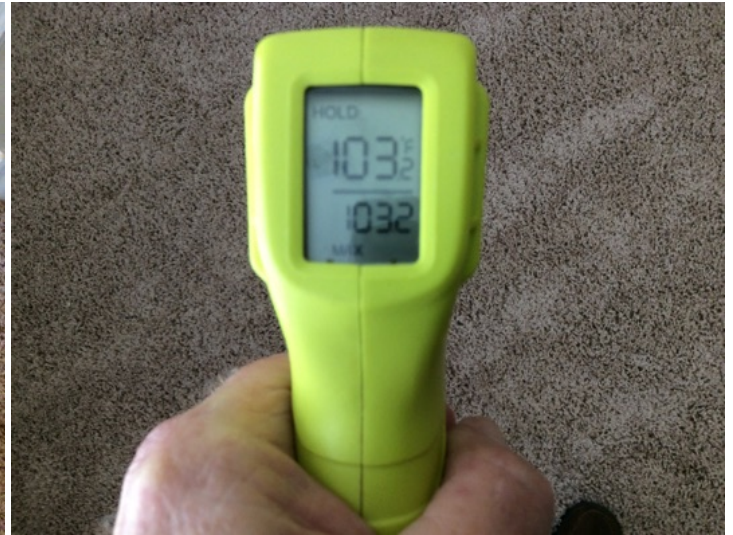
*Upstairs heating supply temperature 103°*

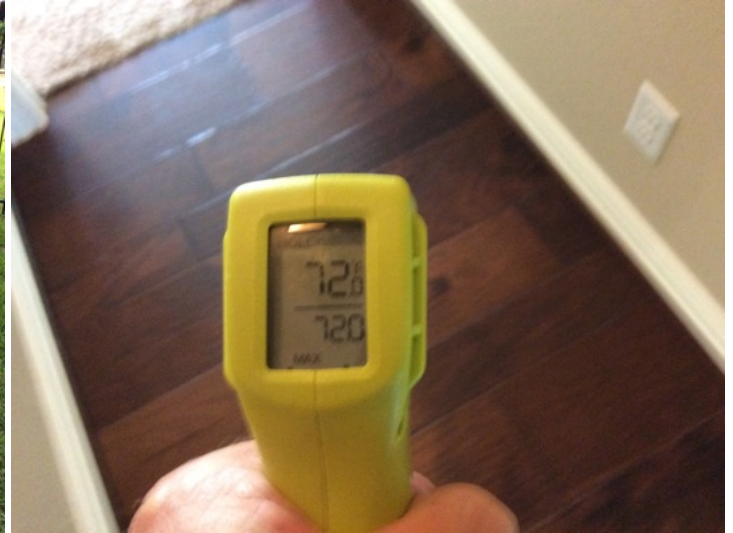
Downstairs cooling return temperature 72°

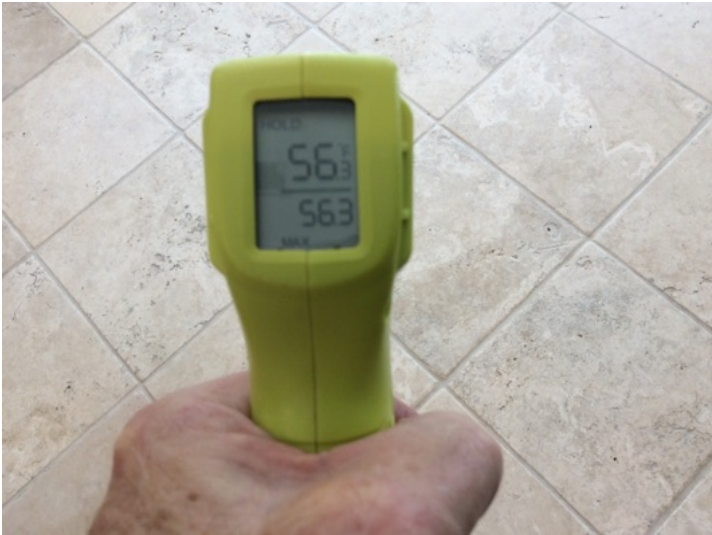
*Downstairs cooling supply temperature 56°*

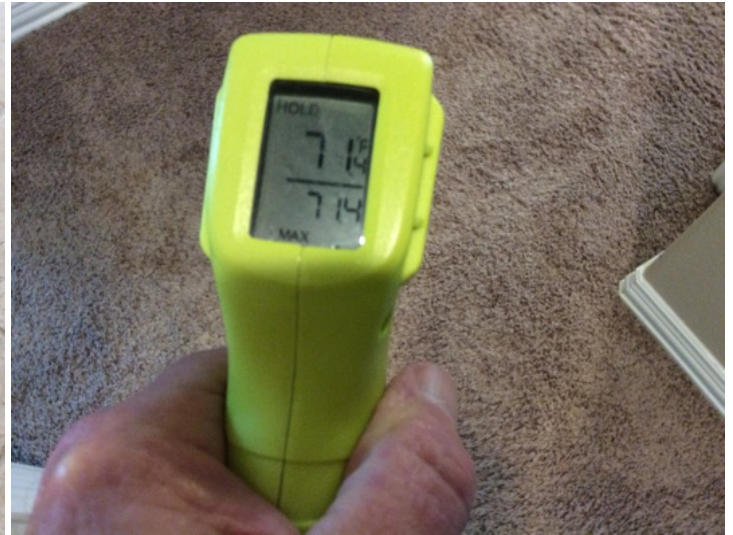
*Upstairs cooling return temperature 71°*

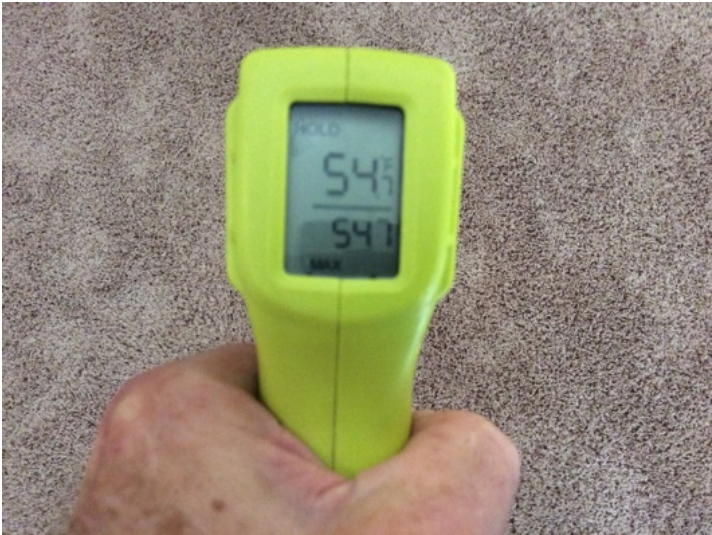
*Upstairs cooling supply temperature 54°*

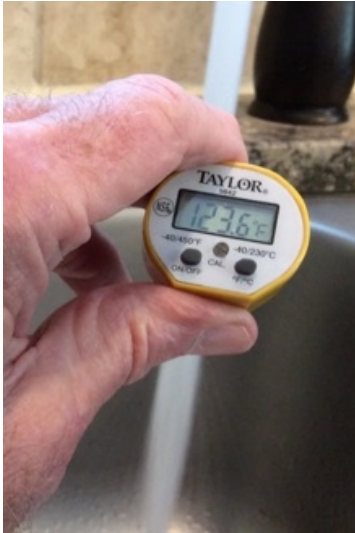
- The water heater and its components were found to be performing and in satisfactory condition at the time of the inspection
- The water temperature at the faucet locations was noted to exceed the {120 degree} scald limit and adjustments on the temperature control are recommended (Heated to 123.6°)

Hot water temperature measured at the kitchen sink was 123.6°

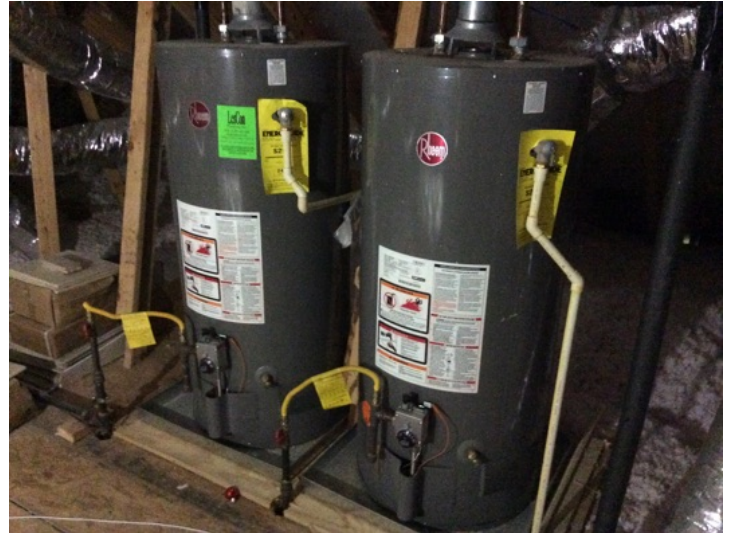
Twin Rheem water heaters piped in series

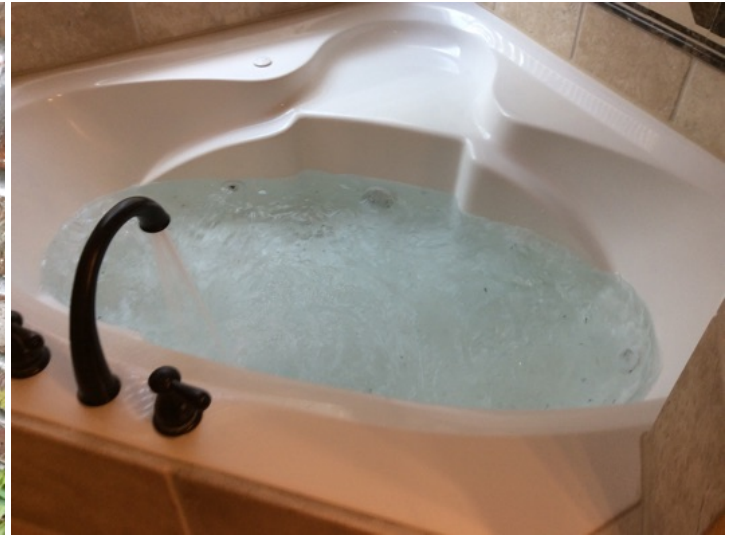
Jetted tub is operational

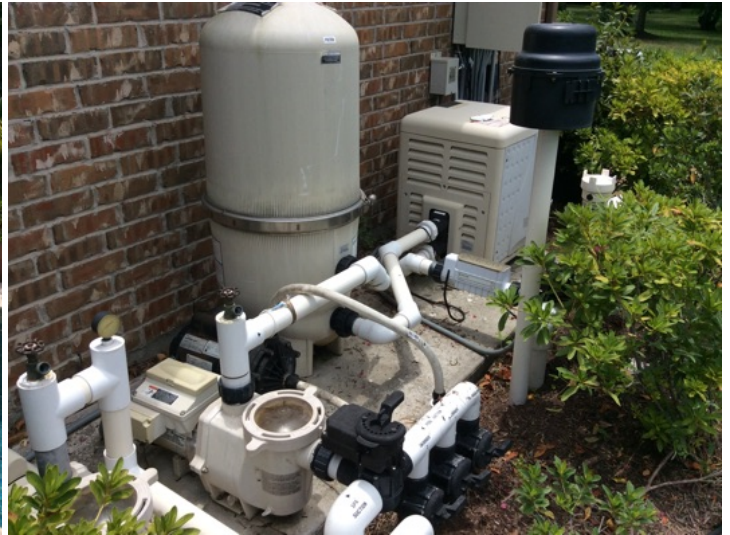
*All three pumps and associated equipment are properly electrically bonded*

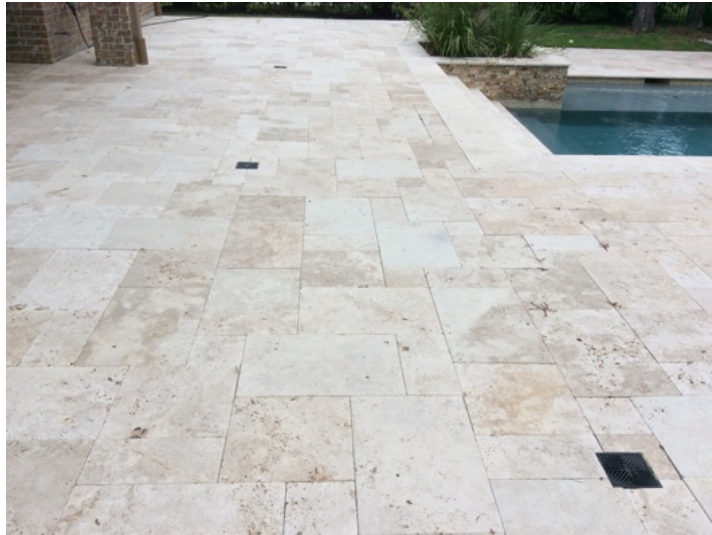
*Pool deck with floor drainage appears to be in good condition*
