REAL ESTATE INSPECTION REPORT

Prepared Exclusively For
Christopher Stamp & Kristyn Grimes

**28919 Copper Break Ct
Katy, TX 77494**

PROPERTY INSPECTION REPORT

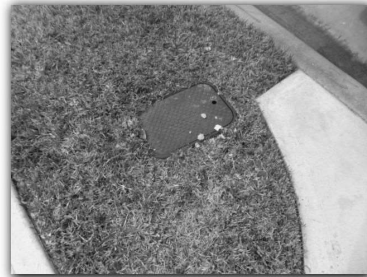
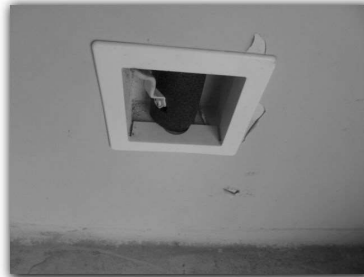
Static water pressure reading: Approx. 60psi

The plumbing in the residence is of the Pex type and appears to be functioning properly with no visible signs of leaking at time of inspection. The inspection can only attest to the piping that is visible noting that the majority of the piping is concealed within walls and under insulation in the attic and is not visible.
