Inspection Report

Property Address:
12639 Pine Bush Dr
Houston TX 77070

Texas Real Estate Inspection Services, Inc

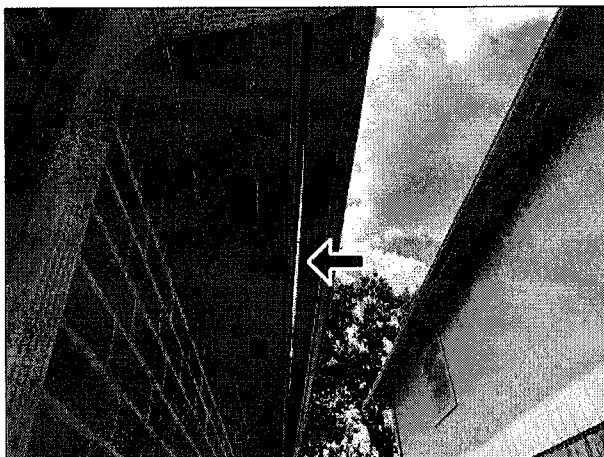
B. Item 1(Picture)

(1) The gutter is loose at the right side of home (facing front). This gutter is also damaged at the corner seam. Loose or leaking gutters can cause deterioration of fascia, soffit or roof edge. It can also cause gutters to pull loose and lead to possible water intrusion. A qualified contractor should repair as needed. *-BEING CORRECTED*

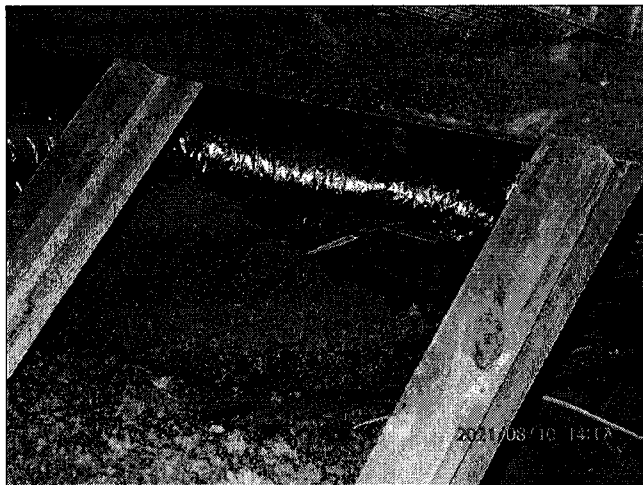
D. Item 3(Picture)

(2) Strongbacks are damaged in the middle portion of the attic. This area is located directly behind the furnace vent plenum. A qualified contractor should repair as needed.

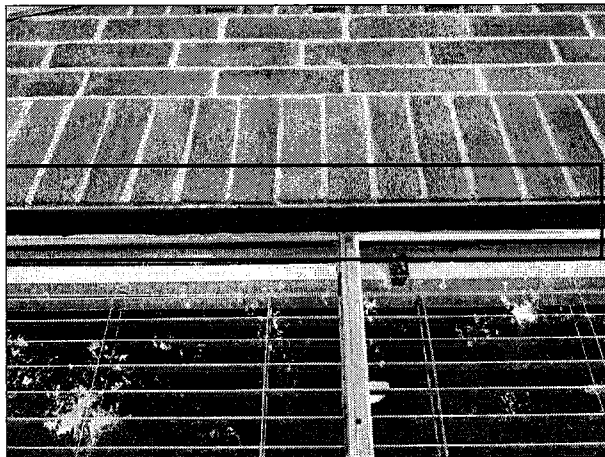
E. Item 7(Picture)

☒ (3) Wall openings at the front, rear and sides of home are not properly flashed. A wall opening, clad in siding material shall be flashed using Z flashing or appropriate counter flashing methods, no matter the location.

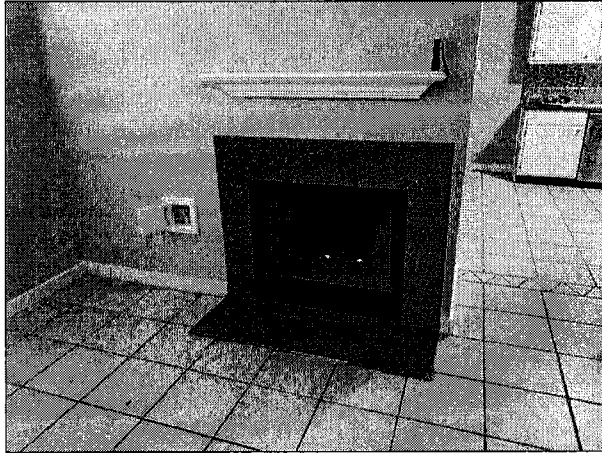
J. Item 1(Picture)

Failure to open the damper during operation will result in CO being released into the living area.

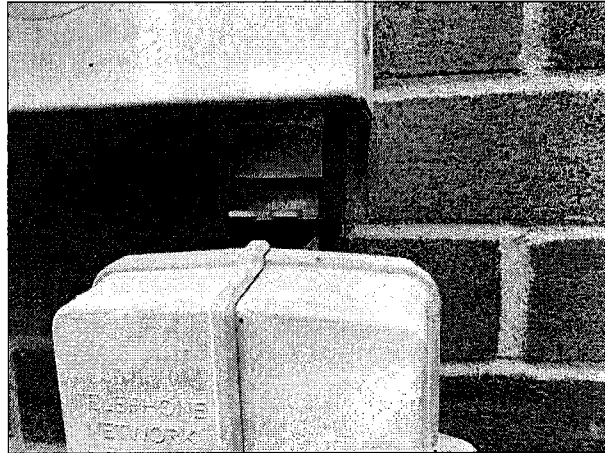
A. Item 4(Picture)

(2) This structures Service Entrances and Panels are not in compliance with current NEC requirements. This is not an indication that they are not functional, but are do not meet current requirements. This is for your information. Correct as desired.

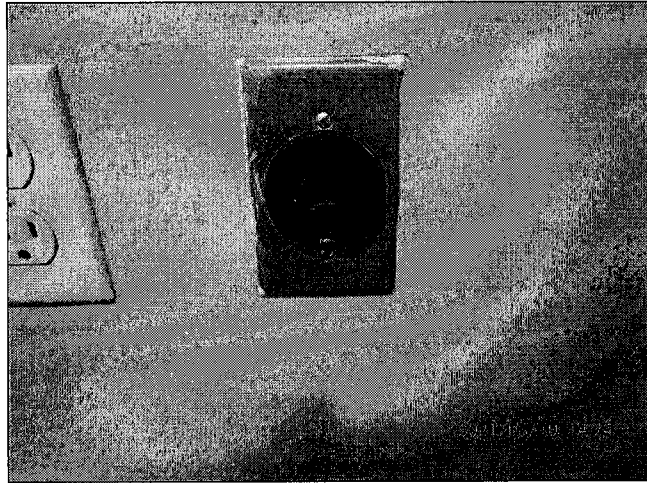
B. Item 1(Picture)

- (1) Exterior outlet at back porch has hot and ground reversed. Recommend repair by a licensed electrician. *- will correct*
- (2) Ceiling fan in living room is loud, sounds like early bearing failure, and it wobbles on high speed. Recommend repair or replacement by a qualified contractor. *-*
- (3) Kitchen outlets near oven are not GFCI (ground fault circuit interrupter) protected as required. Under current electrical standards, this is a location that should have all outlets GFCI protected. Recommend repair by a licensed electrician. *- will correct*
- (4) There are multiple outlets loose in the walls at interior and exterior. Recommend a licensed electrician properly secure these outlets and any other ones found. This is a small repair. *will correct*

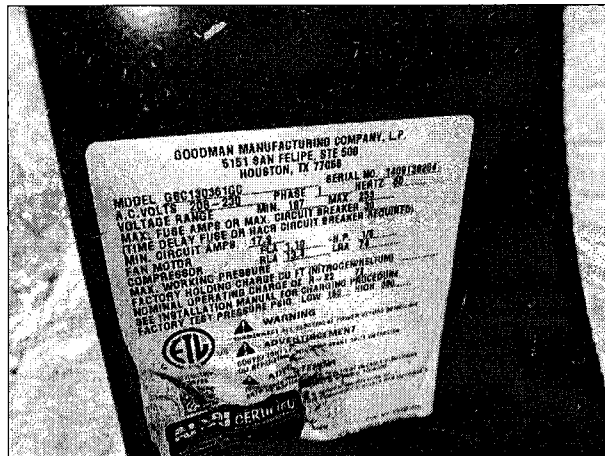
B. Item 2(Picture)

(2) Please note, this unit is using R22 refrigerant which is phased out. This means repairs and maintenance going forward will be more costly or possibly not an option. A general replacement will be likely when issues arise. This is for your information.

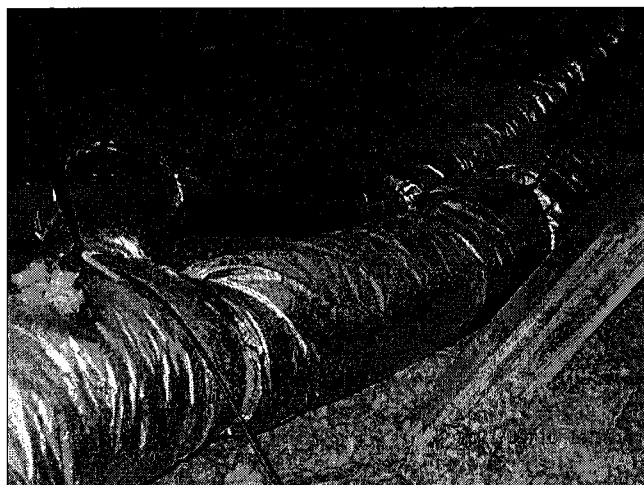
C. Item 1(Picture)

Ductwork is not properly supported and is crimped in the attic space. This will cause sags and restrictions in the system that can cause moisture collection in these areas. A qualified HVAC contractor should correct as needed.

M1601.3.2 Support.

Metal ducts shall be supported by 1/2-inch (13 mm) wide 18-gage metal straps or 12-gage galvanized wire at intervals not exceeding 10 feet (3048 mm) or other approved means. Nonmetallic ducts shall be supported in accordance with the manufacturer's installation instructions.

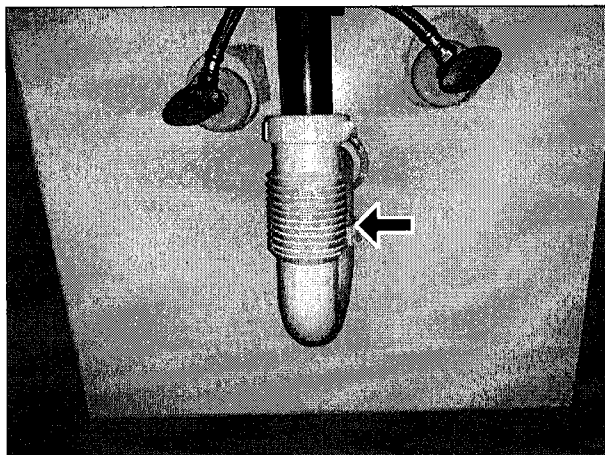
B. Item 1(Picture)

(1) Accordion style drain pipe is used for guest bathroom sink. This is a temporary solution that is prone to clogs and leaks. Recommend a more professional installation by a qualified plumber.

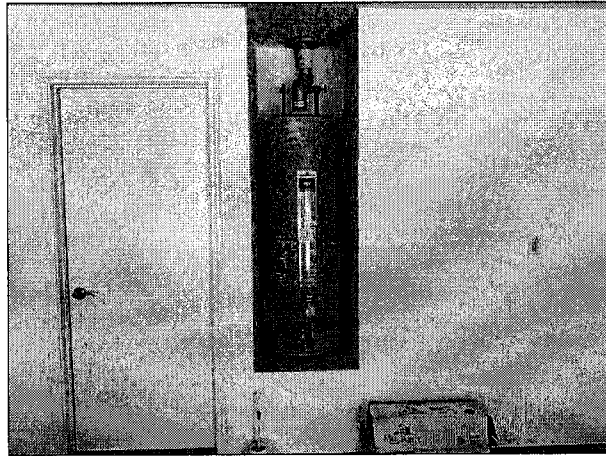
C. Item 1(Picture)

- (1) The water heater is old and has exceeded its typical lifespan. Future life expectancy cannot be determined (**manufactured in 1994**). The average lifespan of a water heater is 7-12 years depending on usage and other factors. Based on age, we recommend replacement before further failure occurs.

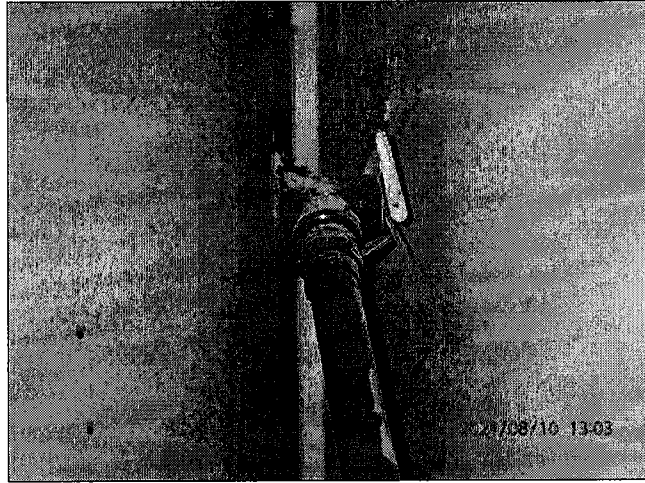
C. Item 3(Picture)

(2) TPR (temperature pressure relief) valve is seized at the water heater. TPR valves are the safety device in the event of a failure with excess temperature or pressure in the tank. Recommend replacement by a qualified plumber.

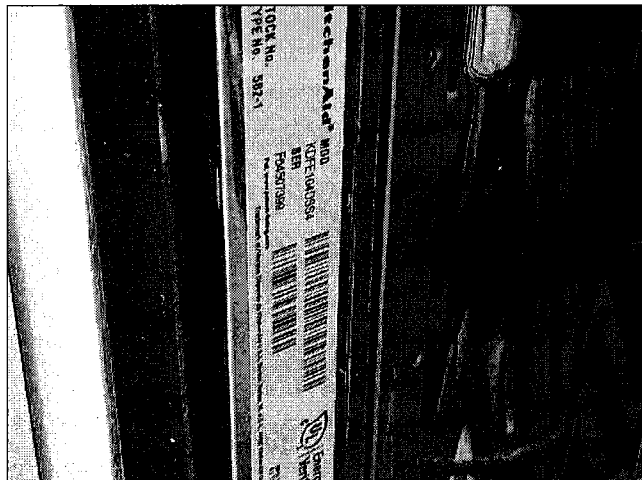
A. Item 2(Picture)

The dishwasher did not complete normal cycle. I recommend repair as necessary.

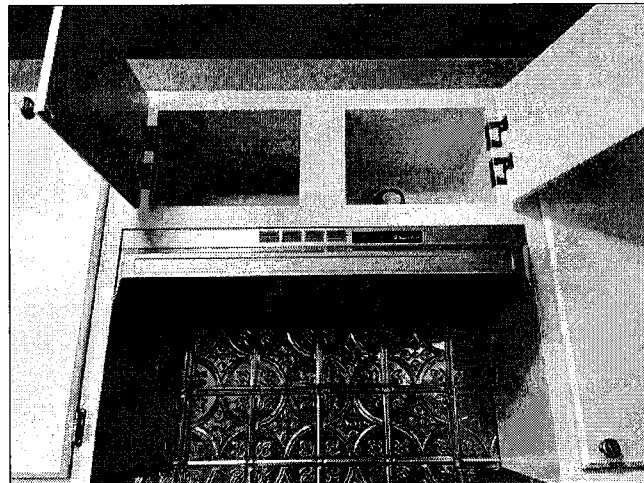
C. Item 1(Picture)

(1) The range hood fan is not properly vented to the exterior. This unit is intended to vent a gas operated range. Under ASHRAE standards, all gas appliances should have exhaust vented to the exterior. I recommend repair or replace as needed.

Single-wall ducts serving range hoods shall be constructed of galvanized steel, stainless steel or copper.

M1503.3 Kitchen exhaust rates.

Where domestic kitchen cooking appliances are equipped with ducted range hoods or down-draft exhaust systems, the fans shall be sized in accordance with Section M1507.3.

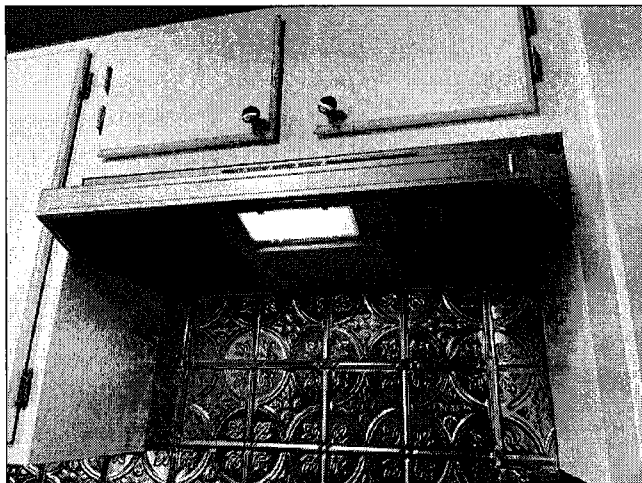
C. Item 2(Picture)

(2) Appears to be functioning at the time of inspection. Tested on all speeds.

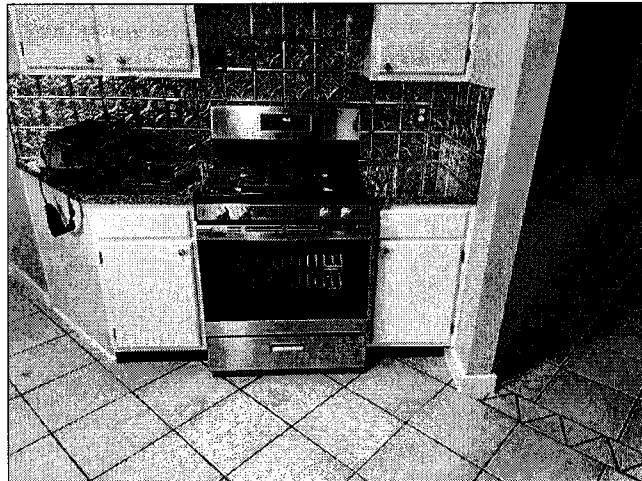
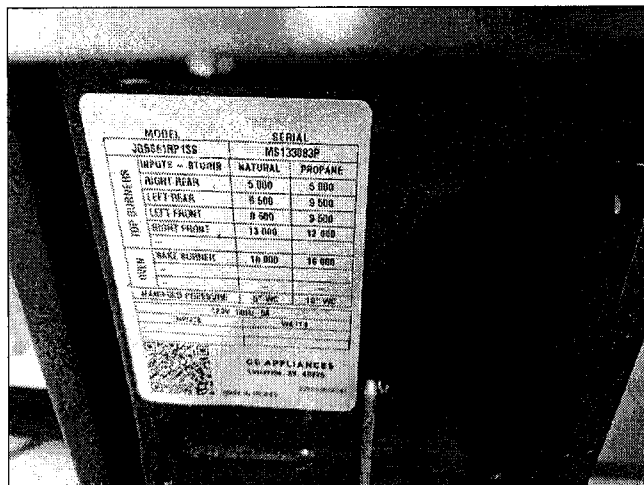
Ranges/Ovens/Cooktops appear to be functioning as intended at the time of inspection. All burners tested on low and high. Oven preheated to 350 degrees, within 20 min the final temperature was measured at 349 degrees. This is within the +/- 25 degrees required

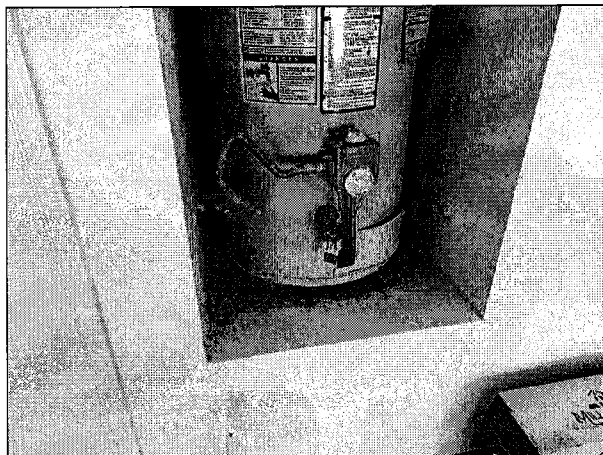
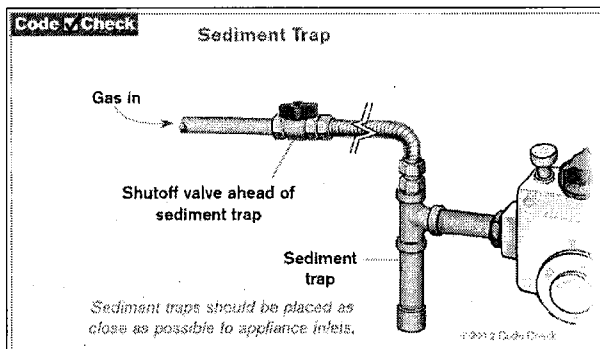
(1) A sediment trap is missing at the furnace and water heater. Sediment traps are required on all gas lines just forward of the appliance served.

G2419.4 (408.4) Sediment trap.

Where a sediment trap is not incorporated as part of the gas utilization equipment, a sediment trap ***shall be*** installed downstream of the equipment shutoff valve as close to the inlet of the equipment as practical. The sediment trap shall be either a tee fitting with a capped nipple in the bottom opening of the run of the tee or other device approved as an effective sediment trap. Illuminating appliances, ranges, clothes dryers and outdoor grills need not be so equipped.

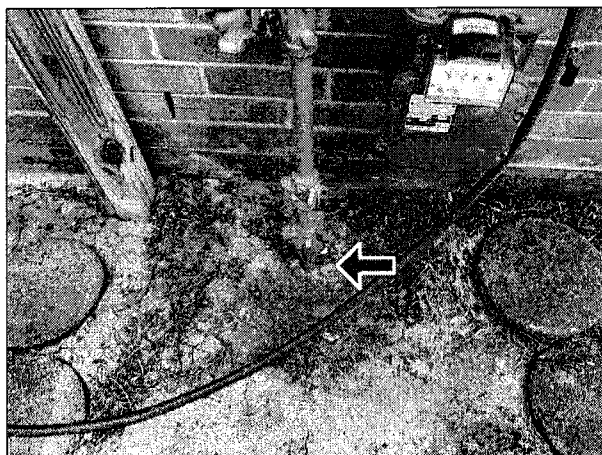
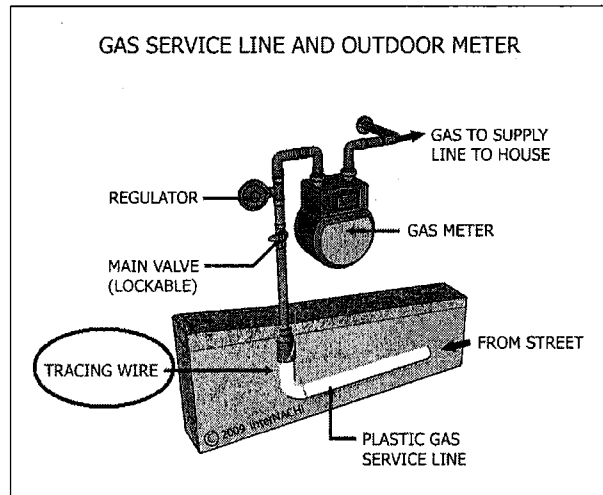
(2) No tracer wire is visible at the gas supply line. This wire is required and should be installed if not present.

G2415.14.3 (404.14.3) Tracer.

A yellow insulated copper tracer wire or other approved conductor shall be installed adjacent to underground nonmetallic piping. Access shall be provided to the tracer wire or the tracer wire shall terminate above ground at each end of the nonmetallic piping. The tracer wire size shall not be less than 18 AWG and the insulation type shall be suitable for direct burial.

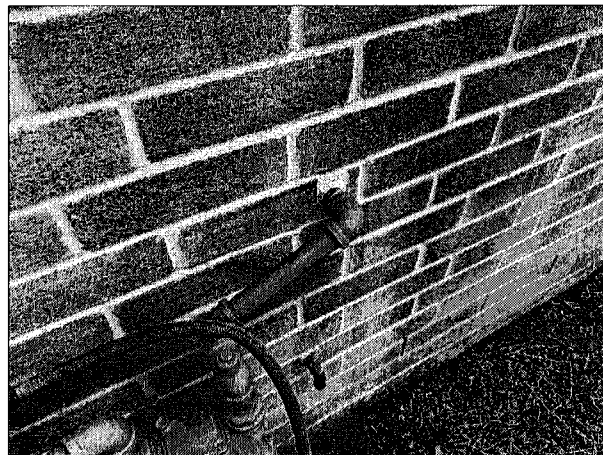
E. Item 5(Picture)

(3) The gas supply line entering the home does not appear to be properly sleeved as required. Recommend sealing the gap around the supply line to prevent moisture intrusion. Correct as needed.

G2414.8 (403.8) Protective coating.

Where in contact with material or atmosphere exerting a corrosive action, metallic piping and fittings coated with a corrosion-resistant material shall be used. External or internal coatings or linings used on piping or components shall not be considered as adding strength.

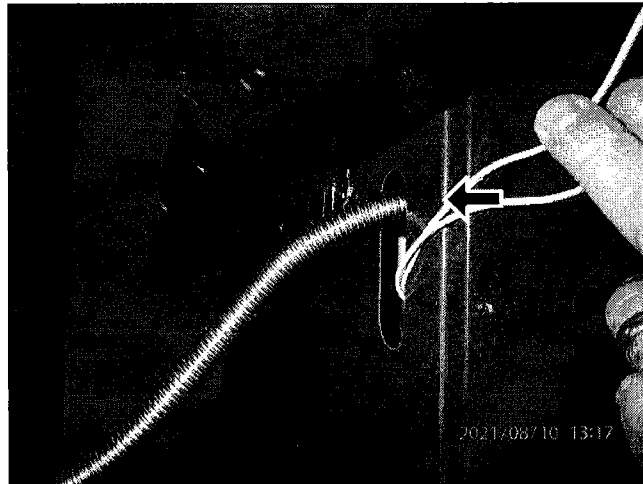
E. Item 6(Picture)

❏ (4) Flex tubing is used to supply gas to the furnaces. This tubing is threaded through the cabinet of the HVAC cabinet. This is a prohibited configuration and needs to be corrected. Only rigid metal piping should be used where cabinet pass through is necessary. A qualified plumber should repair as needed.

G2414.5.3 (403.5.4) Corrugated stainless steel tubing.

Corrugated stainless steel tubing shall be listed in accordance with ANSI LC 1/CSA 6.26.

SECTION 4.4 " PROTECTION" (TracPipe Installation Guide)

The flexible gas piping must be adequately protected from puncture, shear, crush or other physical damage threats. The tubing shall be protected at points of support and when passing through structural members such as studs, joists and plates in accordance with this section. PROTECTION IS REQUIRED WHENEVER THE TUBING IS CONCEALED, RESTRAINED, AND WITHIN 3 INCHES OF A POTENTIAL THREAT.

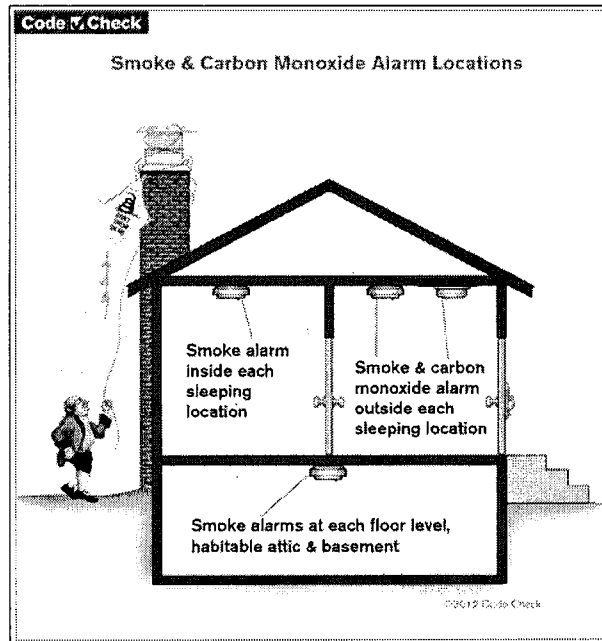
H. Item 1(Picture)

(1) Smoke detectors are not present in all required locations and are not interconnected. They are currently only located in each common hallway to bedrooms. Recommend repair by a qualified contractor.

R313.2.1 Alterations, repairs and additions.

When alterations, repairs or additions requiring a permit occur, or when one or more sleeping rooms are added or created in existing dwellings, the individual dwelling unit shall be equipped with smoke alarms located as required for new dwellings; the smoke alarms shall be interconnected and hard wired.
