PROPERTY INSPECTION REPORT

Concerning: 6646 Miller Shadow Ln, Missouri City, TX 77459
(Address or Other Identification of Inspected Property)

By: Michael Holguin, Lic #3752 ICC #5116880 09/04/2019
(Name and License Number of Inspector) (Date)

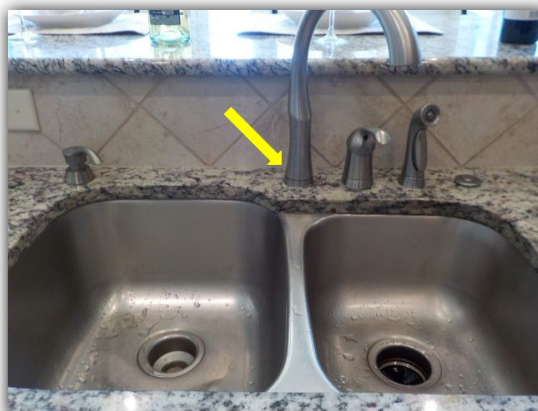
The kitchen sink fixture is loose.
