**5826 Augusta Ct.
Houston 77057**

PROPERTY INSPECTION REPORT

By: Ruben Santillan, Lic #5570 07/27/2021
(Name and License Number of Inspector) (Date)

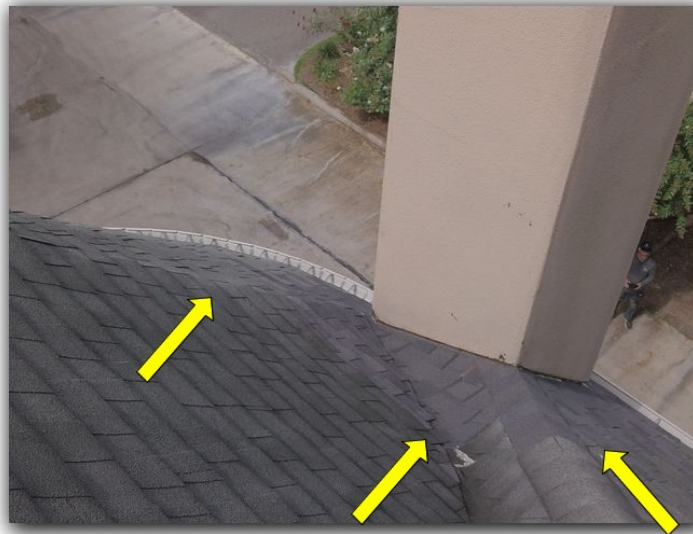
Observed spot repairs to roof surface.(Around the chimney)

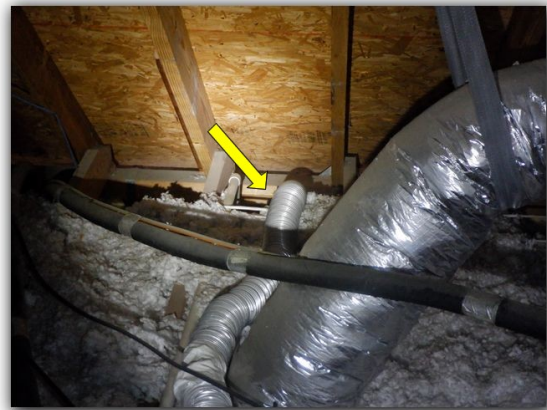
Fig. 7

Terminating exhaust fans to soffits/eaves builds up condensation moisture within the soffit that can deteriorate the fascia board, soffit and/or plywood roof decking and cause paint peeling. A soffit/eave is part of attic air space where exterior air is drafted in to the attic space with the exhaust duct fumes and moisture.
