**HOME
INSPECTION**

**Dave Hilgartner
335 Harbor Addition
Livingston , TX 77351
January 27, 2022**

Inspected By: Erik Placker TREC # 21184

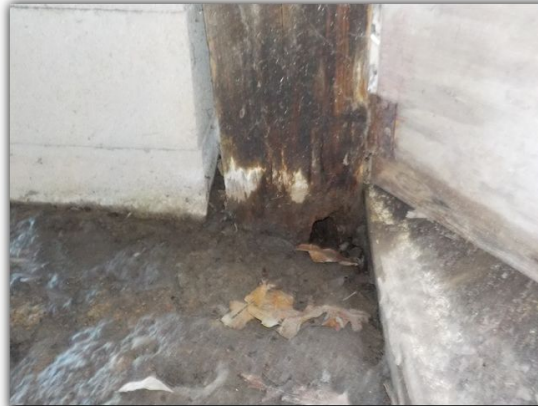
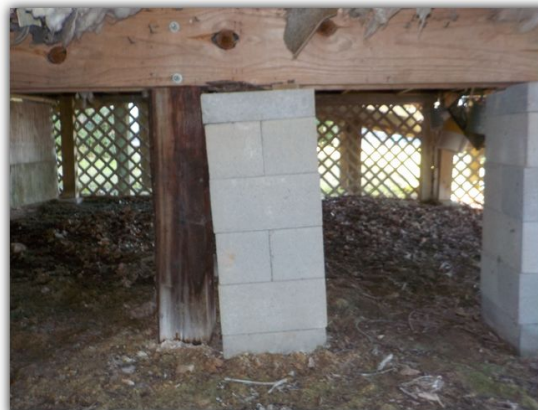
It appears that concrete masonry block piers were installed adjacent to the original wooden piers. This appears to be from deterioration and/or wood rot at the bottom of the wooden piers. Some of the masonry blocks have shifted and are either leaning and/or not in contact with the beam. Some of the block piers were not properly shimmed to support both beams/girders running parallel with each other. Repairs may be needed in order to ensure proper supporting and levelness of the foundation components.

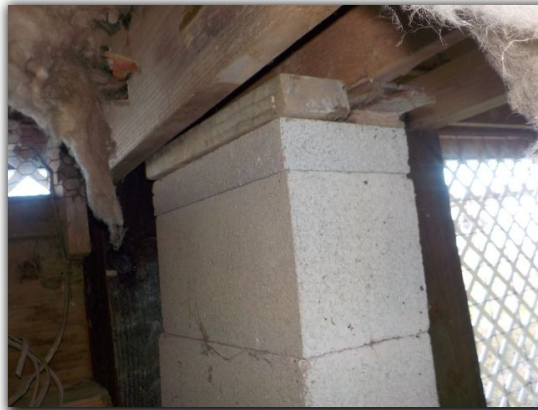
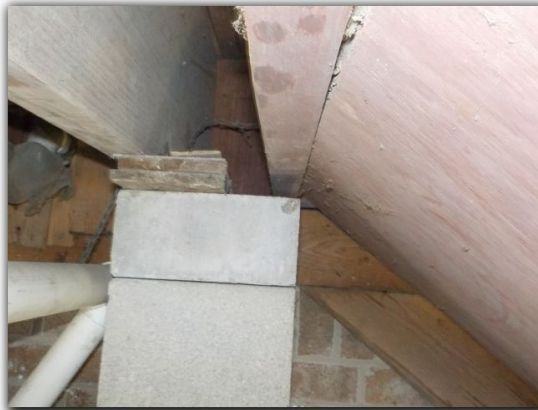
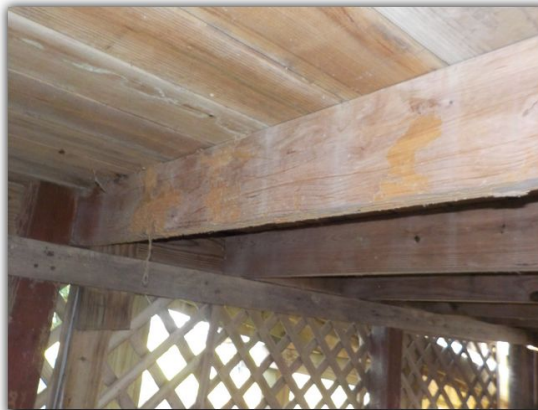
Evidence of previous and/or active wood destroying insects was detected under the screened in porch area of the crawlspace and upward around the door to the porch. A full evaluation of the amount of damage caused by the insects cannot be detected within the walls, voids, or other hidden areas without defacing the property and cannot be address in this report. With the detection of active and/or previous activity of a wood destroying insect, it should be assumed that some degree of damage is present.

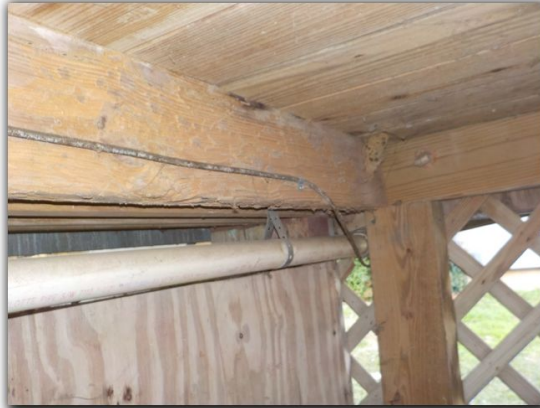
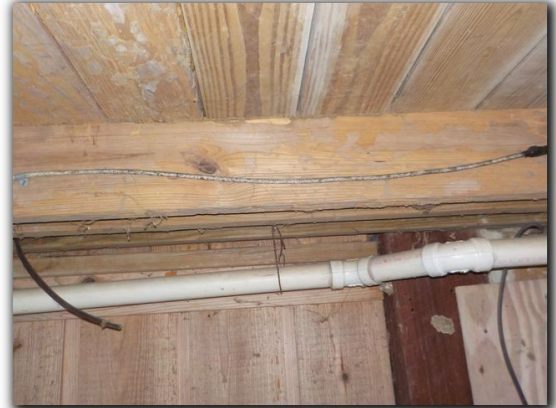
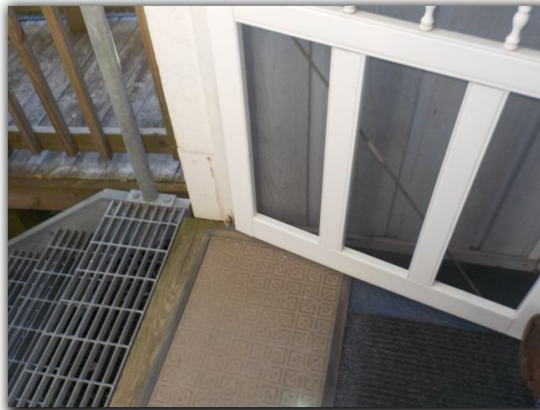
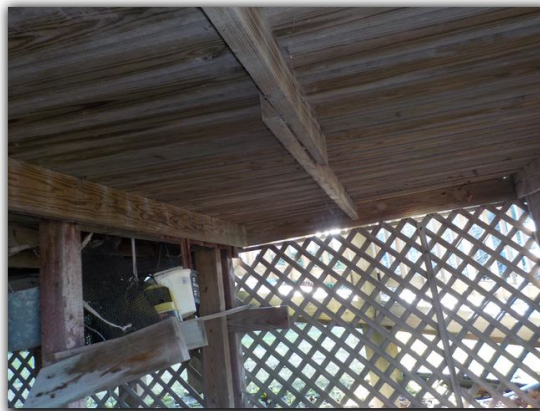
Inadequate amount of piers and/or supports was observed at the foundation for both porches. Piers with proper footers should be installed directly below the intersection of two girders and piers should be placed at over spanning of girders and floor joist to prevent sagging.

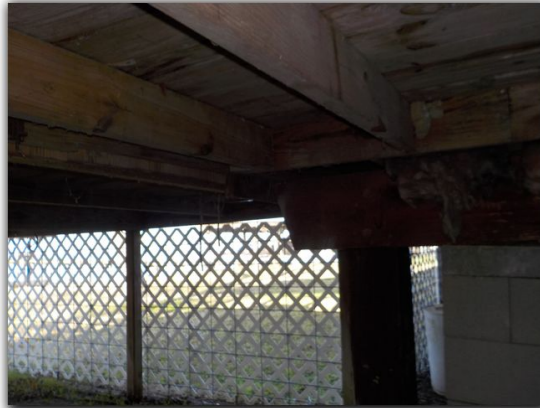
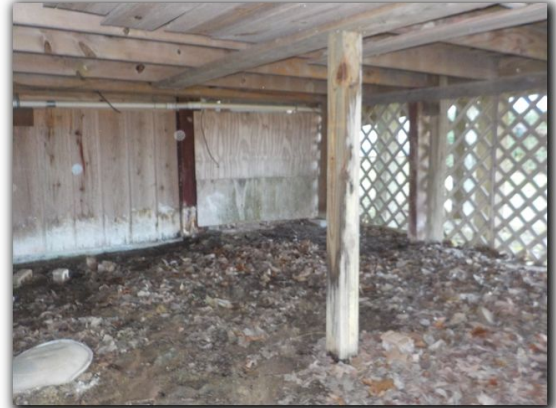
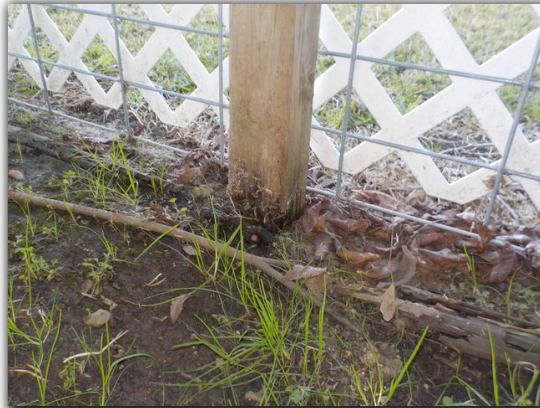
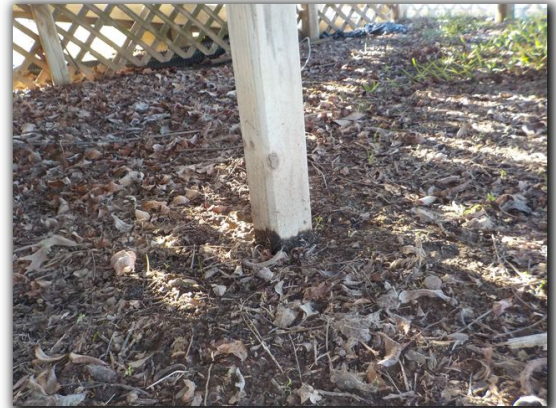
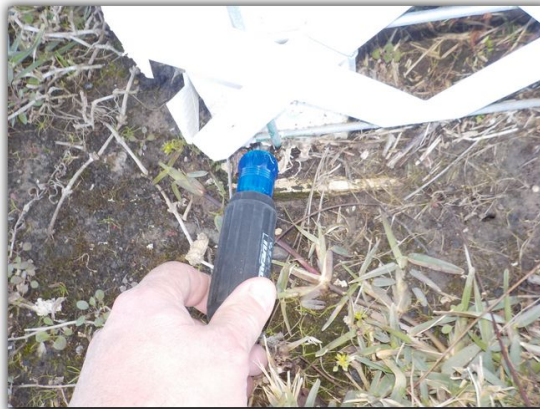
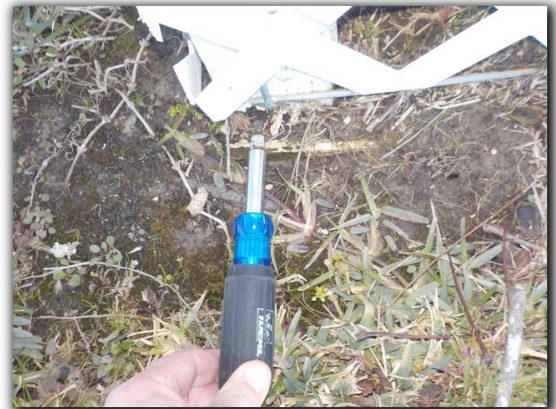
Wood rot and/or deterioration was observed at the bottom of various piers supporting the foundation for both porches.

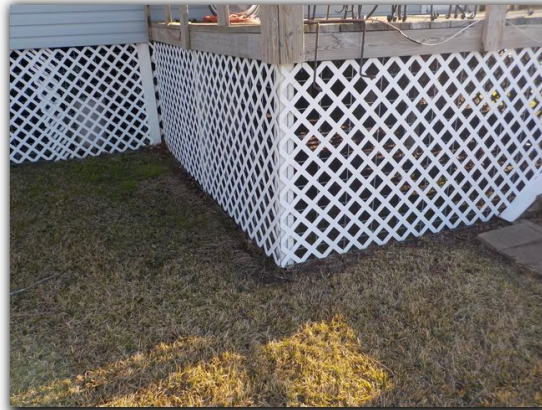
There is evidence of past water in the crawl space. This condition may vary seasonally and/or with precipitation intensity. Lot drainage improvements should be addressed as a first step to controlling water in the crawl space. Moisture will also cause foundations to shift or move over time.

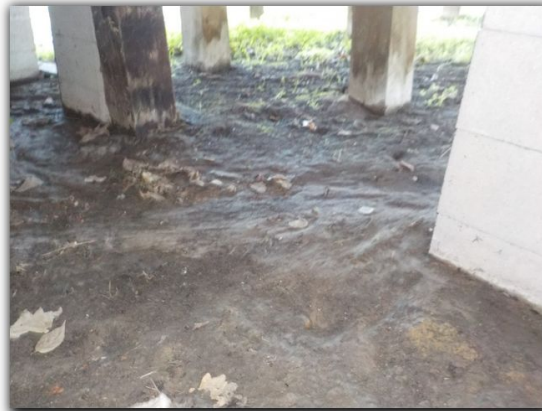
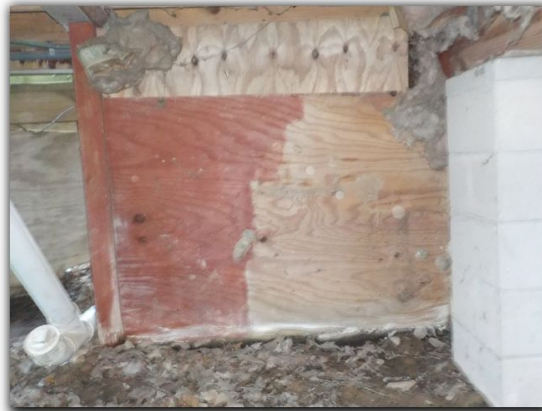
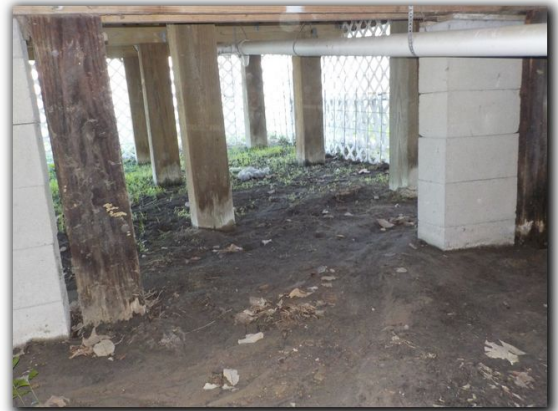
Crawl space has wood to ground contact. Wood to ground contact is a conducive condition for wood rot and can allow wood destroying insects to enter the home. Homeowner needs to remove wood to ground contact and/or have a preventive type treatment done by a licensed pest company.

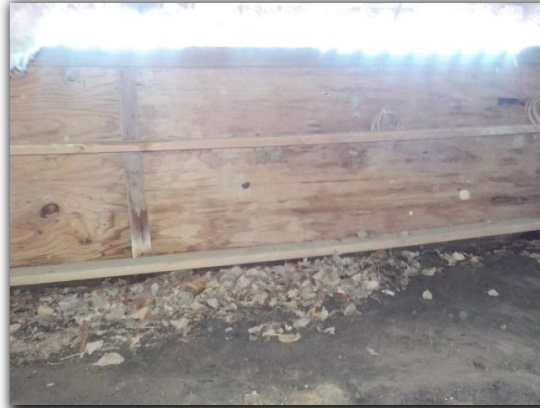
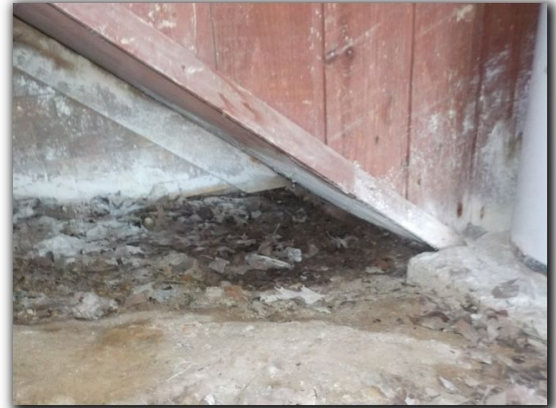
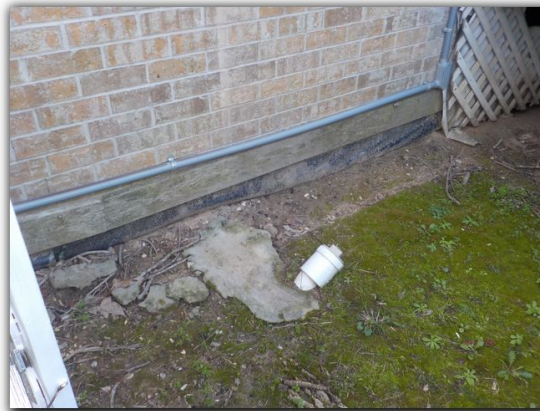
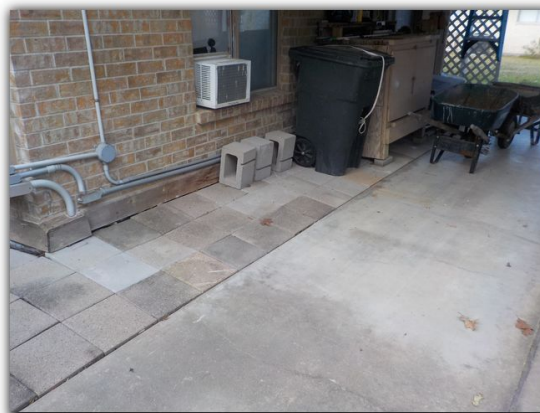
The face of the foundation is obstructed by plastic, wood and/or pavers. These conditions can allow wood destroying insects to enter the structure unseen. Other defects and/or deficiencies could be present.

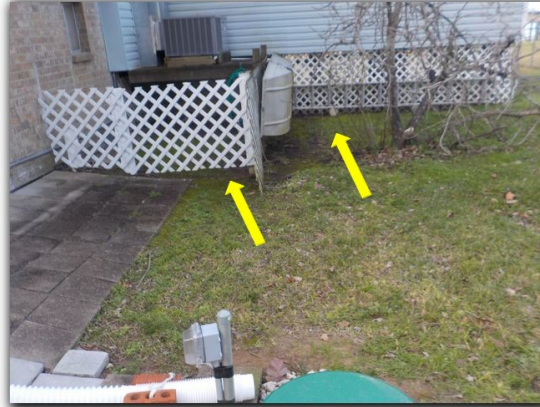
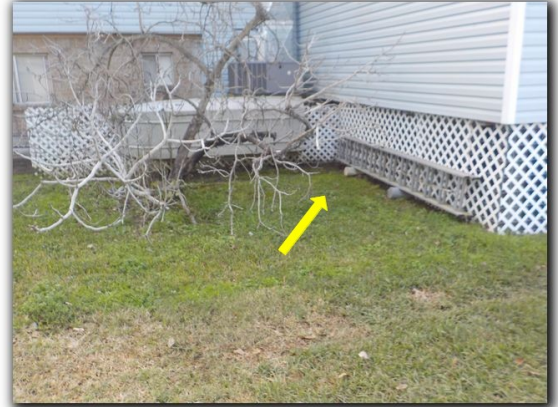
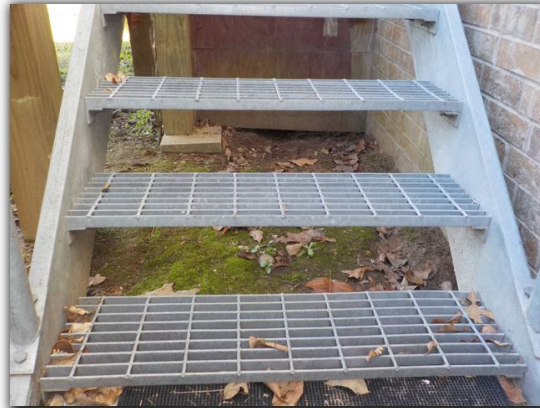
Negative site drainage was observed on the east and west sides of the structure. Proper drainage is needed to help prevent water from entering the crawlspace area.

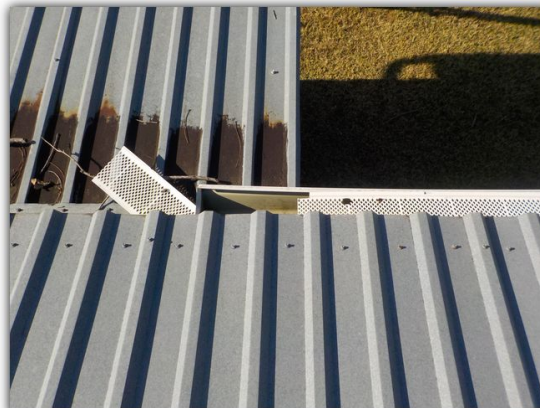
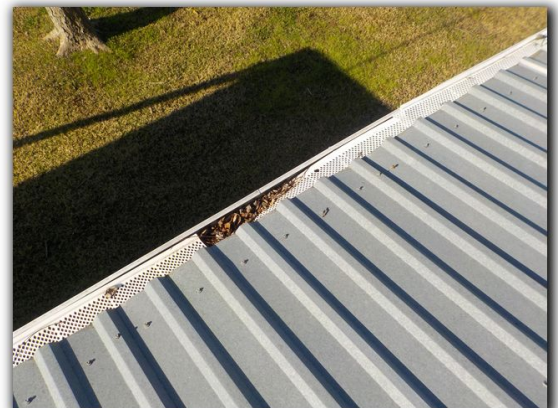
The leaf guards for the gutters was observed to be damaged and/or missing in multiple areas. Recommend cleaning the gutters and repairing the leaf guards.

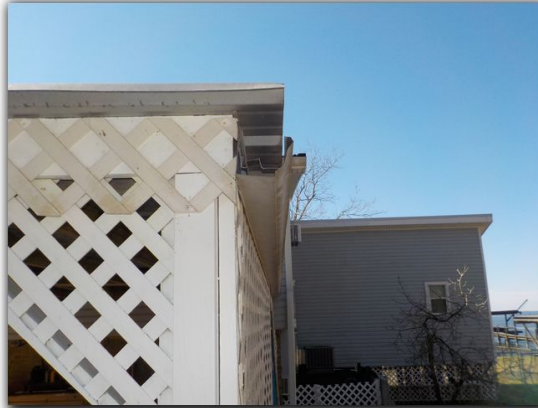
The guttering system downspout is missing on the carport.

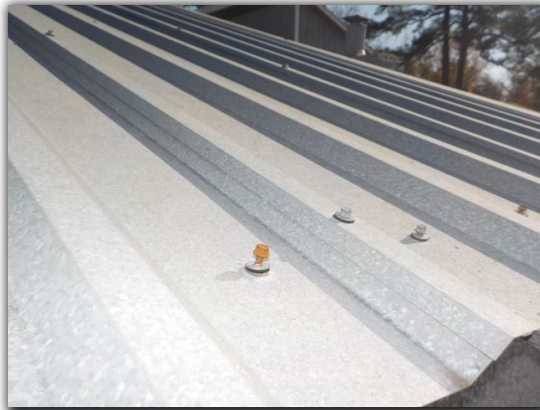
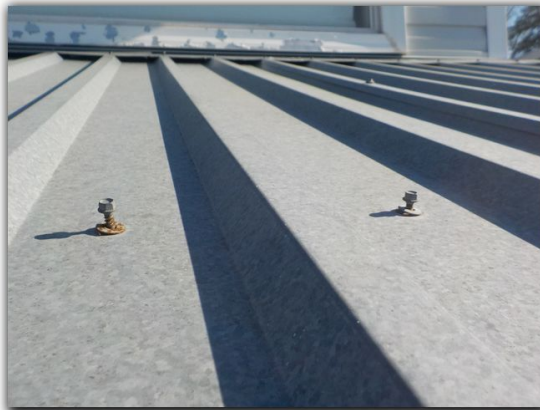
There are fasteners on the metal roof that are raised . These usually can be screwed down to secure the fastener. It is a good idea to inspect the roof annually for fasteners that are getting loose

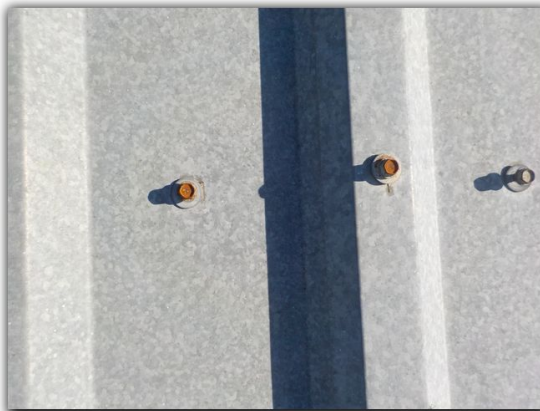
The roof fasteners are starting to rust and/or showing signs of aging. In general metal roof fasteners have a life expectancy of 12-15 years. It appears that the ones present may be nearing replacement.

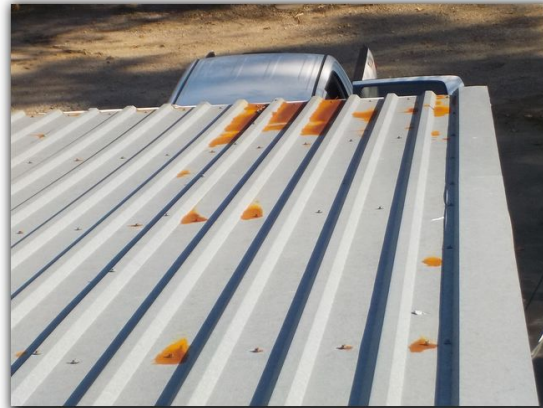
There are areas of the metal roof that have surface rust. I recommend painting or repairing the rusted areas to prevent further deterioration.

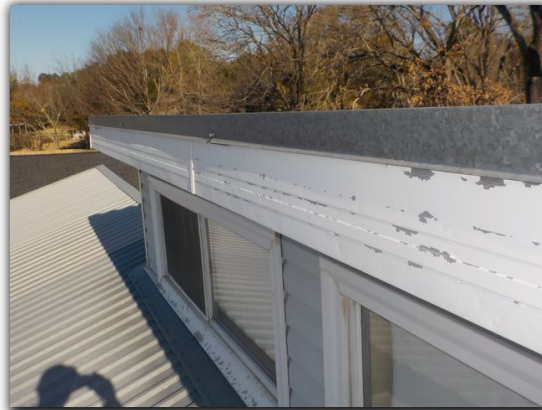
Paint was observed to be peeling at the fascia covering above the lower roof level.

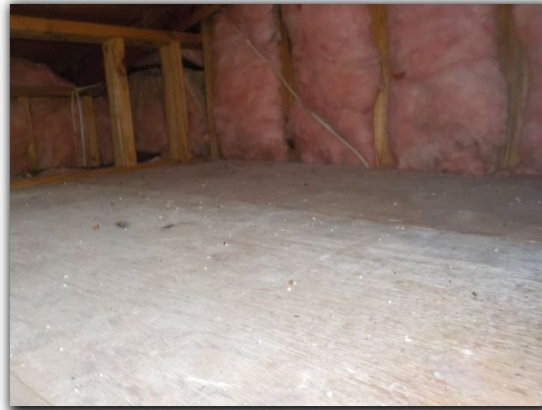
Visible evidence of rodent activity was observed in the attic area. It is recommended to have a Certified Pest Control Operator further evaluate this condition and make corrections as necessary.

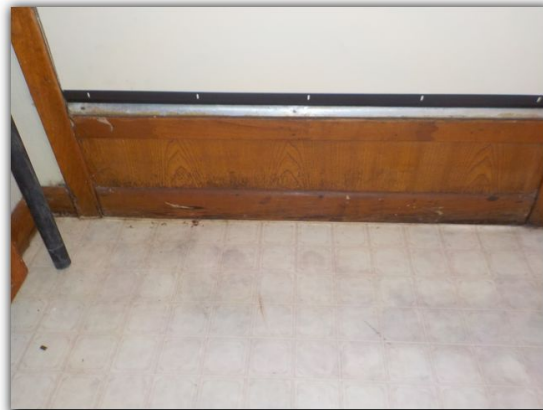
There was an unknown dark like substance observed around the downstairs exterior door. Evaluation of this substance is beyond the scope of this inspection. If any concerns exist on the type and/or nature of this substance, we recommend further evaluation by a professional in the Air Quality sampling field.

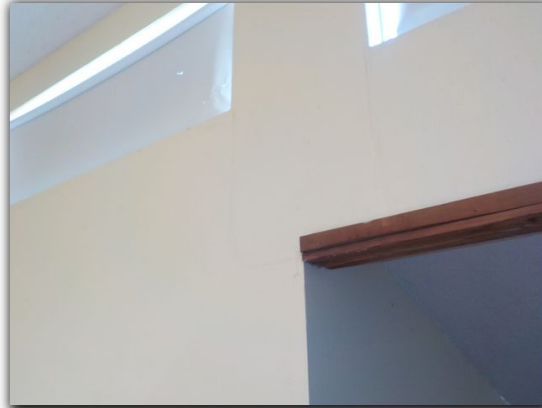
Common hairline wall cracks were noted in the interior gypsum wallboard. Cracks near the interior windows and doors are usually indications that there is some degree of movement occurring in the structure. (In any structure some degree of movement is normal and should not be of concern) the severity of the cracks can be an indication of the amount of movement in a structure.

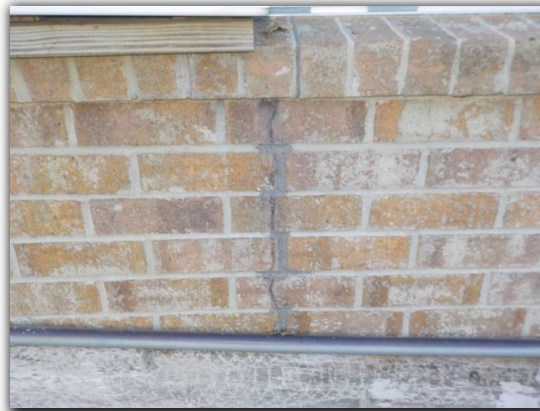
Stress cracks were noted to have been repaired on the exterior walls in various areas. This implies that some structural movement of the building has occurred, as is typical of most houses.

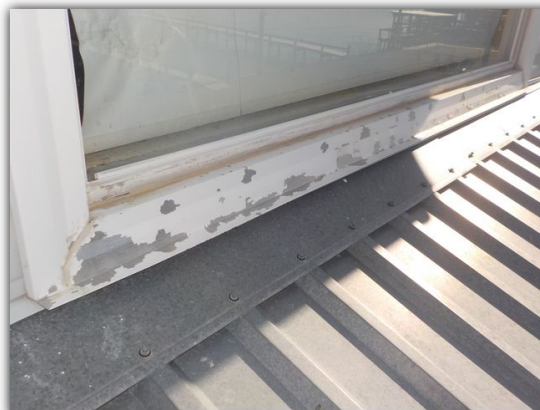
Paint was observed to be peeling at the metal type window trim above the roof structure.

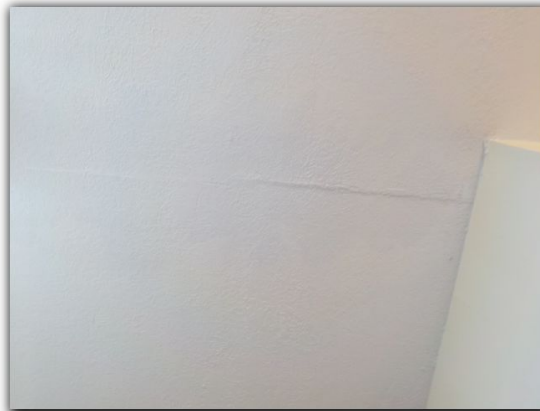
Common ceiling joint cracks were observed in various locations throughout the house.

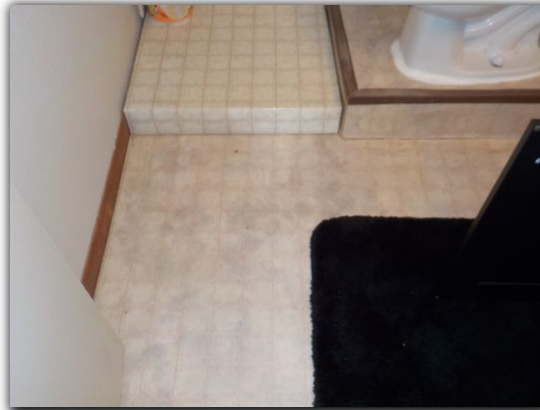
The vinyl floor covering was observed to have moisture damage and/or stains in the downstairs laundry and bathroom. This may be from previous water intrusion that was explained in the sellers disclosure.

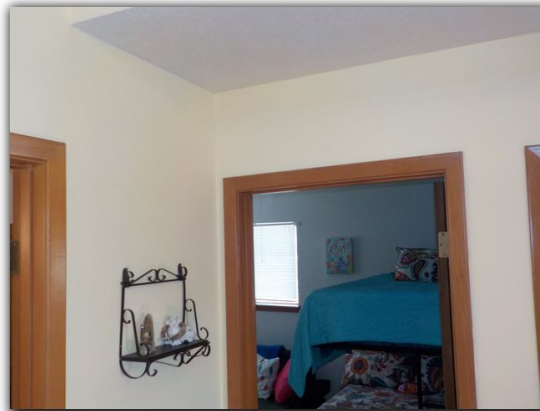
Some of the interior doors frames are out of square and the door has been adjusted to fit the opening. This usually is an indicator of movement within the structure.

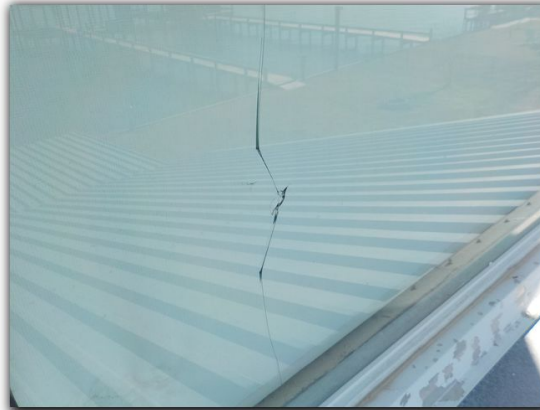
Broken glass panes were noted at one of the high wall windows in the kitchen. Broken glass is considered a recognized safety hazard and limits the energy efficiency of the glass.

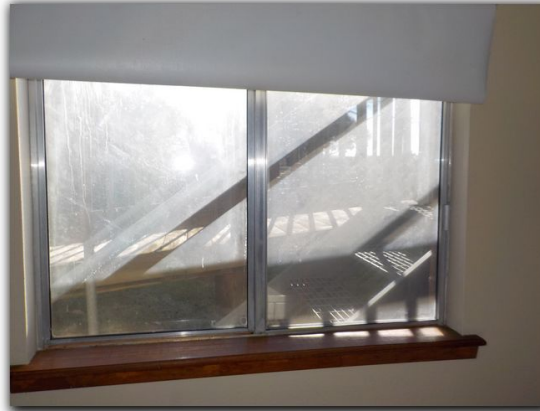
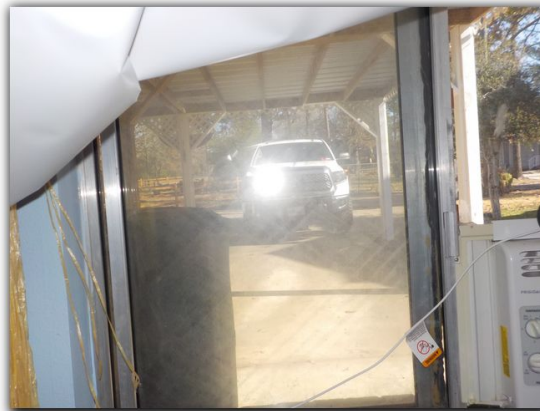
Windows with broken seals were noted at all of the downstairs double pane windows . This allows moisture inside between the panes of glass. This causes fogging to take place, which will eventually cause staining to the point of zero visibility.

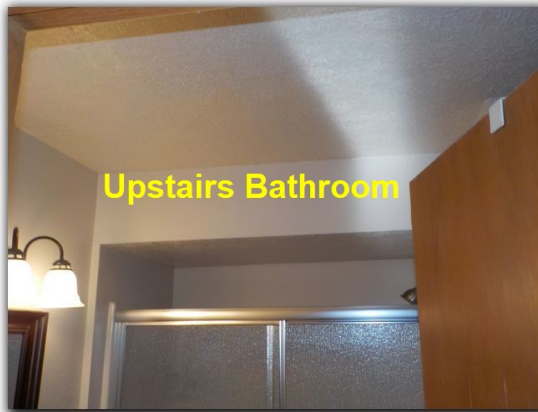
In bathrooms with no windows, an exhaust fan should be installed to remove moisture from the air.

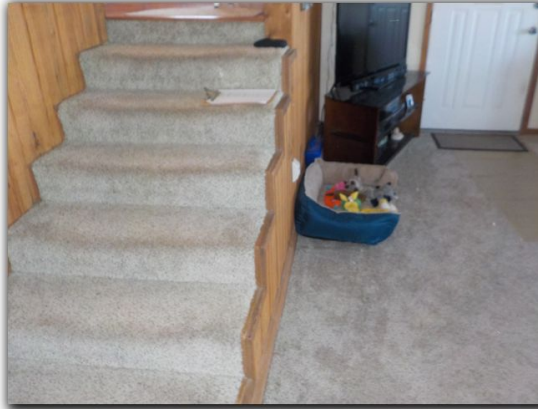
balusters with openings no larger than 4-inches should be installed. This may be an “as-built” condition but Per TREC standards of practice we are required to report this condition as a deficiency. You may consider corrective measures for improved safety.

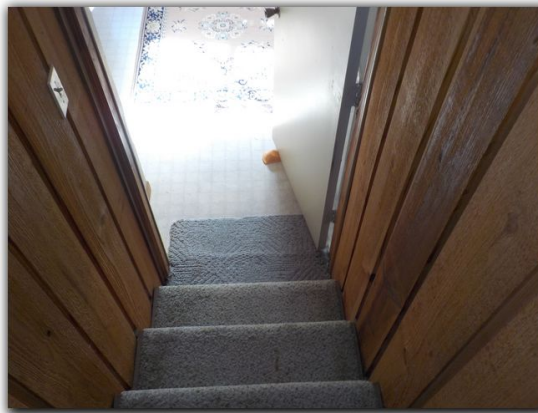
There is no handrail in place for the stairwell. For improved safety, a handrail should be installed.

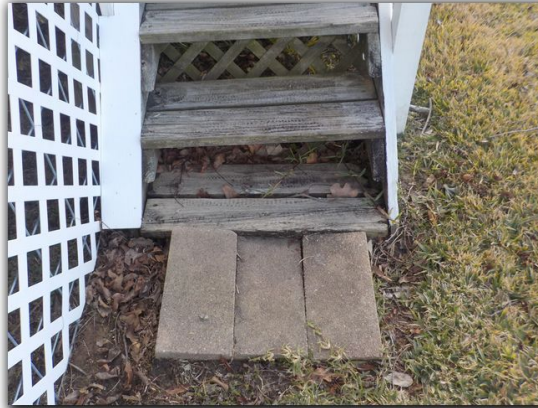
The exterior steps are resting on the ground. Wood to Ground contact is a conducive condition to wood destroying insects and wood rot. This configuration should be avoided.

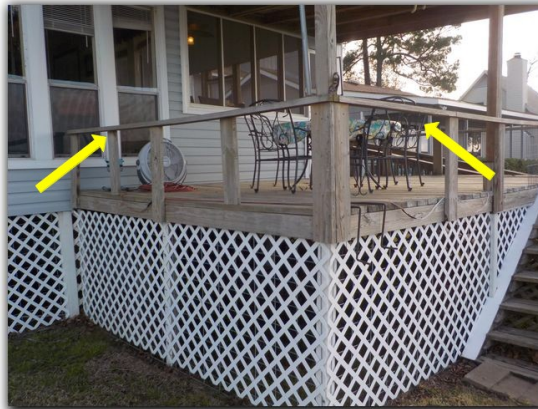
Porches, decks, ramps or balconies that are located 30-inches or more off the adjacent ground (floor or grade) should have guard rails in place for reasons of safety. The guard railing should be installed at a minimum height of 36-inches and guard openings should be no larger than 4 inches. The railing at the covered deck is too short and openings too large.

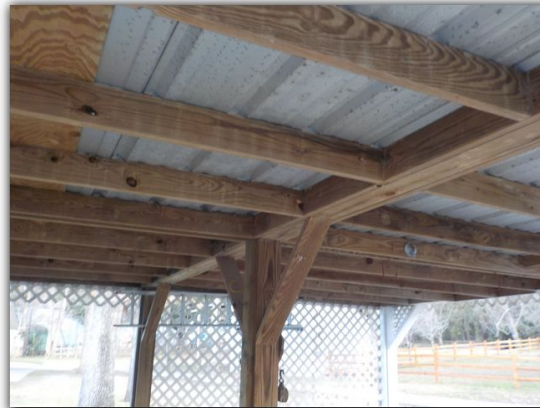
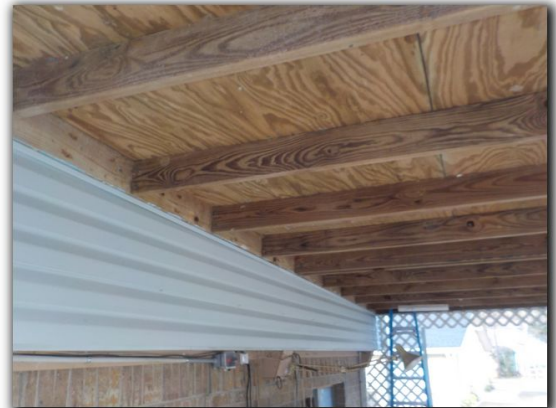
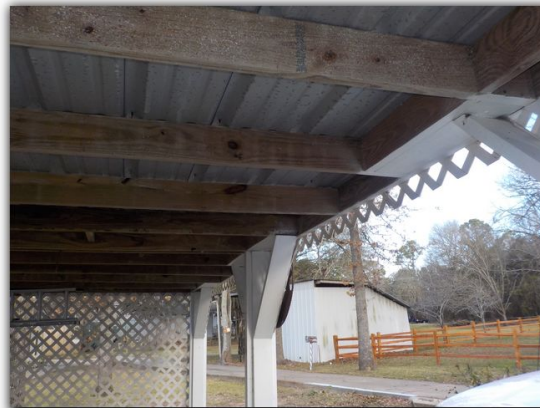
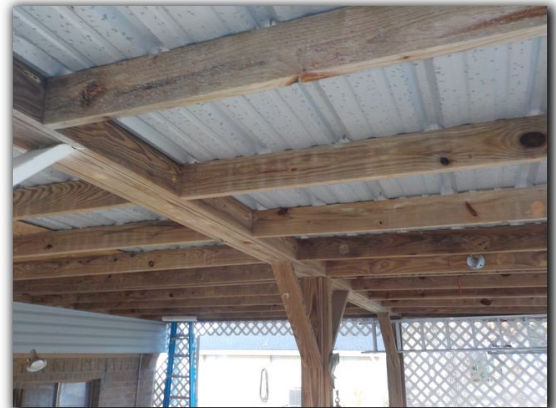
It is recommended to install joist hangers at the rafters for the carport roof structure.

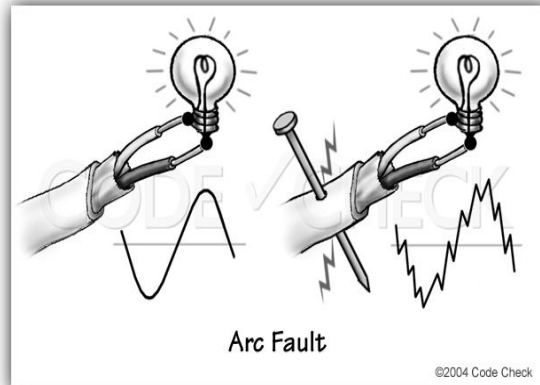
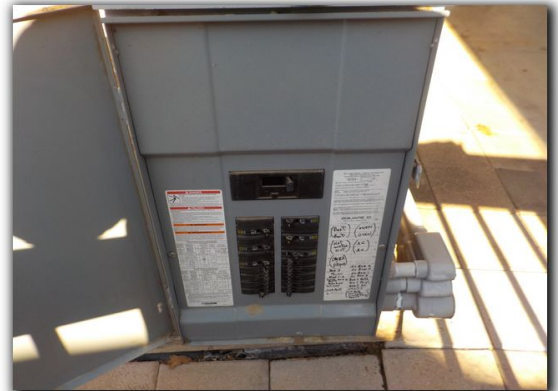
Arc Fault Breakers were not installed.

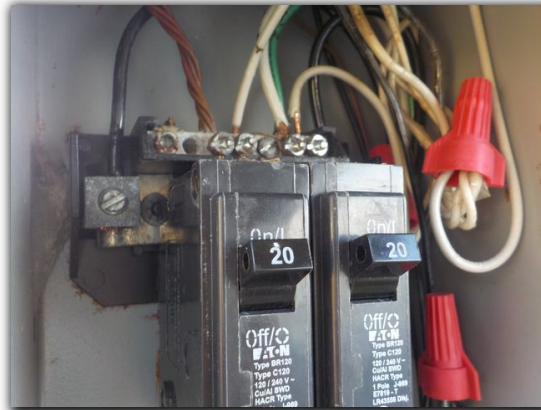
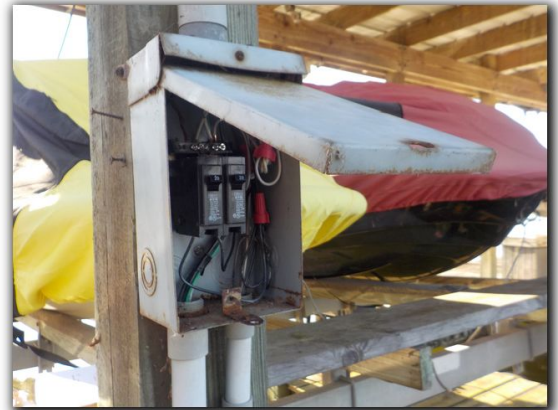
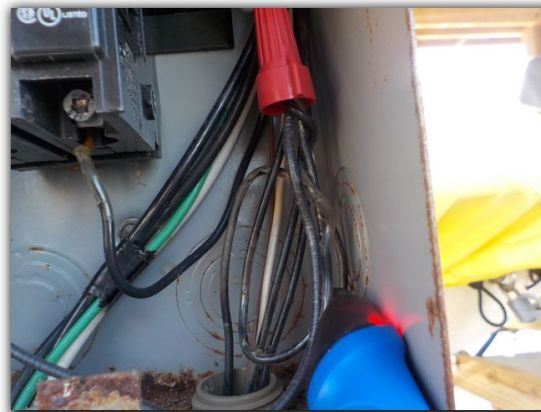
It appears that multiple circuits are wired to one breaker inside the panel box. A load calculation test would have to be performed by a licensed electrician and is recommended.

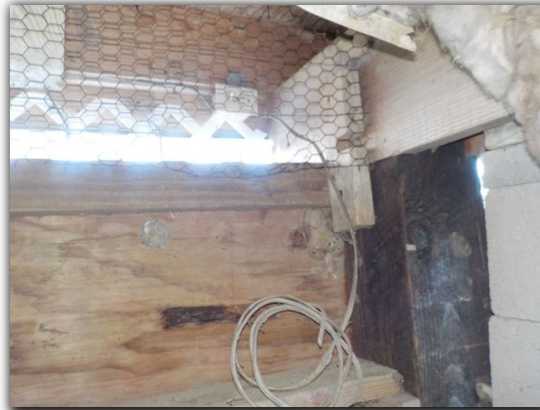
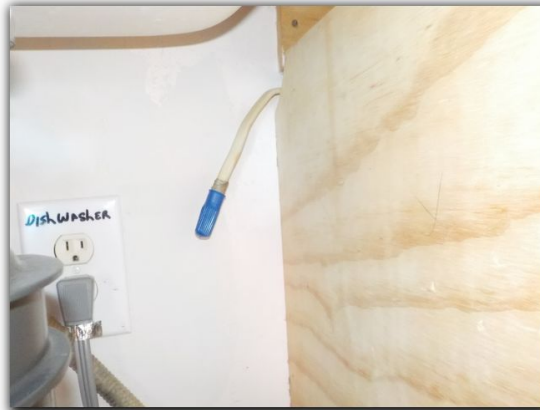
Wires that were improperly spliced or terminated were noted in the crawlspace and under the kitchen sink. Wire ends or splices are recommended to be in junction boxes that are properly mounted and covered. This condition is considered an electrocution/fire hazard and should be serviced by a licensed electrician.

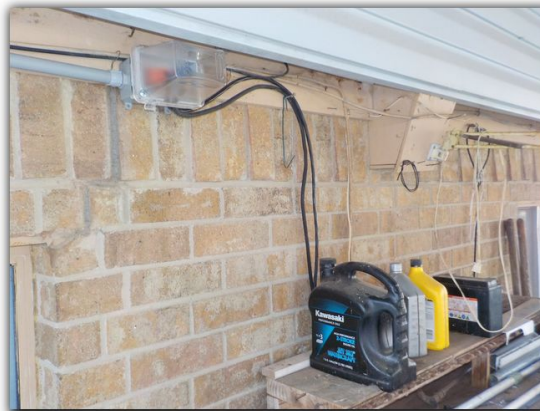
Extension cords were found being used as permanent wiring to both sump pumps. Extension cords are not designed for this application and should not be used as permanent wiring.

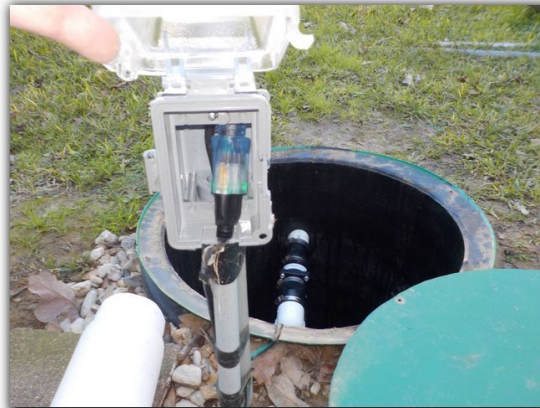
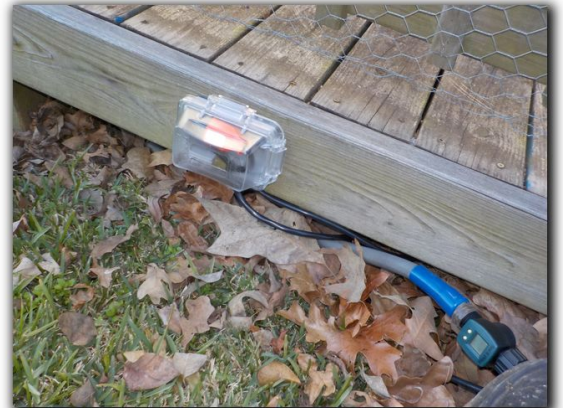
Not all of the exterior receptacles appear to be connected to a ground fault circuit interrupter (GFCI) device. Under current electrical standards, all of the exterior receptacles should have GFCI protection.

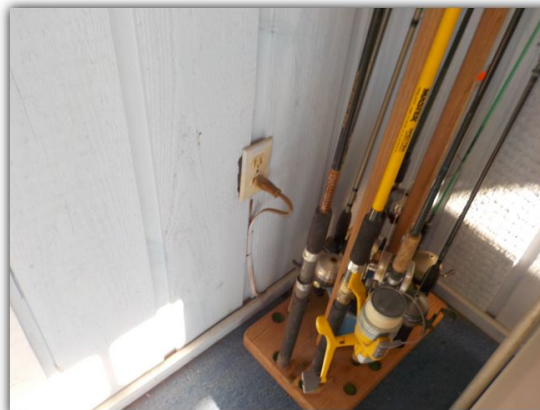
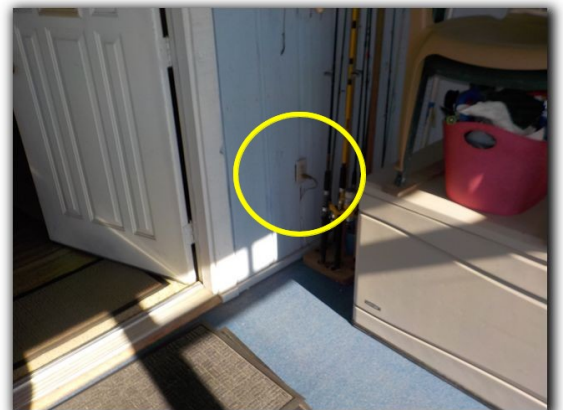
All exterior receptacles and switches should have weather tight covers.

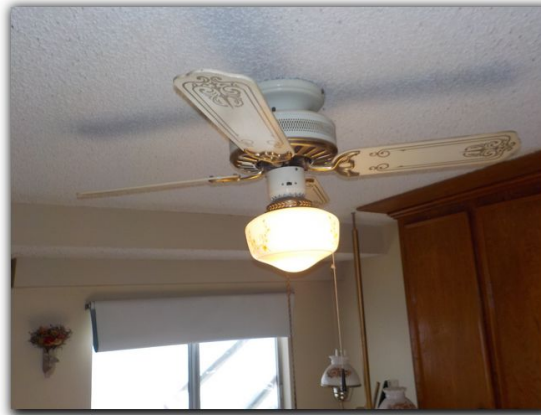
The ceiling fan is not balanced properly and wobbles when operated in the laundry room.

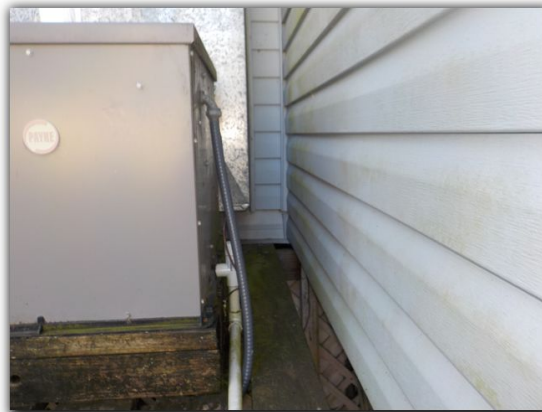
I was unable to locate or observe a service disconnect at or around the heating unit.

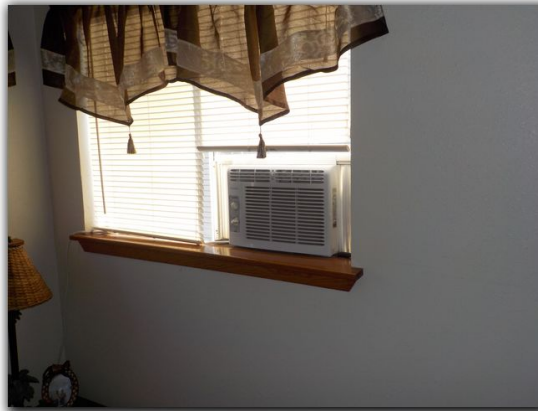
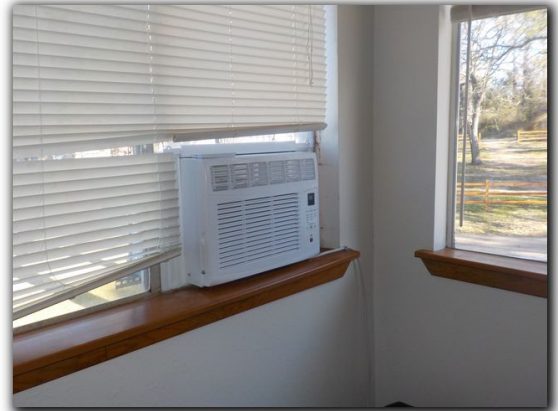
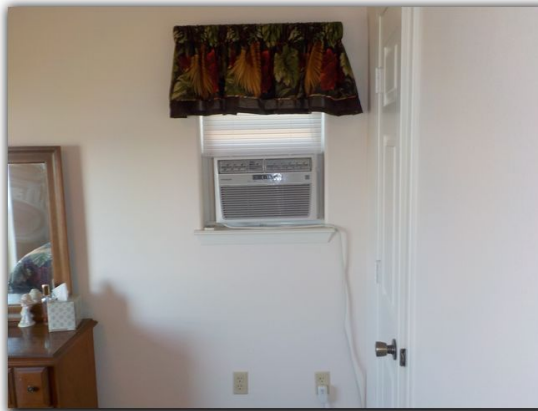
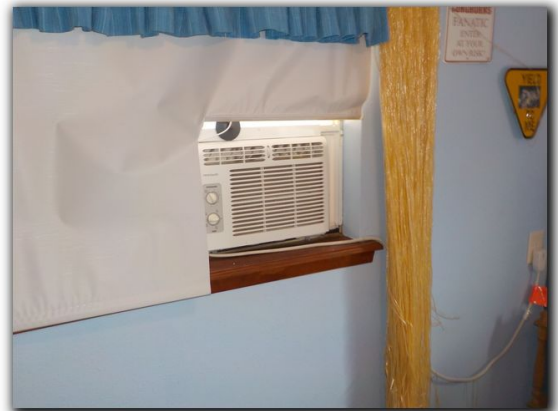
There was 5 windows unit installed in every bedroom. These units are cooling only.

Clients Notice: These units should be serviced regularly if the service date is unknown, then it is recommended that the unit be serviced prior to closing as well as annually.

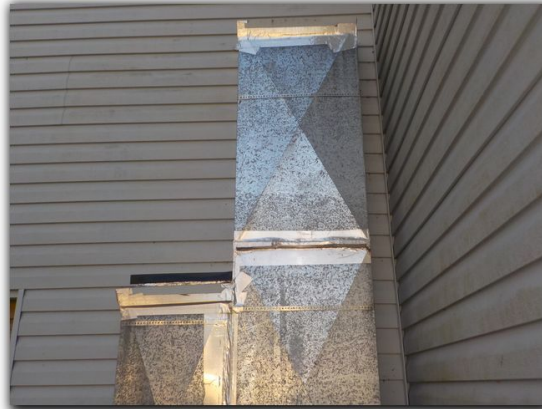
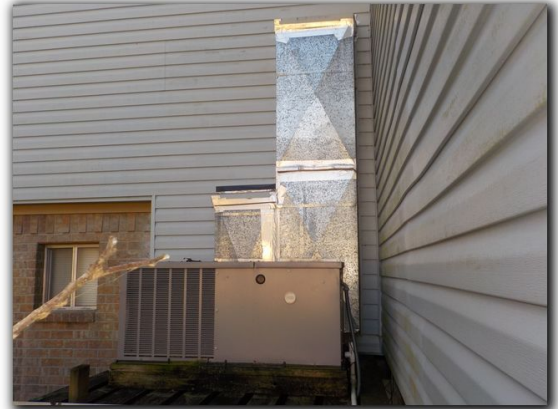
The supply and return plenum is located on the exterior wall and is exposed. Efficiency loss can occur when the plenum is not insulated and is exposed to the exterior elements.

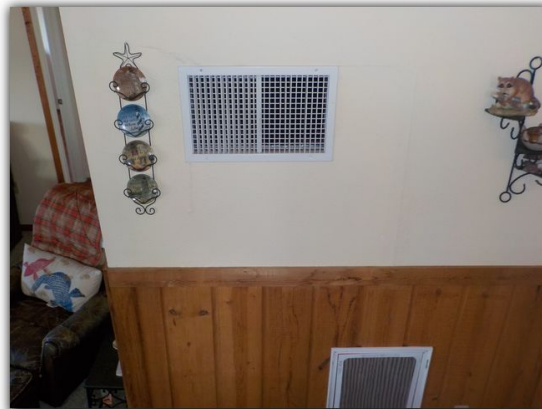
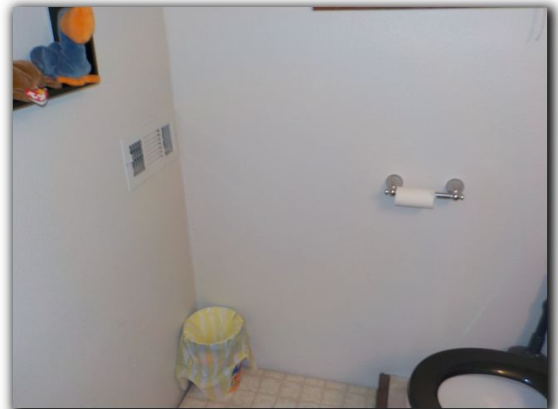
There is only two supply registers for the structure. This is mainly due to the roof structure design of the home and the location of the unit. It may be difficult to control the temperature throughout the house with only 2 supply registers.

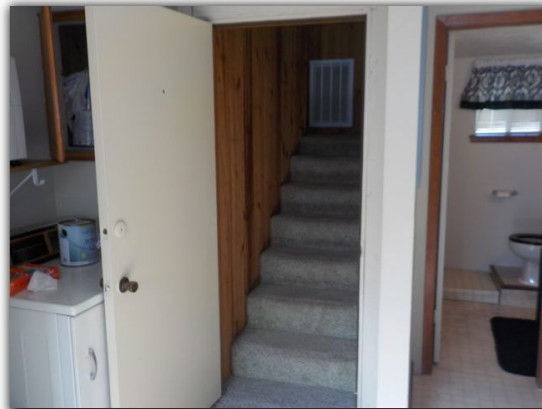
The only return register is located on the middle floor at the stairwell. The door from the downstairs to the stairwell and the downstairs bathroom door will need to be left in the open position to help prevent a negative pressure result and to help control the temperature throughout both levels.

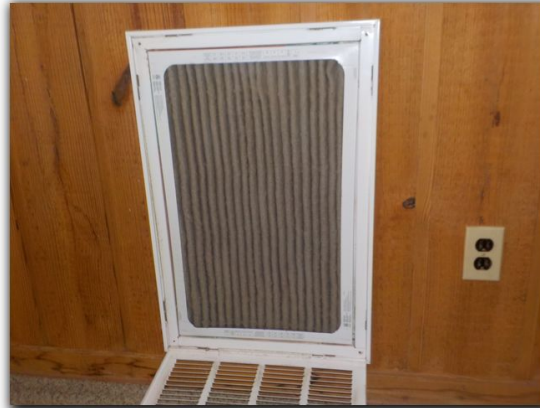
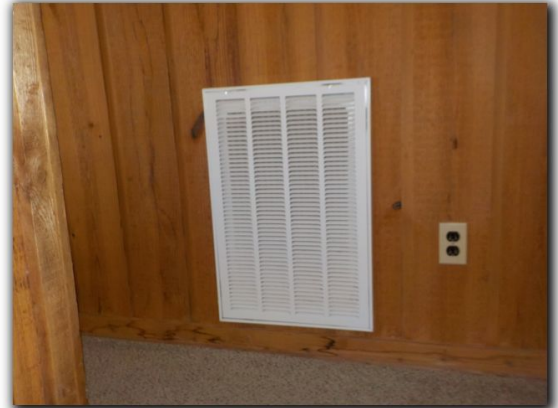
The air filter is dirty and is in need of replacement.

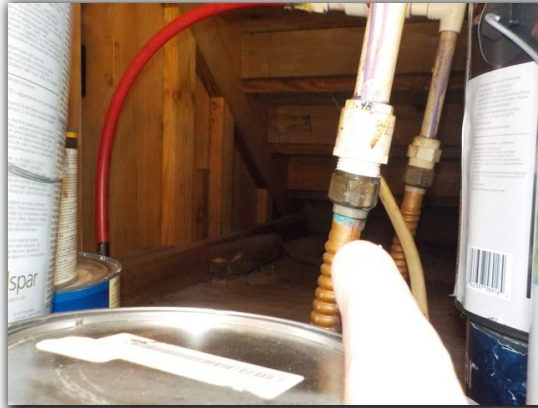
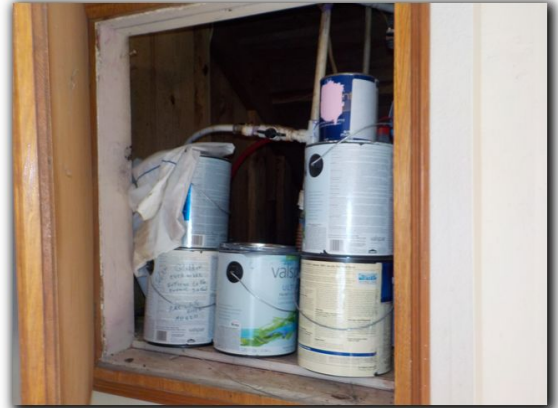
A slow water leak was observed at a supply connection inside the stairwell closet.

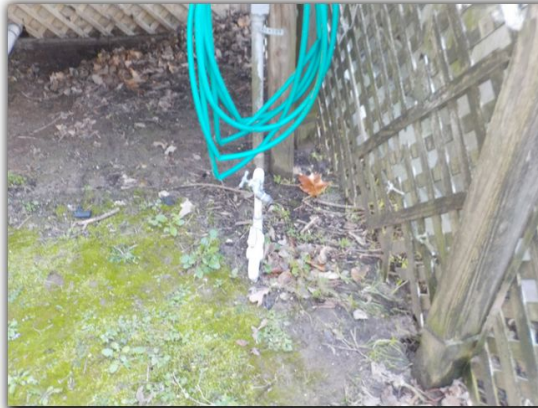
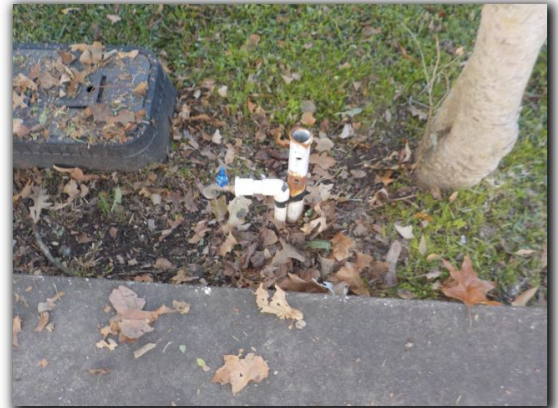
All exposed exterior water supply lines should be insulated to help protect them from possible freeze damage.

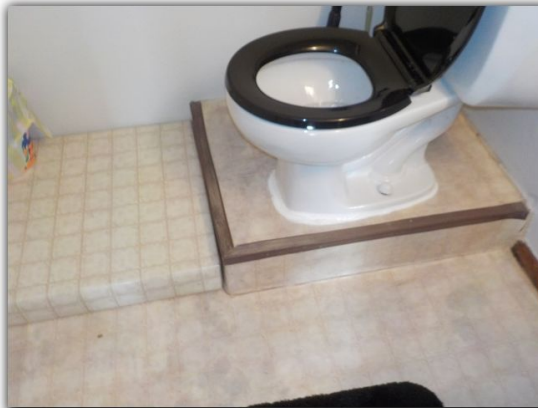
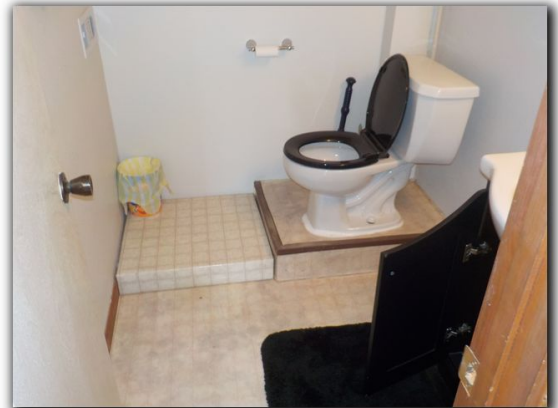
Downstairs Hall Bathroom

The floor elevation changes at the commode. This could present a trip hazard. The change in elevation is to allow a chase for the plumbing to travel through. This is an as-built condition. Care should be taken.

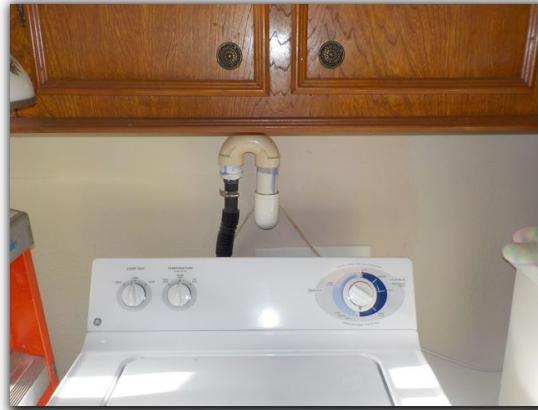
There was no P-trap observed for the washing machine drain line. This does not meet current plumbing standards and should be repaired as needed.

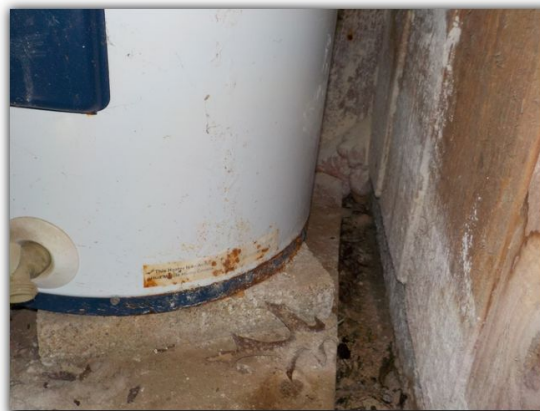
Although the water heater is in the crawlspace, a pan and drain line is recommended. The ground is lower directly behind the unit and against the foundation. In the event of a leak it appears that the water could drain to the low area and possibly penetrate into the structure.

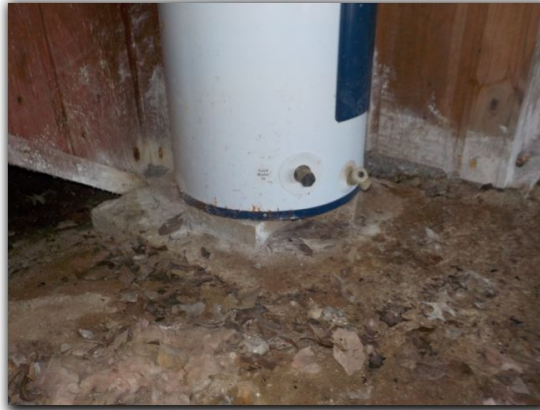
The gas line to the structure has been disconnected from the tank. Note: There was no gas appliances observed for the structure.

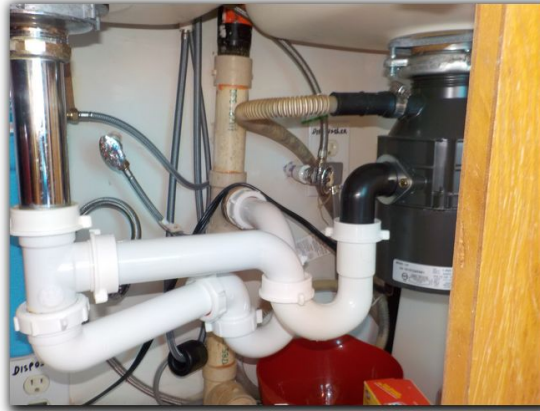
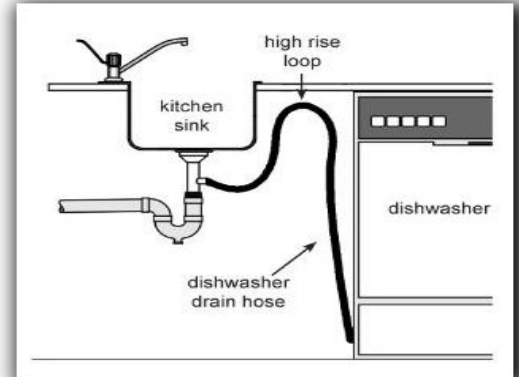
The dishwasher drain hose is not properly installed to prevent back flow or anti-siphoning. It is recommended that an air gap device or high drain loop be installed in the drain line.
