**HOME
INSPECTION**

**Dave Hilgartner
335 Harbor Addition
Livingston , TX 77351
January 27, 2022**

Inspected By: Erik Placker TREC # 21184

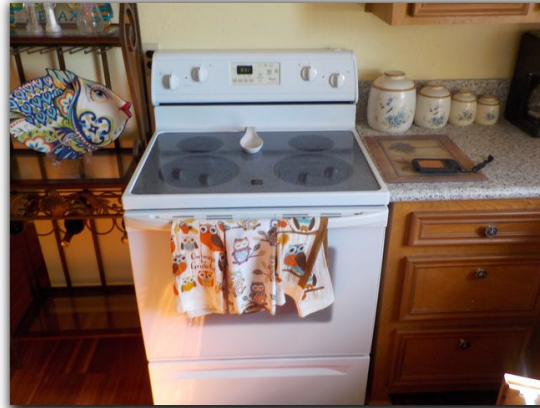
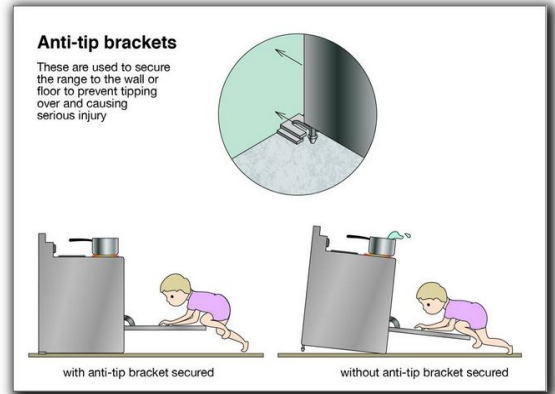
The range can be easily tipped over and should be equipped with an anti-tip device, for safety.

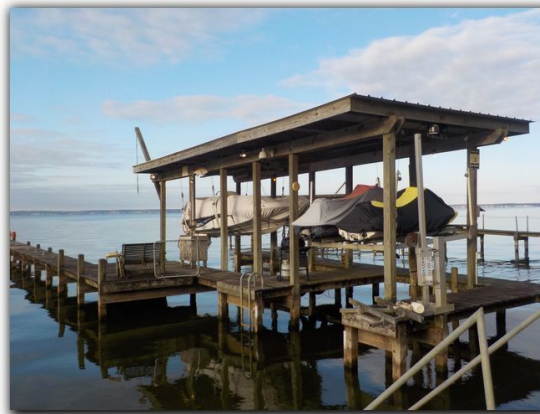
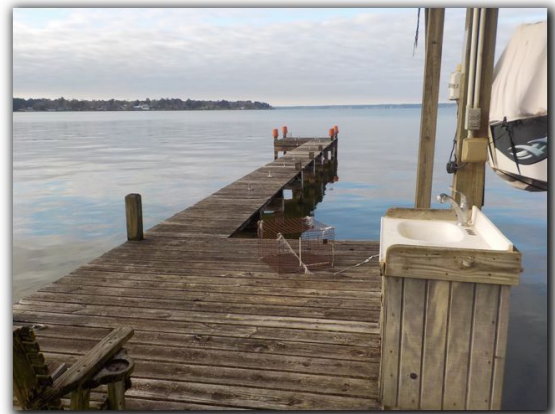
Normal wear was observed at the piers for the boat house. This is a common condition and is not considered a concern at this time.

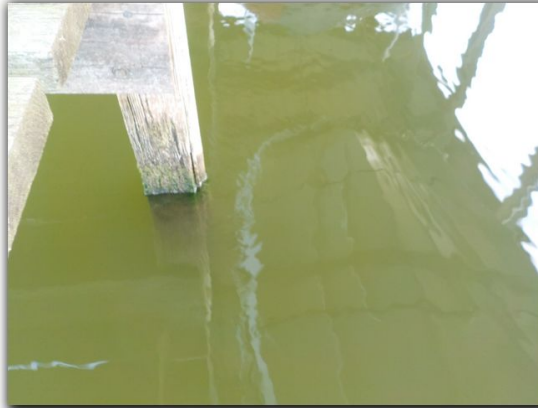
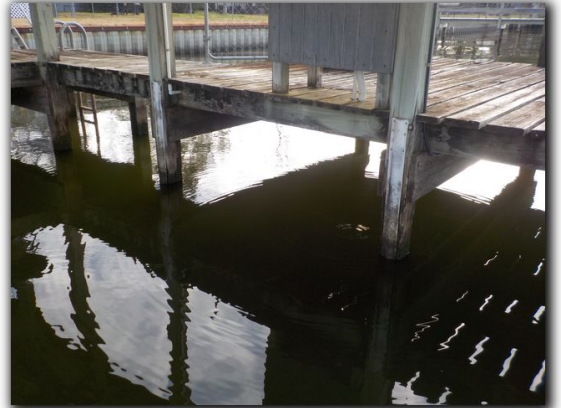
Common weathering of the deck material was observed. Routine maintenance as in cleaning and sealing the wood should be considered to help prolong the life expectancy.
