HEDDERMAN ENGINEERING, INC.

April 10, 2019

REF: CONDITION OF PROPERTY SURVEY

At your request, a visual survey of the house located at 12710 Old Oaks Drive, Houston, Texas, was made by Mr. Pedro Salazar and Mr. David Koteles.

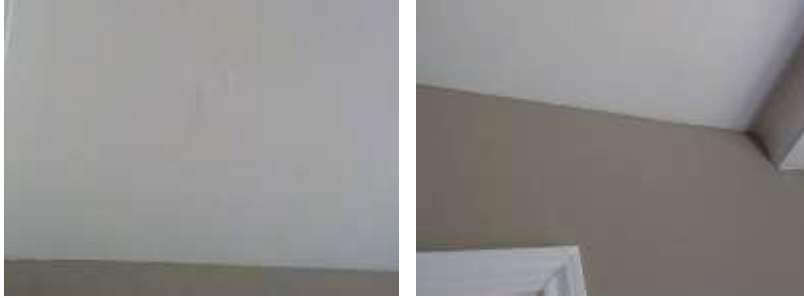
Sheetrock cracks, patches, and/or compression ridges were observed, including at the master bedroom, hallway, southeast bedroom, and family room.

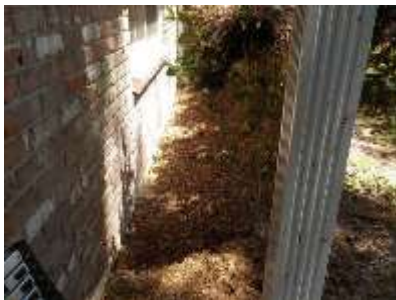
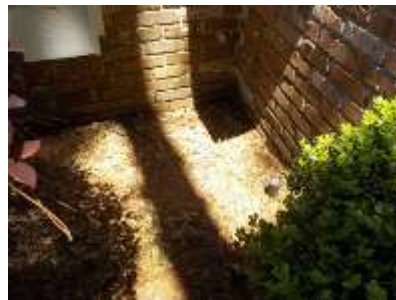
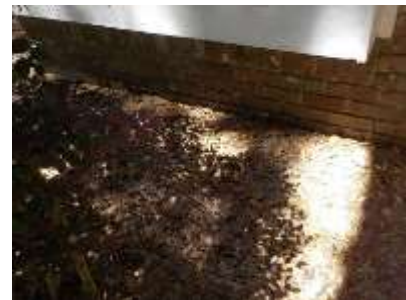
It is pointed out that a portion of the foundation concrete could not be viewed due to soil that was graded near or above the top of the foundation and/or heavy foliage growing against the house. The soil and/or foliage should be removed, and 3-4 inches of foundation concrete exposed.

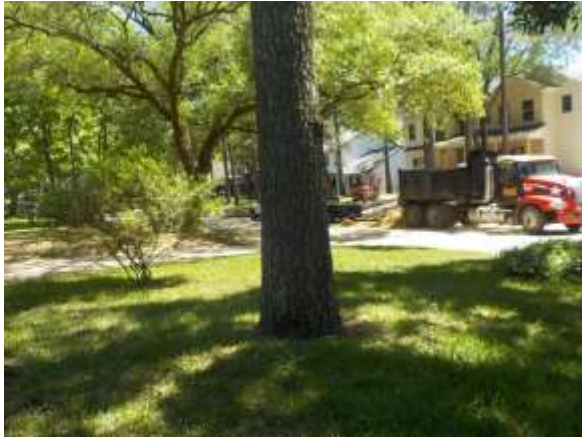
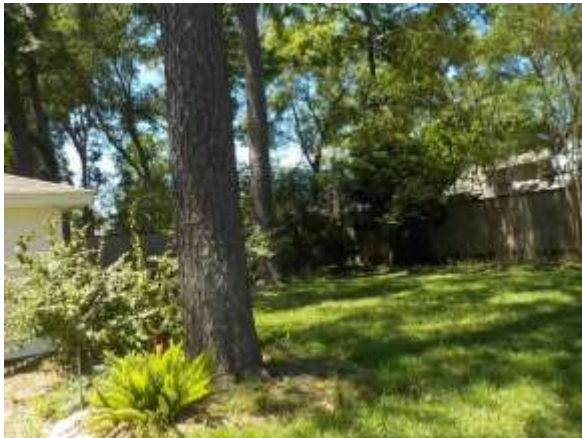
Trees and/or foliage were observed in the vicinity of the house, which can contribute significantly to differential movement of the house foundation. Care should be taken to prevent the trees and foliage from removing an excessive amount of water from near the foundation of the house. Consideration should also be given to cutting the tree roots that extend under the foundation, and installing a root barrier to prevent any further moisture from being removed from under the interior of the house.

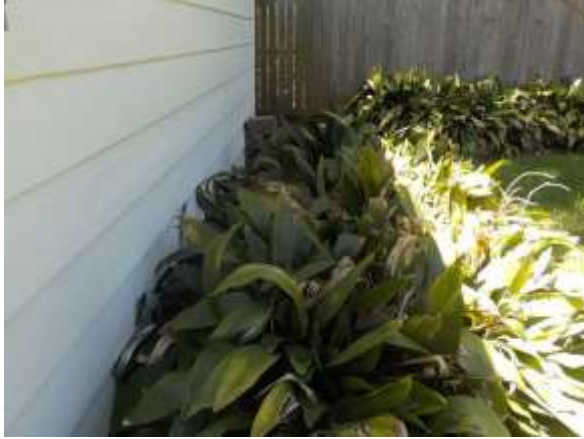
The bushes at the garage were growing against the garage, and need to be trimmed back away from the garage.

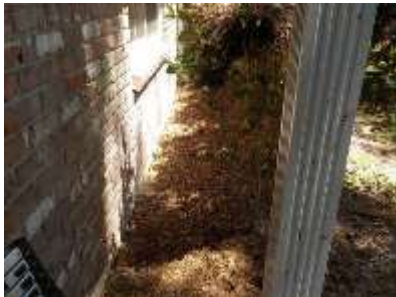
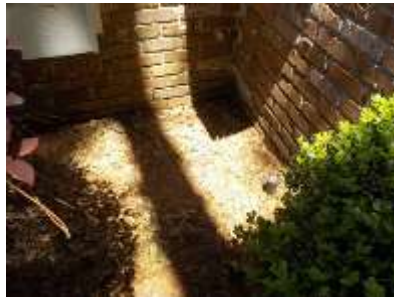
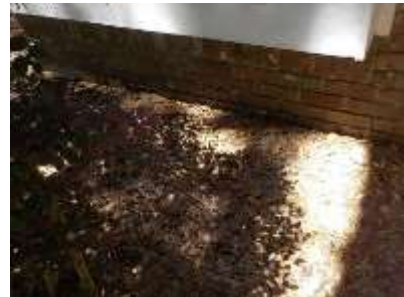
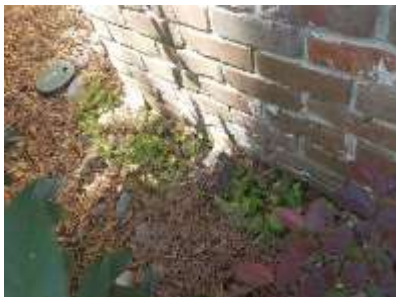
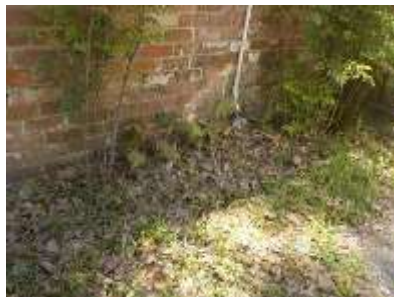
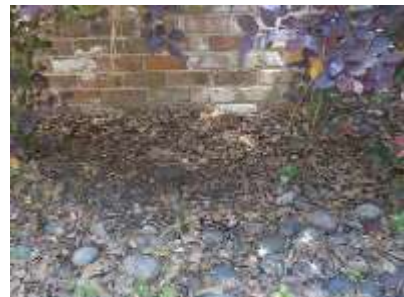
The soil was graded near or above the top of the foundation and/or heavy foliage growing against the house. This condition can cause settlement of the foundation. It is recommended that the soil and/or foliage should be removed, and 3-4 inches of foundation concrete exposed to keep water away from the house.

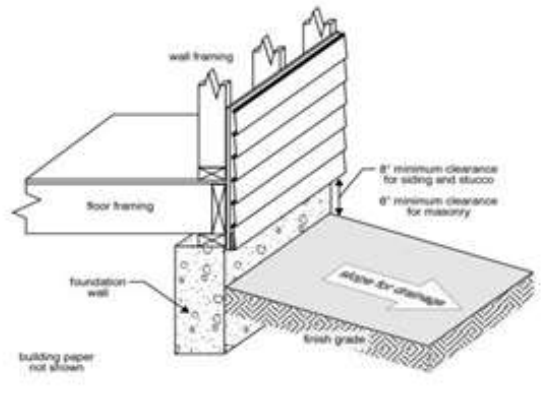
The grade was essentially flat, and it appears that water may pool at some areas after a rain. Further investigation with the homeowner is recommended to determine if water pools for a significant time after a rain. If so, an underground drainage system may need to be installed, and you should contact a company specializing in underground drainage system for a cost estimate.

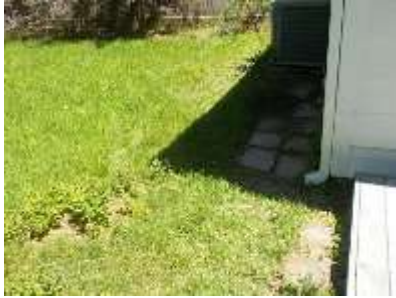
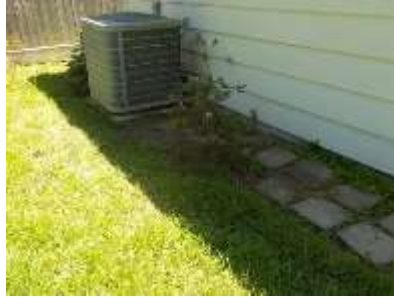
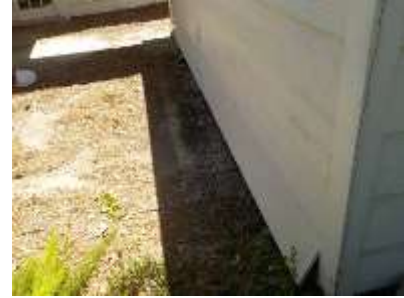
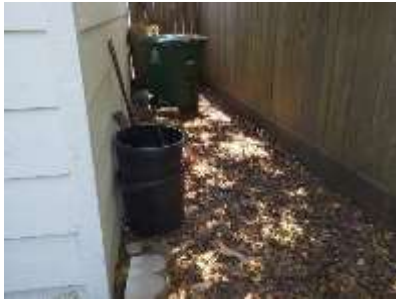
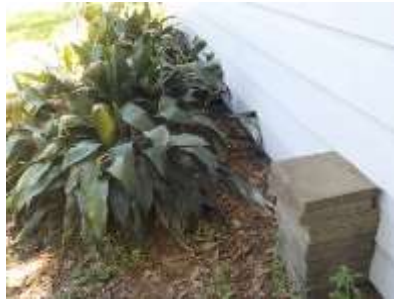
The perimeter drainage was observed to be poor at some areas where the lot is not sloped away from the house (6 inch drop in the first 10 feet) and water will pond. It is recommended that a company specializing in drainage solutions be contacted to provide a recommended solution, along with a cost estimate to provide proper drainage.

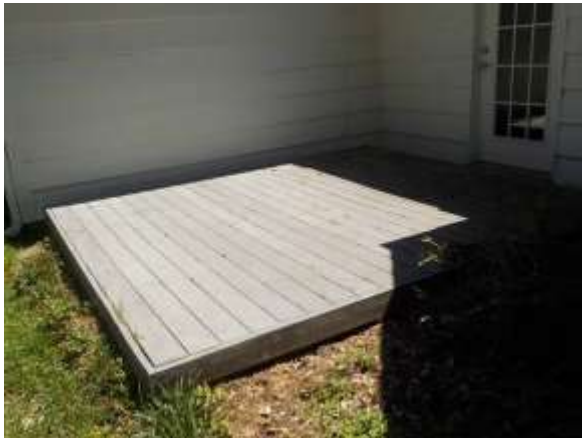
We could not determine if any provision has been made at the rear of the house for drainage under the wood deck. It is recommended that you check with the owner to determine if there are any drainage problems at the deck area, and if any provision for drainage has been made.

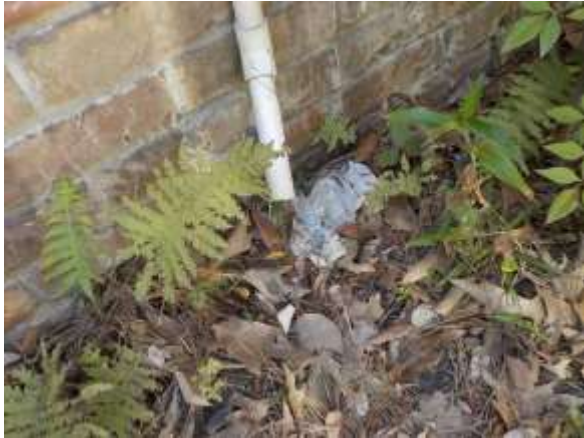
The primary condensate drain line from the air conditioning unit was emptying its water next to the foundation. This can cause the soil in that area to stay saturated, and contribute to differential foundation movement. It is recommended that the drain line be routed to a bathroom sink drain line.

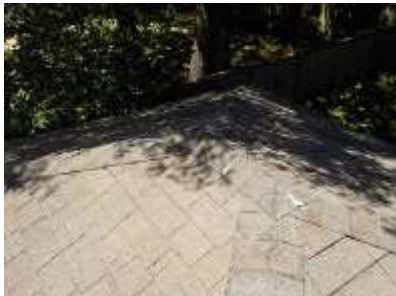
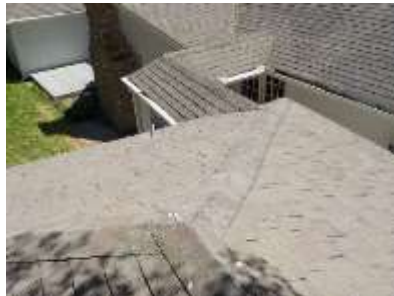
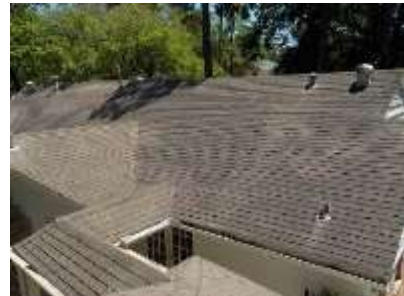
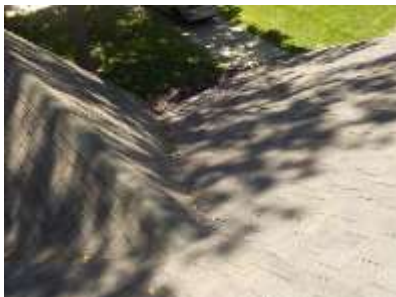
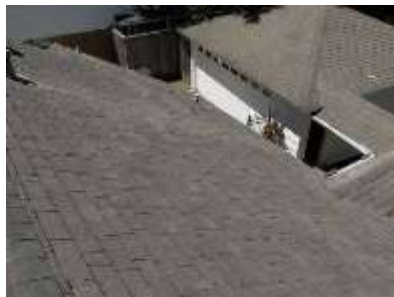
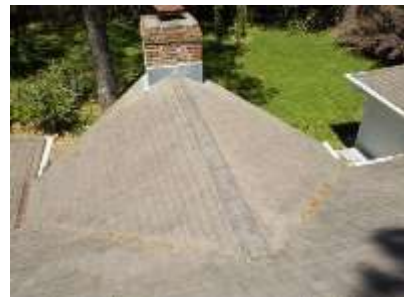
The roof surface was constructed of composition shingles. The life expectancy of a composition shingle roof has been observed to vary from 15 to 20 years, with most requiring replacement at about 17-20 years. We estimate that the age of the roof is approximately 20-22 years.

The composition roof surface was showing evidences of advanced deterioration, including the majority of shingles that were brittle, discolored, curling on the edges, cracked, and losing their aggregate.

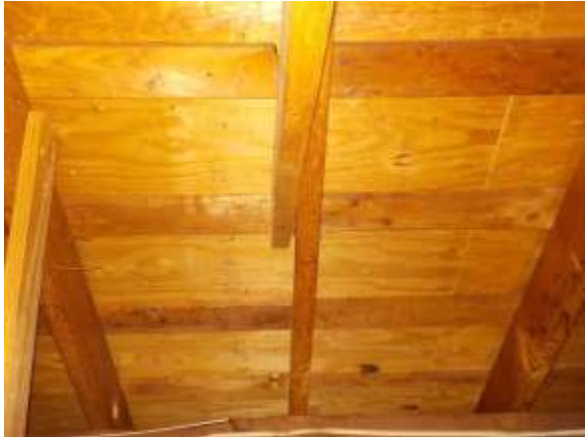
- * The roof decking was observed to be plywood.
- * It was observed that the old wood shingles were removed, and the roof was redecked when the current composition roof was installed. Therefore, this roof is not an overlay, but has one layer of shingles.

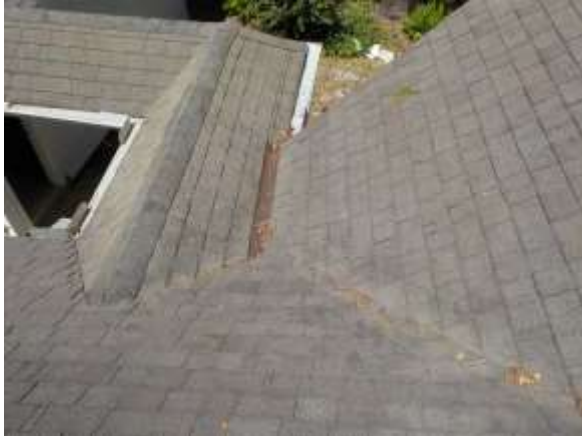
* There was a narrow valley in the roof, where the valley narrows down and will be susceptible to the accumulation of leaves and other debris. This can cause a damming of water running down the valley, possibly causing a roof leak. It is recommended that this valley be monitored, and cleaned on a regular basis.

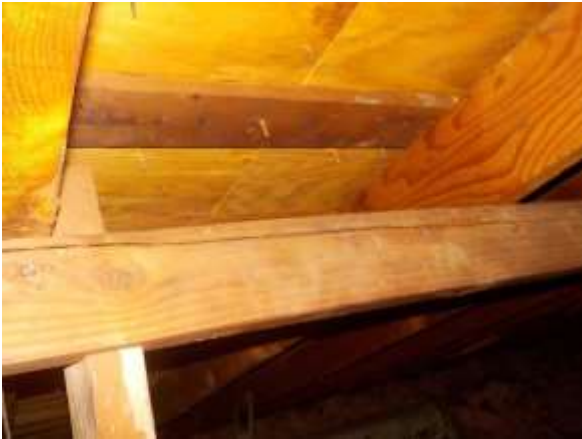
* The vertical braces were spaced farther apart than the currently recommended four feet. However, no significant deflections were visible in the roof framing, and no repairs are recommended.

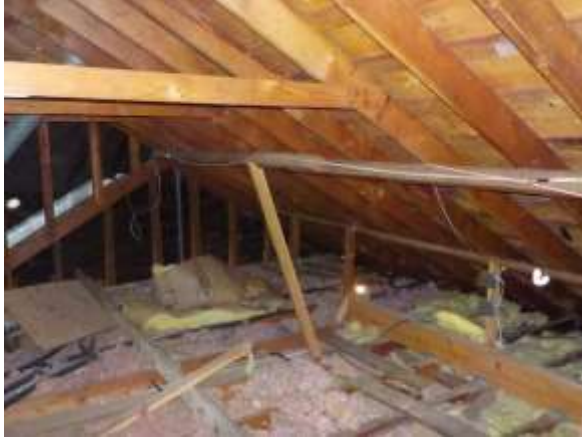
* There were several vertical braces in the upper attic at the purlins that were longer than eight feet, but were not reinforced with another member to make a "T" section of the braces. It is recommended that the braces be reinforced.

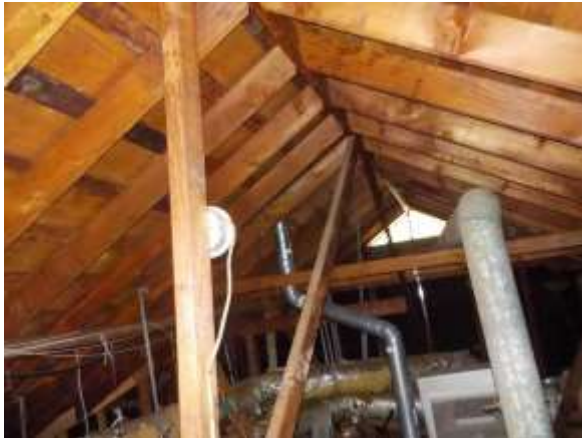
* One of the vertical braces was split and is in need of repair.

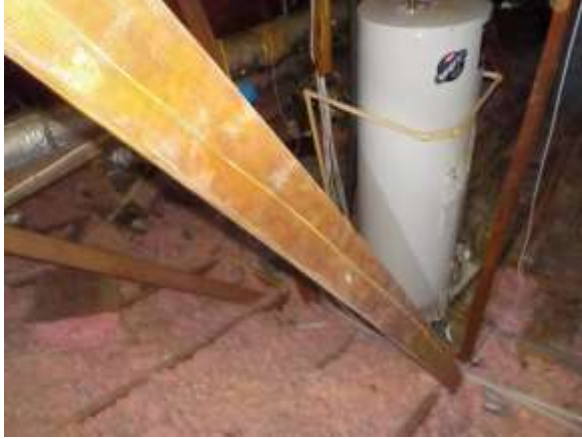
- * One of the collar beams between the roof rafters was cracked and is in need of repair.

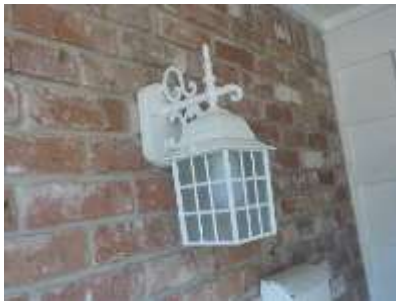
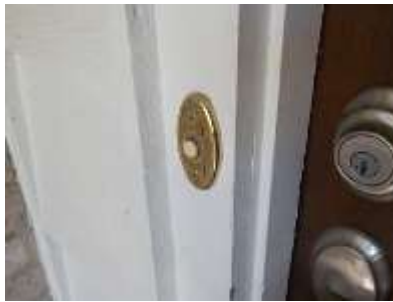
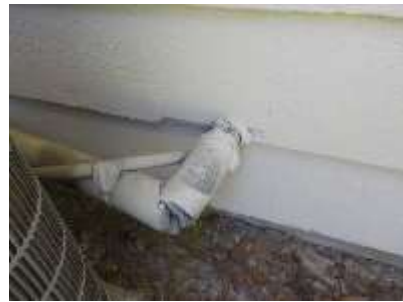
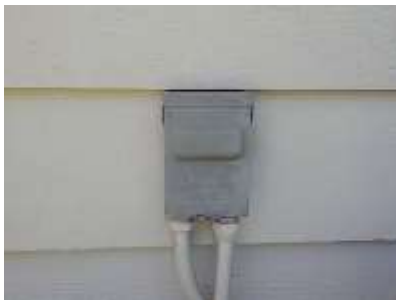
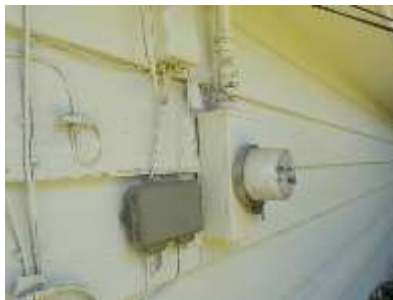
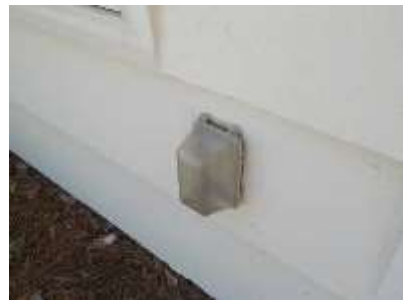
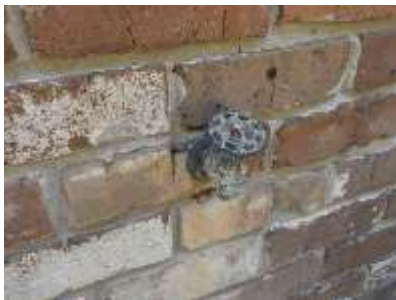
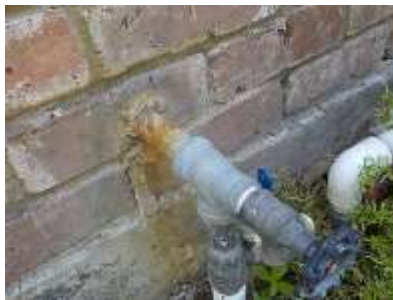
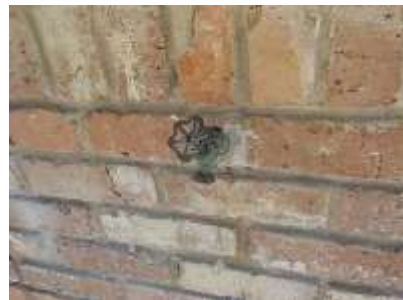
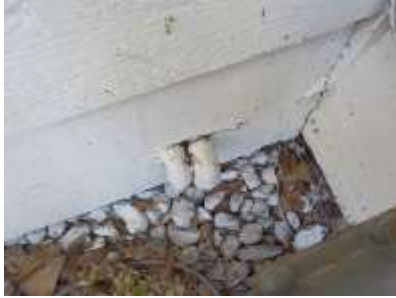
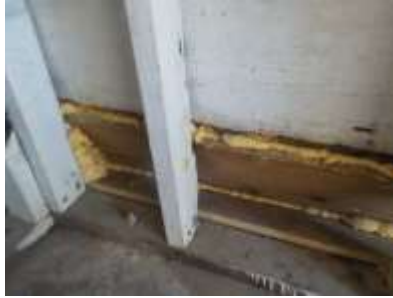
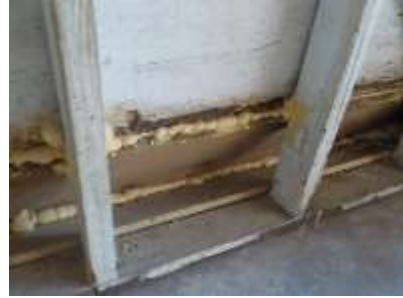
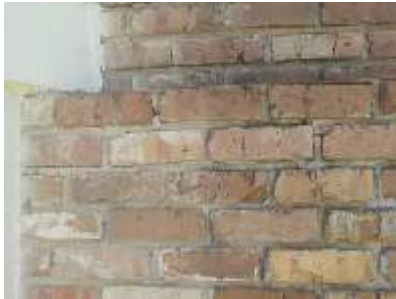
A substantial vulnerability to water penetration was observed at penetrations/openings through the exterior building envelope, and it is recommended that all penetrations/openings be sealed against water penetration. Below is a representative sample of locations and/or photographs showing some, but not necessarily all, locations where there is a vulnerability to water penetration. Have a contractor provide a cost estimate to seal all vulnerable areas against water penetration.

- The exterior light fixtures have not been caulked.
- The doorbell has not been caulked.
- The air conditioning refrigerant lines need to be sealed where the lines penetrate the building envelope.
- The electrical disconnect devices at the air conditioning unit(s).
- The main breaker panel and meter.
- The exterior electrical outlets and/or conduit.
- Piping penetrations.
- Expanding foam was installed at several penetrations, but expanding foam is not a water proofing material. Have the foam cut back flush with the veneer and caulk installed over the foam.
- The transition between dissimilar materials did not have adequate caulk joints.
- The mortar for the brick veneer, where small voids were visible in the mortar that can allow water penetration.

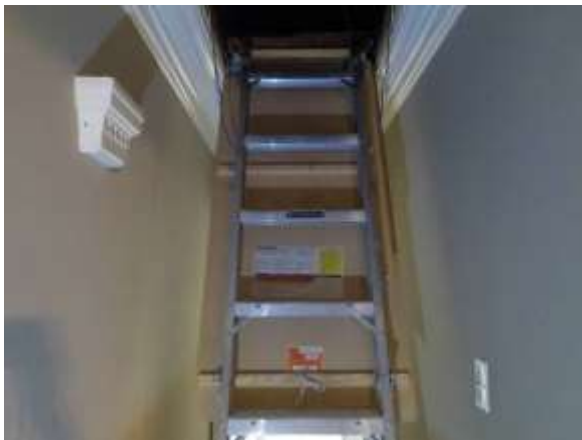
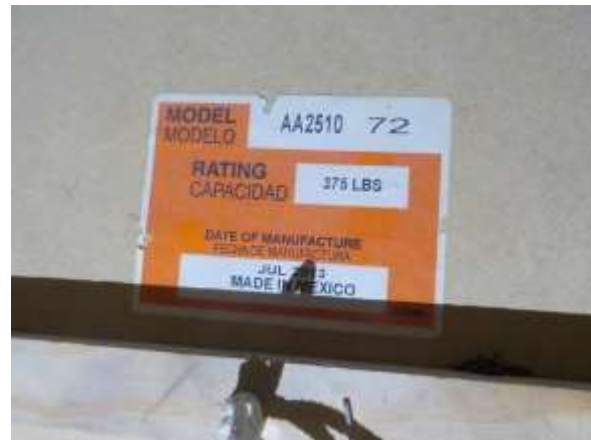
The stair assembly was not properly installed or secured to the framing members, and repair is needed for safety purposes. The condition(s) can be a safety hazard, and repair is needed, as an improperly installed stair assembly can possibly collapse. Defective conditions we observed included the following:

- The nails used to secure the ladder assembly to the attic framing were not installed through the holes in the spring arm pivot plates on the sides of the access ladder.

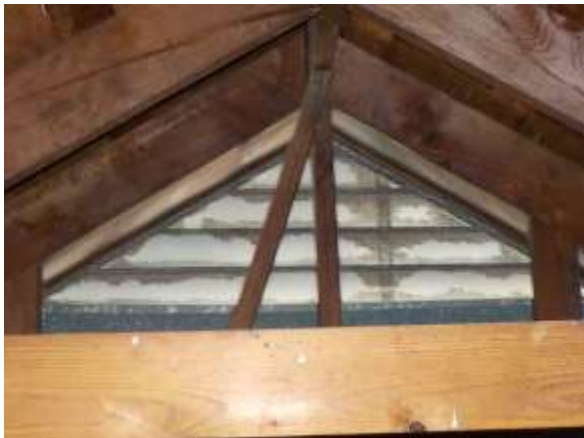
The gable vent screens were torn at both ends of the house and need to be replaced.
Obtain Cost Estimate

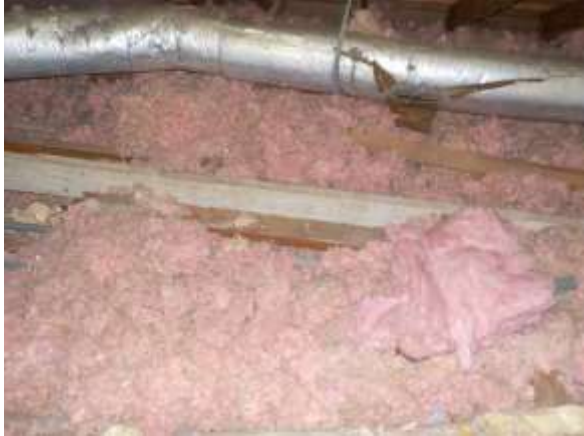
The insulation in the attic was thin by today's standards. This attic appeared to have approximately 4-5 inches of fiberglass blown-in insulation in the ceiling. It is recommended that consideration be given to installing additional insulation. Current construction standards for new homes have insulation that is a minimum of an R-30 rating.

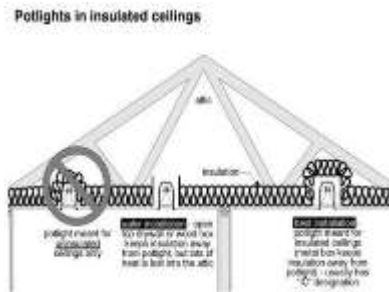
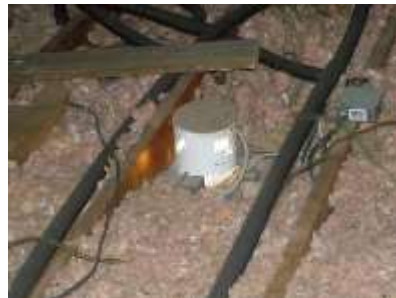
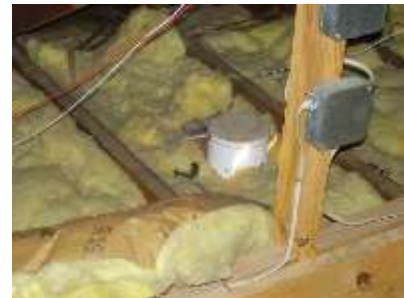
The insulation was in contact with the recessed lights, which can be a fire hazard and shorten the life of the light bulbs. It is recommended that the insulation be pulled back to provide a three inch air space.

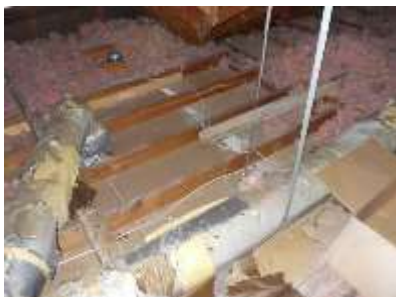
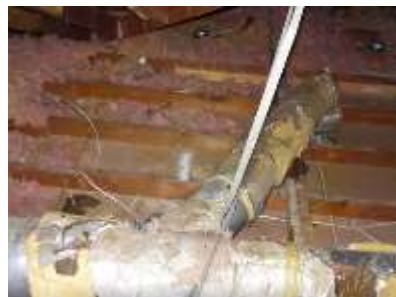
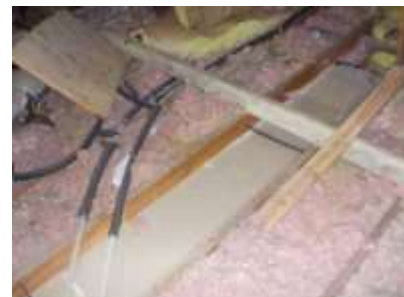
The insulation in the attic was missing from between some of the joists.

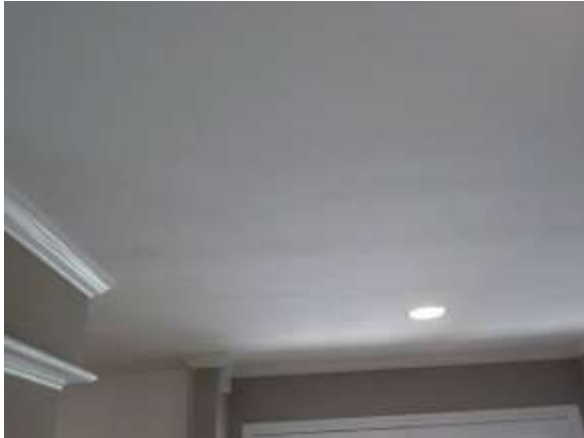
Water stains were observed at the ceiling of the southeast bedroom. This is located under the attic space, and the stain(s) appear to be related to plumbing leaks. Have a plumber and/or a service company find the source of the water stains, and provide a cost estimate for any needed repairs.

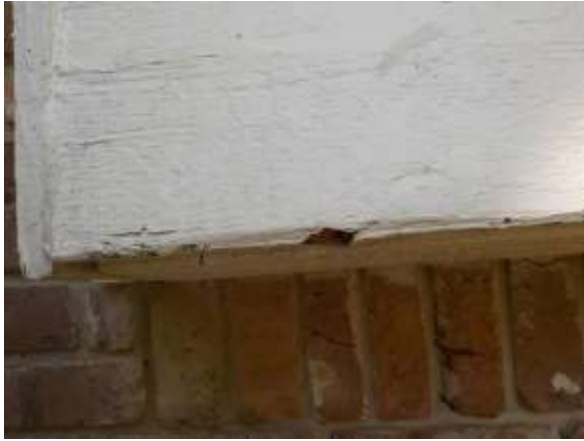
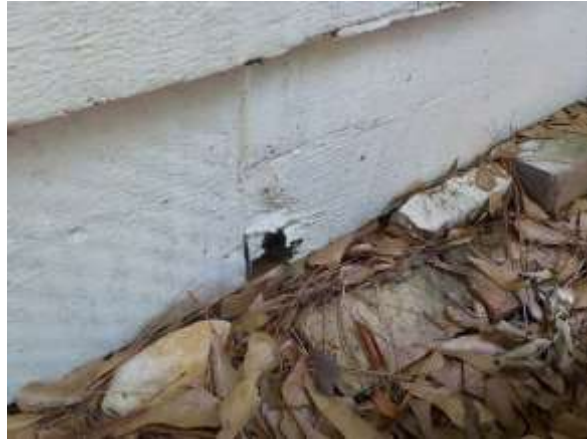
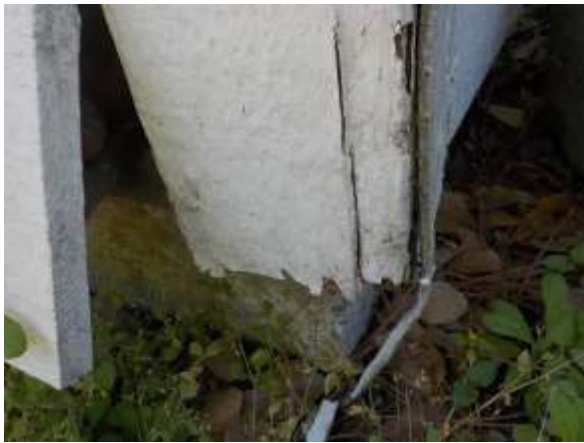
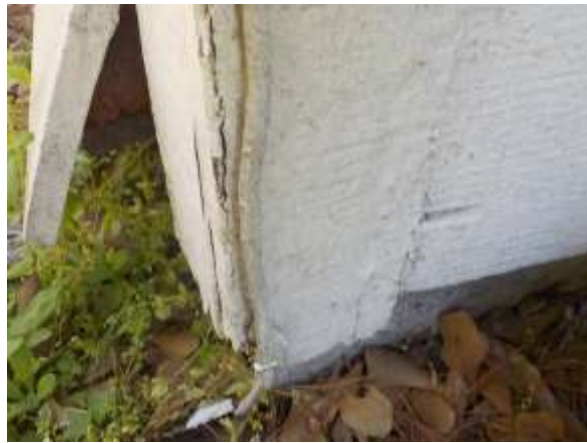
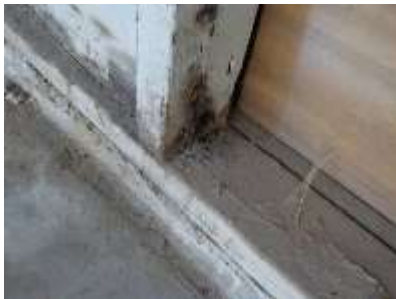
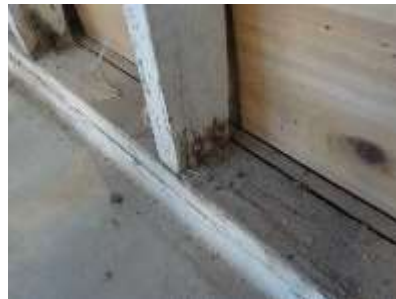
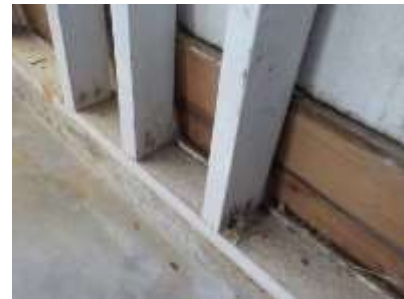
Wood rot was observed and it is recommended that the damaged wood be replaced. It is pointed out that additional damage could be present under the rotted material that will not be visible until the outer rotted materials are removed. Have a service company determine the entire scope of wood rot throughout the house, and provide a cost estimate to replace all rotted wood.

Locations included: front bay window, garage siding, garage siding trim, and bottom framing of the garage.

Obtain Cost Estimate

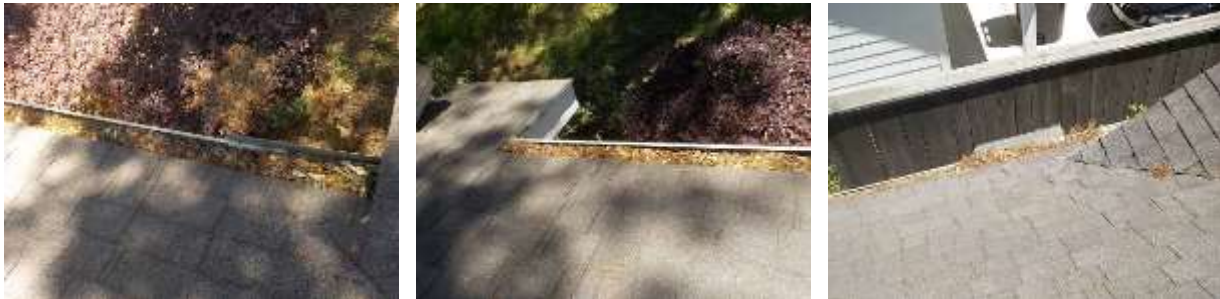
The gutters were observed to have debris in them and are in need of cleaning.

Obtain Cost Estimate

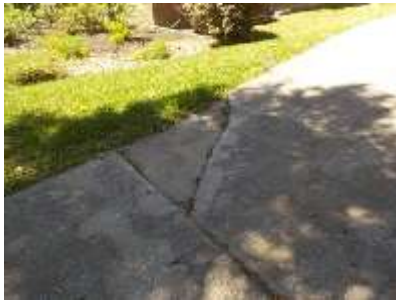
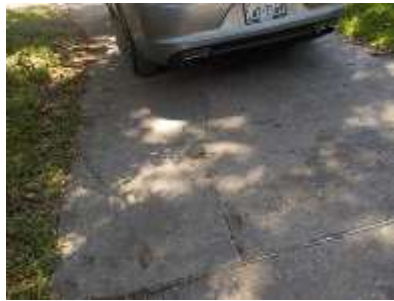
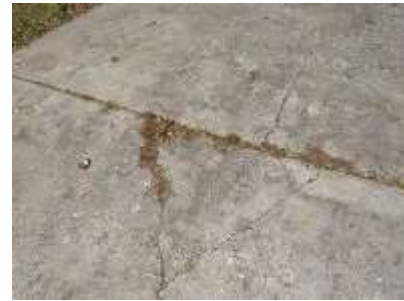
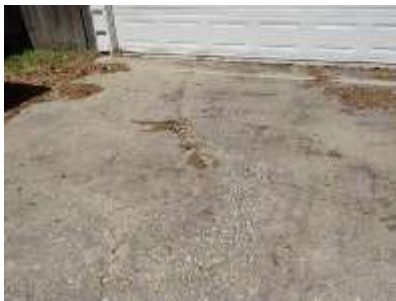
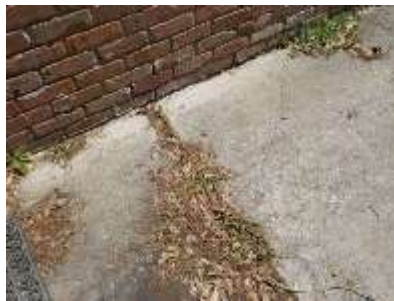
The driveway concrete was badly cracked, and the damaged portion presents a tripping hazard. It is recommended that a contractor be contacted to provide a cost estimate to make the needed repairs.

Obtain Cost Estimate
