PROPERTY INSPECTION REPORT

Concerning: **12710 Old Oaks Drive, Houston, TX 77024**

By: **David J. Koteles #22594**

4.10.19

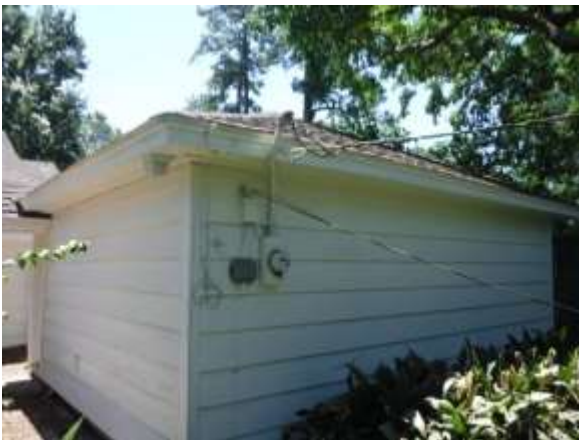
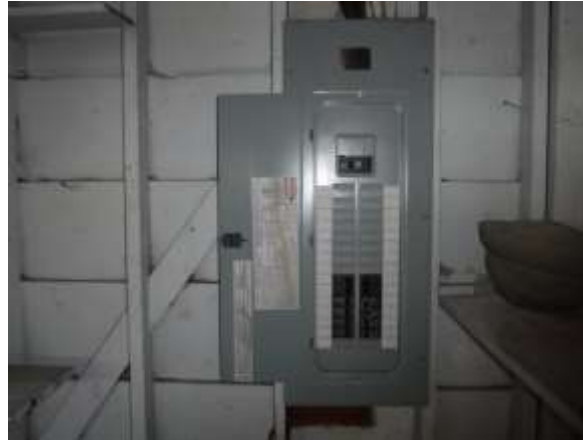
Type of Wiring: Romex

Type of System: 2 and 3-wire system

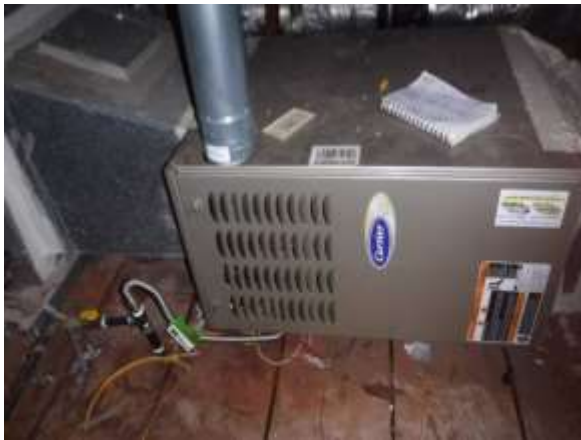
The heating for the house was provided by a natural gas-fired horizontal furnace located in the attic. The equipment was as follows:

<u>Manufacturer</u>	<u>Size</u>	<u>Date</u>	<u>Location</u>
Carrier	88,000-BTU	2014	Attic

The furnace was operationally checked at the time of the inspection, and no repairs were indicated to the operation of the furnace.

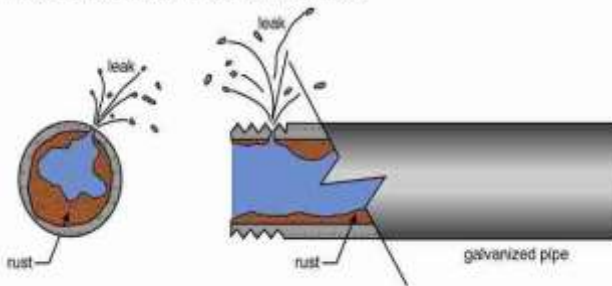
rusting of galvanized pipe can greatly reduce water pressure and will eventually cause leaks as rust creates holes in the pipe walls

problems are likely to occur soonest on pipes carrying hot water, horizontal pipes and at threaded (thinner) sections

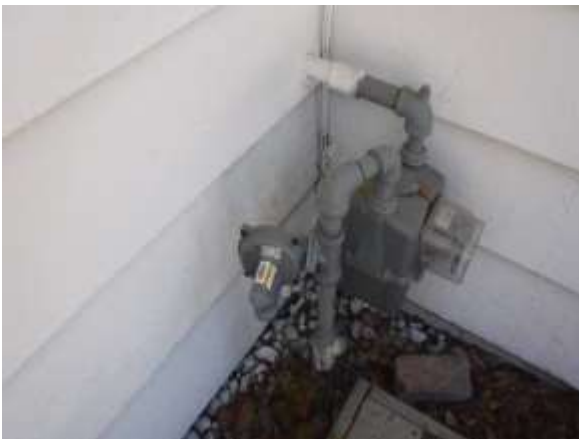
Gas Lines

The gas meter, with the main shut off valve for the gas to the house, was located at the rear of the house.

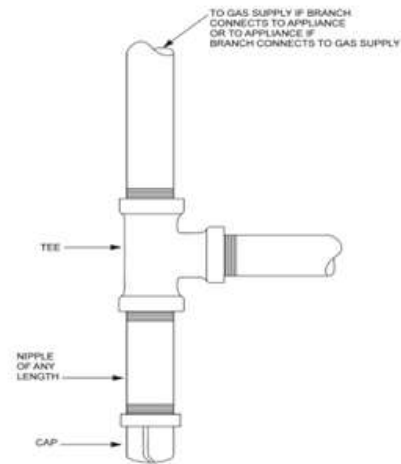
Clip art showing a sediment trap in gas line

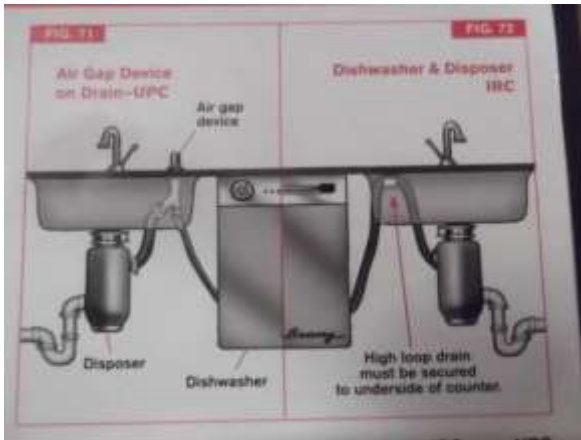
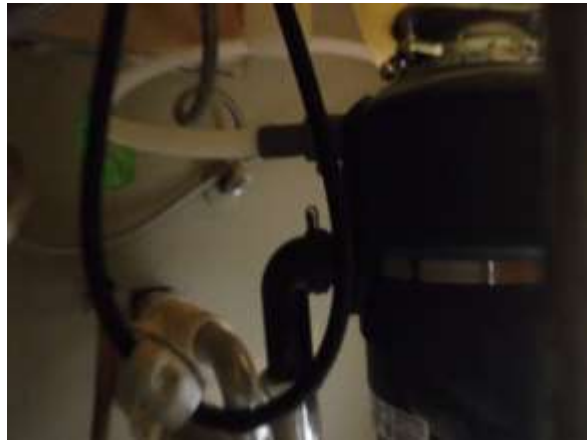
No items requiring repair were visible at the time of the inspection for the operation of the dishwasher. The drain line under the sink was looped up so that the top of the loop was higher than the point where the drain line connected to the disposal. This will help to prevent garbage from running down the drain line into the dishwasher. The dishwasher should be adjusted to be flush with the adjacent cabinets.

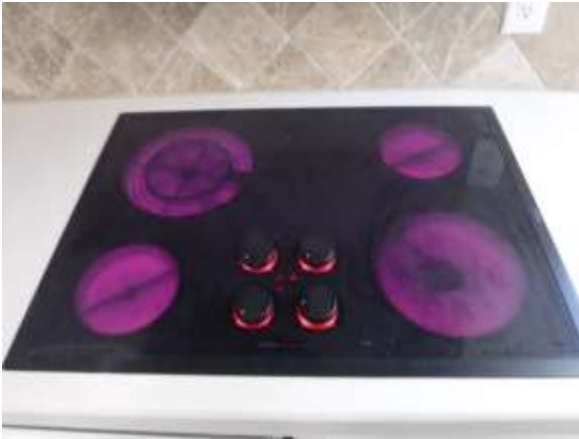
Electric Cooktop

No items requiring repair were visible for the operation of the electric cooktop. All of the elements and controls were operating properly at the time of the inspection.

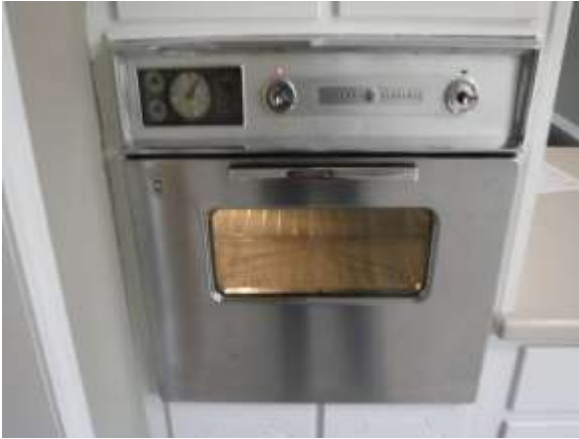
Electric Oven

The oven was functional at the time of the inspection. However, due to the age and/or condition of the equipment, it is the opinion of the inspector that it has only a limited amount of life remaining.
