2411 Dabney Manor Ct.
Katy, TX 77449

PROPERTY INSPECTION REPORT

Concerning: 2411 Dabney Manor Ct., Katy, TX 77449
(Address or Other Identification of Inspected Property)

By: Nicholas Jones, Lic #9019 11/01/2018
(Name and License Number of Inspector) (Date)

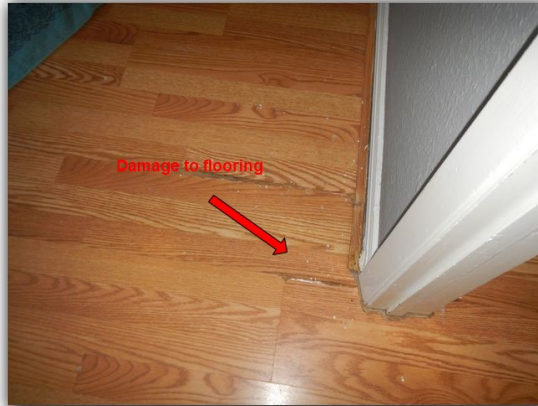
Note: Cosmetic defects are not a part of the scope of a T.R.E.C. inspection. However, cosmetic defects are sometimes included as they may be a symptom of conditions that are part of a T.R.E.C. inspection such as leaks and water penetration.

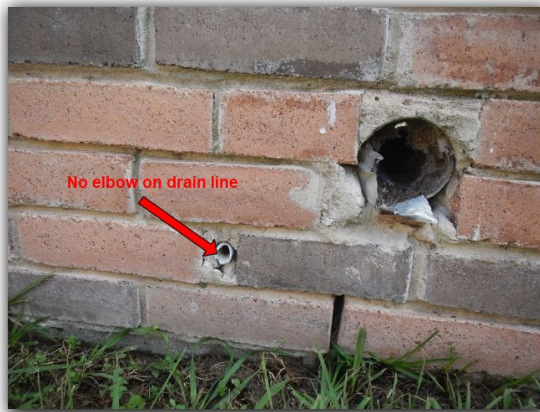
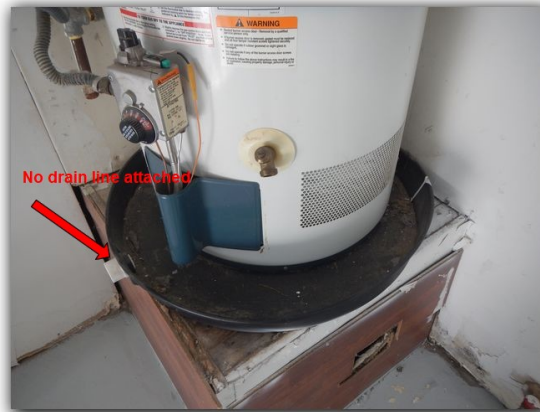
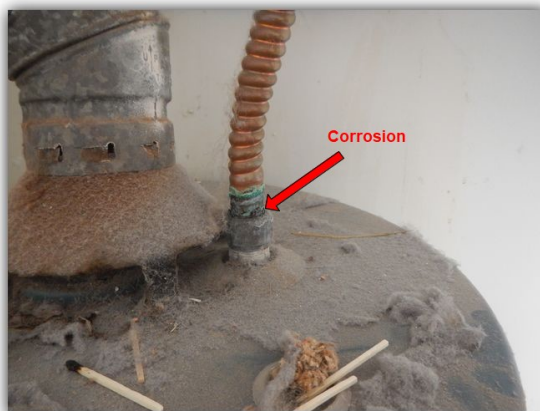
The water heater was observed to be performing as intended at the time of inspection.
