Inspection Report

PROPERTY INSPECTION REPORT

Concerning: 645 Davis Rd., League City, TX
(Address or Other Identification of Inspected Property)

By: Brad Leland, Lic #TREC #5229 10/04/2017
(Name and License Number of Inspector) (Date)

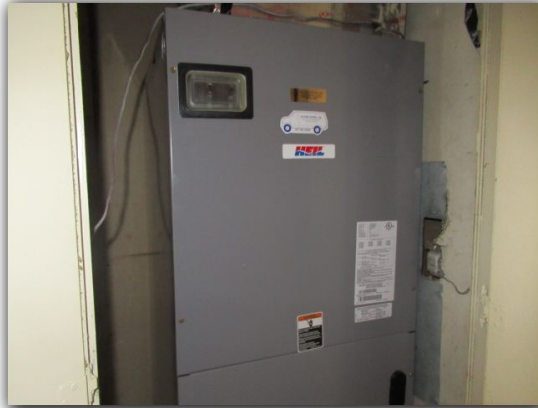
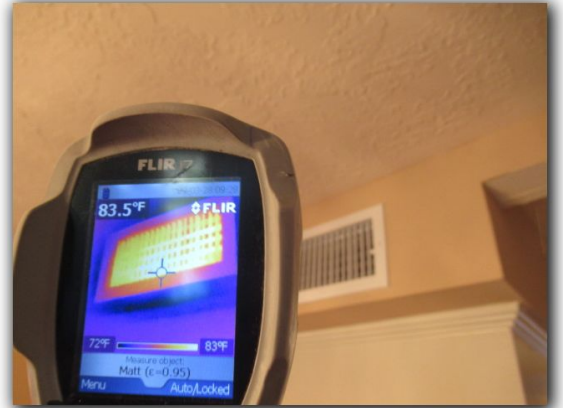
Comments: The heating equipment was performing properly.

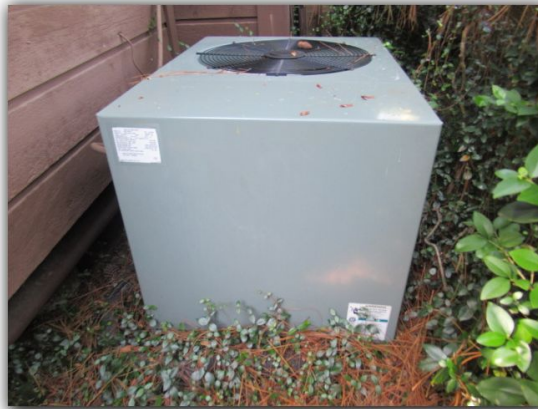
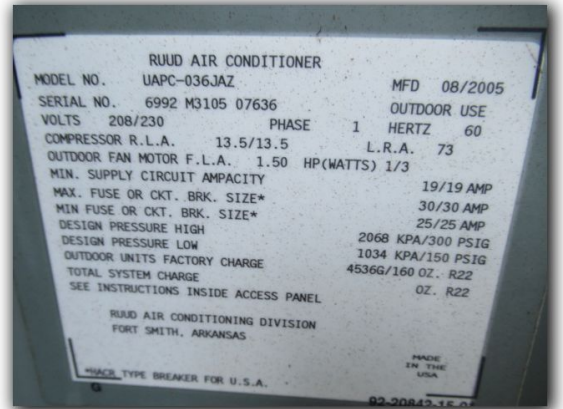
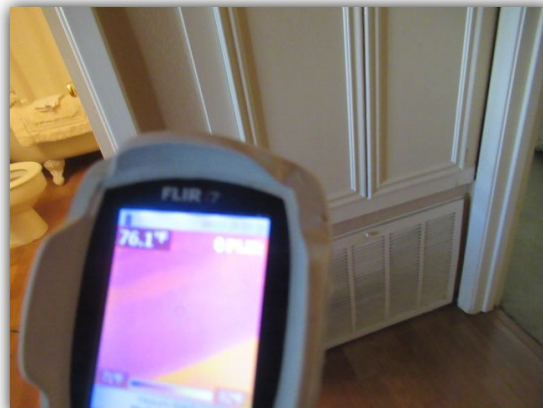
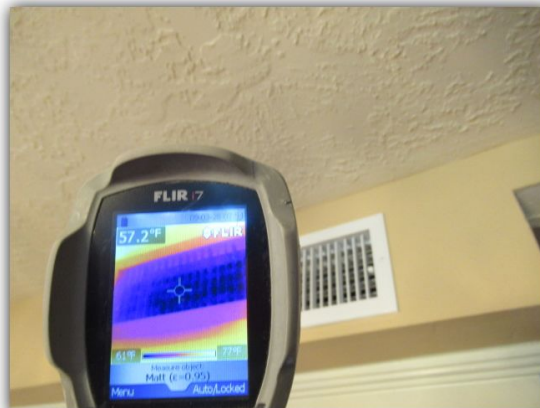
Differential Air Temperature Drop During Operation:
Air Going Into System: 76 f Returned Air: 57 f

The air coming out of the vents should be 14 to 21 degrees cooler than where it goes into the cold air return. These readings are within the recommended tolerances for proper operation.

Comments: The AC system was performing properly, no defects noted.

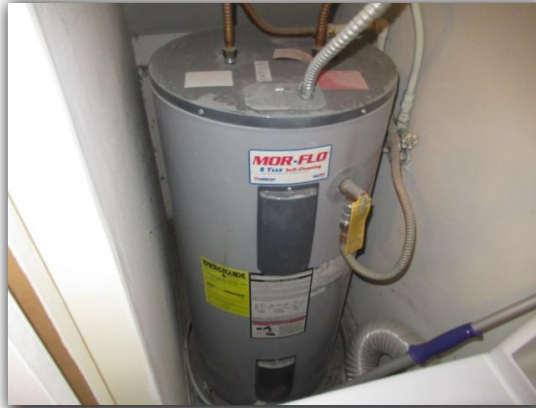
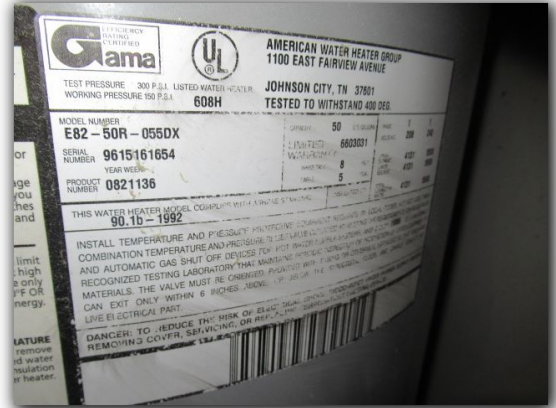
Note: The inspection does not check the operation of the temperature & pressure relief valve(s) since valves appear to be over 3 years old and manufacture recommends replacement of TPR valves over 3 years of age. Malfunction of the valve during testing could result in loss of use of unit as the valve may stick and drain continuously.

Comments: The temperature and pressure relief valve should drain into a line that is plumbed to the outside and may go horizontally or down, but cannot go back up. (This keeps debris from going back to the valve) This line can be 3/4" C.P.V.C Plastic (not reduced in size) and should terminate from 2 to 6 inches from the ground.

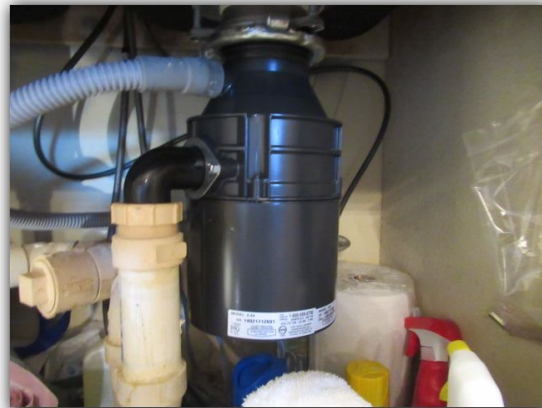
Comments: Appears to be performing properly at this time.
