HEDDERMAN SERVICES

MECHANICAL INSPECTION

11010 Wickersham Ln
Houston TX 77042

MARCH 4, 2021

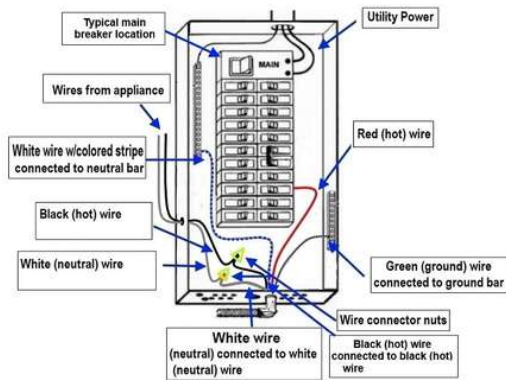
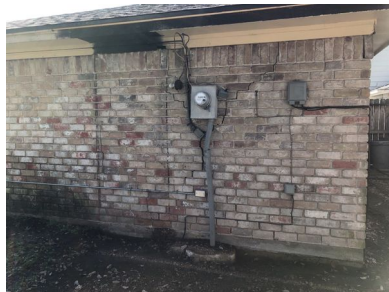
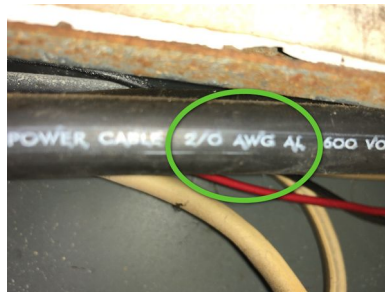
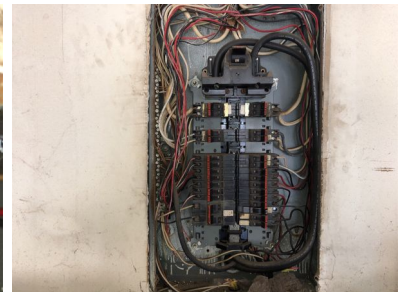
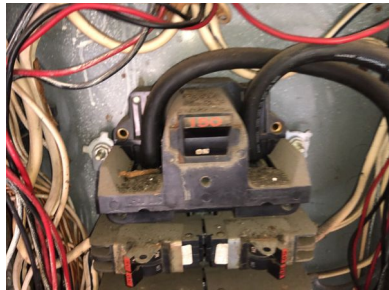
Circuit Breaker Wiring Diagram

The breaker panel(s) did not contain any Arc Fault Circuit Interrupters (AFCI). This is an “as-built” condition, that does not meet current building code standards. AFCI devices are intended to protect against fires caused by electrical arcing in the wiring, by shutting off the power to the circuit when an electrical arc is detected in the circuit. Homes built prior to 2002 were not required by the National Electrical Code (NEC) to be protected by AFCI devices. Since this home was built prior to 2002, the breaker panel is not required to be retrofitted with new AFCI breakers. If adding AFCI breakers is desired, it is recommended that you contact an electrician for further information.

The manufacturer's data sticker was missing or illegible and we could not determine the rating of the breaker panel. It is recommended that an electrician be contacted to evaluate determine if the panel is adequately rated for this application.

Further investigation is recommended

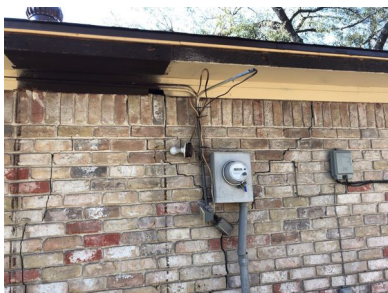
North exterior

A light fixture was hanging by its wires.

Obtain Cost Estimate

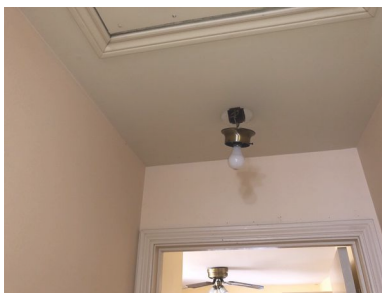
2nd Floor Hallway

A portion of the electrical wiring was exposed where electrical conduit was not properly or not completely installed.

Obtain Cost Estimate

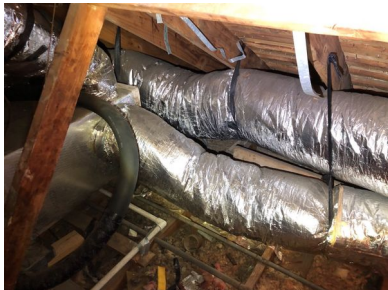
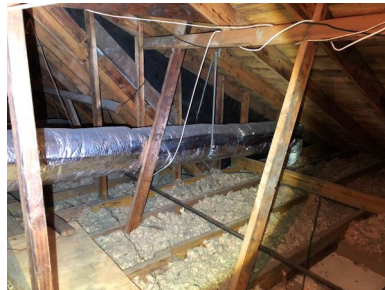
1: Ducts - No clearance between ducts

We observed that some of the air ducts in the attic were in contact with each other, which can cause condensation to form on the outside of the ductwork. It is recommended that the ducts that are touching be separated. Typically, this is done by inserting a piece of fiberglass batt insulation or duct board between the ducts.

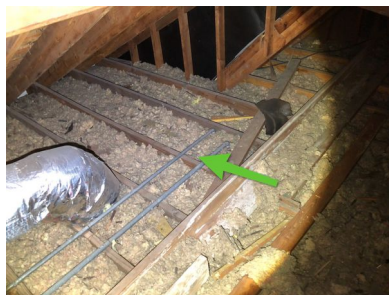
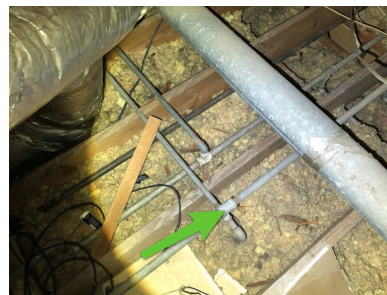
1: Water Pressure Low

The water pressure was lower than normal, and the source of the problem was not apparent at the time of the inspection. It is recommended that a service company find the source of the problem and provide a cost estimate for any necessary repairs.

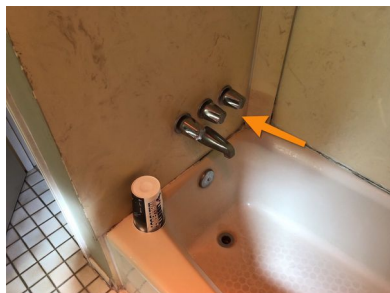
A drip leak that needs to be repaired was observed at a faucet.

Obtain Cost Estimate

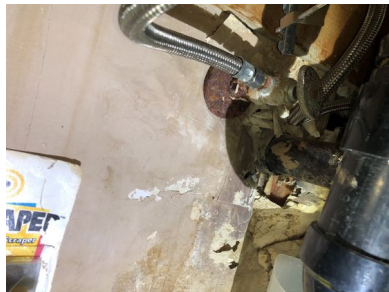
Master Bath

The water supply line and/or shut off valve was significantly corroded and should be replaced.

Obtain Cost Estimate

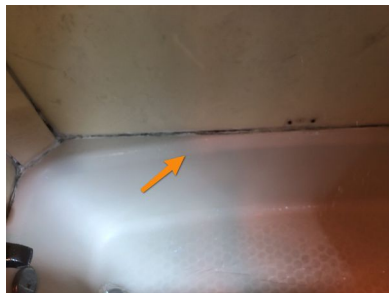
7: Tub - Caulk needed

The tub needs to be caulked.

Obtain Cost Estimate

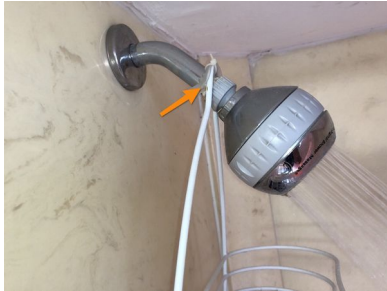
2nd Floor Bathroom

The shower head was leaking at the connection and needs to be repaired.

Obtain Cost Estimate

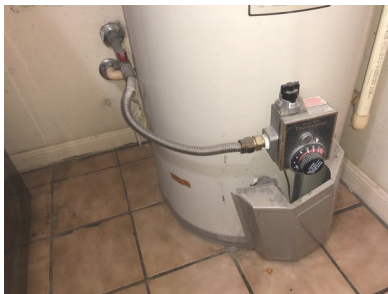
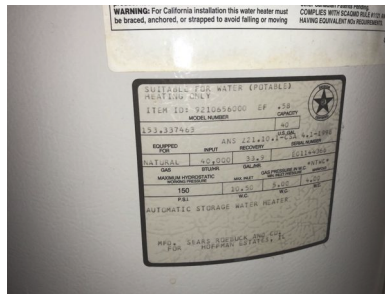
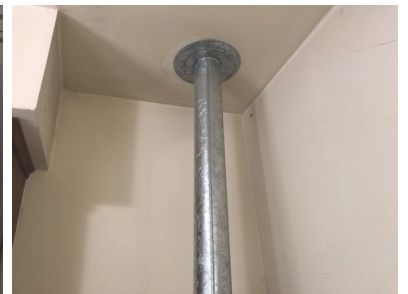
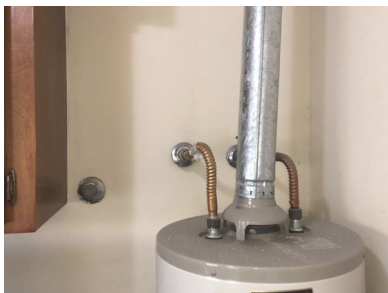
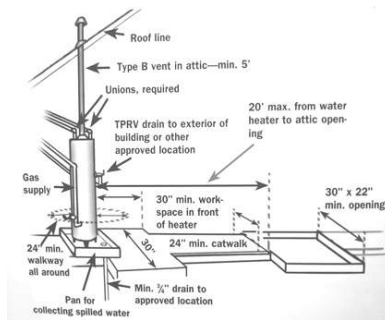
The hot water for the property was provided by the following natural gas fired gas water heater(s):

<u>Location</u>	<u>Brand</u>	<u>Capacity</u>	<u>Age</u>	<u>Energy Type</u>
Utility	Kenmore	40 Gal	2001	Gas

Due to the age and/or condition of the equipment, it is our opinion that the equipment has only a limited amount of life remaining. Normal life expectancy for a water heater in the Houston area is approximately 10-12 years.

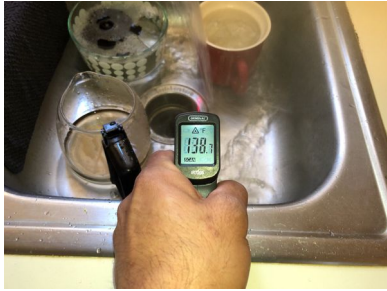
The generally recommended maximum temperature setting for a hot water heater, to prevent accidental scalding, is 120-125 degrees. It is recommended that the water heater thermostat be adjusted to and maintained in this temperature range.

The temperature of the hot water at the kitchen sink was 138 degrees.

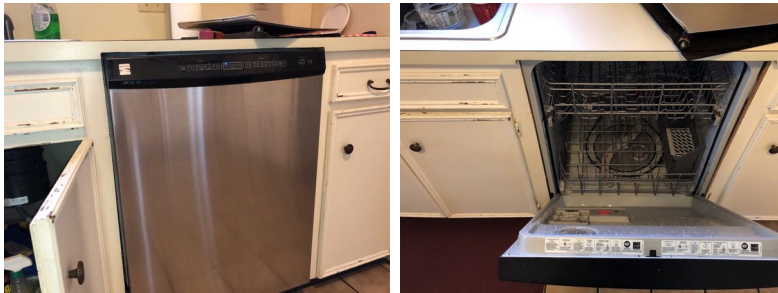
1: No Anti-Siphon

The drain line under the sink was not equipped with an anti-siphon device, nor was it looped up so that the top of the loop is at least six inches above the entrance of the drain line into the disposal. It is recommended at least that the drain line be looped to prevent the water from the garbage disposal from siphoning back into the dishwasher, or an anti-siphon device installed.

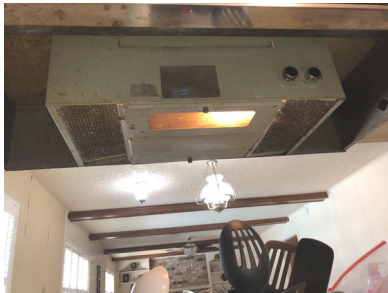
1: Grease Filter - dirty

The grease filter was dirty and needs to be cleaned.

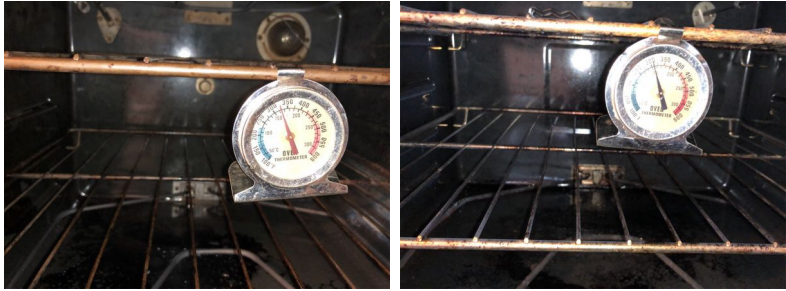
1: Ovens - One improperly calibrated

Both oven thermostats were checked, and one was properly calibrated, and the other was not properly calibrated. The thermostats were set at 350 degrees, and the upper lower oven did not heat to within the allowable ± 25 degrees. The ovens were checked with an oven thermometer, and the upper oven was found to heat to 325 degrees, and the lower oven to 310 degrees.

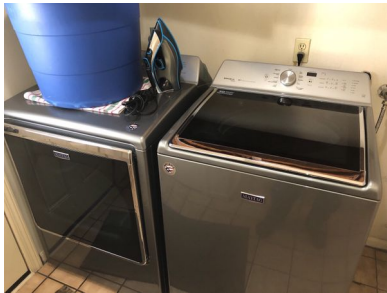
The vent was connected to the dryer but was not tested. It is recommended that the vent be checked for an excess of lint and that it be cleaned if necessary. (Information)

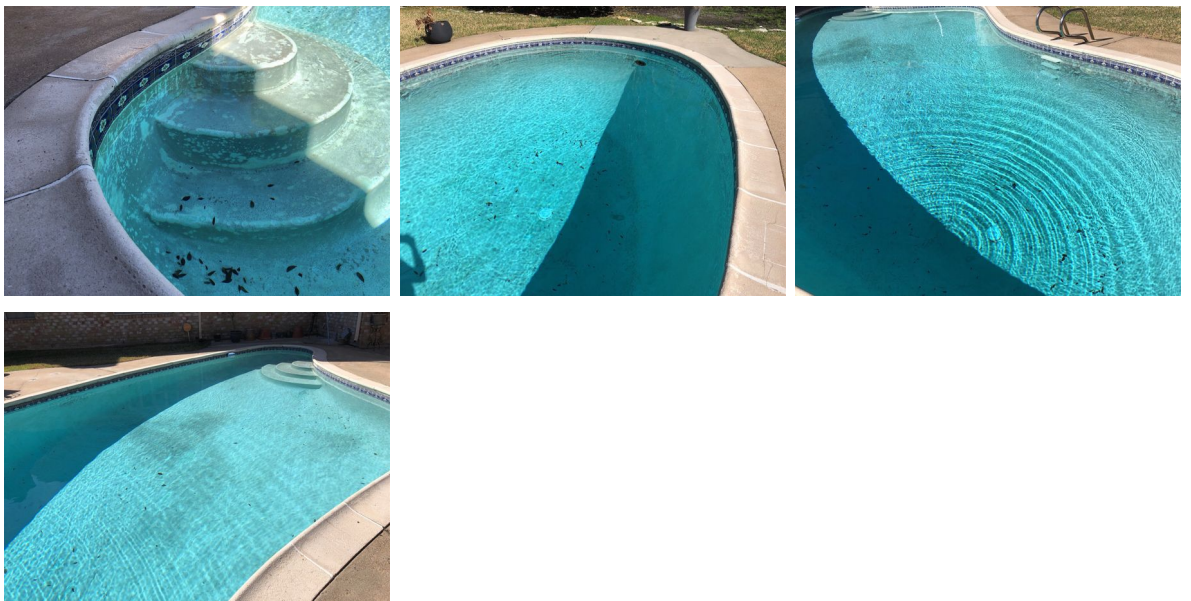
Pool Surface - limited life:

The surface of the pool was beginning to spall, and the plaster finish has only a limited amount of remaining life. It can be anticipated that the pool will need to be replastered in the next few years.

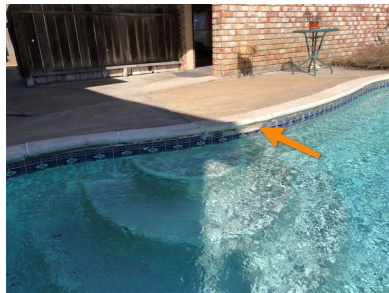
1: Water Tiles - Missing/Damaged

The waterline tiles were cracked or damaged and need to be repaired or replaced.

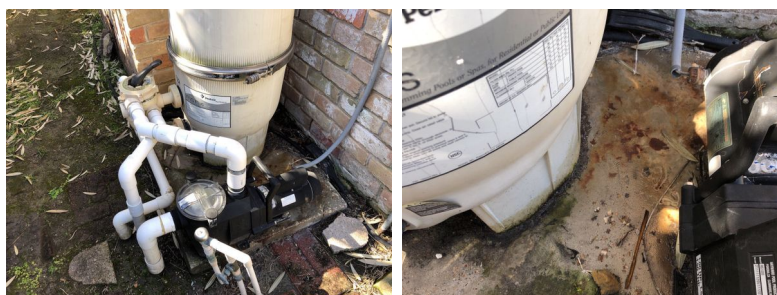
4: Leak at Equipment

Evidence of a leak was observed where the pad under the equipment was wet. It is recommended that a service company be contacted for further investigation and to make any needed repairs

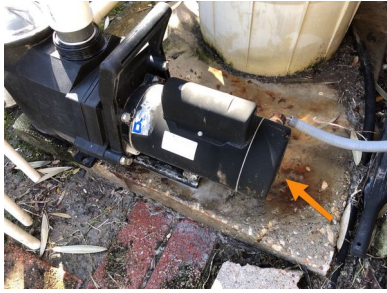
5: Casing - Not bonded

The exterior metal casing on the motor was not properly bonded.

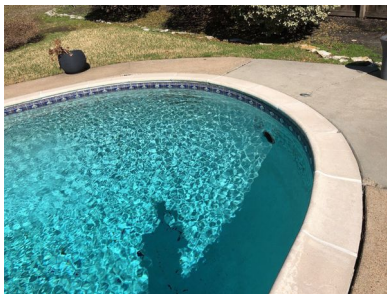
The light was nonfunctional at the time of the inspection. When the light is repaired, the service company should verify that it is protected by the Ground Fault Circuit Interrupt device.
