HEDDERMAN SERVICES

STRUCTURAL INSPECTION

11010 Wickersham Ln
Houston TX 77042

MARCH 4, 2021

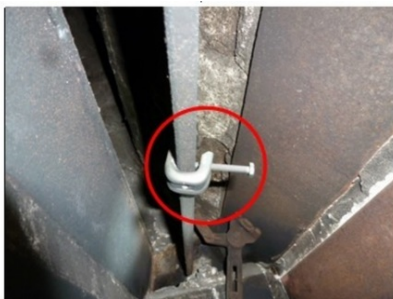
HEI file photo showing c-clamp in masonry fireplace

HEI file photo showing c-clamp in metal fireplace

The fireplace was equipped with a ceramic gas log. The smoke chamber and flue pipe were free from built-up soot, the damper was operational, and the firebox was properly sealed. While the draw of the chimney was not able to be checked, no evidences of poor draw were visible, and no repairs were needed to the fireplace. It is pointed out that the damper was not equipped with a spacer device to prevent the damper from closing completely. This device keeps the damper open slightly, even when it is in the closed position, to prevent combustion gases from building up in the living space should the gas log be operated when the damper is closed. It is recommended that the clamp be installed for safety purposes.
