PROPERTY INSPECTION REPORT

Juliana Maldonado	
(Name of Client)	
229 Cunningham Fir Trail, Conroe, TX	
(Address or Other Identification of Inspected Property	y)
Ali Quiroz / TREC #23448 / Key Rose Inspections LLC	12/2/2020
(Name and License Number of Inspector)	(Date)
	(Name of Client) 229 Cunningham Fir Trail, Conroe, TX (Address or Other Identification of Inspected Propert Ali Quiroz / TREC #23448 / Key Rose Inspections LLC

Report Identification: 229 Cunningham Fir Trail

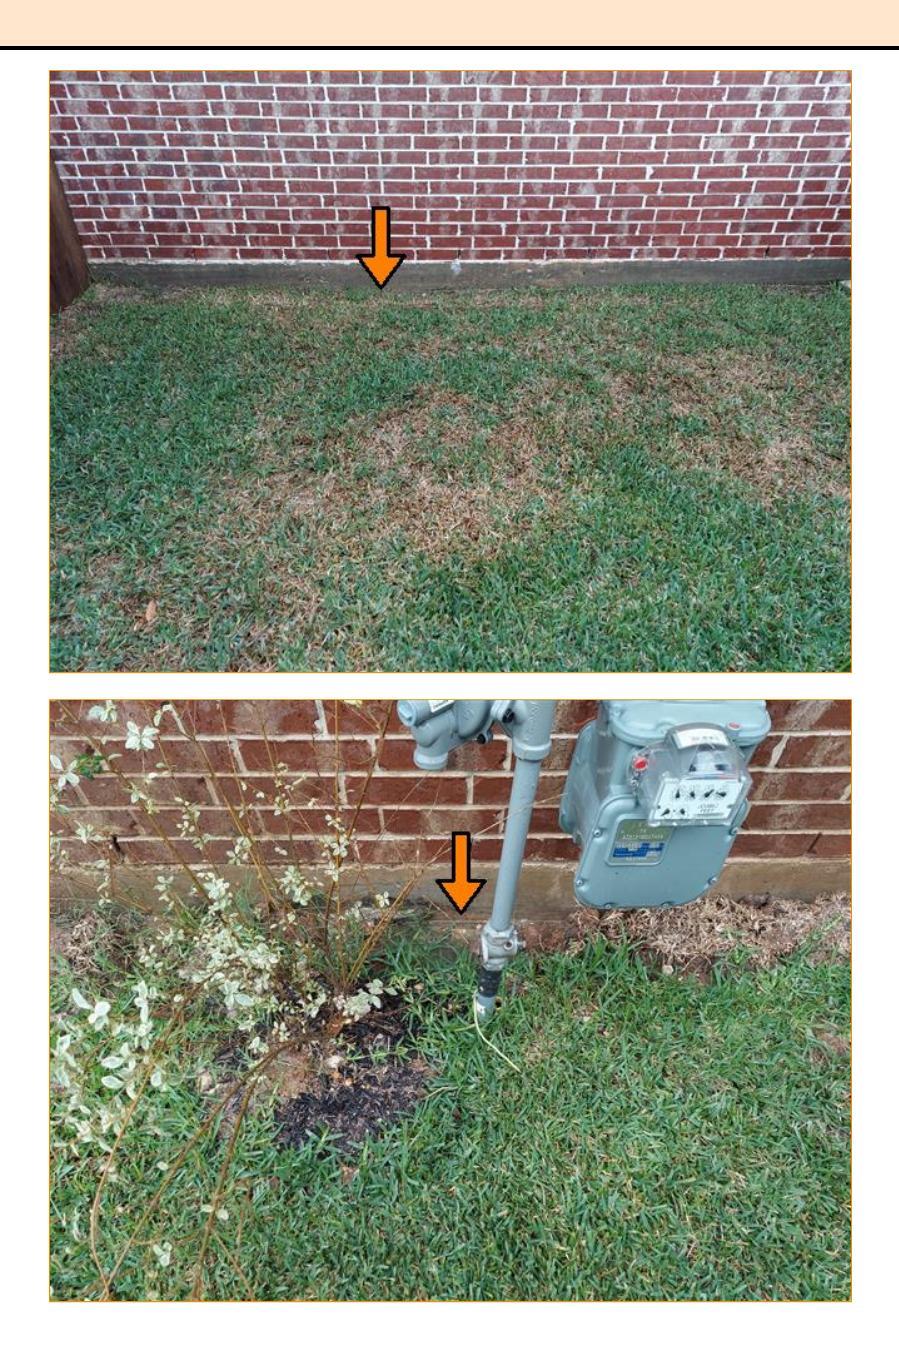
Depressions and/or negative drainage (sloping back toward the building) in the landscape around the home can cause improper drainage and contribute to puddles & standing water that can consequently cause deterioration of materials, erosion and breeding grounds for mosquitos.

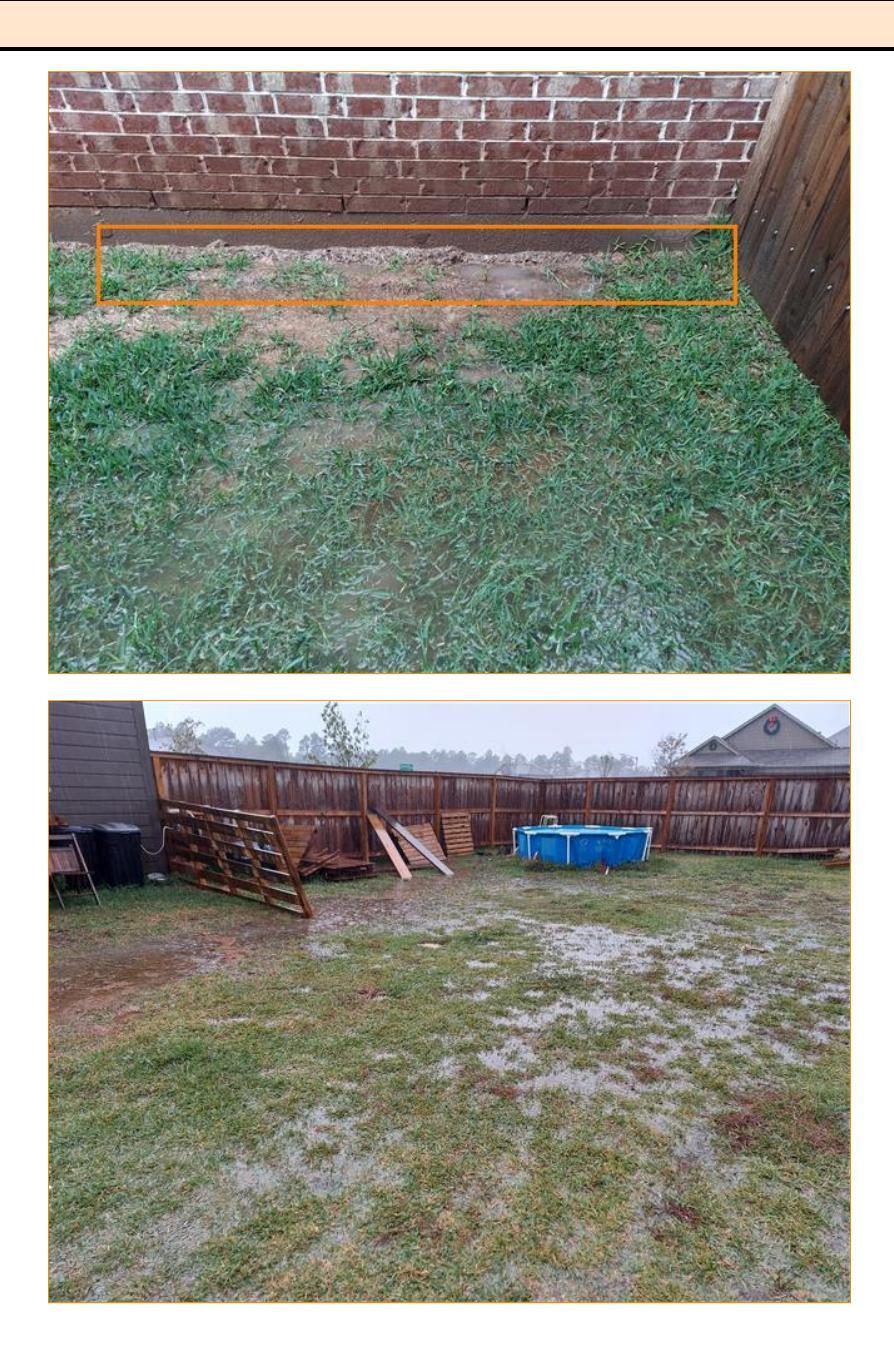
Planter/Garden FYI: Vegetation beds can trap moisture onto the exterior components/foundations from continued saturation of the ground. In addition, flower/garden beds should not interrupt the 6" per 10' drainage rule to divert water away from the home.

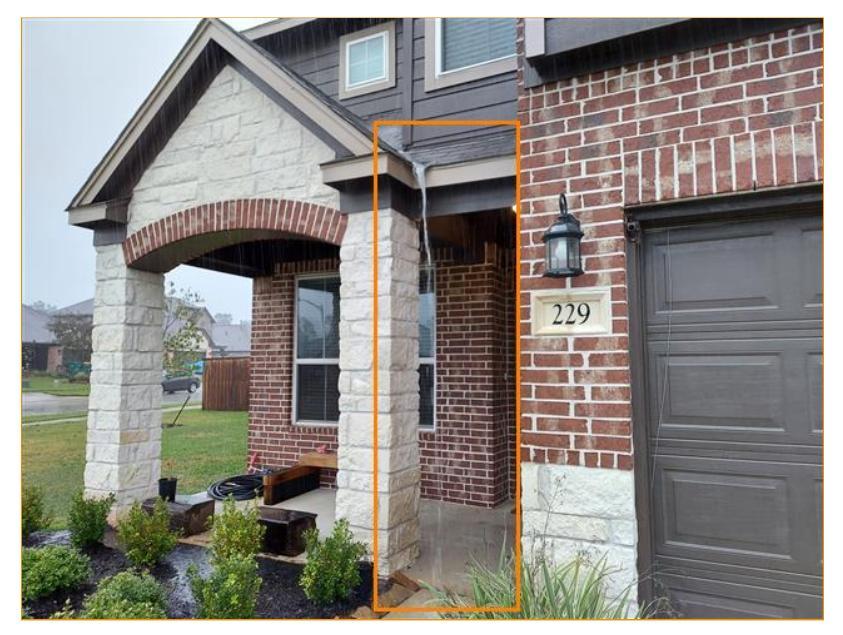
Some type of complete and proper guttering system is recommended all around the house as to create controlled drainage away from the building. Ideally, gutters should terminate away from the structure.

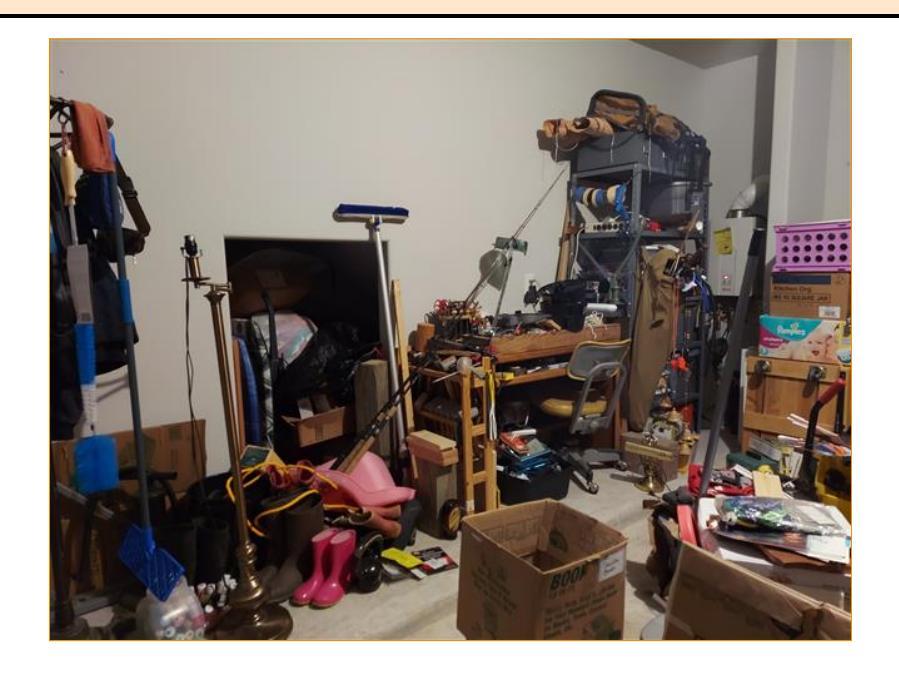
The fire wall for the property could not be properly inspected/fully evaluated due to belongings.

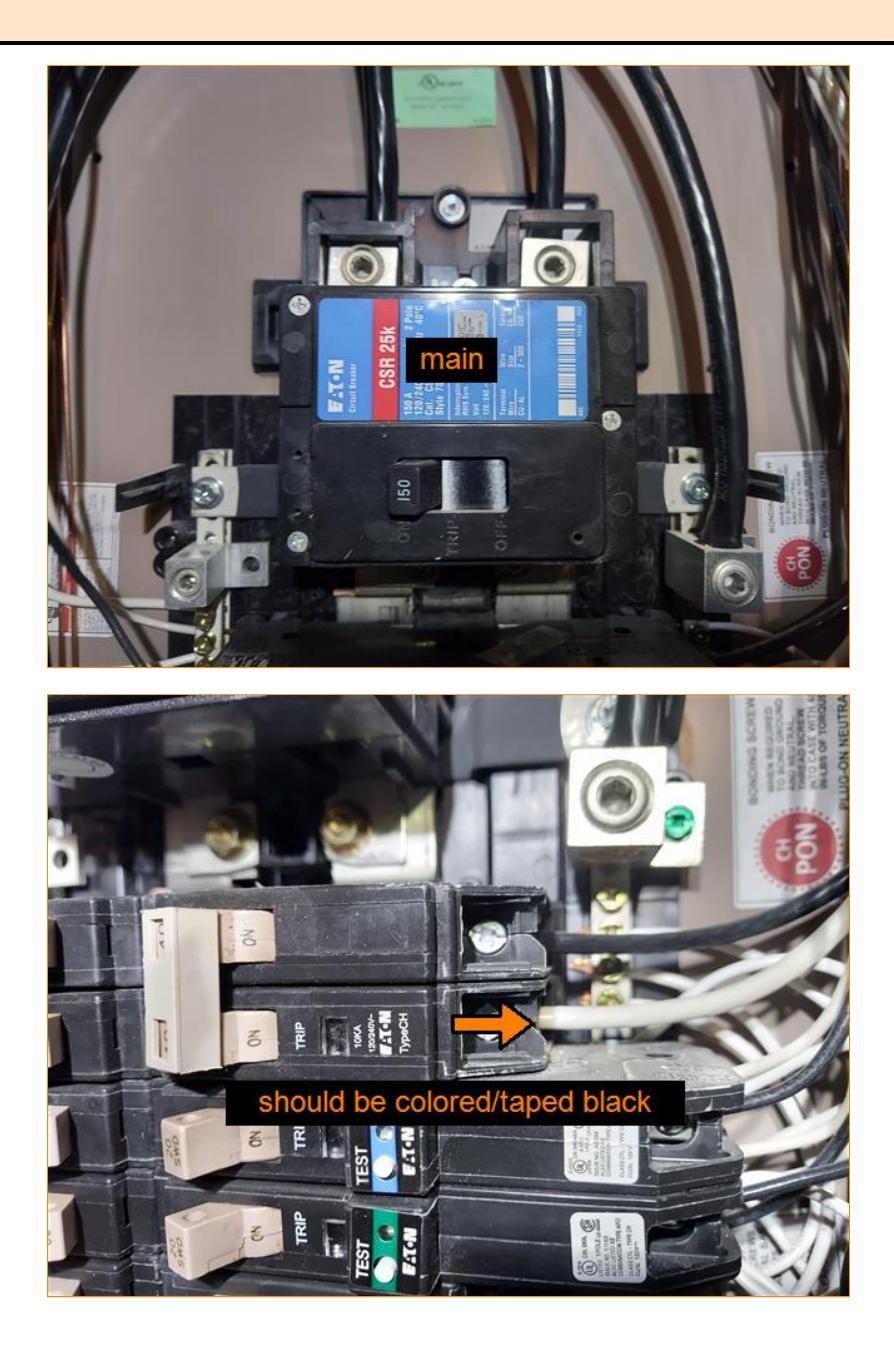
The main electrical panel had wires other than black/red used in hot/live slots without proper marking and occupant mentioned that the kitchen GFCI breaker would trip for no reason at times.

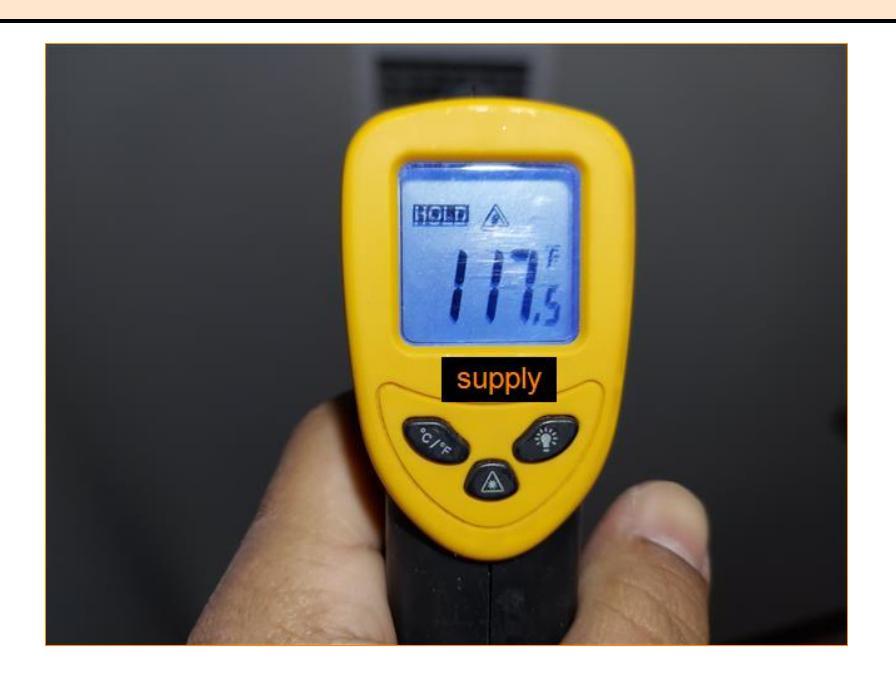
Attic furnace units should be maintenanced annually for optimal and safe use.

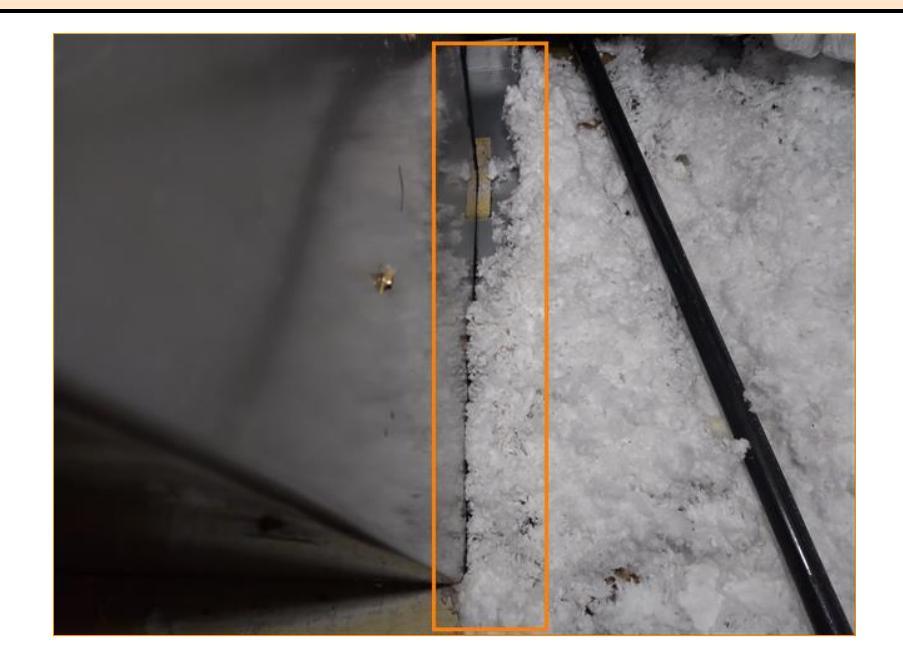
Location of Thermostat(s): Hallway Comments: The duct system had a sharp bend and/or kinked in areas which can restrict air flow.

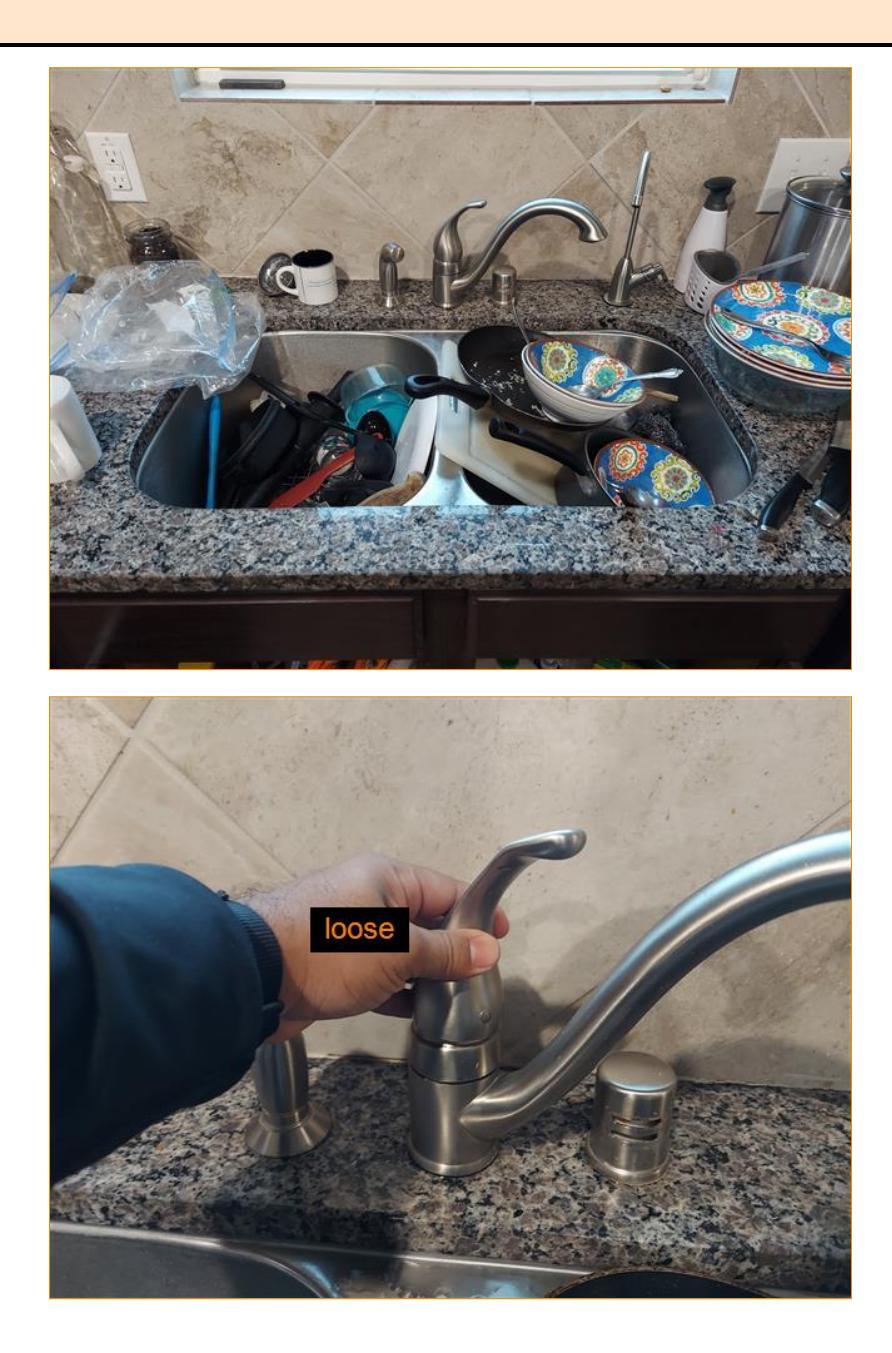
The kitchen sink and area had loose components and in need of sealant work.
