RESIDENTIAL INSPECTION REPORT

4622 Banning Dr
Houston TX 77027

Basim Shami
FEBRUARY 5, 2020

Inspector
Allen Lott TREC 7484
TREC Professional Inspector 7484
713-885-6000
alltex@alltexinspections.net

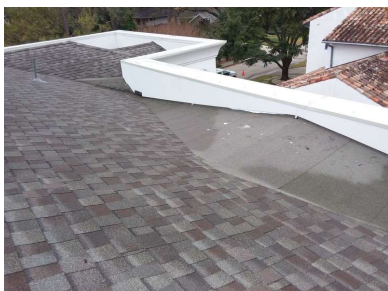
1: Damaged Coverings

Roof coverings exhibited general damage that could affect performance. Consider repair to prevent premature deterioration and/or moisture related issues.

Recommendation: Contact a qualified roofing professional.

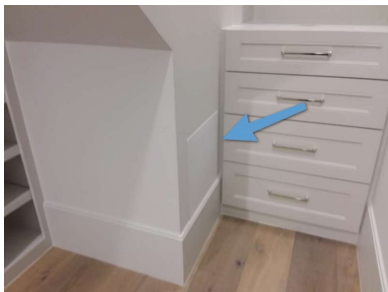
The fireplace direct vent appliance had low clearance to a combustible surface. Manufactures installation guidelines were not available at the time of this inspection. Recommend verifying allowable clearances to vertical and horizontal surfaces prior to use.

Recommendation: Contact a qualified fireplace contractor.

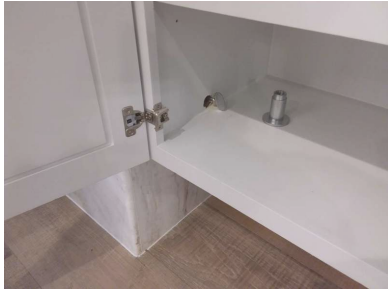
The gas valve did not have proper clearance to allow proper operation. The cabinet will need to be modified to allow proper access.

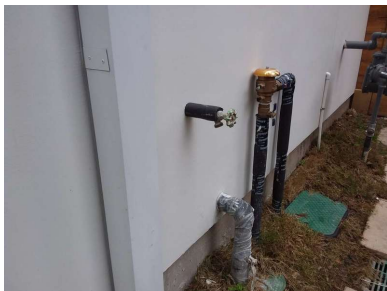
Anti siphon devices not present or improperly installed. Anti siphon / backflow prevention devices are vacuum breakers that prevent contaminated water from entering the potable water system. Items may be purchased at any hardware store and screwed in place before installing a hose.

Recommendation: Contact a handyman or DIY project

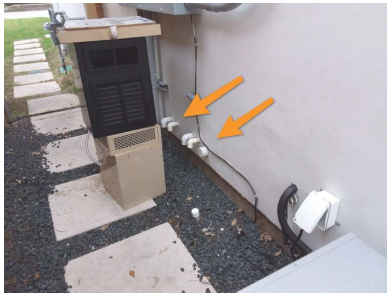
The discharge line extension is missing or too short. If the valve extension is higher than 6" from the floor and the valve opens, the discharge may cause injury to anyone in this area. Current standards require the relief valve should be piped to a maximum of 6 inches above grade.

Recommendation: Contact a handyman or DIY project

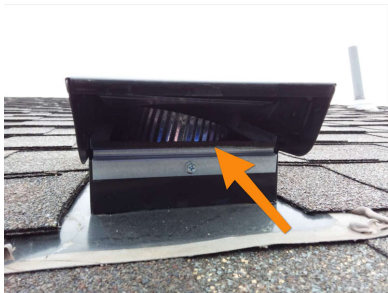
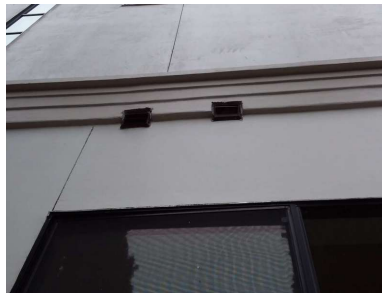
The ventilation exhaust flue cap or cover was missing, damaged or improper. Current standards require the exhaust flue to be equipped with a backdraft damper door to prevent pest intrusion when the unit is not operating.

The exhaust vent prevent the operation of the damper door at the roof penetration.

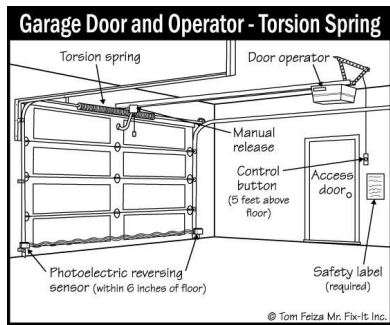
Safety reversing sensor is not mounted in its correct location. Safety reversing sensors should be installed no higher than 6 inches above the garage floor to protect children and pets.

Recommendation: Contact a handyman or DIY project

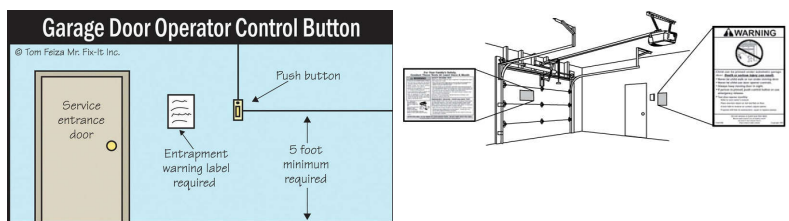
2: Warning Labels

Required overhead door and/or gate automated closure warning labels are missing/deteriorated.

Recommendation: Contact a handyman or DIY project
