**BPG Inspection, LLC**

**19059 Painted Boulevard  
Porter TX 77365**

Client(s): Carlson  
Inspection Date: 10/8/2020  
Inspector: Murray Campbell , TREC #22455

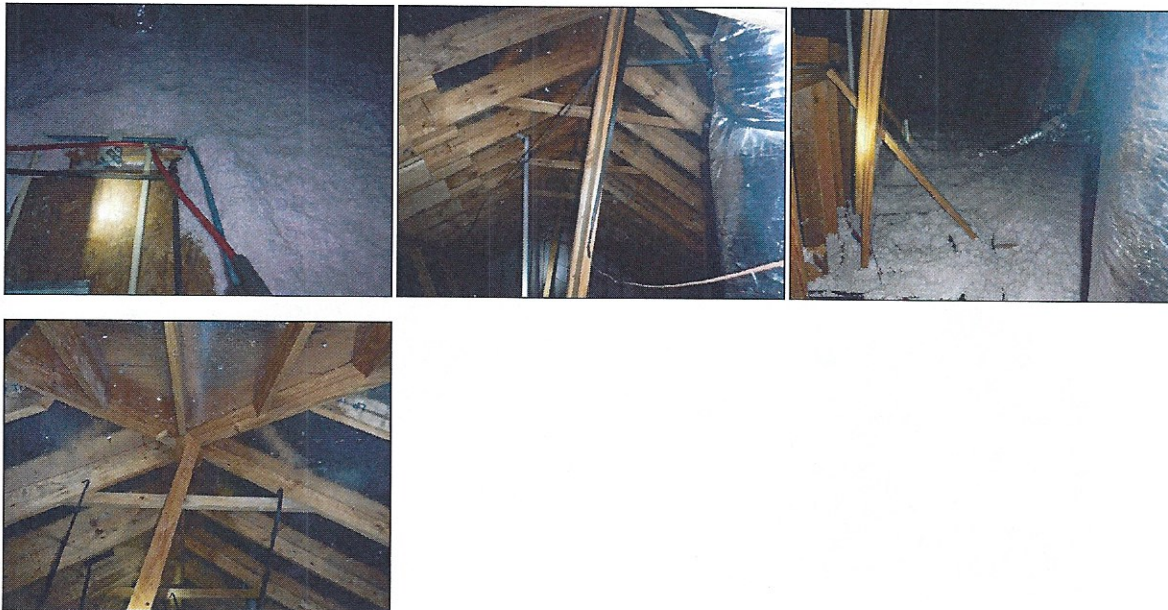
The structure was in good condition. No leaks were active or apparent at time of inspection. Insulation determined to be at acceptable levels/depths. At accessible areas inspected.

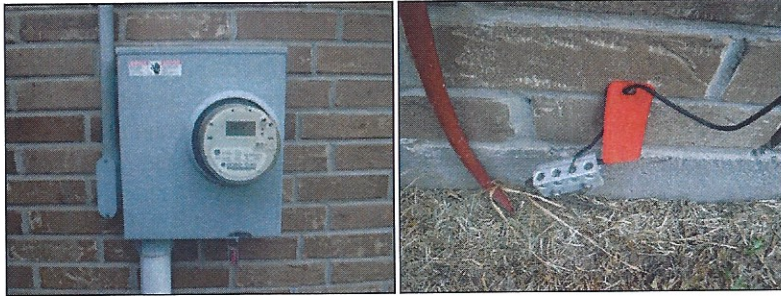
System panels installed correctly, grounded and bonded.

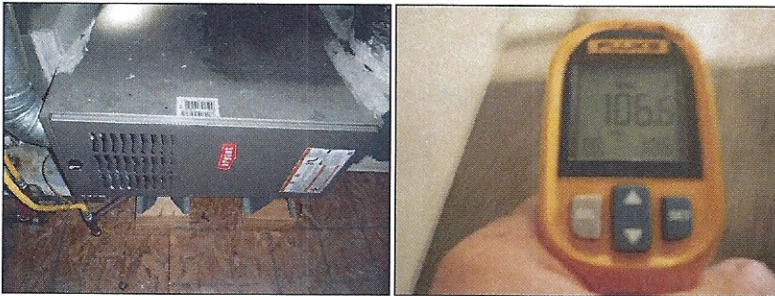
The unit functioned at the time of inspection. Proper heating operation is determined by at minimum of 100 degrees being supplied from all home supply grills.

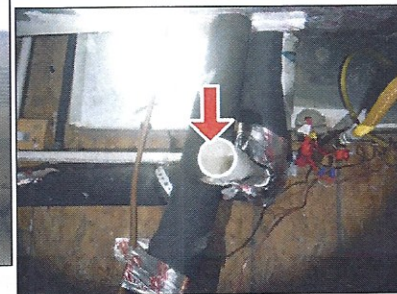
- 3. The cooling system plenum shows signs of past excessive moisture conditions (bio-growth stains). This is common for cooling systems that are installed in a interior closet, or even in the attic. Ensure air flow is not restricted (dirty filters) and the condensation drain line is periodically flushed to prevent drain line blockage. Consider having the unit serviced by a licensed HVAC technician.

The cooling system plenum shows signs of past excessive moisture conditions (bio-growth stains). This is common for cooling systems that are installed in a interior closet, or even in the attic. Ensure air flow is not restricted (dirty filters) and the condensation drain line is periodically flushed to prevent drain line blockage. Consider having the unit serviced by a licensed HVAC technician.

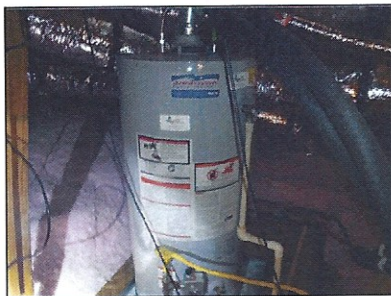
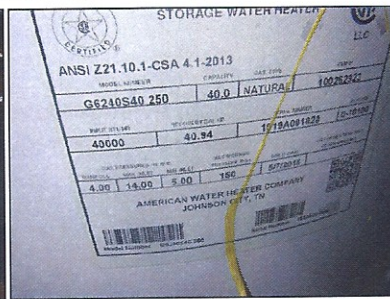
The water heater functioned normally at time of inspection.

Temperature readings at sinks were measured at a higher than suggested setting. The U.S. Consumer Product Safety Commission (CPSC) urges all users to lower their water heaters to 120 degrees Fahrenheit. In addition to preventing accidents, this decrease in temperature will conserve energy and save money. Most adults will suffer third-degree burns if exposed to 150 degree water for two seconds. Burns will also occur with a six-second exposure to 140 degree water or with a thirty second exposure to 130 degree water. Even if the temperature is 120 degrees, a five minute exposure could result in third-degree burns. Consumers should consider lowering the thermostat to the lowest settings that will satisfy hot water needs for all clothing and dish washing machines.
