## **INSPECTION GROUP**

Property Inspection Report #3/29/202210157 East Kemp Forest Drive  
8616 Daffodil St. Houston, TX 77063

## PROPERTY INSPECTION REPORT FORM

10157 East Kemp Forest Drive, Houston, TX 77080

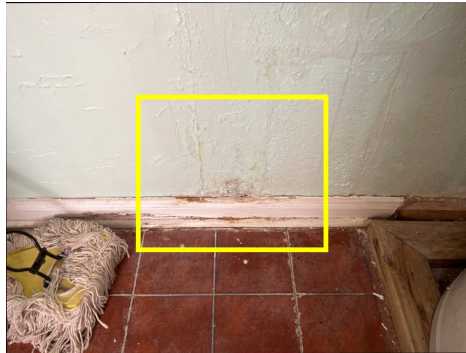
Water stains observed in utility room, moisture meter indicated that stains are not active (wet) at the time of inspection.

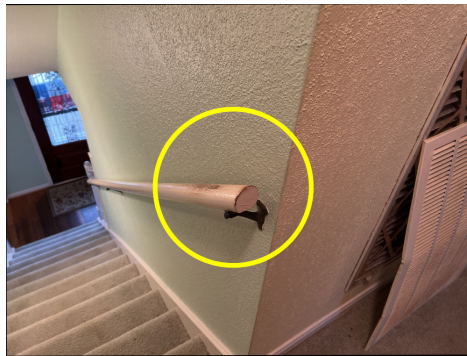
Hand railing should return to the walls as per current building code.

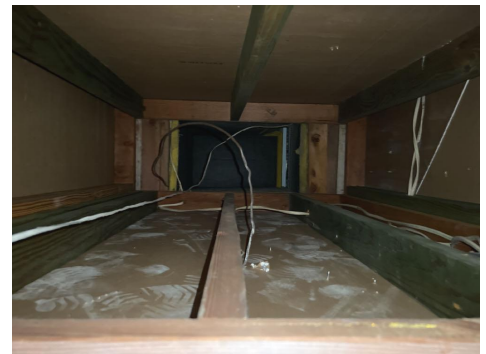
The return air chase is not properly sealed.

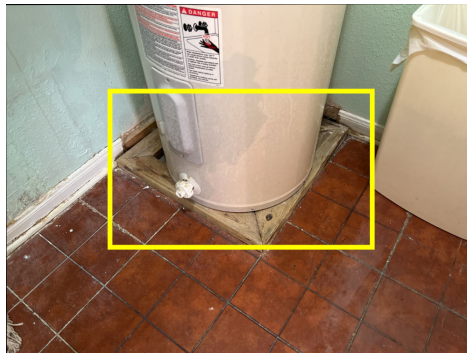
No drain pan under the water heater in utility room.
