## HEDDERMAN ENGINEERING, INC.

REF: CONDITION OF PROPERTY SURVEY

At your request, a visual survey of the house located at 8706 Lupton Lane, Houston, Texas, was made by Mr. Javier Almodovar and Mr. Daniel Koteles.

**8706 Lupton Lane**

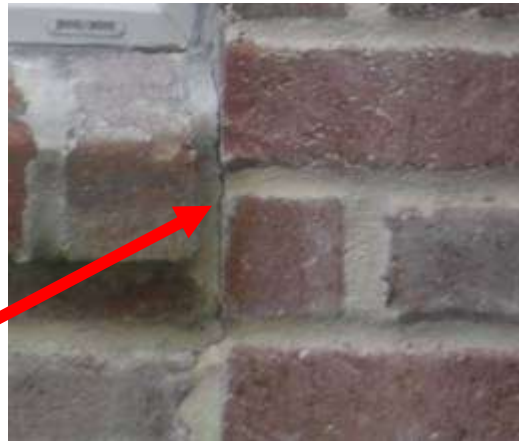
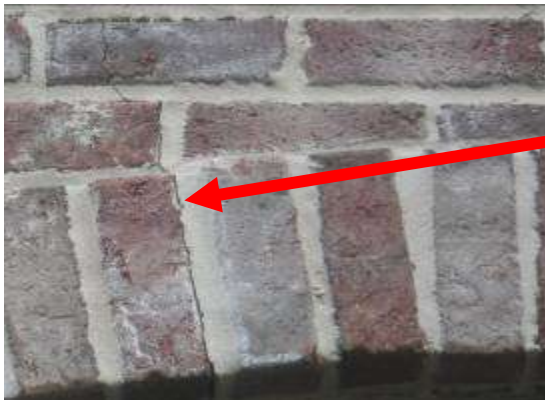
Front of the house

Cracks in the exterior veneer were minimal in number and degree. It is recommended to repair all the visible cracks.

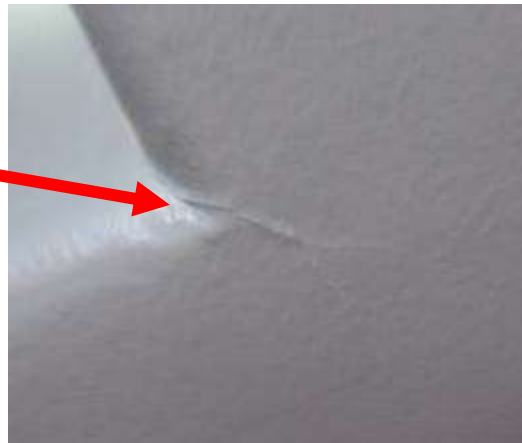
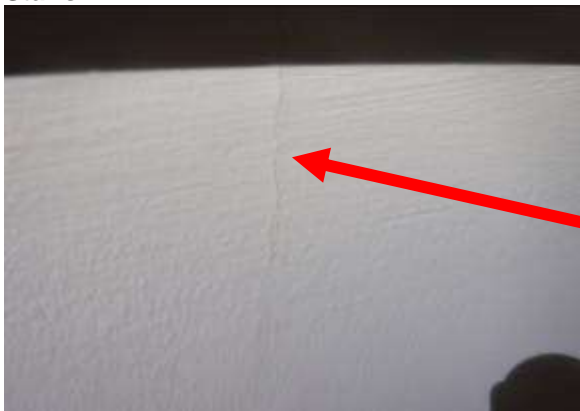
Game room

Sheetrock cracks were observed, including at the 2<sup>nd</sup> floor southeast bedroom, stairs, game room, and the 2<sup>nd</sup> floor west bedroom. It is recommended to repair all the visible cracks.

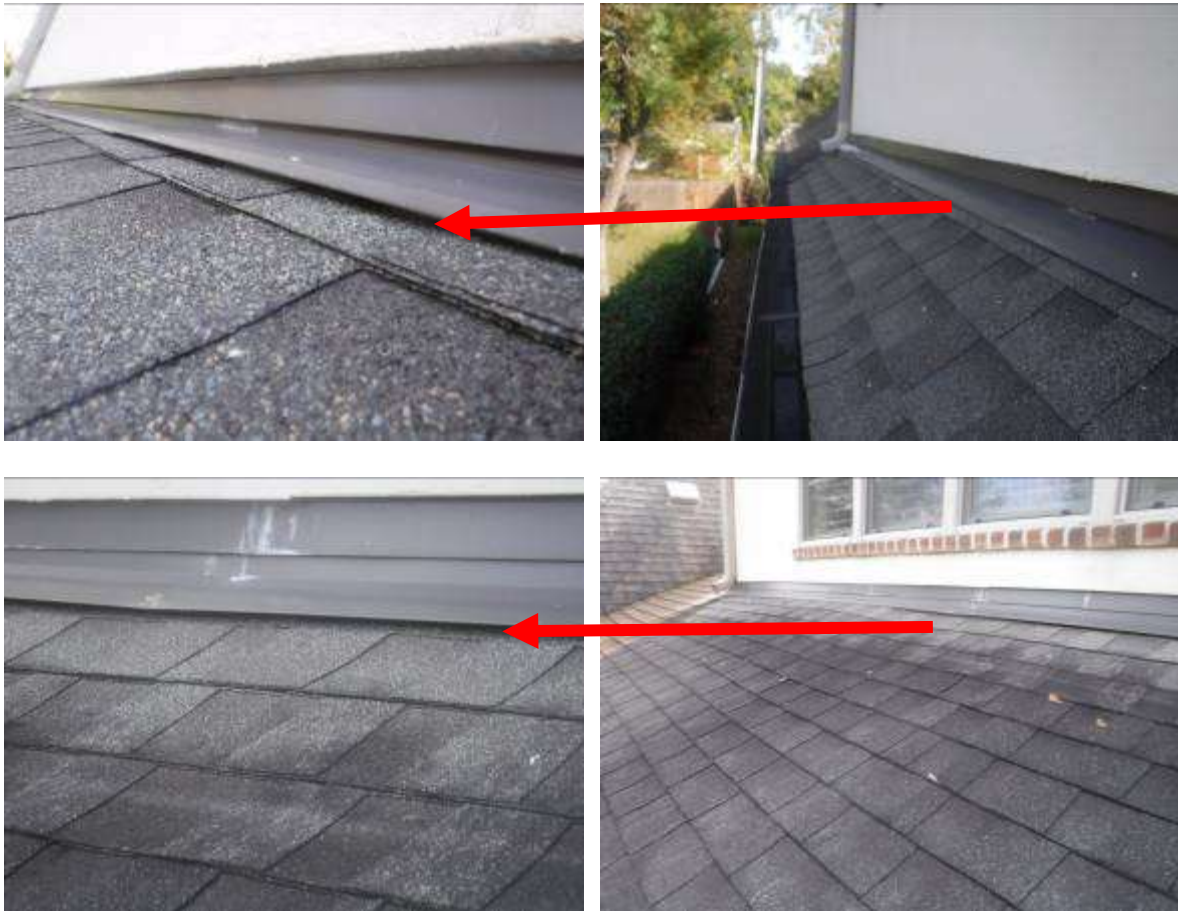
- \* The metal flashing at the junction of the low roof and a vertical wall was not secured properly, and can allow wind-blown water to enter the living space. The flashing needs to be resecured to the roof.

**Obtain Cost Estimate**

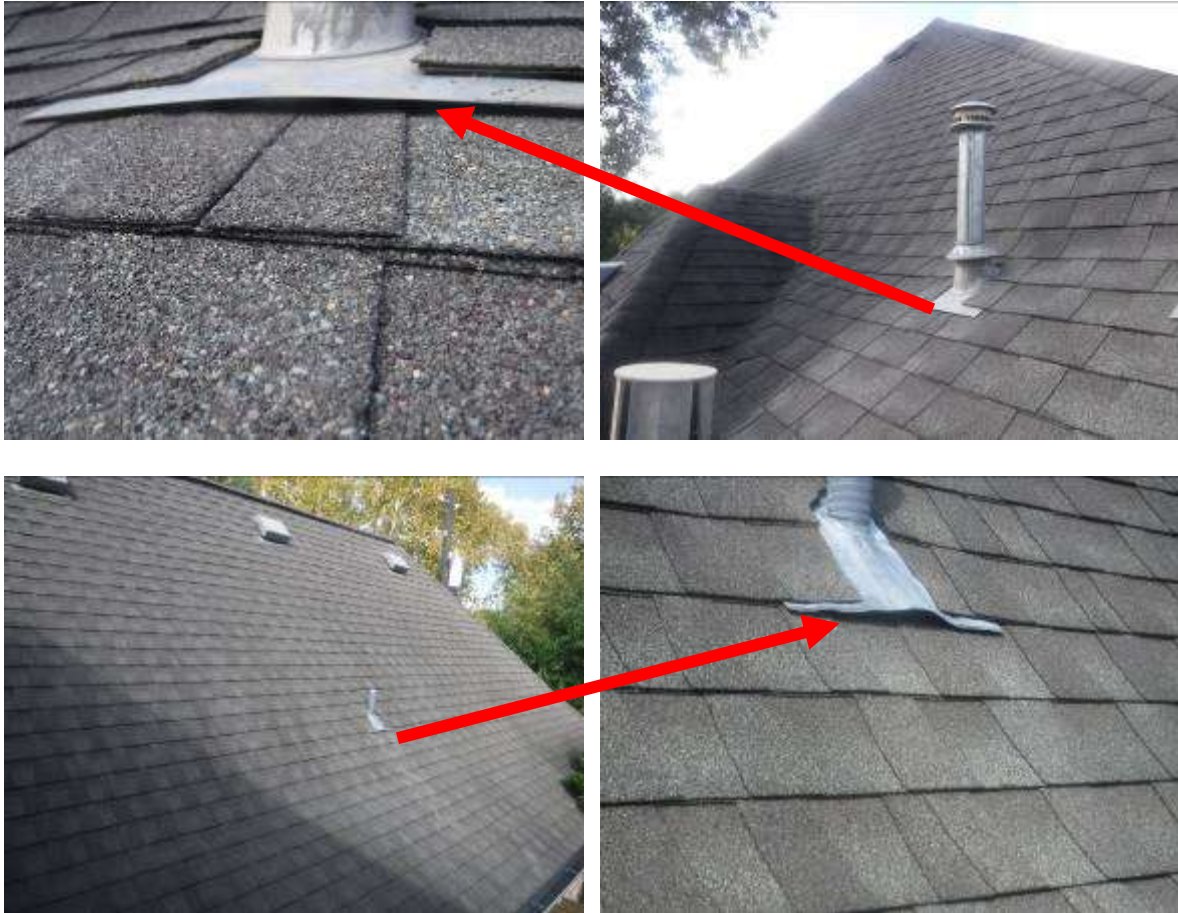
- \* The metal flashing at some of the roof jacks was not secured properly, and can allow wind-blown water to enter the living space. The flashing needs to be resecured to the roof.

**Obtain Cost Estimate**

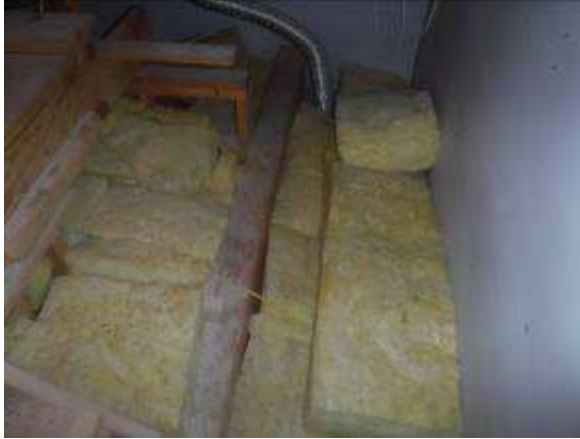
The insulation in the attic was average by today's standards. The normal amount of insulation for attics in this area is an R30 energy rating. This attic had 9-1/2 inches of fiberglass batt insulation in the ceiling, which was marked as being an R30.

The insulation in the attic was in contact with the recessed lights, which may be a fire hazard. We saw no evidence on the outside of the recessed cans to indicate that the cans were rated as “IC”, which is the manufacturer designation for “Insulation Contact”. Further investigation is recommended, including dismantling the trim kit in the ceiling below. If the recessed cans are NOT “IC” rated, then the insulation needs to be pulled back, and a three inch air space provided around the lights to prevent overheating and a possible fire hazard.

**Obtain Cost Estimate**

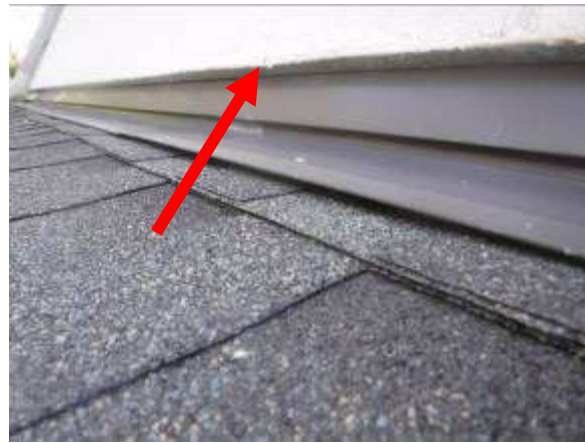
**J-flashing**

The stucco veneer was a traditional hardcoat stucco that was approximately  $\frac{3}{4}$ -1 inch thick. Expansion joints were observed in the stucco at regular intervals, and the flashing at the bottom of the stucco walls was observed to be the older J-flashing, rather than the newer weepscreed flashing. A weepscreed has holes in the bottom to allow moisture in the wall a path to exit the wall, rather than being kept inside the wall, and possibly causing mold, mildew, or other moisture related problems.

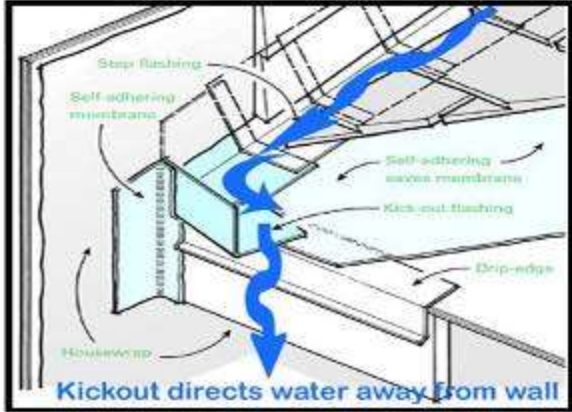
**Schematic of kickout flashing**

No kickout flashing has been installed at the roof/wall intersections. A lack of kickout flashing can possibly allow water to be routed off the roof into the wall cavities, causing wood rot, damage from wood destroying insects, mold, etc. We saw no evidence at the time of the inspection of any water penetration at the flashings, and therefore, no repairs are indicated. However, as a routine recommendation, we recommend that a contractor be contacted to provide a cost estimate to install the kickout flashing at all roof/wall intersections to prevent the possibility of water penetration in the future.

**Obtain Cost Estimate**

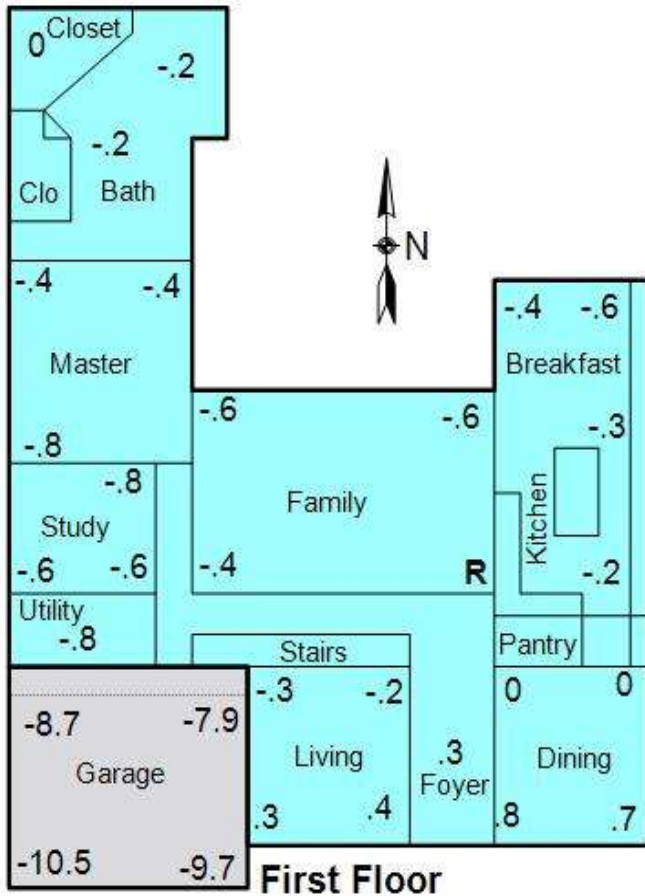
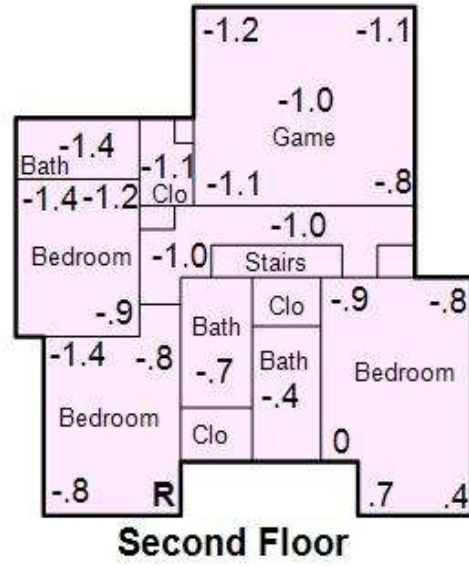
Elevation Readings  
8706 Lupton Lane

The floors were checked with an electronic level, and were observed to be acceptably level throughout the house. The difference in elevation between the high point and low
