PROPERTY INSPECTION REPORT

Concerning: 8706 Lupton Lane, Houston, TX 77055
(Address or Other Identification of Inspected Property)

By: Daniel Koteles #21157 11-06-18
(Name and License Number of Inspector) (Date)

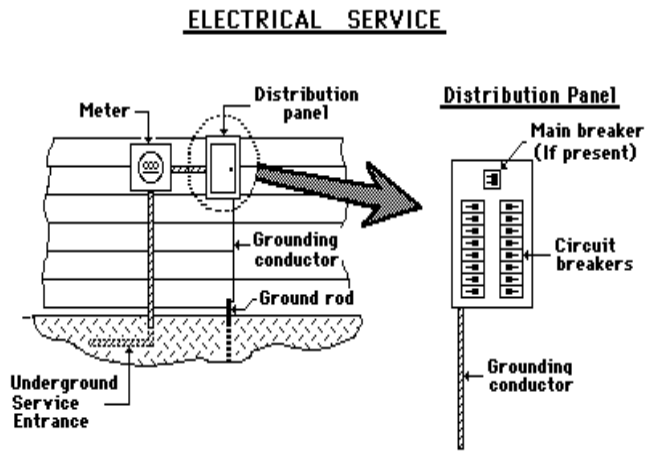
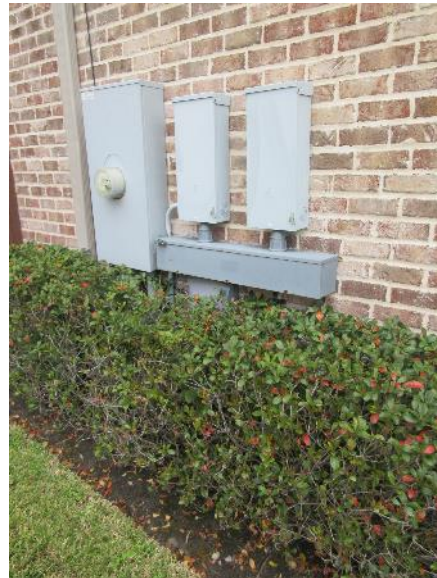
A. Service Entrance and Panels

ELECTRICAL SERVICE

Type: Underground **Voltage:** 120/240 **Phase:** Single **Amps:** 400-Amps
Meter: Side of the house

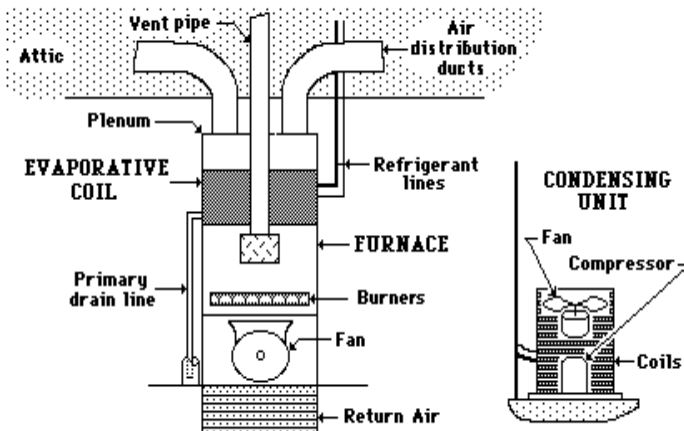
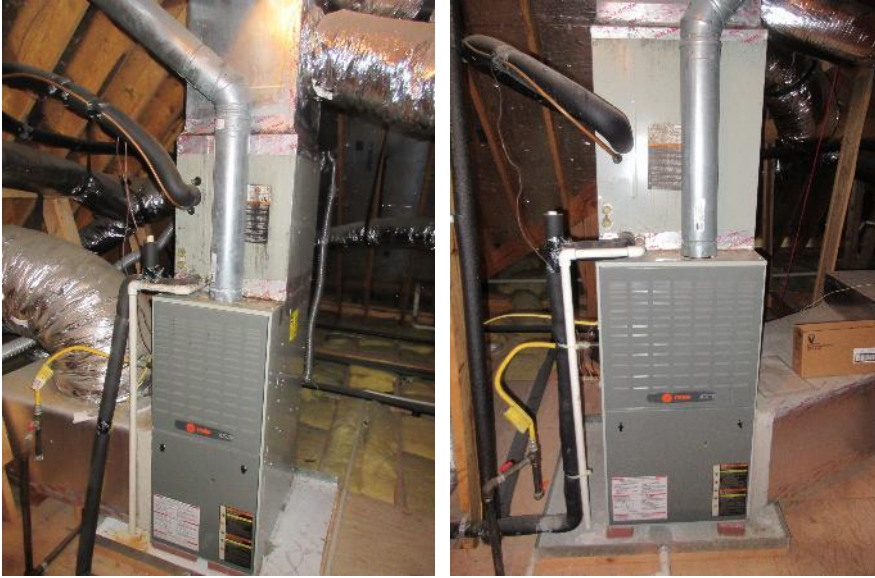
Heating, Ventilation, and Air Conditioning

The heating for the house was provided by two gas-fired vertical furnaces located in the attics. The equipment for the individual zones was as follows:

Zone	Manufacturer	Size	Date	Location
Master Suite	Trane	80,000-BTU	2008	Attic
2 nd Floor	Trane	80,000-BTU	2008	Attic
1 st Floor	Trane	80,000-BTU	2007	Attic

The furnaces were operationally checked at the time of the inspection, and no repairs were indicated to the operation of the furnaces. The furnaces responded to the thermostats, and the burners came on, and were heating.

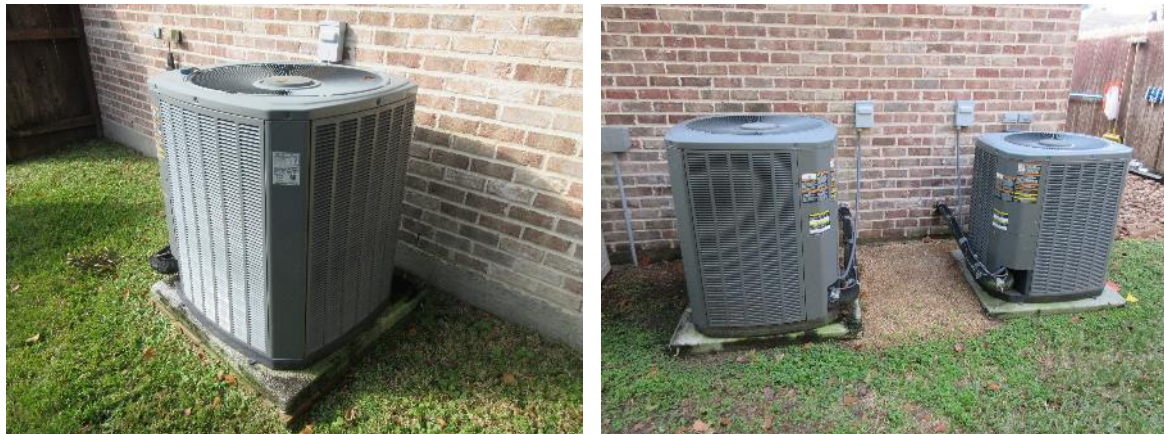
The air conditioning for the house was provided by three forced air split systems, and the equipment for the individual zones was as follows:

Zone	Condensing Unit		Date	Evap. Coil	Date	ΔT(degrees)
Master	3-ton	Trane	2008	3-ton	2008	19
2 nd Floor	4-ton	Trane	2008	4-ton	2008	14
1 st Floor	4-ton	Trane	2008	5-ton	2008	16

The upstairs and downstairs systems had a less than normal temperature differential across the evaporator coils (only 14-16 degrees). Have a service company find the source of the problem, and provide a cost estimate to make any necessary repairs.

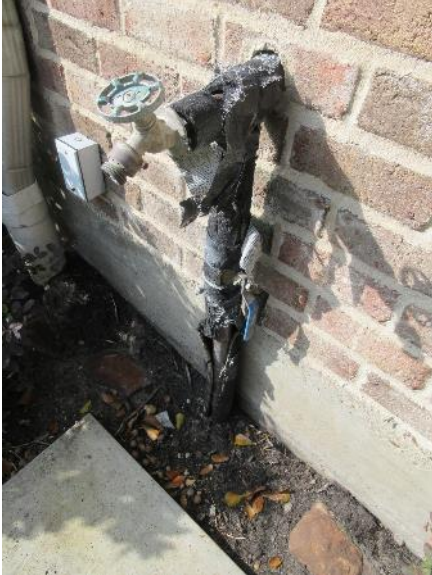
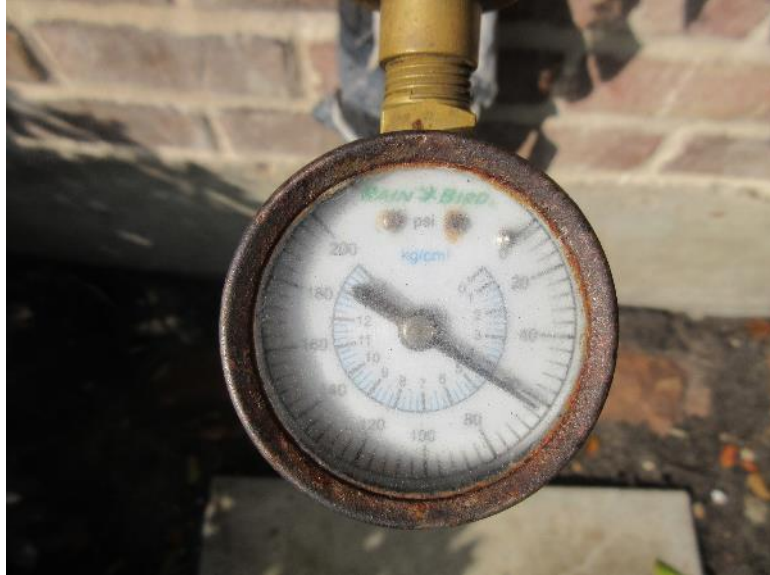
Water Service / Supply Piping

The shut-off valve for the main inlet water line was located at the exterior of the house at the east side of the house.

The water pressure to the house at the time of the inspection was checked with a pressure gauge at the hose bibb nearest the shut off valve, and the pressure was observed to be 62 psi.

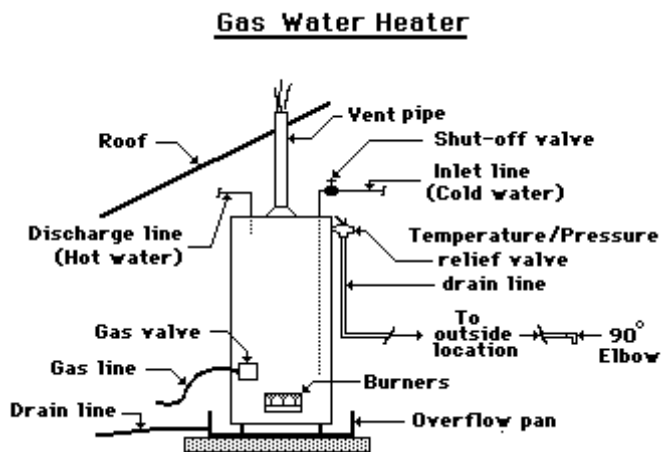
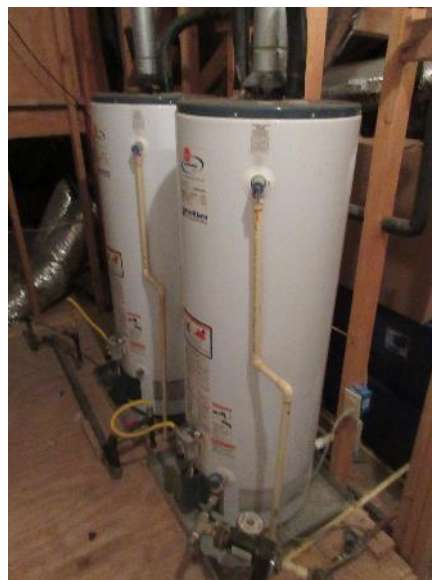
<u>Manufacturer</u>	<u>Size</u>	<u>Date</u>	<u>Piping Type</u>	<u>Location</u>
Rheem	50 Gallon -Gas	2008	Copper	Attic
Rheem	50 Gallon -Gas	2008	Copper	Attic

The water heaters were functional at the time of the inspection. However, due to the age and/or condition of the equipment, it is the opinion of the inspector that they have only a limited amount of life remaining. Normal life expectancy of a water heater in the Houston area is approximately 7 to 10 years.

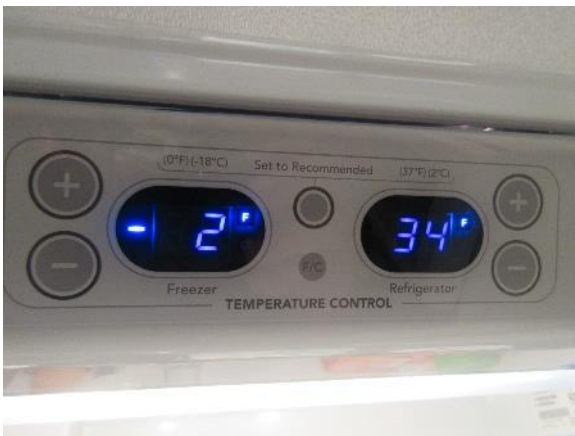
Refrigerator/Freezer

It is pointed out that our inspection of the refrigerator is only cursory to see if the refrigerator compartment is cooling, and the freezer compartment is freezing. The freezer was cooling to -2 degrees and the refrigerator to 34 degrees at the time of the inspection, according to the digital display inside the refrigerator.

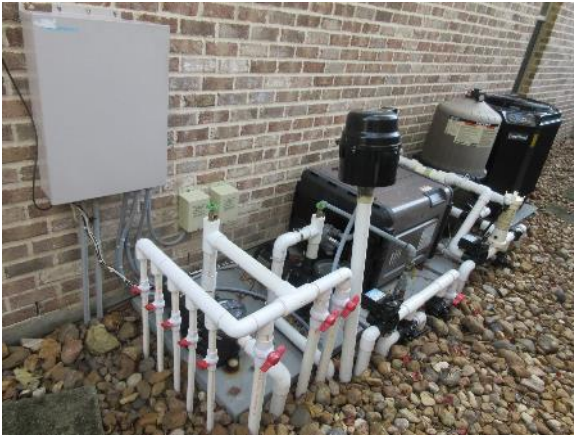
The swimming pool was an in-ground gunite pool covered by a plaster finish. The pool equipment was located at the west side of the house.

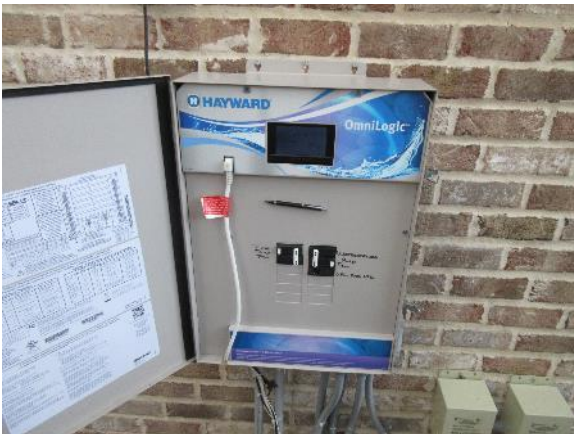
Control Panel

The control panel was functional at the time of the inspection. We operated the controls in the “Service” mode to turn on the various pumps, filter, heater, water feature, lights, etc. and the panel was functional.

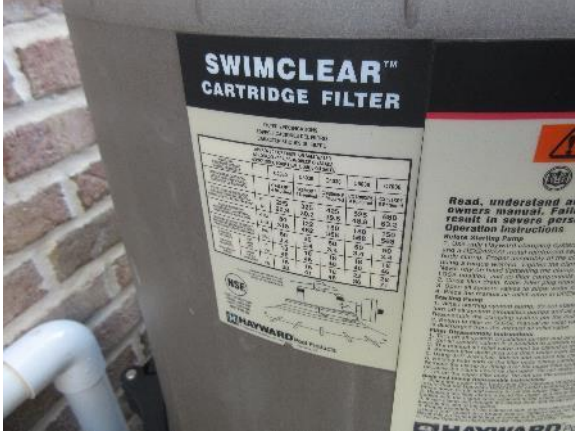
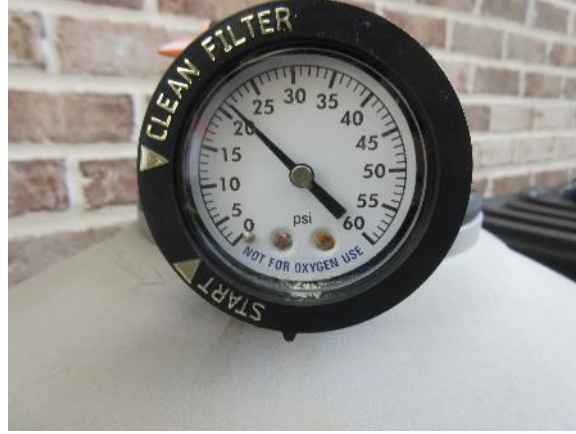
Pool Filter

The pool filter was a cartridge filter that was functional at the time of the inspection, and showed an operating pressure of 21 psi. This is within a normal range of operation, and no repairs are recommended.

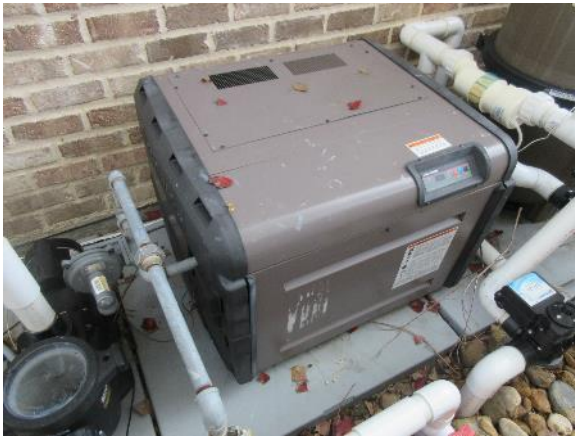
Heater

The furnace was operationally checked at the time of the inspection, and the burners did come on, and were operated for approximately 5 minutes.
