## HOME INSPECTIONS INC.

**Concerning:** 1922 Mistyvale Court Richmond, Texas 77406

March 23, 2020

Report Identification: 200322-2 1922 Mistyvale Court

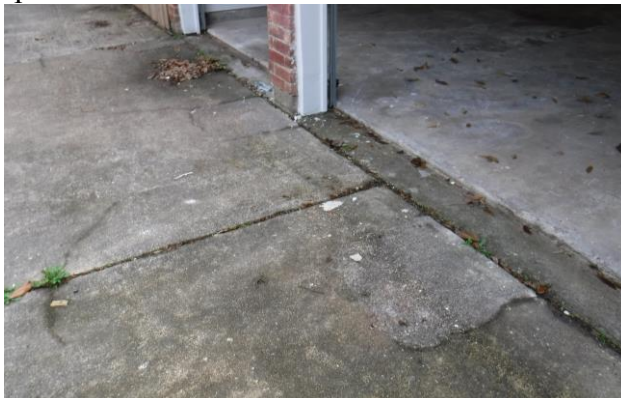
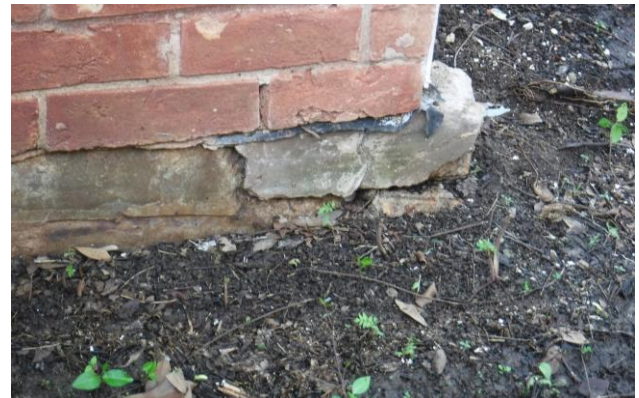
- ★ There is exposed steel on the foundation; remove the rust and apply a primer coat and then cover with a high strength non-shrink grout.

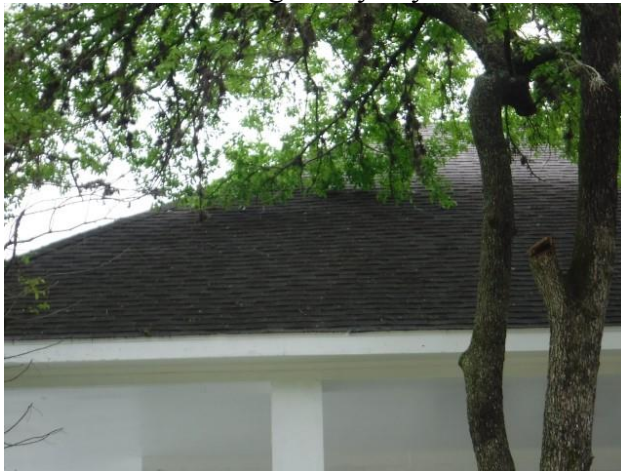
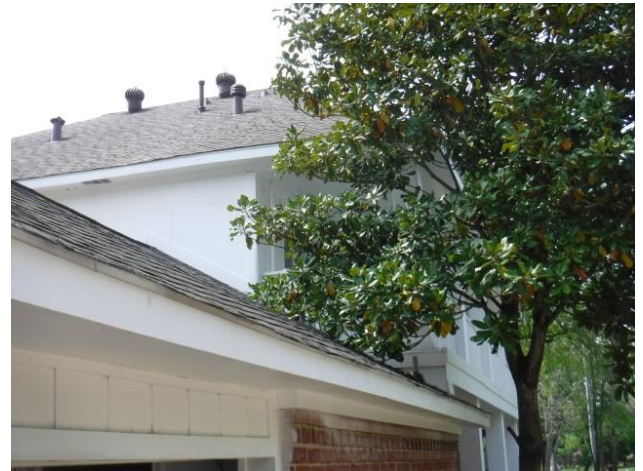
★ There are tree limbs on or very near the roof. Tree limbs should be a minimum of 4 feet from the roof to allow for strong windy days without contact.

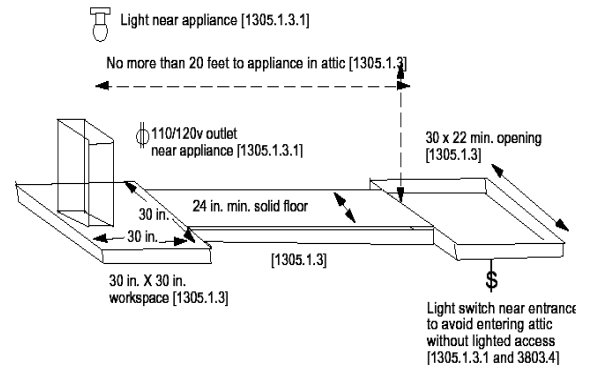
- ★ Particleboard is not an approved material to use for flooring. Particle board is flexible and easily damaged. Recommend upgrading to plywood in the attic.
- ★ There is loose / damaged decking observed in the attic. These areas should be nailed down or repaired as needed to prevent tripping hazards.
- ★ The attic access is inadequate to the water heaters and attic equipment, a minimum of a 24-inch-wide walkway to equipment. REF IRC M1305.1.3

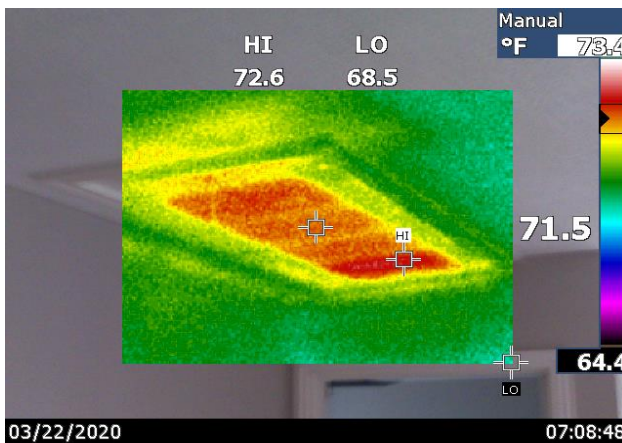
- ★ The attic access door is not insulated and the gap at the door frames are not properly sealed / insulated with expanding foam. The door should be insulated with a hardboard insulation panel. The thermal image shows the transfer of heat and temperature differential. Recommend installing a full door insulation tent or cover as seen in image at right. There are many different types available online or hardware stores.

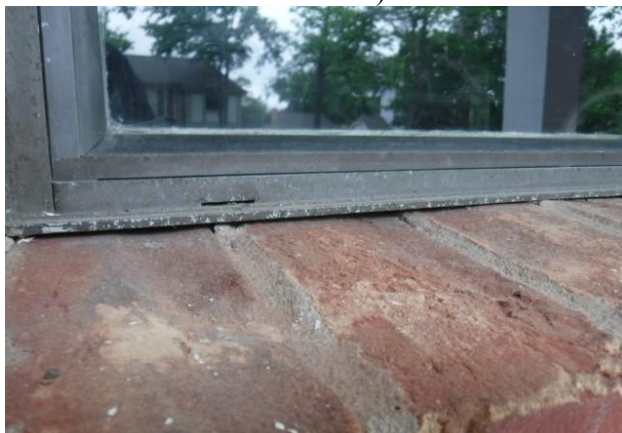
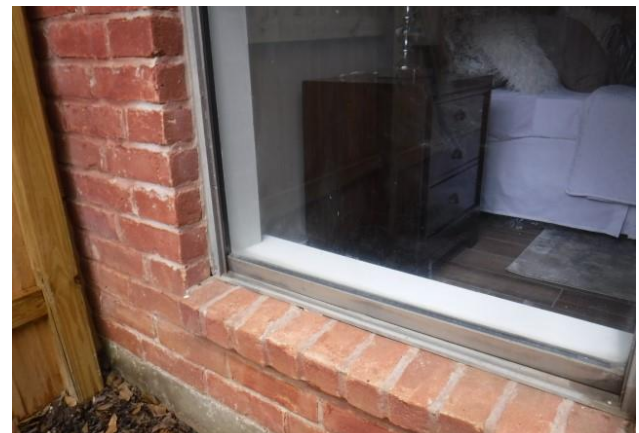
- ★ The sealant at most penetrations of the house is deteriorated or gaps in material. All penetrations and openings around the exterior should be properly sealed with caulk, screen mesh, expanding foam or mortar as needed to keep out moisture and unwanted pests (Do not seal up weep holes where the brick meets the slab).

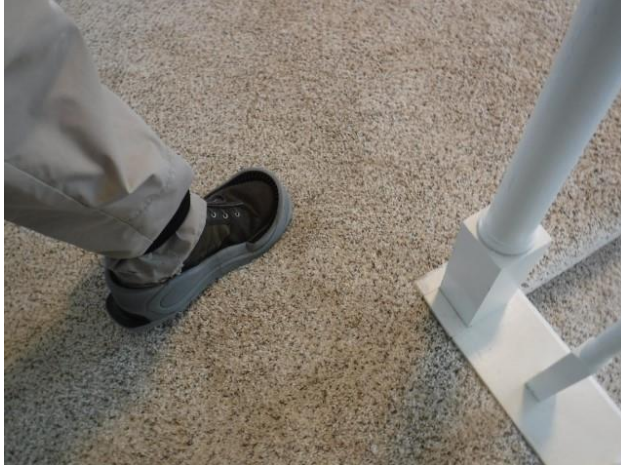
- ★ The flooring is uneven and has a soft spot at the top of the stairs.

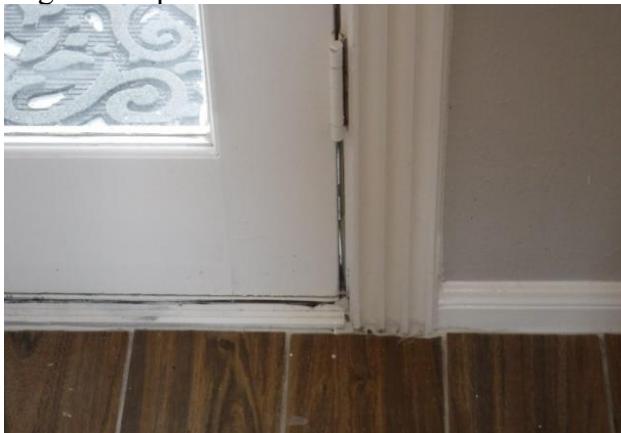
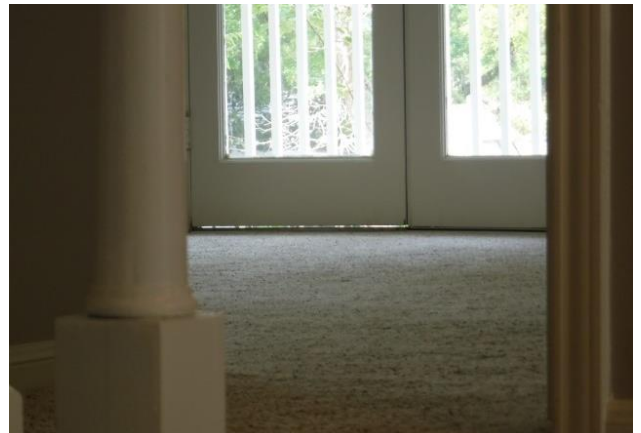
- ★ The door has visible daylight showing around the sides; front, garage and upstairs front left bedroom at bottom. The weather stripping should be replaced, or the door adjusted to provide an airtight fit to prevent loss of conditioned air.

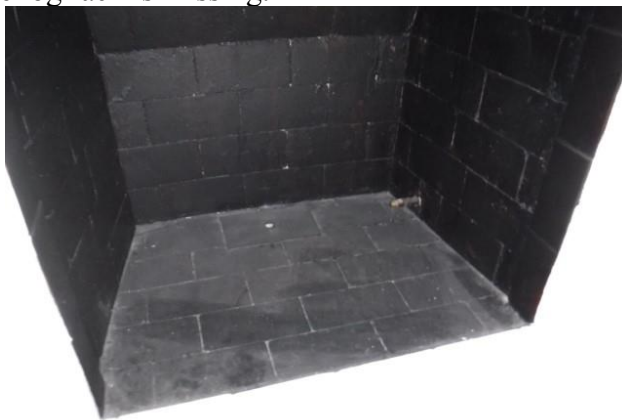
- ★ The house fireplace is missing the damper clamp. All gas fireplaces should have a required damper bracket that prevents the damper from completely closing to allow gas to escape to the exterior in the case of a gas leak. REF IRC 2433.1
- ★ The log rack is missing.

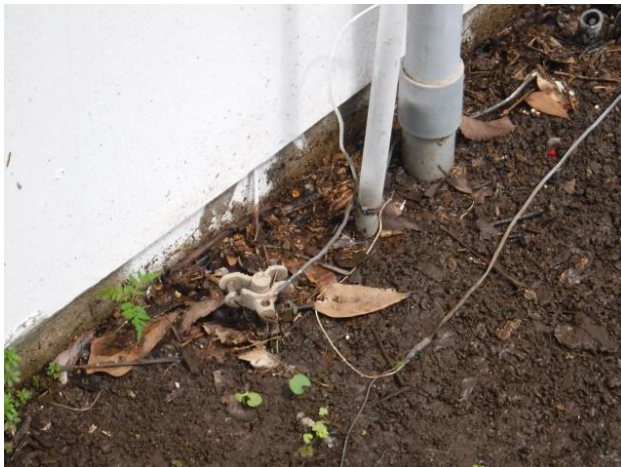
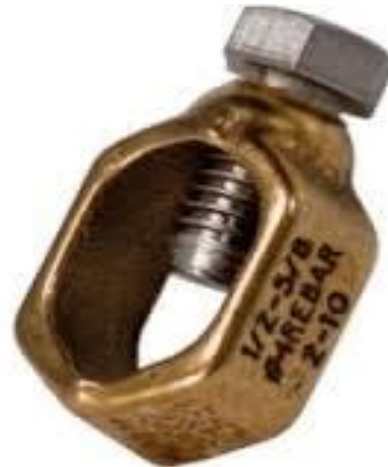
- ★ The ground rod clamp is not rated as a grounding clamp. A proper grounding clamp rated for the purpose should be used such as the acorn clamp.

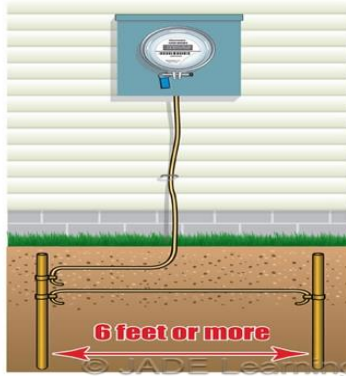
- ★ The inspector did not observe a supplemental grounding system (2 grounding rods no closer than 6 feet apart) as required in the 2011 National Electric Code. The exception is a primary grounding system with less than 25 ohms to ground. (NEC 250.53(A)(3). Note: Concrete encased electrodes “Ufer Grounds” are no longer acceptable due to the inability to verify full ground contact. It is recommended that a licensed electrician be contacted for further information/evaluation. (Typical for a house of this age. House was built before the new electrical code update).

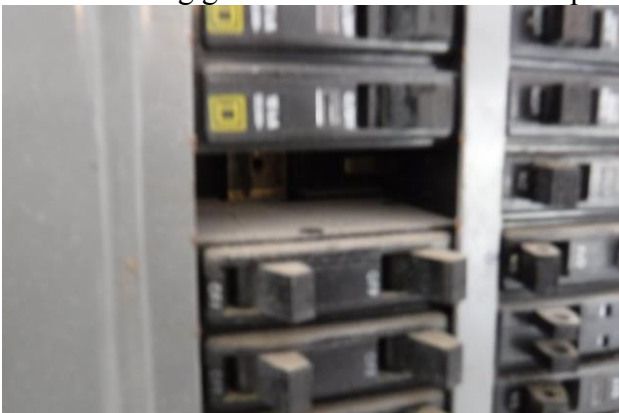
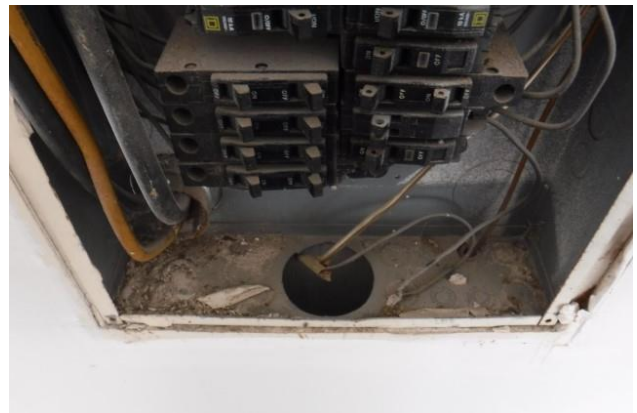
- ★ There are knock out covers missing leaving a hole or space for pests to enter.
- ★ There is a missing grommet at the inside of the panel.

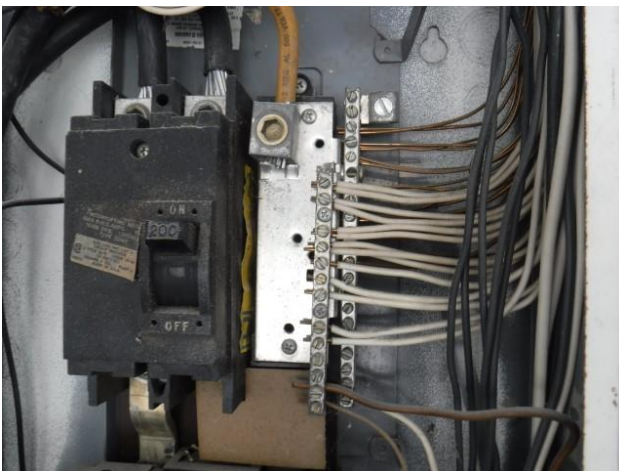
- ★ The neutral wires are current carrying conductors and should not be double lugged. Grounded Conductor Terminations—Each grounded conductor shall terminate within the panelboard in an individual terminal that is not also used for another conductor. NEC 408.21

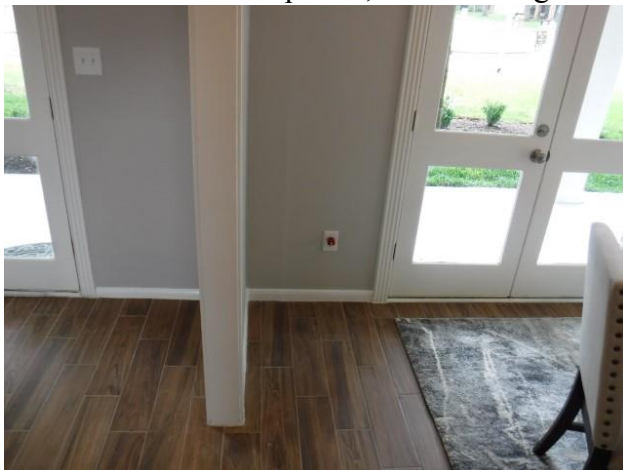
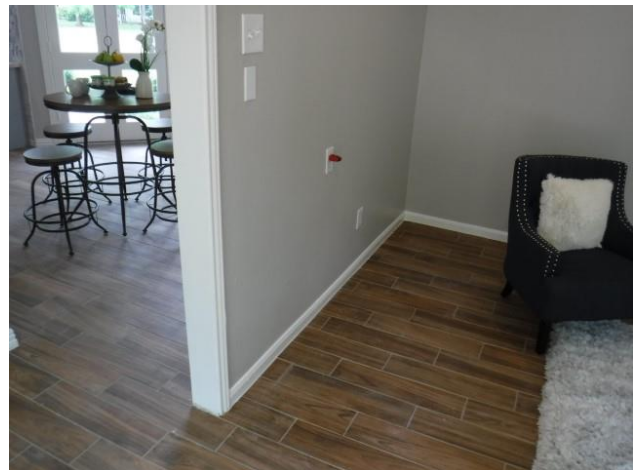
★ There is a 3-prong outlet that is not grounded; dining room.

★ The outlet does not have power; formal living.

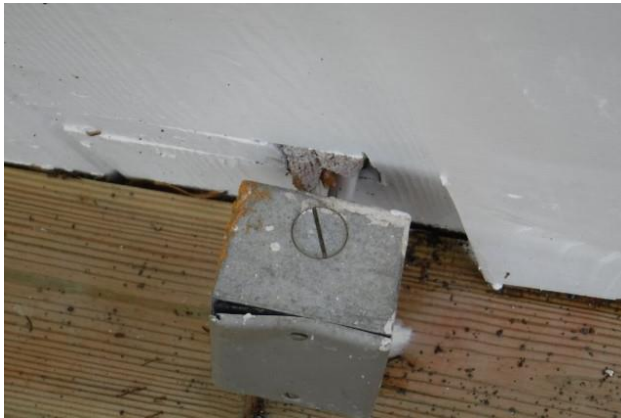
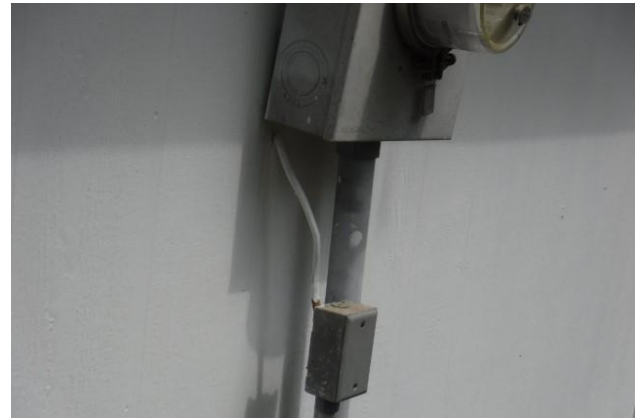
- ★ The conduit is not properly installed or connected; wiring should be totally concealed; back patio junction box.
- ★ The exposed electrical wiring is required to be installed in an approved conduit. REF IRC E3702.3.2

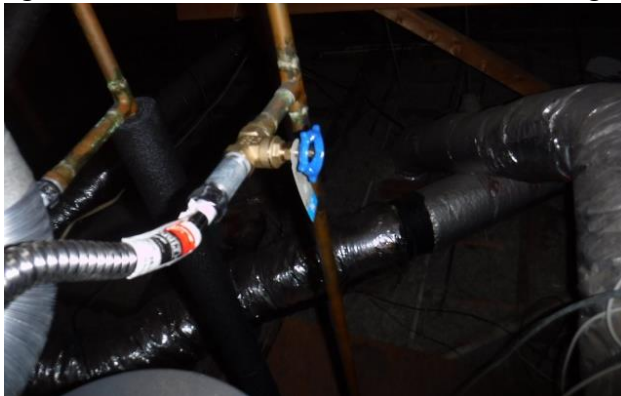
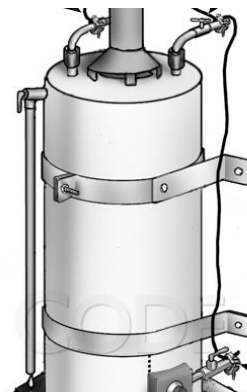
- ★ The gas line and water lines should be bonded together at the water heater(s). REF IRC 3509.6

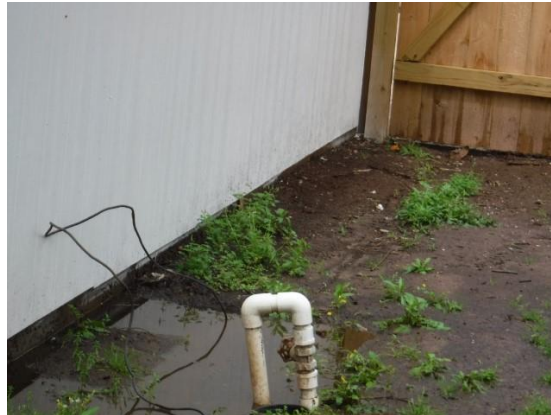
Note: There is a water line with valve at the back of the garage who purpose is unknown.

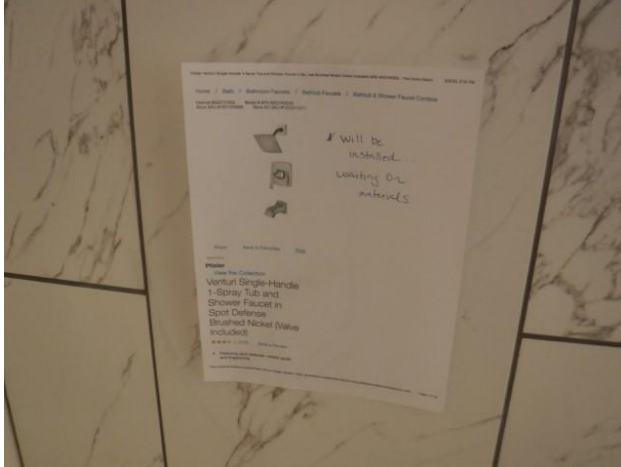
- ★ The water is off to the upstairs front bathtub. Waiting on a new faucet assembly.
- ★ The faucets require sealant at the wall to prevent moisture from penetrating behind shower / tub wall.

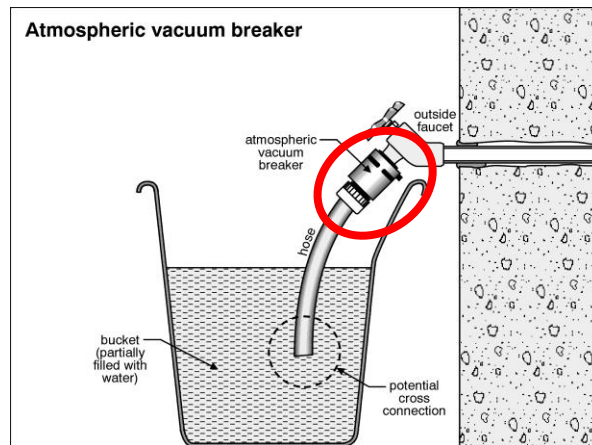
- ★ There is a damaged handle at the right-side faucet.
- ★ Exterior hose bibs are missing required back flow prevention devices. They protect our clean water supply from possible contamination and can be purchased at most hardware stores.

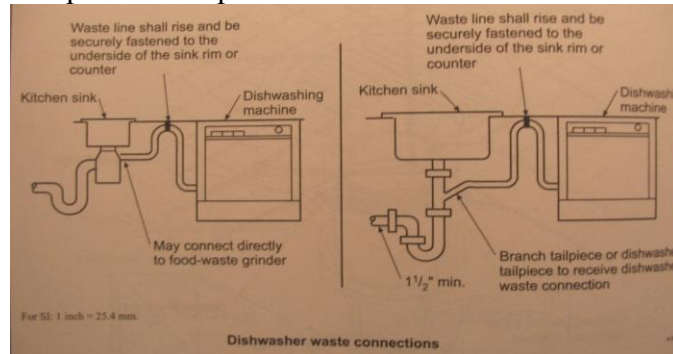
- ★ The dishwasher drain line should be elevated above the drain to prevent gray water from entering the dishwasher from the disposal or tailpiece.

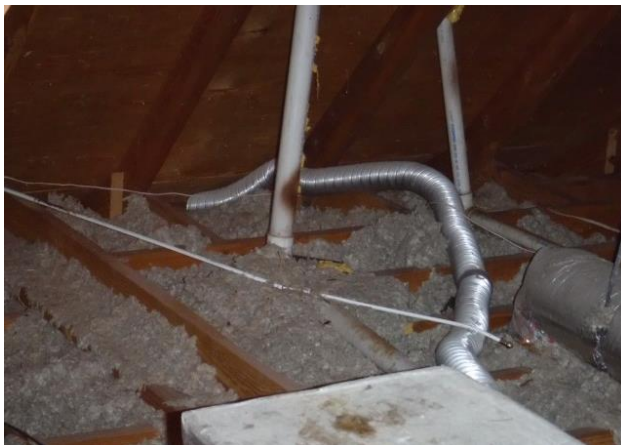
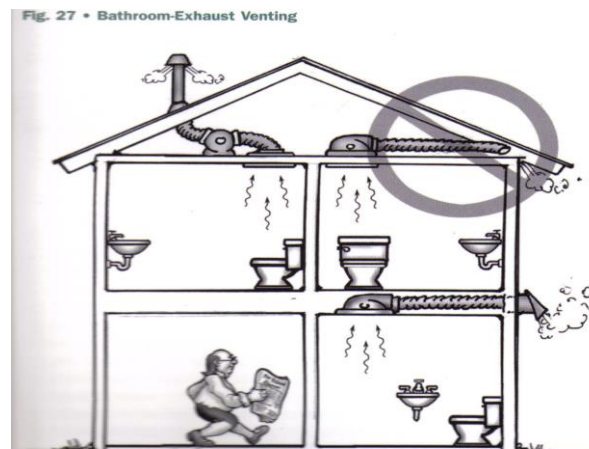
★ The bathroom vents should go to the exterior. The soffit or eave of the house is designed as an intake for attic ventilation not for an exhaust.

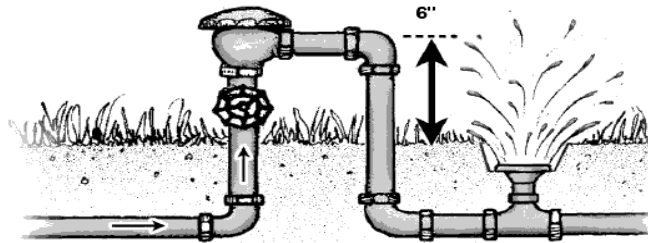
Fig. p13 • Vacuum Breaker

- ★ There system is not operable.
- ★ The presence of a vacuum breaker to protect the clean water supply system was not observed. The vacuum breaker should be installed where it stands a minimum of 6 inches above the highest sprinkler head.

Vacuum breaker min. 6" above highest head
