Report Identification: 321 Preston Ln, League City TX 77573 - November 15, 2021

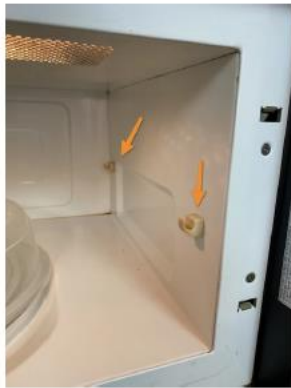
### 3: Handle/Damaged

The microwave door handle is damaged. Remedy as needed.
