Inspection Report

Property Address:
321 Preston Ln.
League City Tx 77573

PROPERTY INSPECTION REPORT

By: Jared Buchanan 22516 22516 / Buchanan Home Inspection 11/2/2021

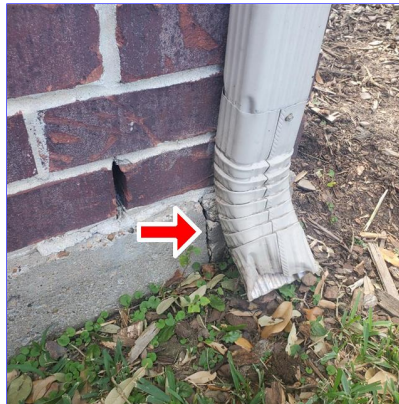
The foundation appeared to be operating as intended, however, several corner pops, that appear cosmetic, were noted in some areas and should be evaluated by a professional foundation contractor and repaired to help prevent further damage

A. Item 4(Picture) Corner pop at the northwest corner of the home

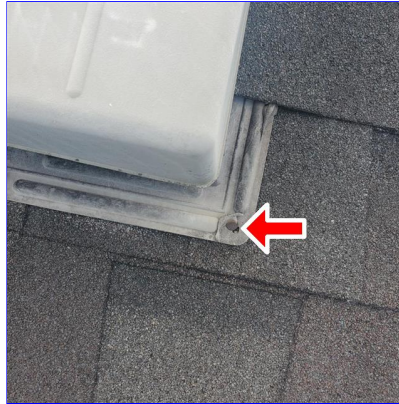
C. Item 2(Picture) Exposed nail on vent flashing on the left facet of the roof

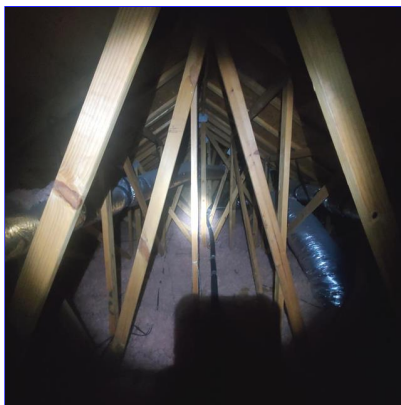
D. Item 2(Picture) General view of attic.

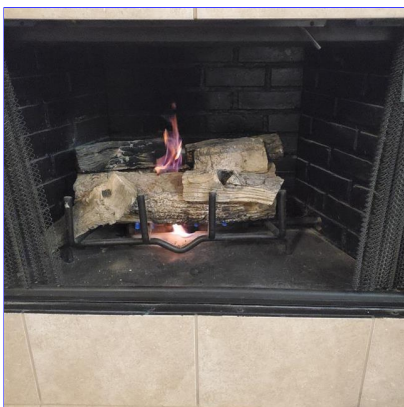
J. Item 3(Picture) General view of fireplace

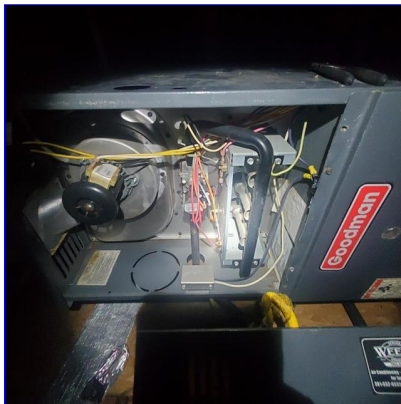
A. Item 3(Picture) General view of Goodman gas furnace.

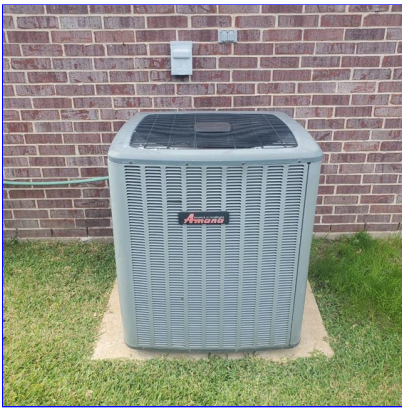
B. Item 5(Picture) General view of Amana AC

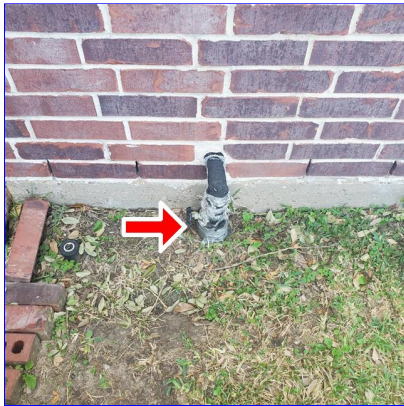
A. Item 1(Picture) Main water shut-off is at the left side of the home near the front of the home

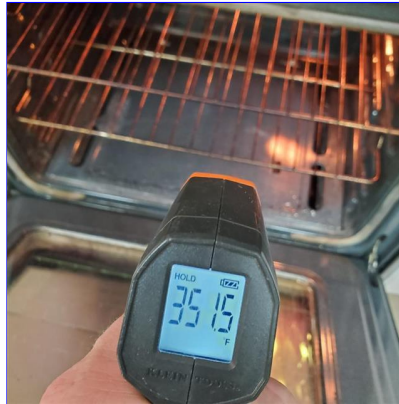
C. Item 2(Picture) Oven temperature should be within 25 degrees plus or minus of 350 and was approximately 351 degrees when tested

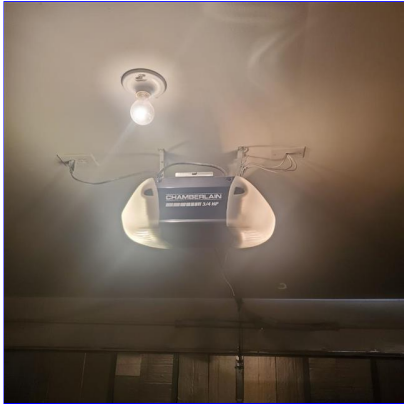
G. Item 1(Picture) General view of Chamberlain garage door operator

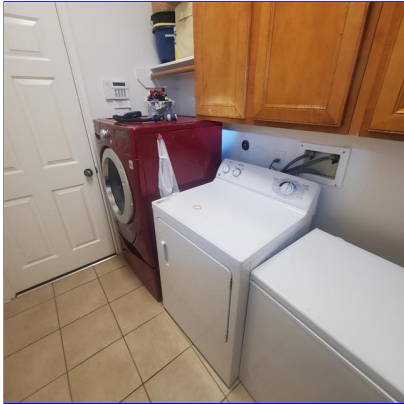
H. Item 1(Picture) Dryer in place at time of inspection
