PROPERTY INSPECTION REPORT FORM

Address of Inspected Property: 9219 Newburgh Houston, TX. 77095

Name of Inspector: Rod Scarborough TREC License # 7189

Date of Inspection: November 6, 2021

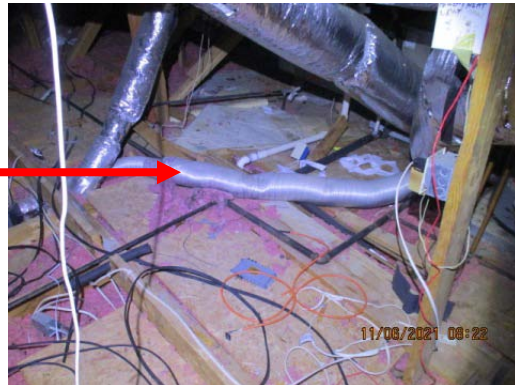
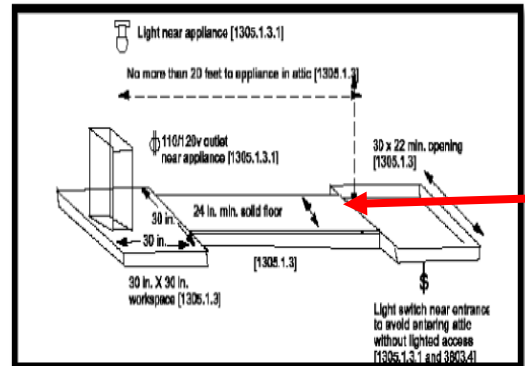
☒ The attic does not have a clear unobstructed passageway with solid flooring for access to the appliances where access is required.

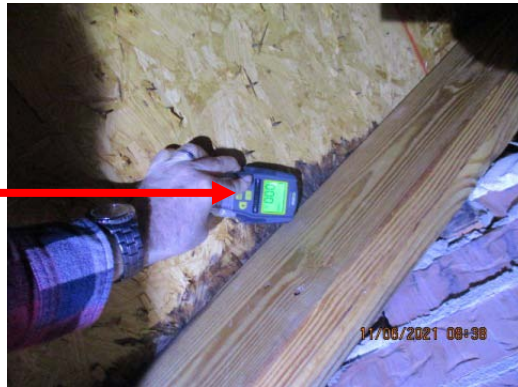
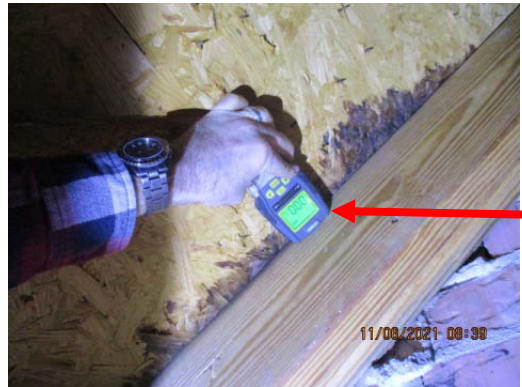
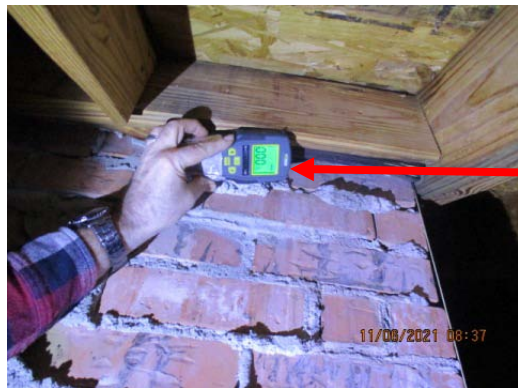
Ⓢ Existing/previous moisture penetration/staining were observed in some areas. A moisture reading was performed in the accessible areas & the level of moisture was within the acceptable range at the time of the inspection.

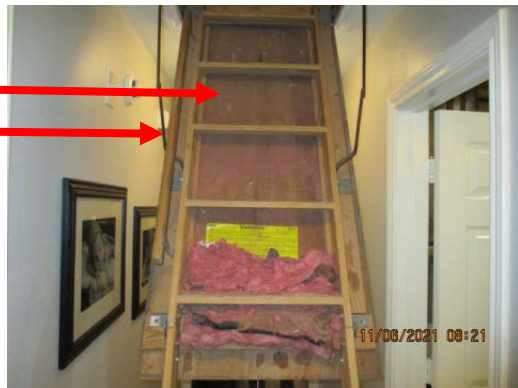
The attic access is missing weather stripping & insulation. Recommend sealing to help reduce energy cost.

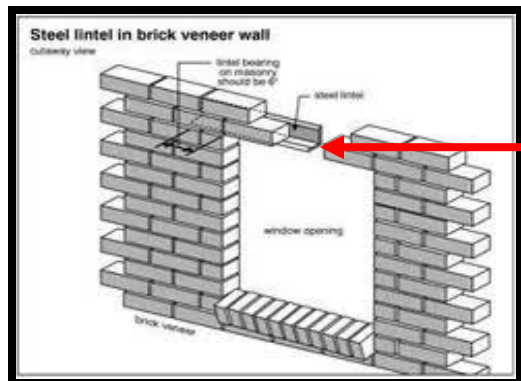
FYI Minor surface rust was observed on some of the lintels at openings above doors/windows etc. Recommend removing rust & priming/painting the lintels.

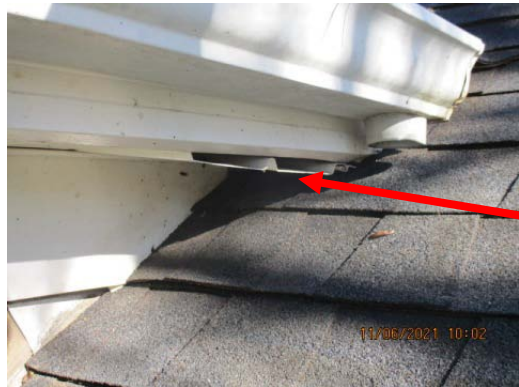
FYI Trees/vegetation are too close/attached to the structure in some areas which limits the visibility of the exterior wall and the overall exterior wall inspection.

FYI The soffit trim to the right of the front porch is loose/not properly secured. Recommend securing.

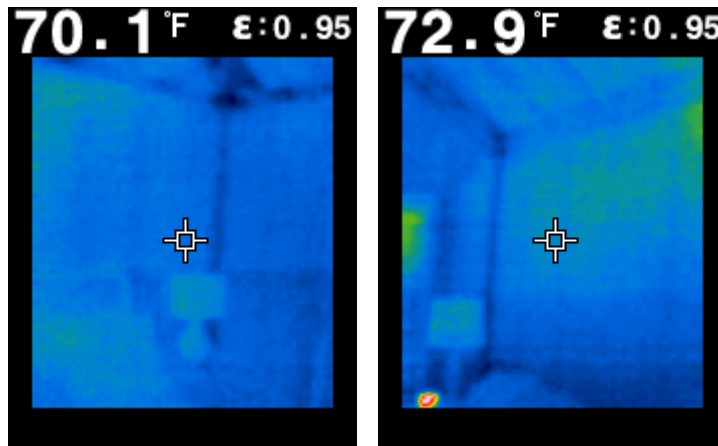
Existing/previous moisture penetration was observed but may not be limited to the base of the wall the storage area on the side of the garage. A moisture reading was performed & moisture was detected at the time of the inspection. Recommend further evaluation to determine if any hidden structure damage has occurred.

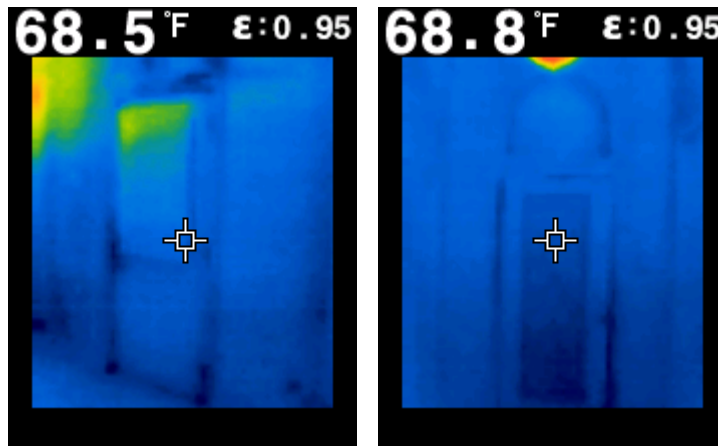
Damaged/decayed doors were observed at the base of the back door & door leading into the storage area off the garage. Recommend repair/replacing.

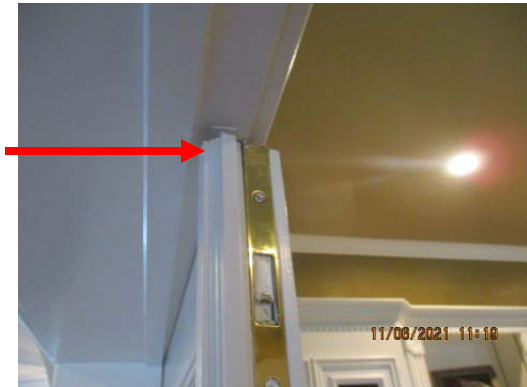
Some of the doors are missing door stops. Recommend replacement.

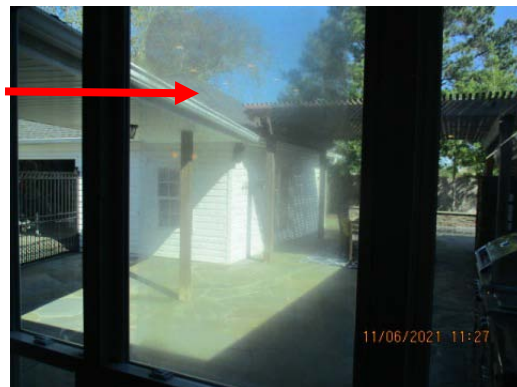
What appeared to be thermal pane/seal failure between the glazing panels was observed at the window in the main living area. Recommend replacing.

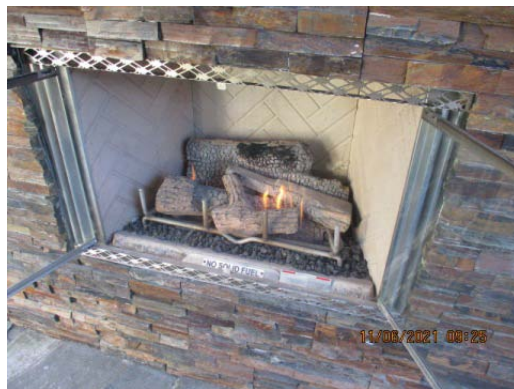
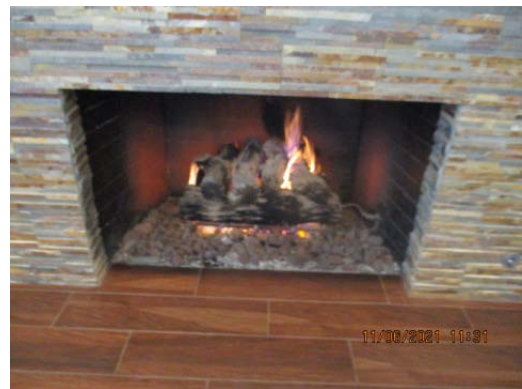
Fireplaces had gas logs in the fireboxes which limits the visibility of the firebox & the possibility of detecting potential deficiencies.

The interior fireplace damper does not have a damper block/stop installed. Fireplaces with gas logs should have a damper block installed to prevent the damper from being closed.

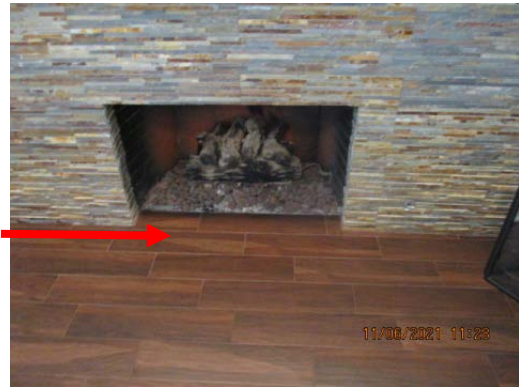
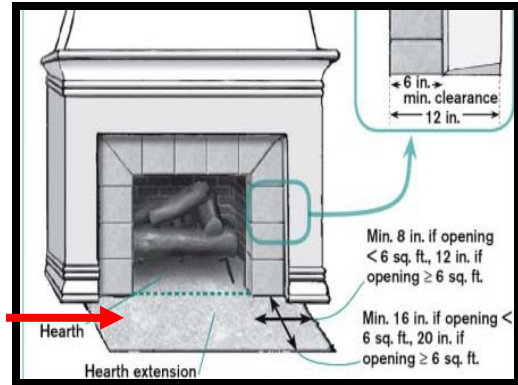
Spark resistant screen/glass doors are not installed at the interior fireplace. Recommend installing as required.

The interior fireplace does not have a hearth extension as required.

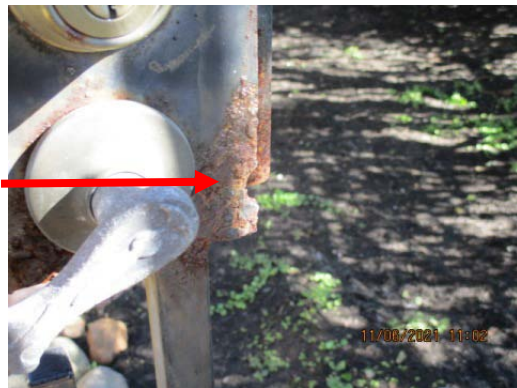
Fencing: Appeared to be functioning as intended however the iron fencing/material showed signs of aging/rusting damage in some areas. Recommend repair.

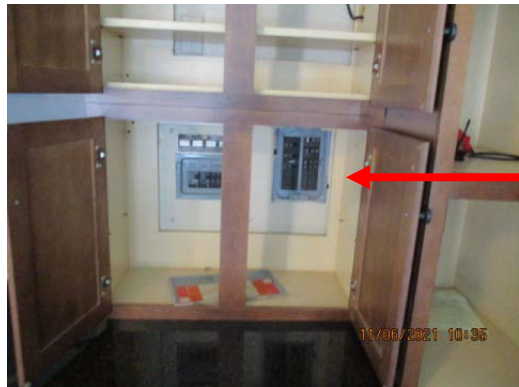
The main panel could not be opened & inspected due to cabinets blocking access. Recommend further evaluation prior to closing.

- Breakers are not properly labeled. Recommend labeling as required.
- The main access panel is not installed. Recommend replacing.
- Improper panel clearances, panels should have a minimum of 30" left to right & 36" clearance in front of the panels.

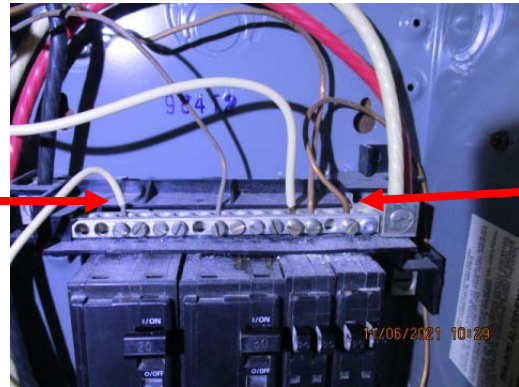
from contacting the metal enclosure and any equipment grounds. Recommend repair.

Breakers are not properly labeled. Recommend labeling as required.

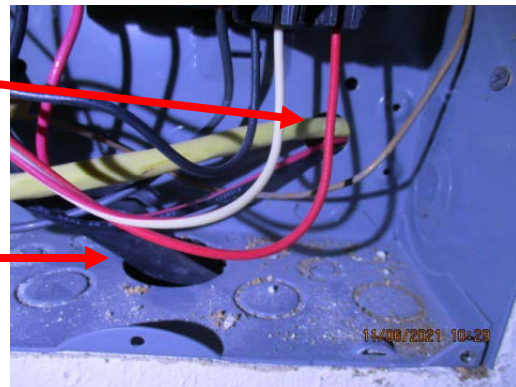
Conductors are not properly protected at penetration at the bottom, back & top of the panel.

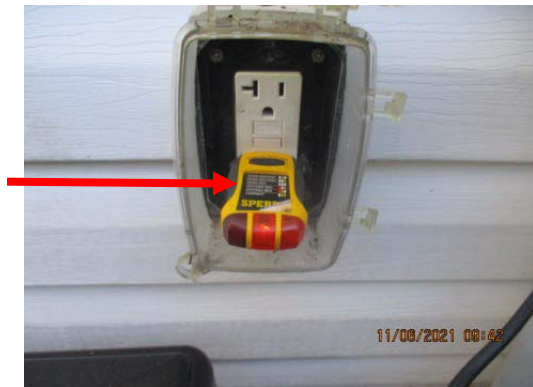
GFCI protection is not available for all the outlets in the garage as required by today's standards. This is a safety issue, it is recommended that GFCI protection be added.

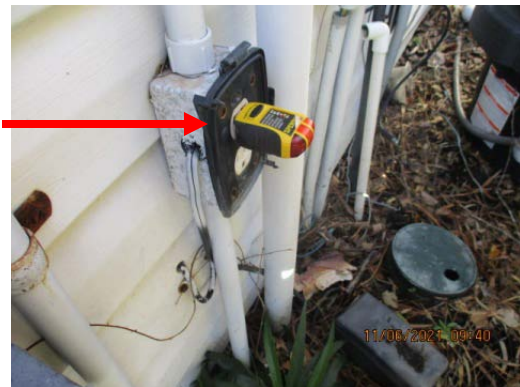
The exterior outlet weather tight cover in the back side of the garage is missing. Recommend replacing.

Improper connections/terminations of conductors in the attic were observed. All connections in conductors should be made in approved enclosures, typically panel boards, junction or J-boxes, and gang boxes (a gang box is what is behind switches and outlets).

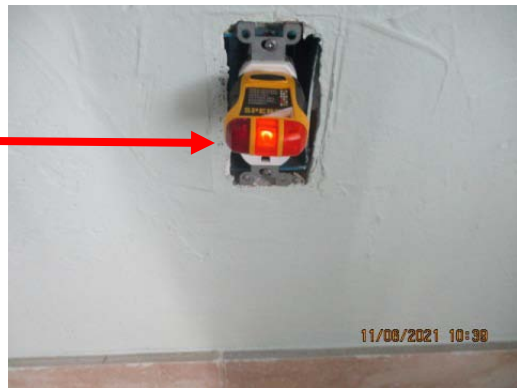
The outlet on the right wall in the storage area off the garage appears to have open ground. Recommend further evaluation.

Some of the outlets in the storage area off the garage & the outlet under the kitchen sink are missing cover plates. Recommend replacing.

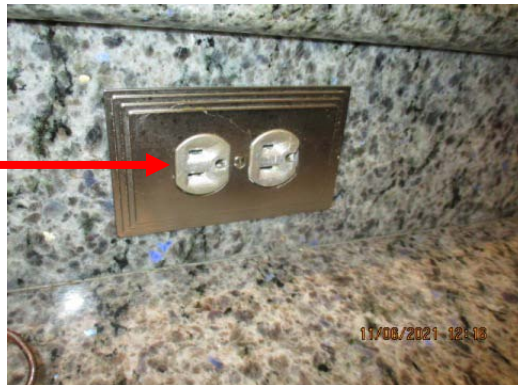
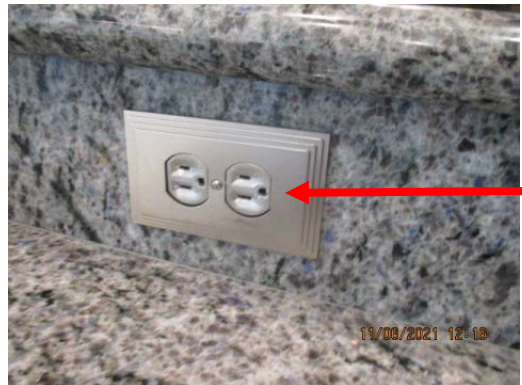
Some of the outlets/wall boxes in the kitchen are loose/not properly secured. Recommend securing.

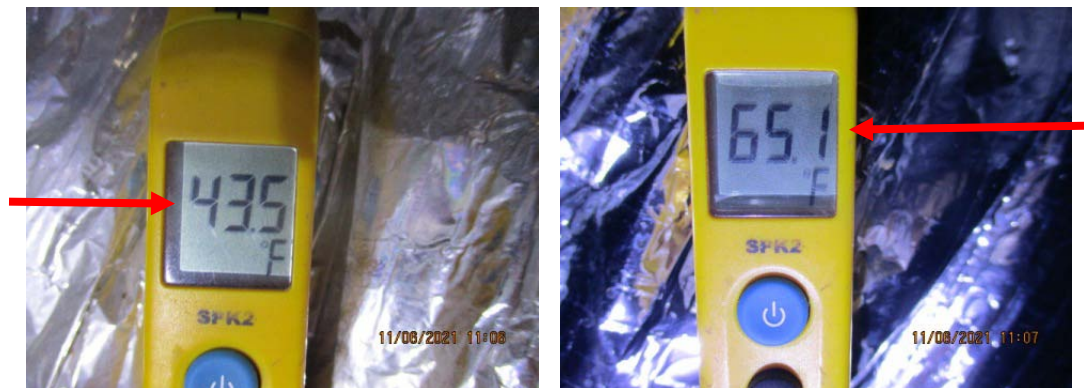
Supply air temp: 43.5 Degrees (as measured at the discharge side of the coil in the attic)
Return air temp: 65.1 degrees (as measured at the return side in the attic)

A variance of 15 - 22 degree between the supply and return air is considered to be functioning as intended.

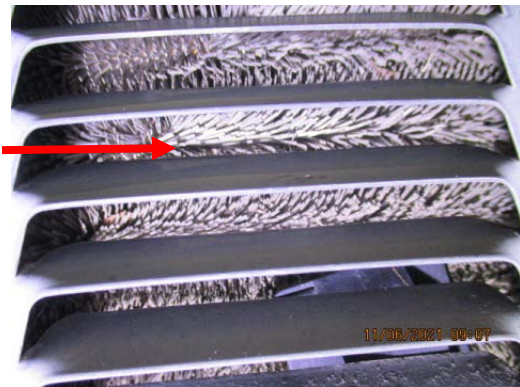
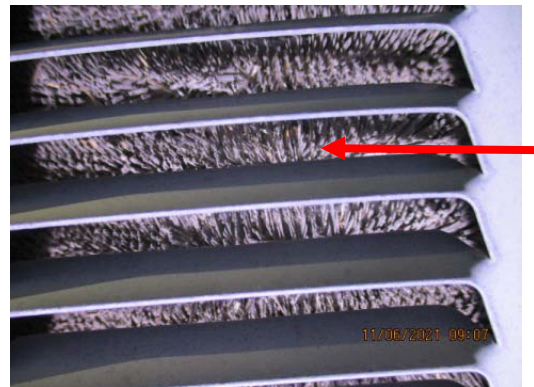
- The condensing unit was making a buzzing/loud sound. Recommended that the equipment be further evaluated by a licensed HVAC Technician prior to closing.
- The primary drain line in the attic is not fully insulated a minimum of the 1st 15' from the evaporator coils. Recommend properly insulating to prevent possible moisture damage due to condensation forming & dripping into the attic space.
- The condensing unit did not have the required 3" clearance from grade.
- The condensing unit coil is dirty. This reduces the air flow, recommend cleaning.

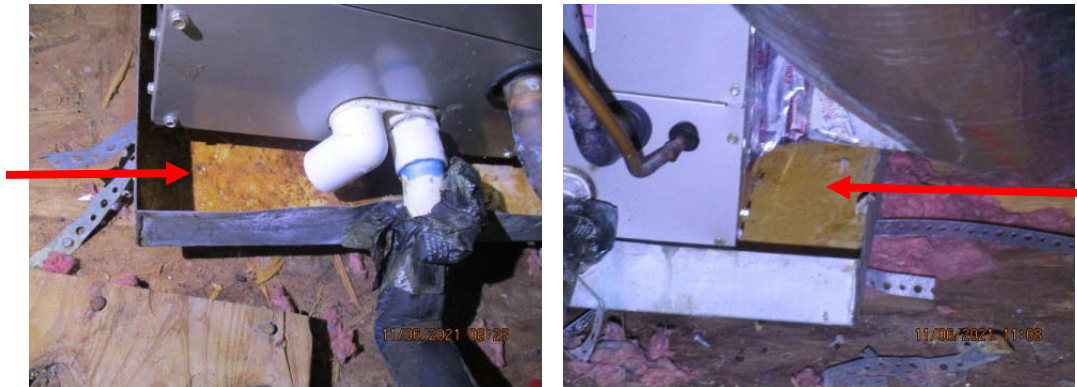
Rust was observed in the secondary drip pan. This is an indication of previous/existing condensation leaking from the primary drain pan. Due to not knowing the extent of the rust damage it is recommended that the pan be replaced.

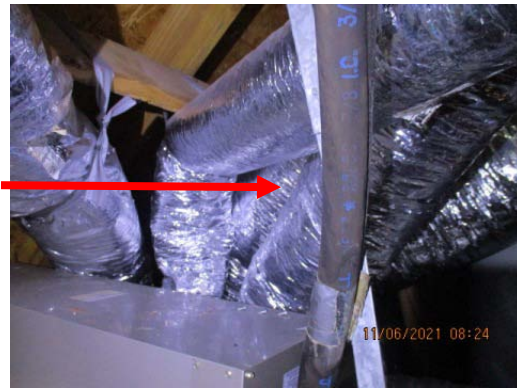
The flex duct was observed to be in direct contact with other pieces of duct in some areas

of the attic. Recommend adding insulation between the ducts or rerouting ducts should be considered to prevent condensation between the ducts.

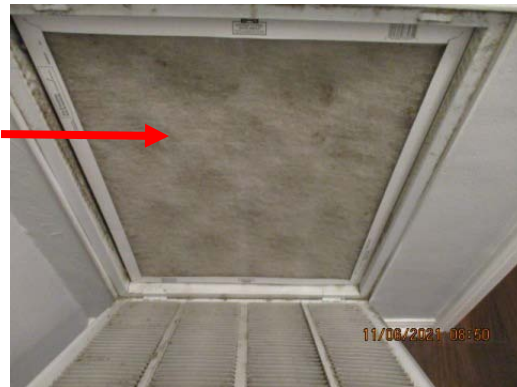
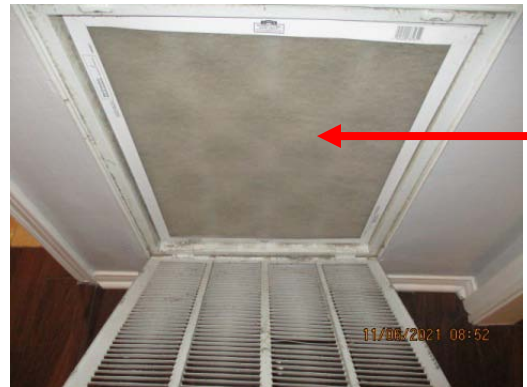
Return air filters are dirty, recommend replacing.

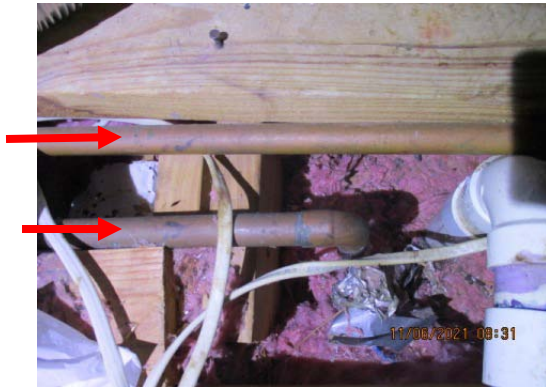
The water supply lines are not properly insulated in all areas of the attic space. Recommend adding insulation.

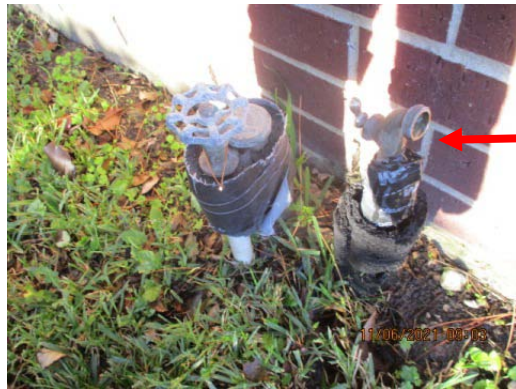
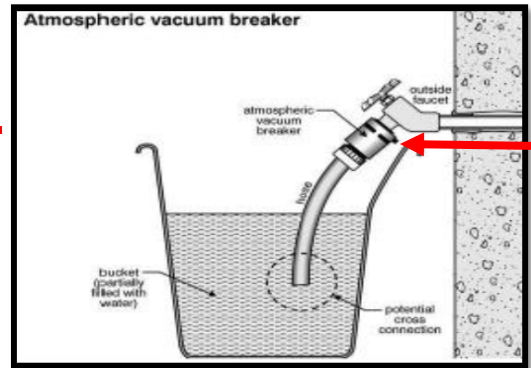
Back flow preventers/vacuum breakers are not installed. Recommend installing to prevent water from backing up into the water system.

The hose bib on the right side of the structure is missing the handle. Recommend replacing.

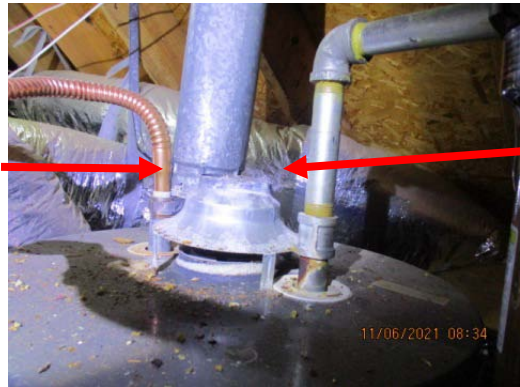
Flue vent for the water heater is not properly strapped. Recommend strapping to prevent shifting & possible moisture penetration.

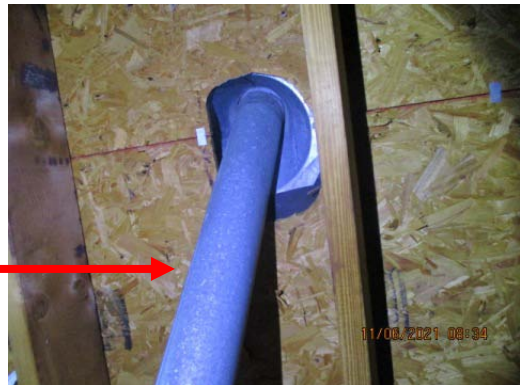
Flue vent for water heater is too close to combustibles where it penetrates the roof decking. Recommend cutting back a minimum of 1".

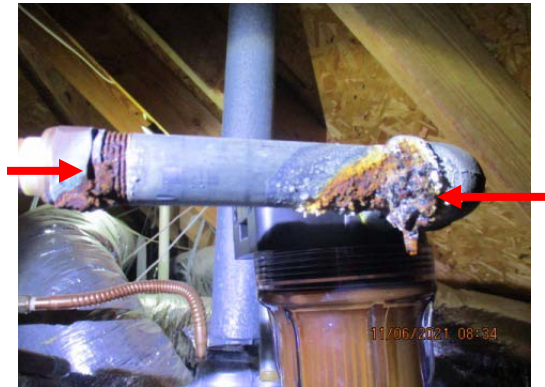
The TPR Valve drain line does not terminate within 6" to grade. TPR Valve drain lines should terminate within 6" to grade and in a safe location to prevent the possibility of injury in the event the TPR Valve were to discharge.

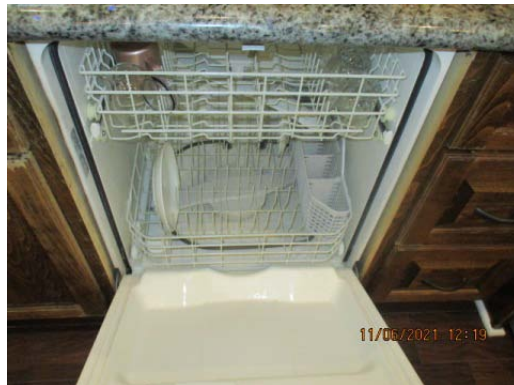
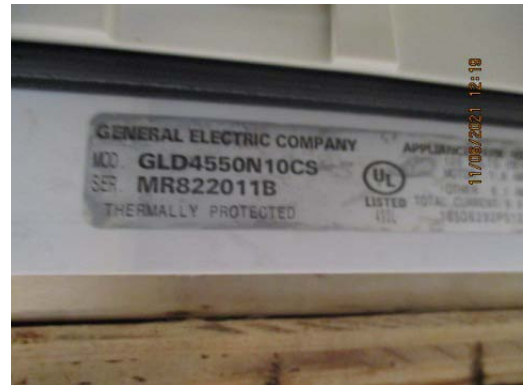
☒ Air gap in the dishwasher drainpipe is not installed, when installed properly the air gap prevents the potential backflow of contaminates from the disposer back into the dishwasher. The dishwasher drainpipe should be secured to the underside of the counter to create an upside down "U" in the drainpipe.

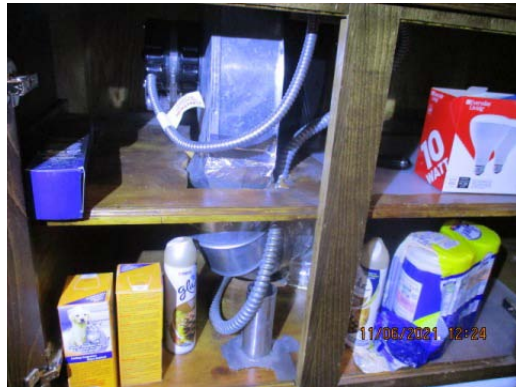
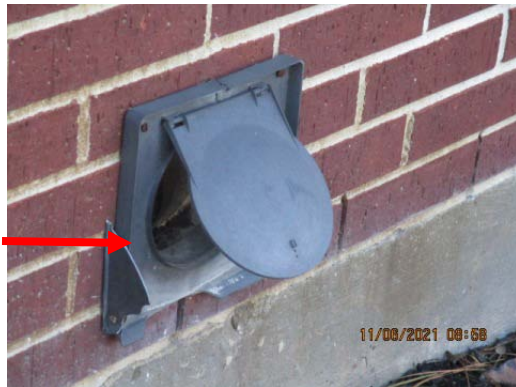
Exhaust vent cover plate is damaged. Recommend replacing.

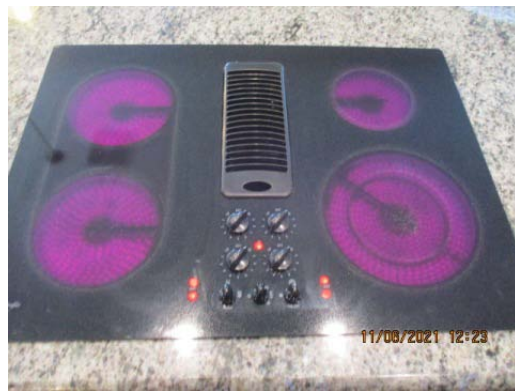
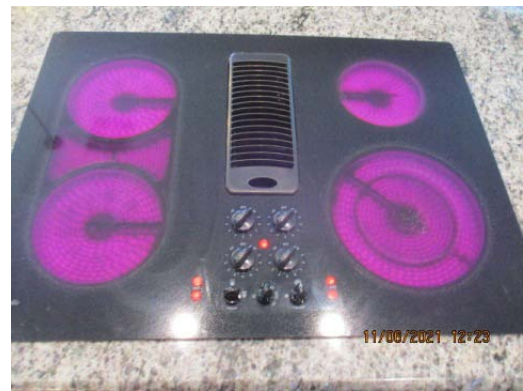
Cook Top: Electric

The cook top was operated and is functioning as intended.

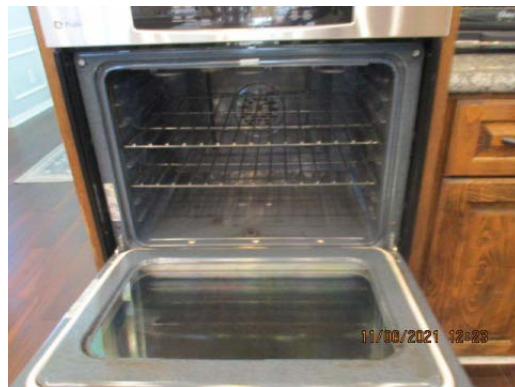
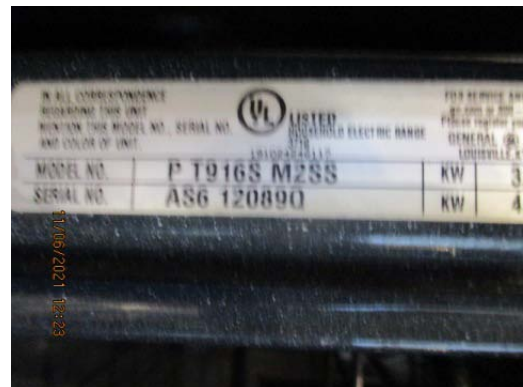
Oven: Electric

The oven was operated and is functioning as intended however there were deficiencies as described below.

The oven light did not function as intended.

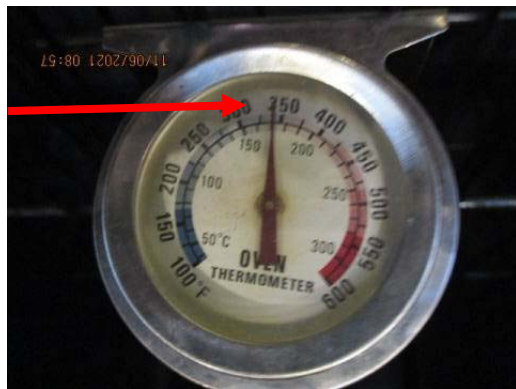
The oven was turned on to 350 degrees and allowed to cycle through the preheat function, a temperature reading was performed and read 330 degrees, a variance of 25 degrees is considered acceptable. Recommend recalibrating the oven to the correct temperature as required.

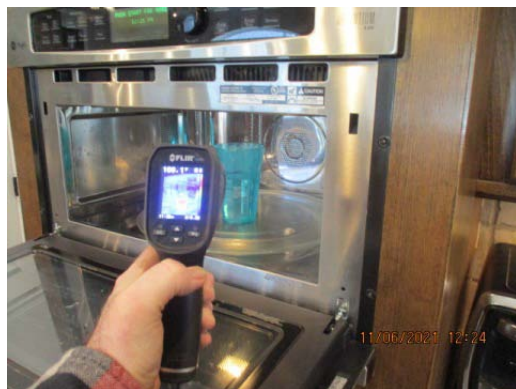
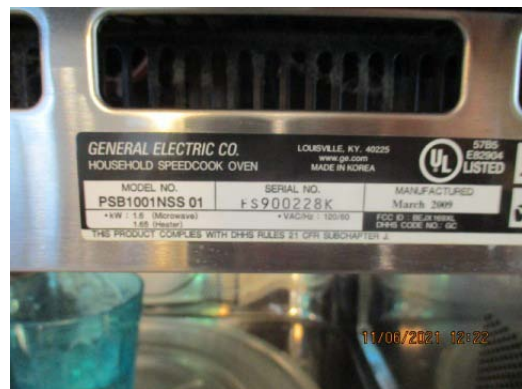
The microwave was operated and is functioning as intended.

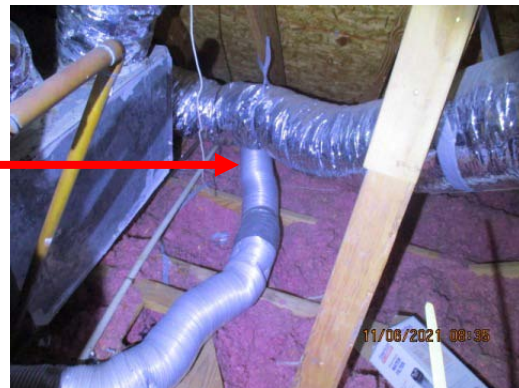
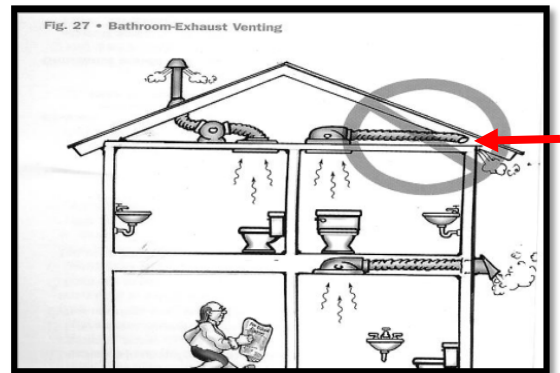
The exhaust vents are functioning as intended however there were deficiencies as described below.

Bathroom exhaust vents are vented to the soffit and not through the roof deck or exterior wall as required.

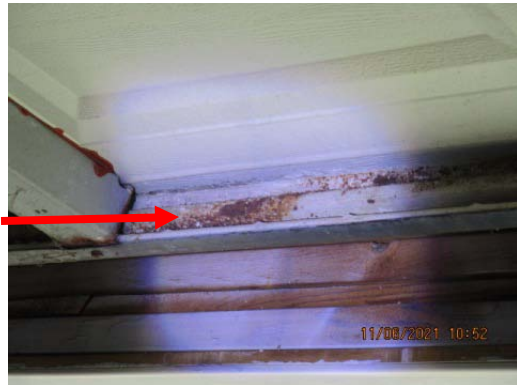
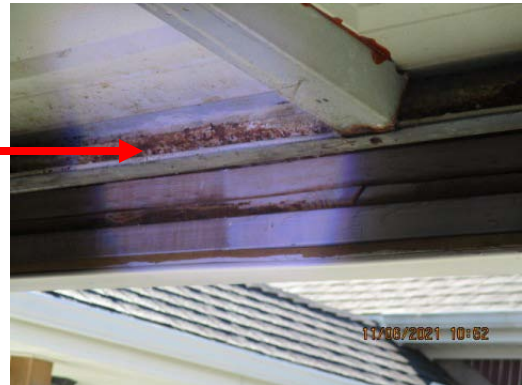
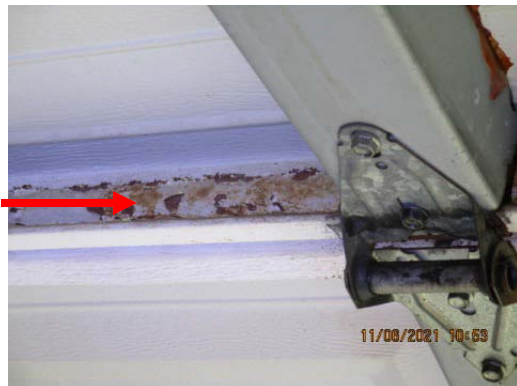
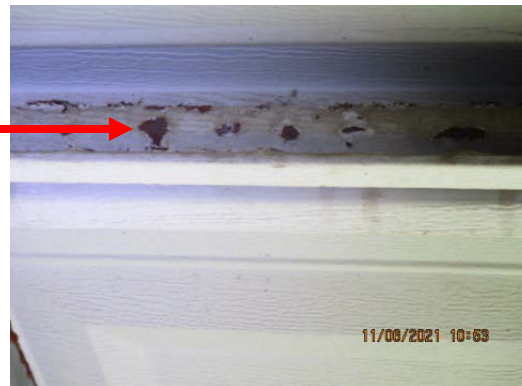
The two lower garage door panels showed signs of rusting. Recommend replacing.

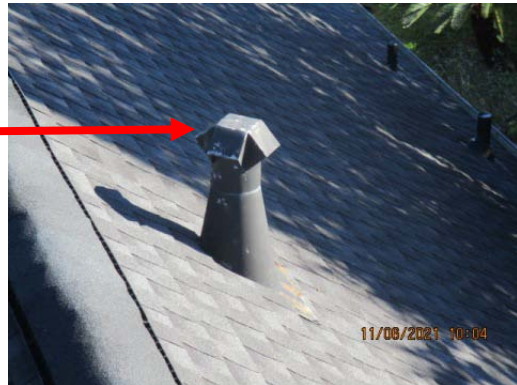
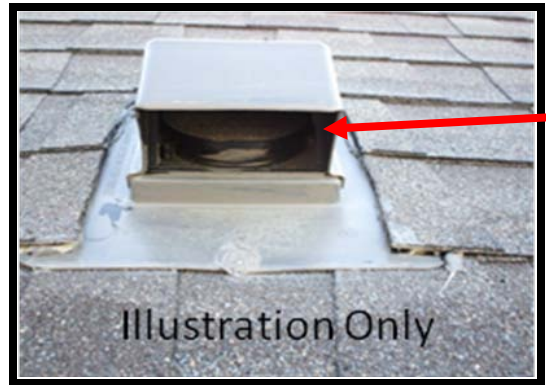
The dryer duct termination at the roof line is the wrong type for today's standards. The dryer duct should be fitted with a closeable gravity or automatic damper (a back draft damper). A screen may not be installed at the duct terminus, as it can trap debris, which poses a fire hazard.

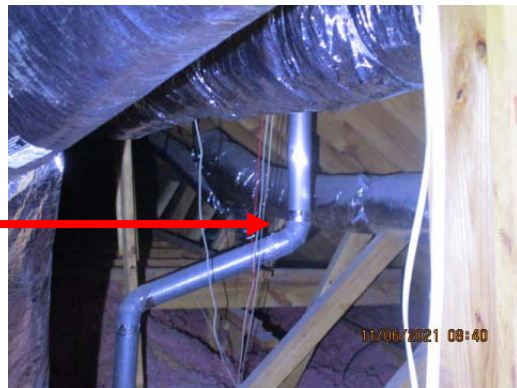
Dryer vent in the attic appeared to be dirty/filled with dryer lint & is dumping dryer lint into the attic space. This may be a potential fire hazard & should be properly cleaned.
