MOLD & MOISTURE INSPECTION REPORT

DATE: 01/20/2022

**PROPERTY: 10410 Gerlach St
Houston, TX 77034**

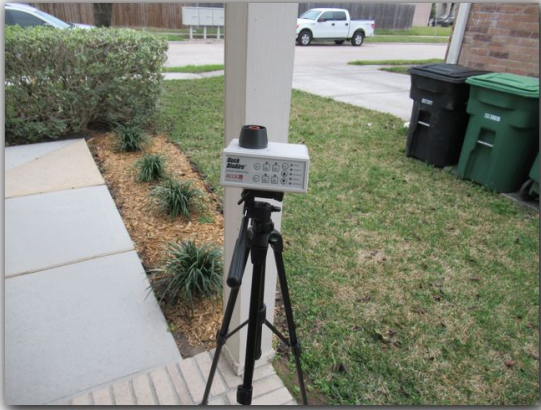
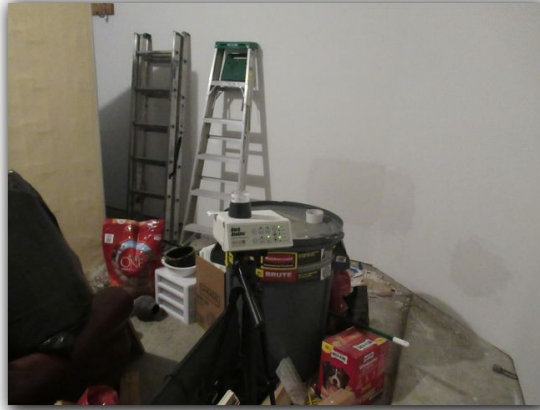
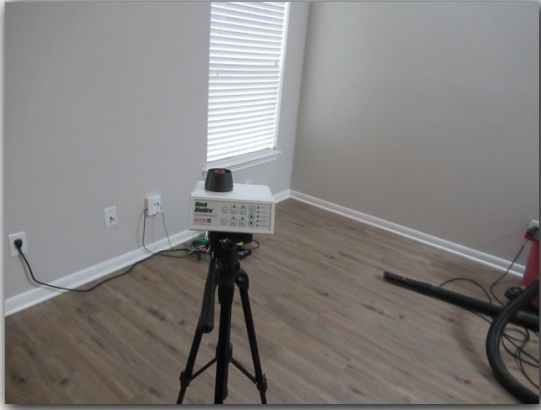
Two samples were taken inside the building/house and one was collected as a control/base sample. Samples were taken at the front (exterior) porch, the garage and the family room.
