November 18, 2021

PROPERTY INSPECTION REPORT

Concerning: 1519 Prince Street, Houston, TX 77008
(Address or Other Identification of Inspected Property)

By: Kyle Coats, Lic #22450 11/18/2021
(Name and License Number of Inspector) (Date)

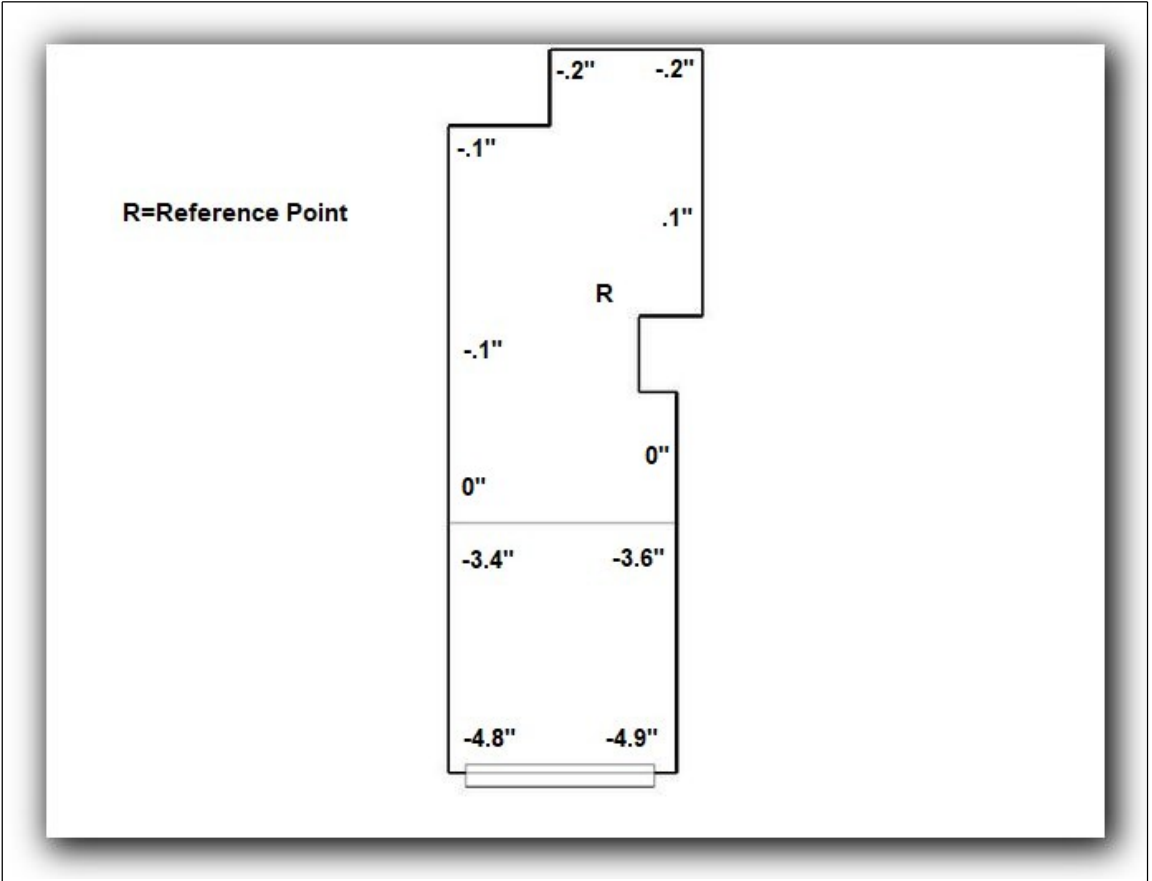
The below graph reflects measurements taken during the inspection to assist with determining the performance of the foundation. The outline / drawing is not to scale and does not accurately reflect every detail of the foundation walls.

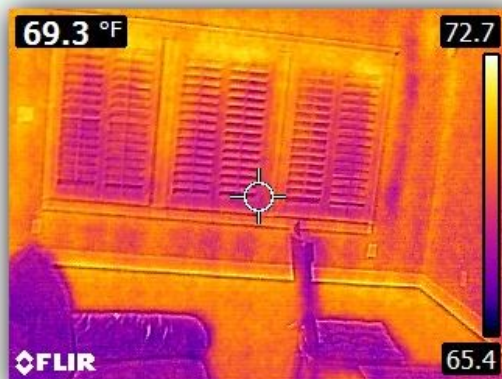
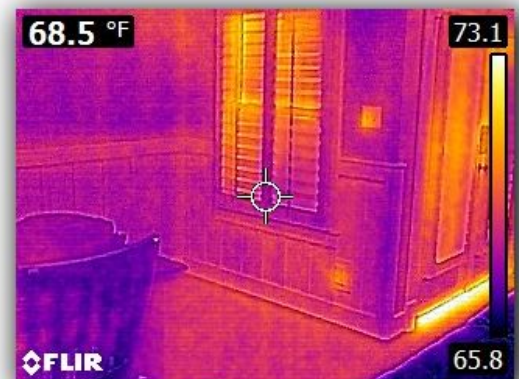
During the inspection of the interior walls of the structure with a infrared camera abnormalities were not noted. The picture(s) below are a sampling of some image(s) taken during the inspection.

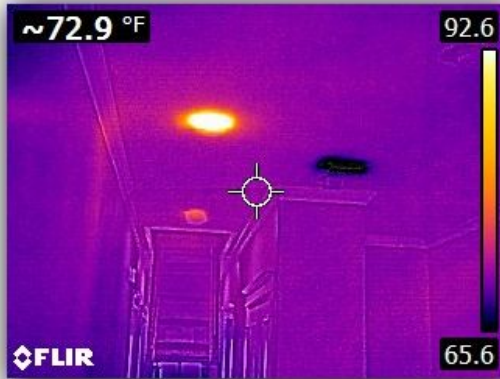
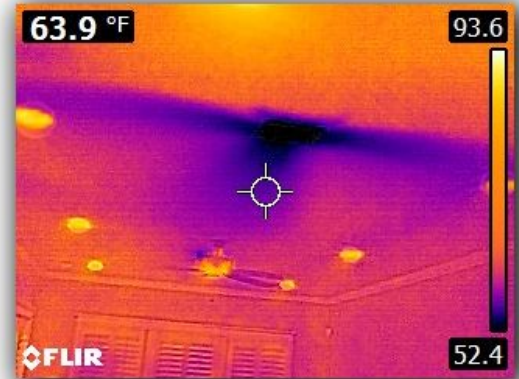
During the inspection of the ceilings on the interior of the structure with a infrared camera abnormalities were not noted. The picture(s) below are a sampling of some image(s) taken during the inspection.

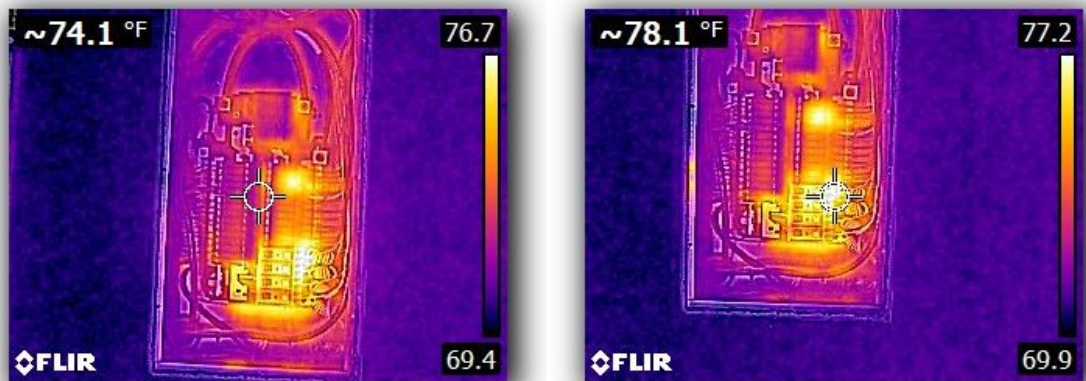
During the inspection of the electrical panel with a infrared camera significant abnormalities were not noted. The picture(s) below are a sampling of some image(s) taken during the inspection.

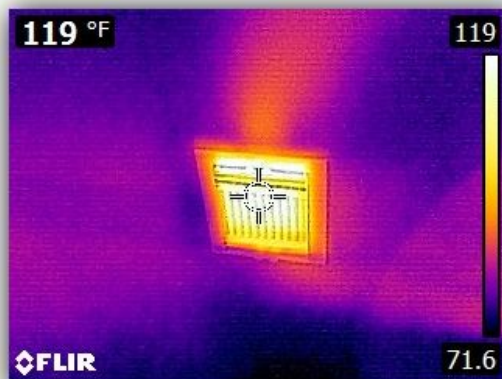
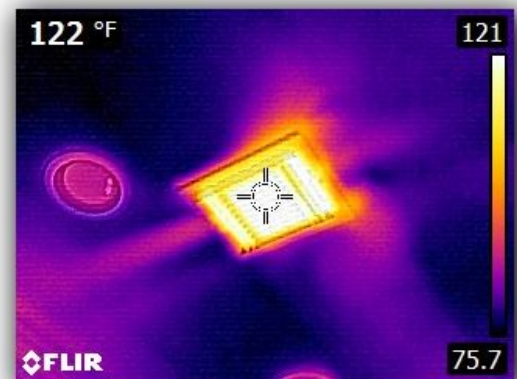
At the time of the visual inspection, the furnace was performing its intended function. However, the heat exchanger within the furnace is not visible & was not inspected. Yearly inspections of the heat exchanger and servicing of the furnace should be performed by a licensed HVAC technician to keep the system in good working order.

☒ Sediment leg not installed at gas line

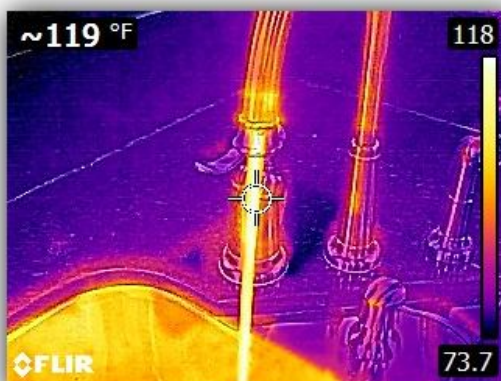
The hot water heater was functional at the time of inspection. The unit should be drained and flushed periodically to eliminate chemical deposit buildup. Adjust temperature to a maximum of 120 degrees to prevent scalding.

- ☒ Sediment trap not installed at gas line
- ☒ T & P valve terminates too high at exterior of property - >6"

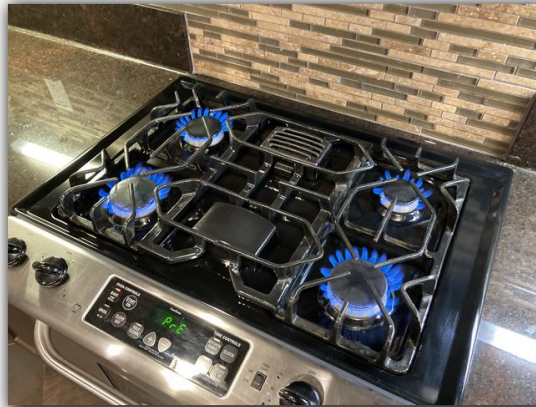
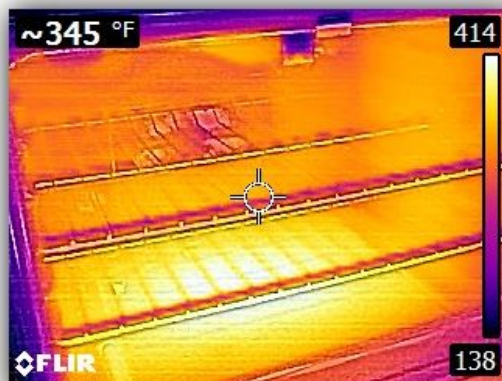
Oven Temperature Measured When Set at 350 Degrees F = 345

☒ The gas valve for the range and / or oven is not accessible.
