**Property Address: 28435 Eli Eagle Street
Katy, TX 77494**

PROPERTY INSPECTION REPORT

Type of inspection: Pre pour foundations
Year Built: 2021 / Builder,
Weather condition: Mostly cloudy,
Approximate Temperature Range: 65 Degrees Fahrenheit
Customer was present at the time of inspection.
Start Time / Date of Inspection: 7:25 AM on March 23, 2021

Type of property: Single Family Dwelling
Year Built: 2021 Builder,
Weather condition: Partly cloudy,
Approximate Temperature Range: 80 - 85 Degrees Fahrenheit
Customer was present at the time of inspection.
Start Time / Date of Inspection: 8:45 AM on October 26, 2021

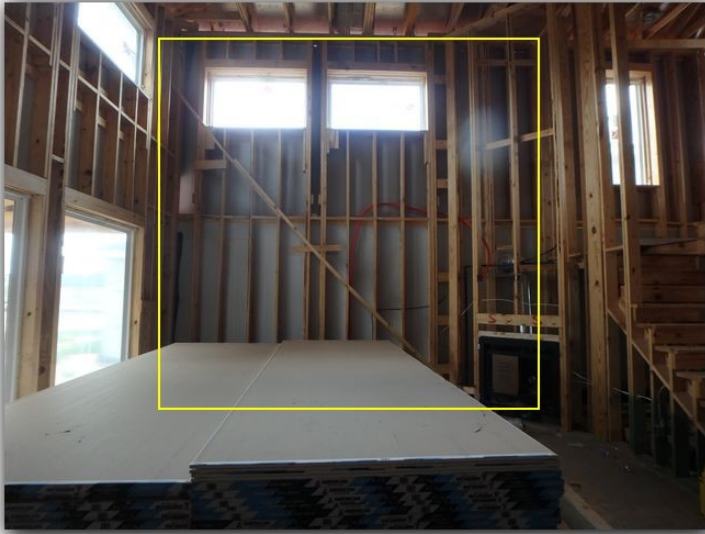
Wind storm brackets: The hurricane / wind storm brackets were not installed.

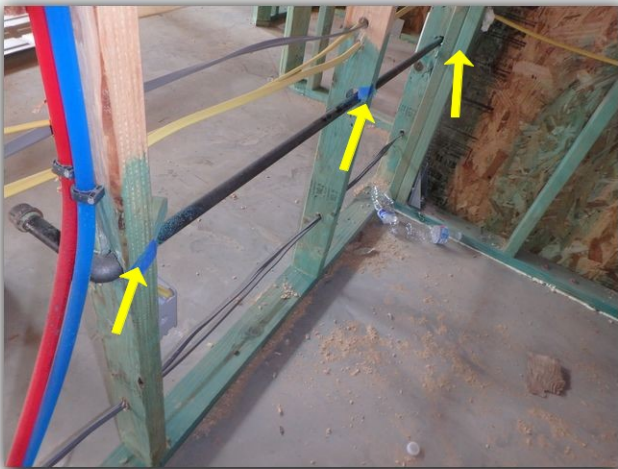
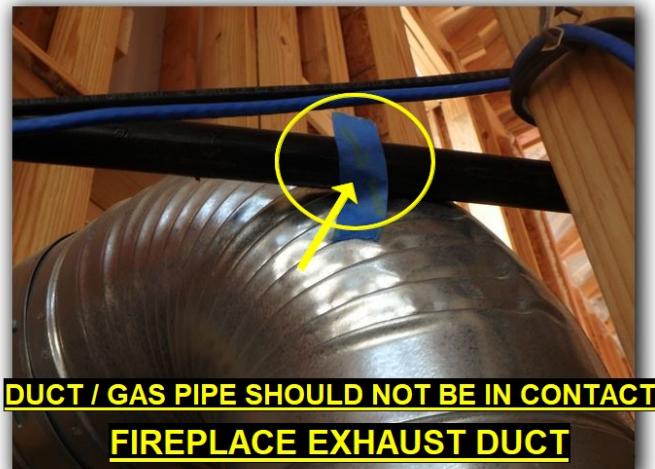
Electrical wires in contact with gas pipes: Insulate / install sleeve in kitchen for cook top gas pipes, and in fireplace area.

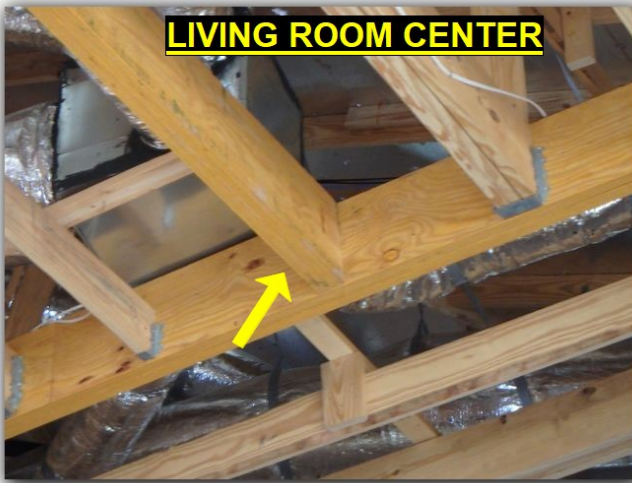
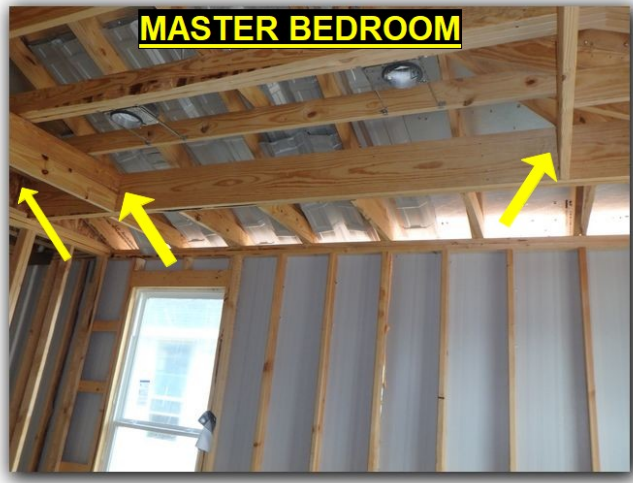
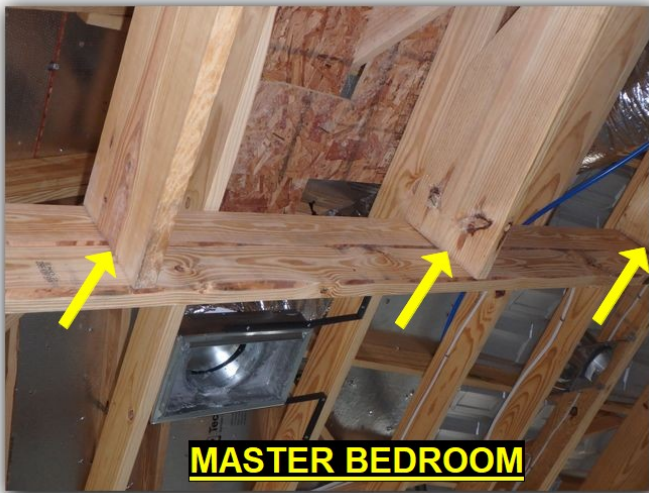
Joist hangers: To be installed at living room mid section ceilings on large beam on kitchen side, master bedroom large joists and connected hanging elements.

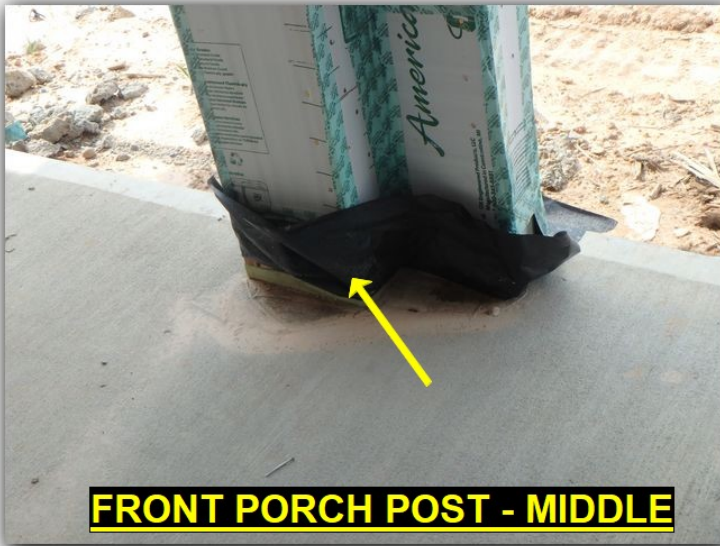
Front Porch post: Center post: The post bottom to be anchored to concrete floors.

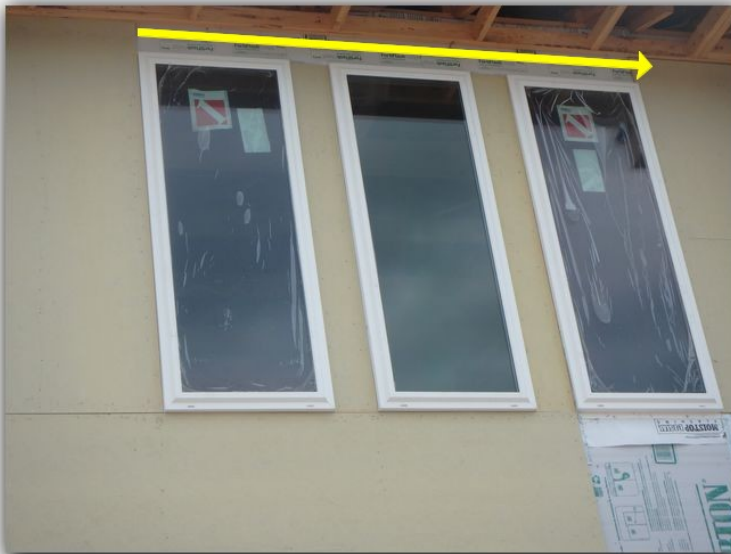
Windows: Flashing: Exterior side headers: Flashing to be installed on some windows, such as on front, and back side patio areas.

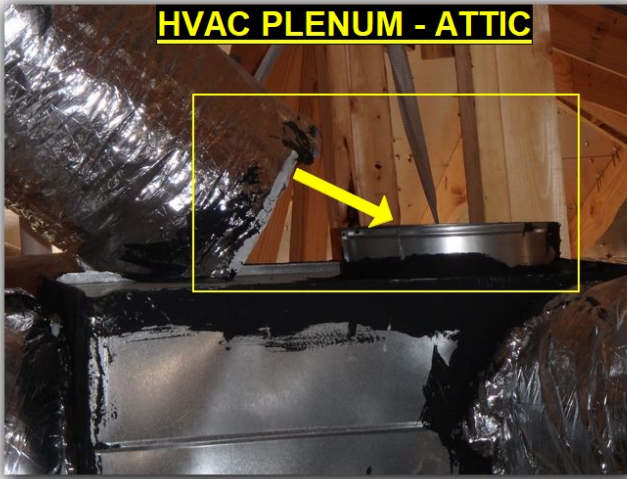
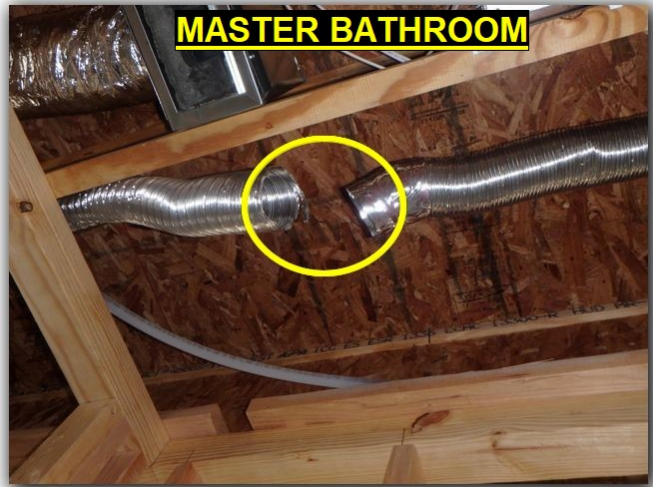
Air ducts at HVAC plenum: Attic: The hanging air duct to be connected to plenum.

Exhaust blower duct: Master bathroom: Securely connect the exhaust duct.

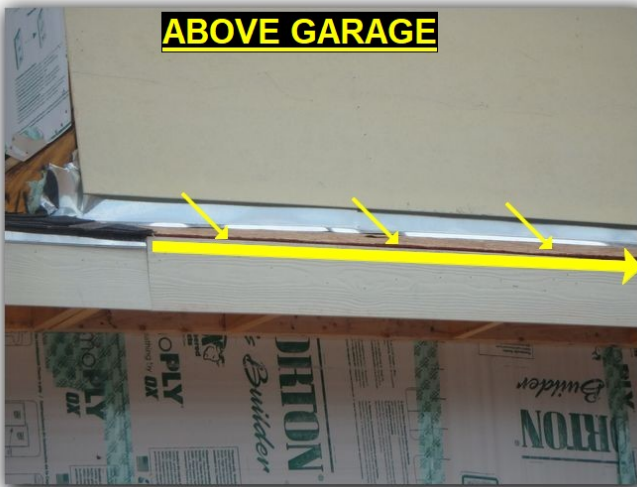
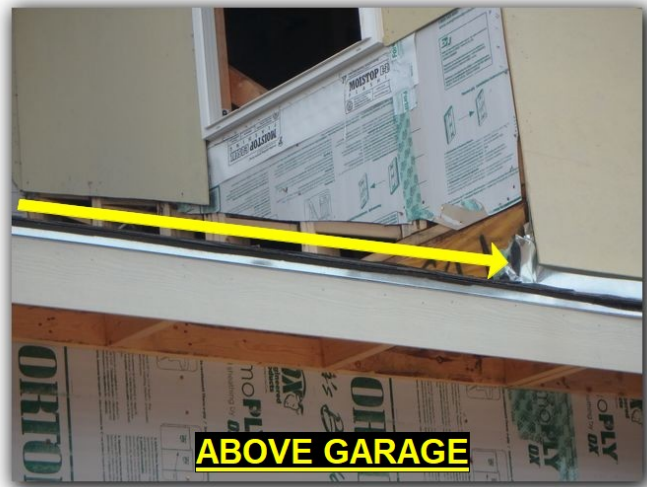
Flashing at roof drip edges: Garage roof right side:

Flashing / Structural sheathing: Above garage: Right side: To be completed as per this construction phase

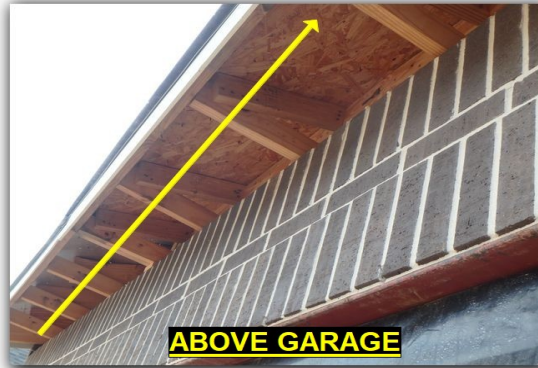
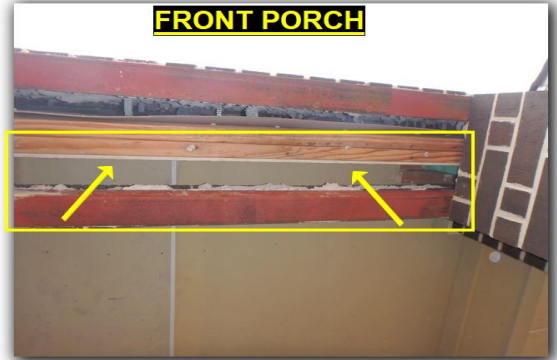
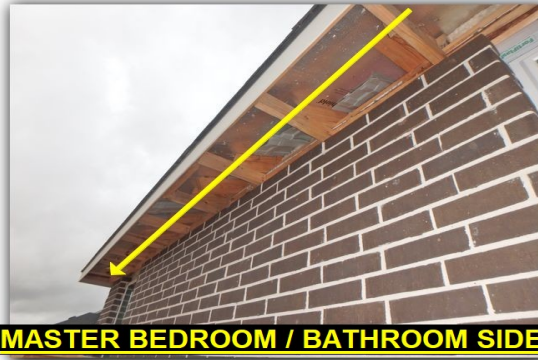
Comments: Soffit boards: Install soffit boards at garage front, front porch, and on back side at patio and master bedroom exterior areas.

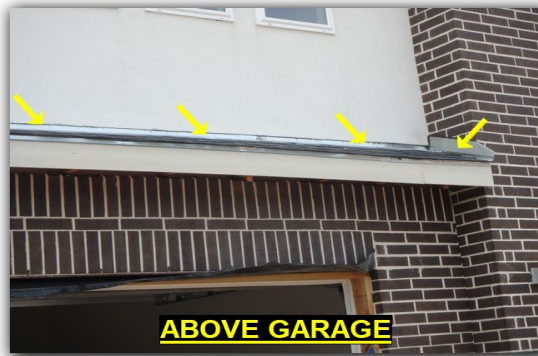
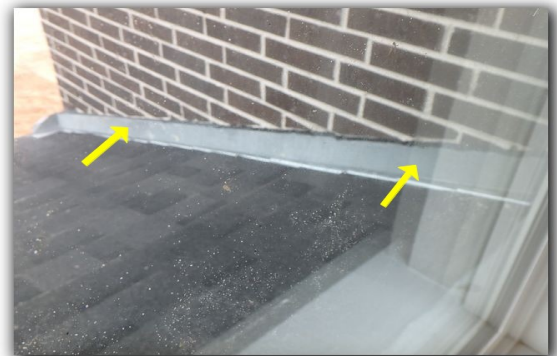
Flashing: All flashing to be painted, such as at window headers, and on roof coverings at drip edges, and at roof / wall joints.

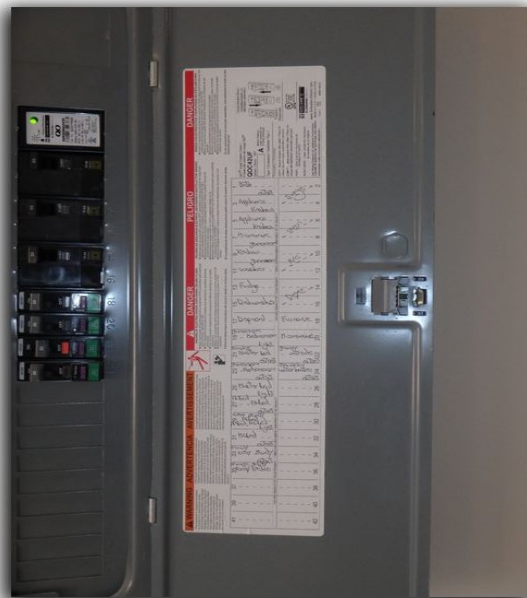
No such certificate was posted on or in the garage Electrical Distribution Panel.

A permanent certificate need to be completed and posted on or in the Electrical Distribution Panel by the builder or registered design professional. The certificate shall not cover or obstruct the visibility of the circuit directory label, service disconnect label or other required labels. The certificate shall list the predominant R-values of insulation installed, and also the U factors and SHGC (Solar Heat Gain Coefficient) for fenestration.

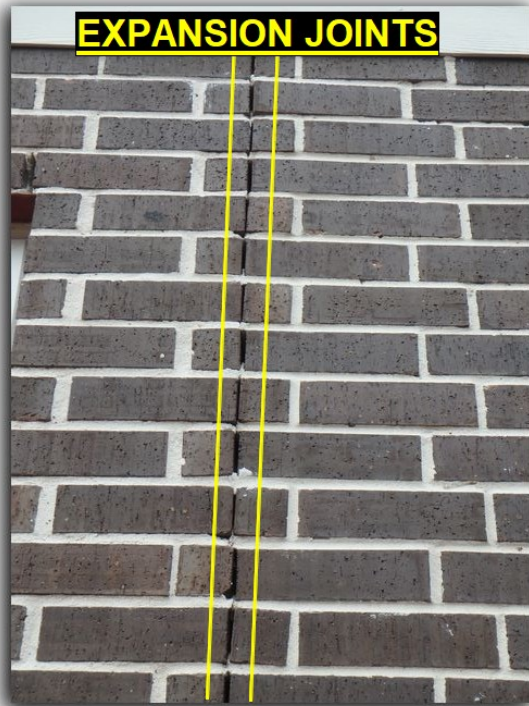
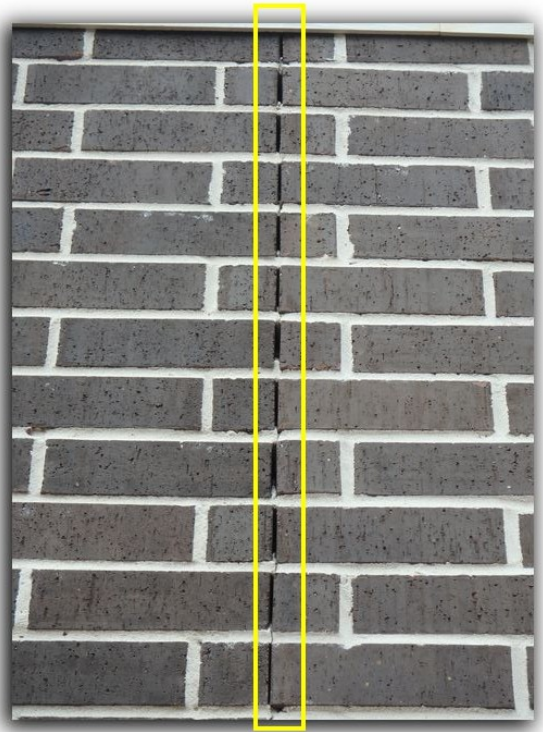
Brick veneer: Expansion joints: Both sides expansion joints to be caulked. :

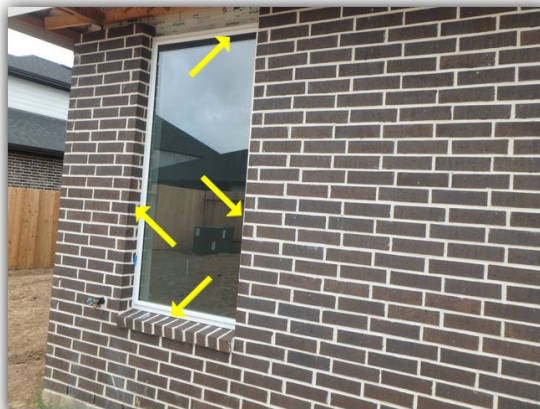
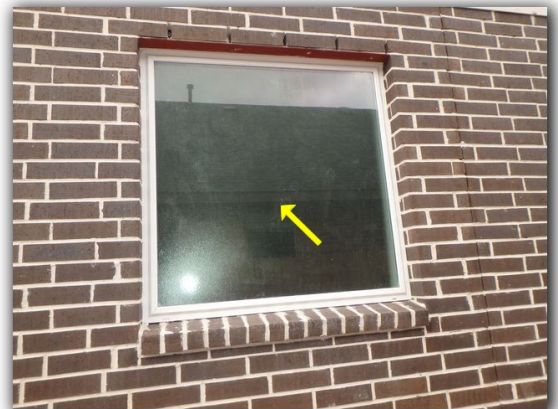
Window frames with exterior walls: All window frames / brick veneer to be caulked as needed.

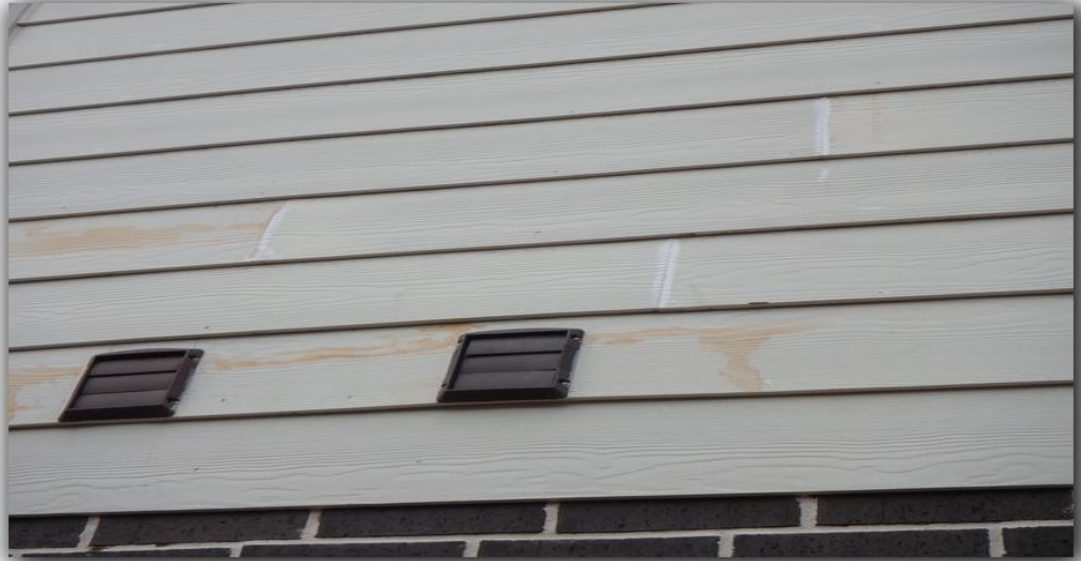
Cement Boards: Most sidings need to be painted as needed.

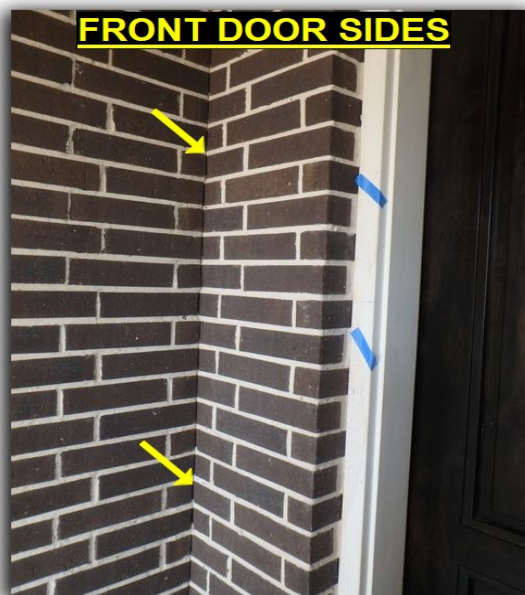
FRONT DOOR SIDES

Front porch: Brick veneer / wall corner joints to be caulked as needed.

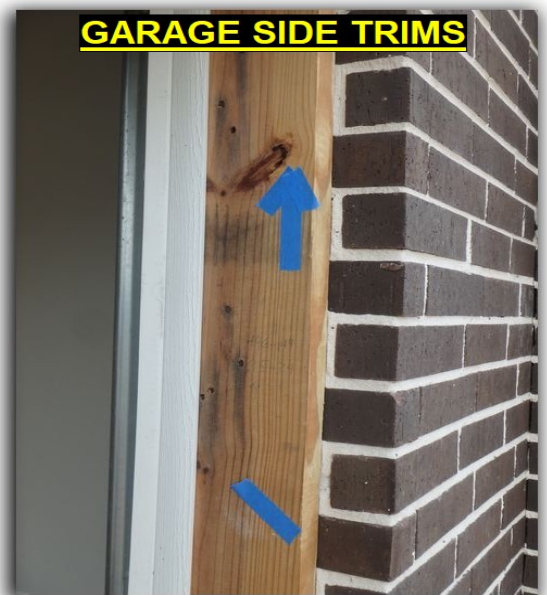
GARAGE SIDE TRIMS

Garage front sides: Trims to be painted / caulked as needed.

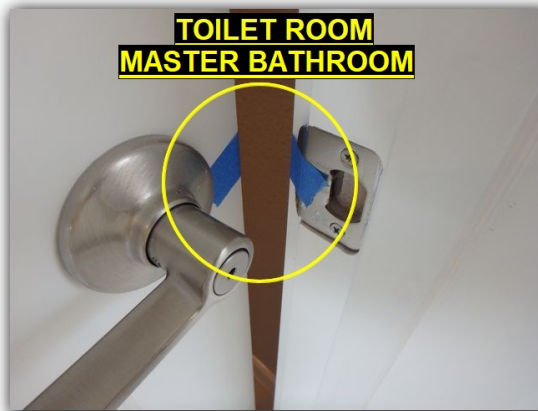
Master bathroom: Toilet room: The door latch was not operating as intended.

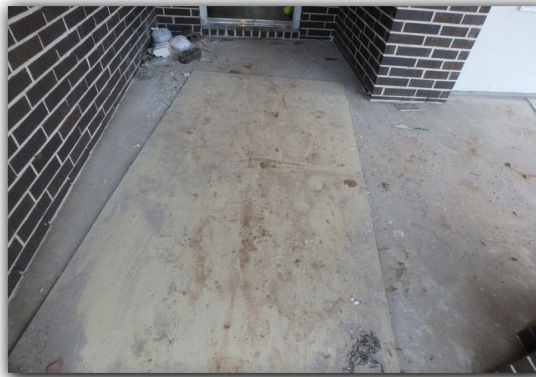
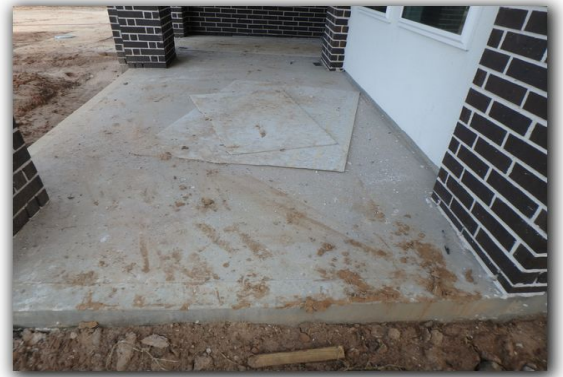
Comments: Front Porch: No significant deficiency was observed.

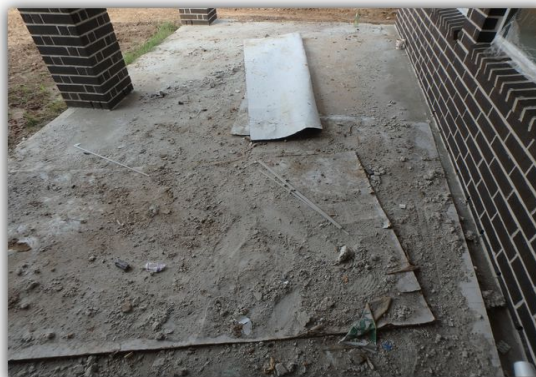
Patio: The patio floors need to be cleaned. The concrete blocks could not be observed for cracks.

The patio floors need to be cleaned. The concrete blocks could not be observed for cracks.

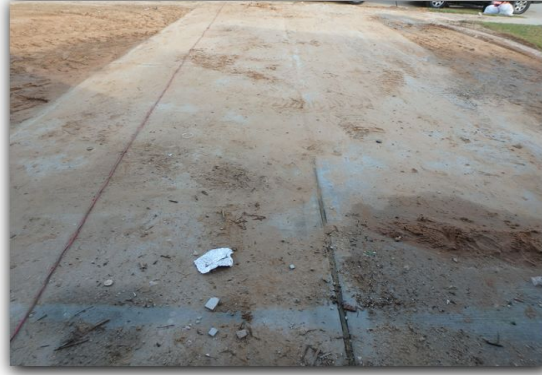
Drive Way: The drive way need to be cleaned. The concrete blocks could not be observed for cracks.

The drive way need to be cleaned. The concrete blocks could not be observed for cracks.

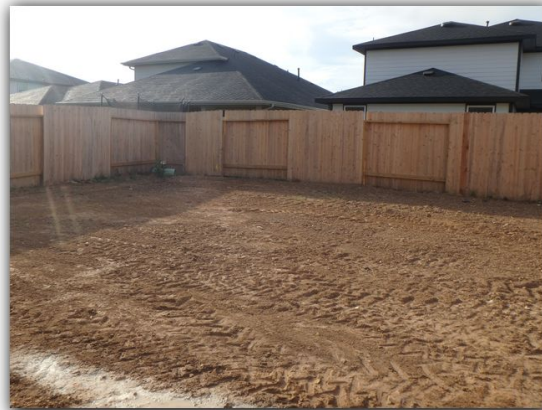
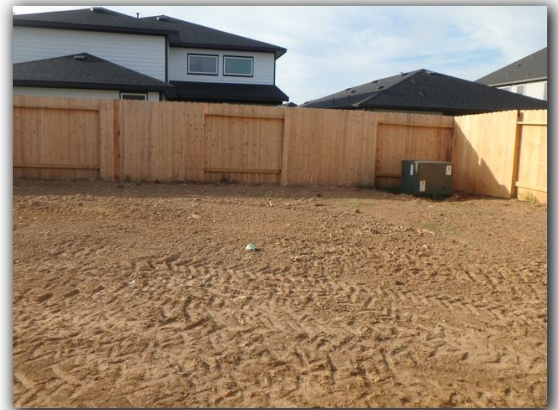
Fence: No significant deficiency was observed.

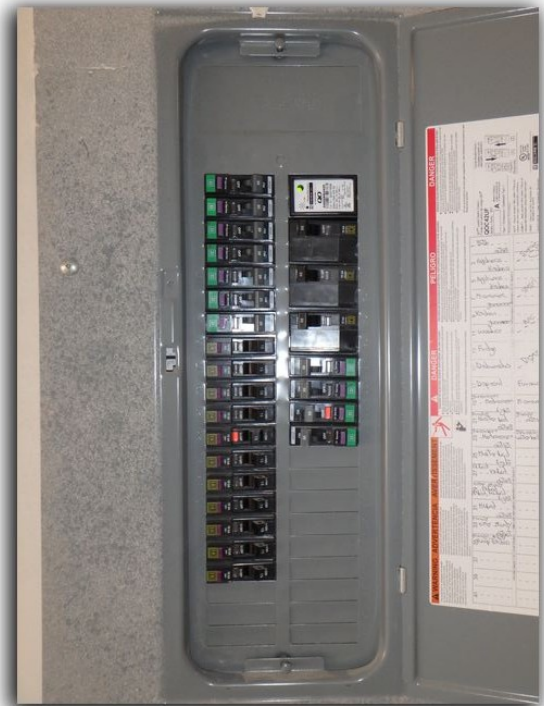
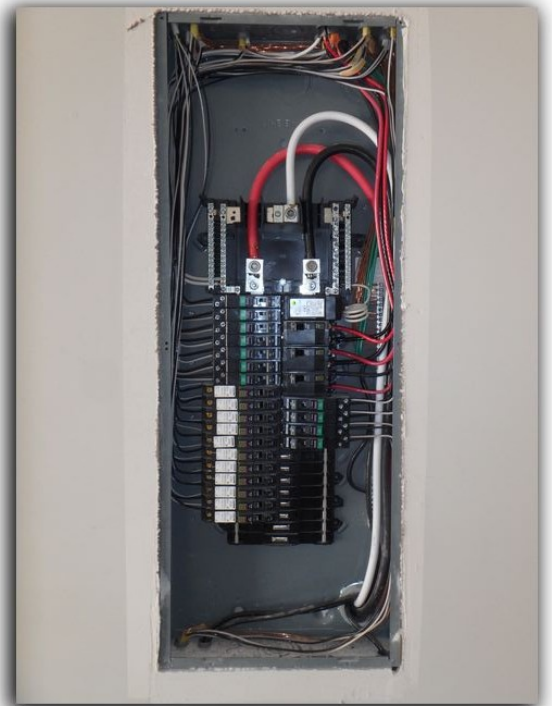
Electrical Service Panel: Make: SQUARE D

Location: Inside Garage: Left side wall.

The electrical service panel was rated for 200 AMPS.
Main Disconnect - Circuit Breaker was 200 AMPS.
Maximum circuit breaker rating was 50 AMPS.

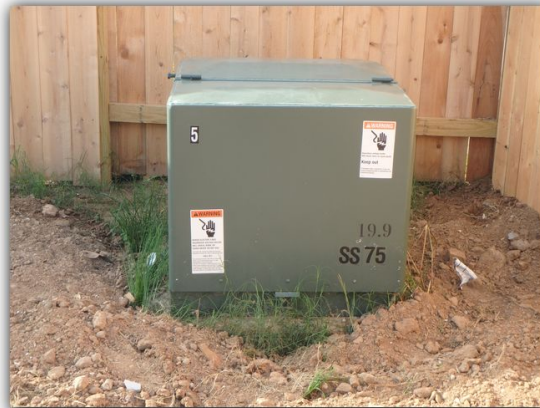
Underground High Voltage Electric Cables: Back yard right corner: For safety of children, please make a soft barrier around the high voltage under ground cable enclosure to prevent children playing near it.

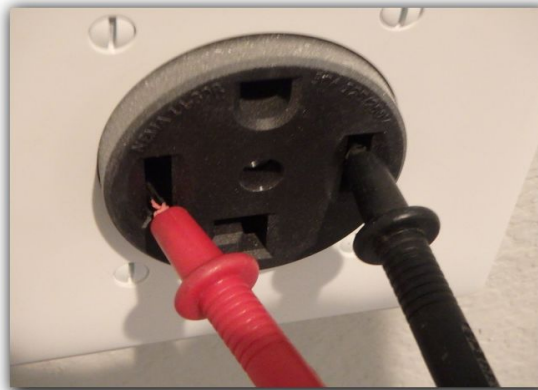
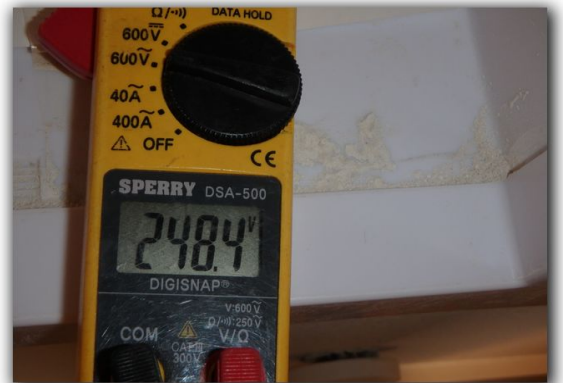
Clothes Dryer Power Receptacle Outlet: Was wired with four pin connections, fourth wire as the dedicated ground as intended.

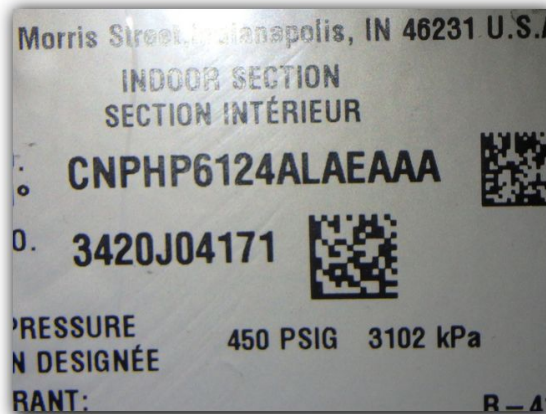
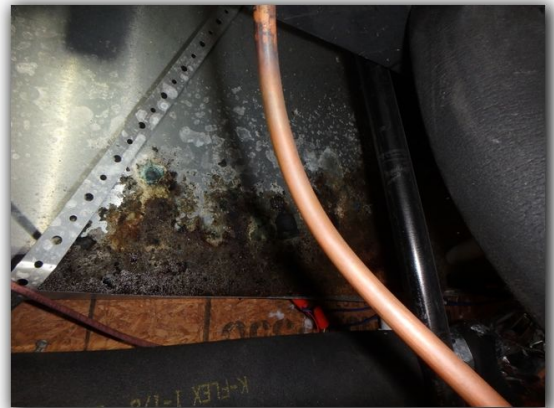
Secondary drain pan: The drain pan was significantly corroded. Also cool air was leaking from the front bottom edge near the primary drain pipe. To be further diagnosed and repaired by a licensed HVAC contractor.

Cooling Equipment: Secondary drain pan: The drain pan was significantly corroded.. Also cool air was leaking from the front bottom edge near the primary drain pipe. To be further diagnosed and repaired by a licensed HVAC contractor.

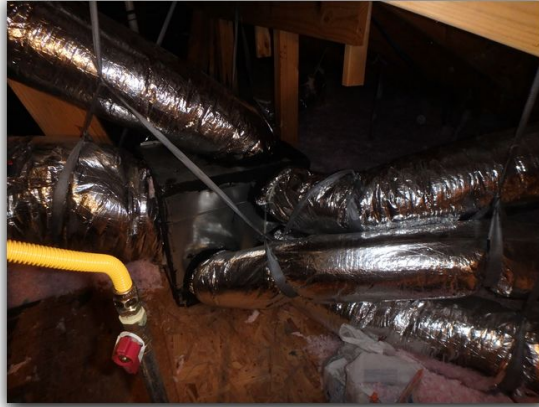
Second floor registers: Install the missing grille where required.

Clean the registers from clogged insulation in second floor front left bedroom / closet.

Duct Systems: Second floor registers: Install the missing grille where required.

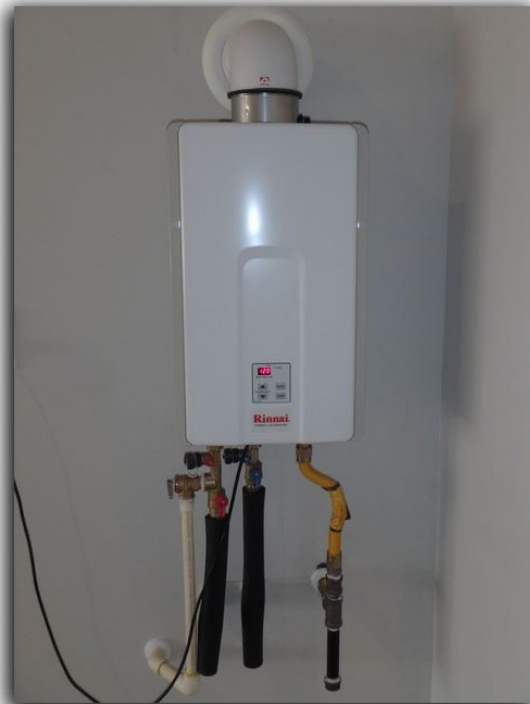
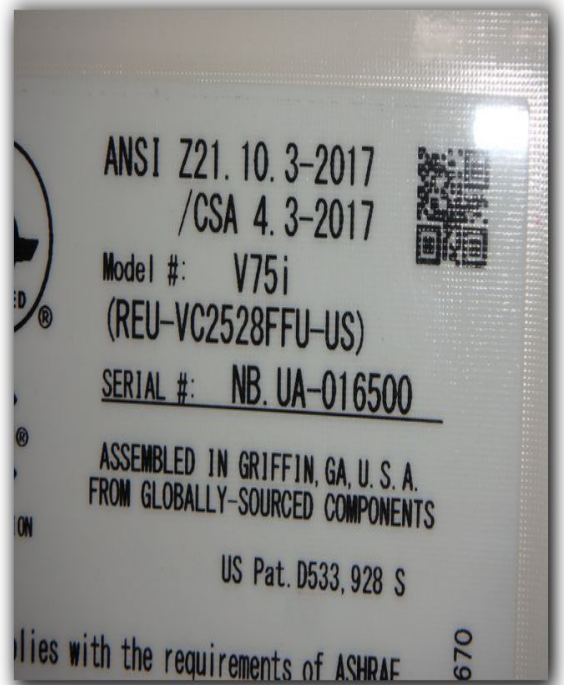
Comments: Make: RINNAI

MFG DATE: February 2021

Temperature and Pressure Release valve: The TPR valve was operational.

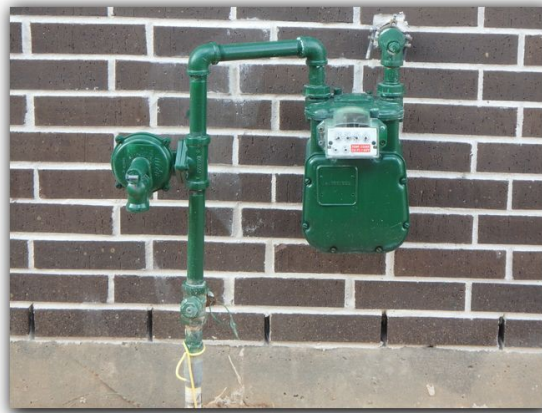
Comments: Gas Meter and Gas Supply: Gas meter was located on side of the house. Natural gas supply was available at the time of inspection.

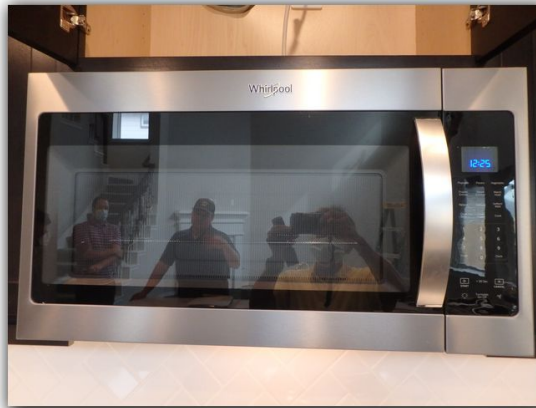
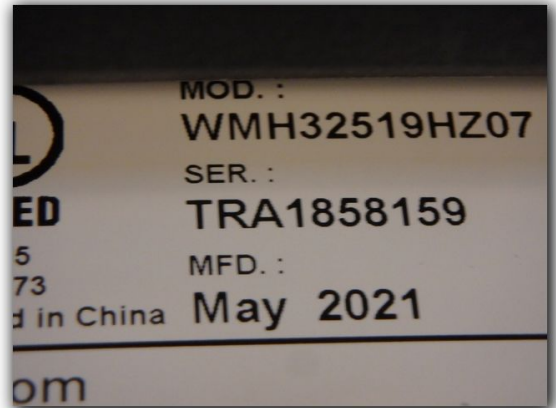
Comments: Microwave Oven: WHIRLPOOL

The unit was operational and was performing the functions as intended.

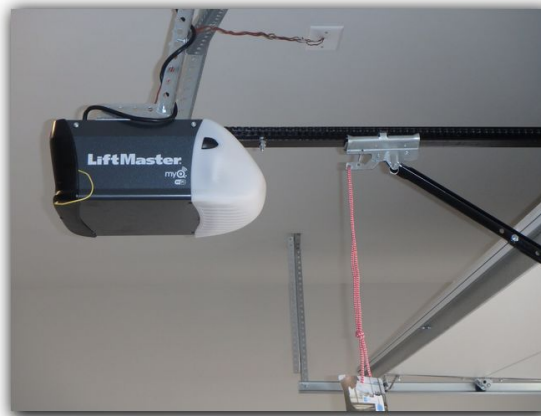
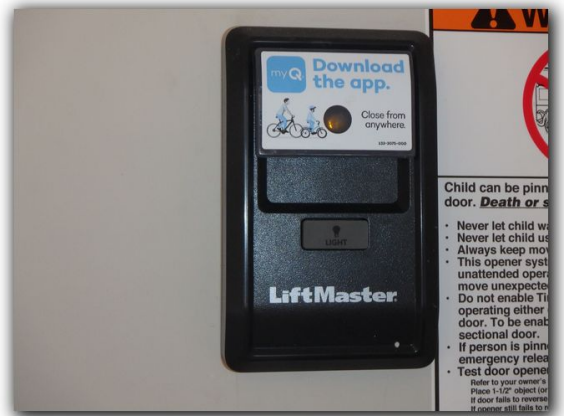
Comments: Make: LIFT MASTER. Number of units: One

The unit was operational and was performing the functions as intended. .

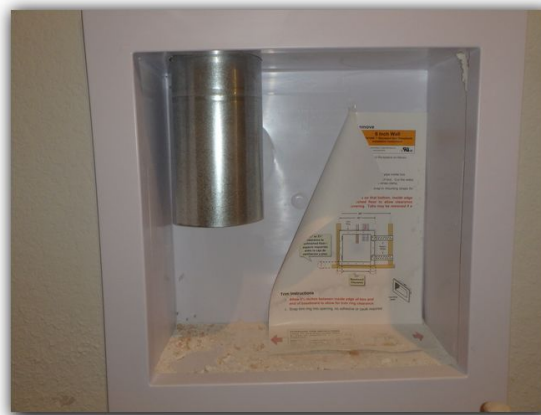
Comments: Dryer Exhaust System: The dryer exhaust system appeared to be installed as intended.
