Property Inspection Report

710 Seaway Dr, El Lago, TX 77586 Inspection prepared for: Corey Garcia

Date of Inspection: 1/8/2022 Time: 10:00 AM

Inspector: James Duke License #21718 Huntsville, TX 77340 Phone: 936-439-5003

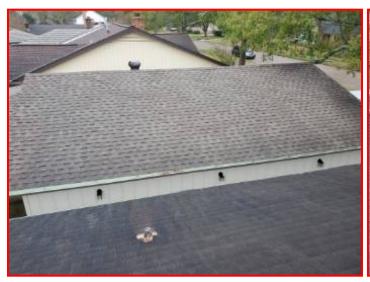
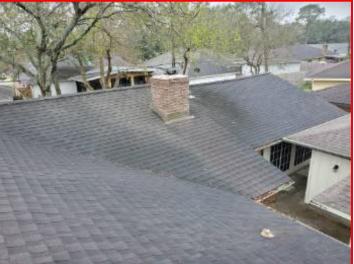
- Recommend all nails, penetrations, flashing be painted and caulked every three to four years. Asphalt or composition shingles have a service life from {15-30} years depending upon the shingle quality, installation and maintenance. Metal roofs tend to have {25-35} year life.
- Repairs noted
- Damaged or missing shingles

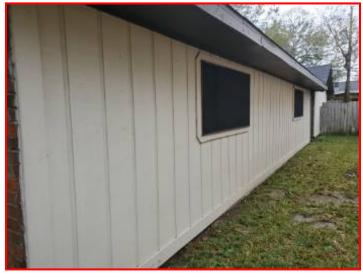
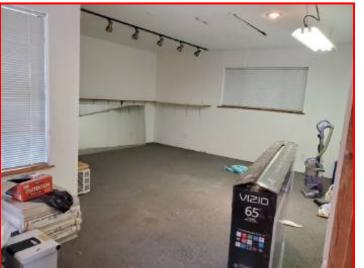
Cracks were noted.

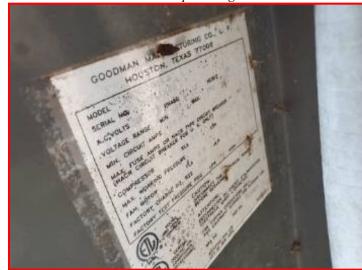
Return temp 64 degrees.

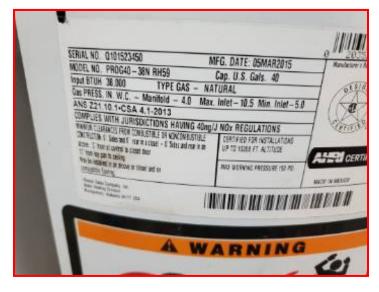
- 40 gallons
 - Comments:
 - Satisfactory condition at the time of the inspection
 - The typical life expectancy and/or operational life of a water heater is approximately {10} years depending on usage and maintenance
