FIG Services LLC d/b/a FOX INSPECTION GROUP  
Property Inspection Report #181102DW-5630 Cheena Drive  
11227 Endicott Lane Houston, TX 77035  
(Office)713.723-3330 (Email) [office@foxinspectiongroup.com](mailto:office@foxinspectiongroup.com)

## ***PROPERTY INSPECTION REPORT***

**Concerning:** 5630 Cheena Drive, Houston, TX 77096  
(Address of Inspected Property)

**By:** David Wagner, 20531 11/02/2018  
(Name and License Number of Inspector) (Date)

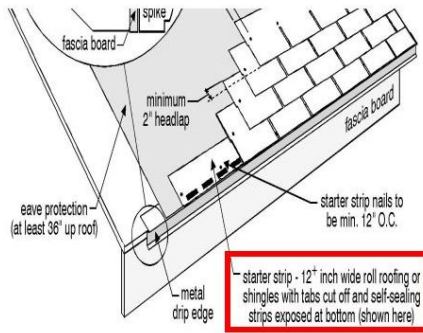
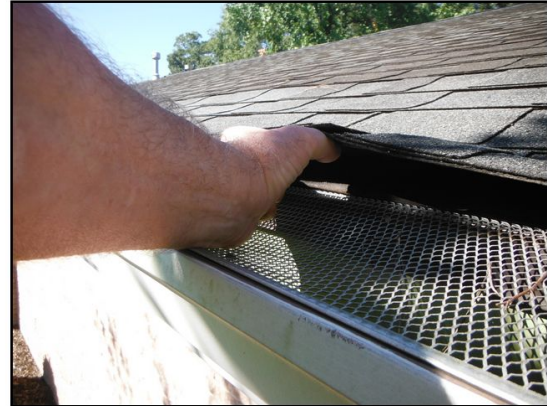
One or more areas of raised shingle tabs from fasteners not secured down properly or nail heads popping up through shingles.

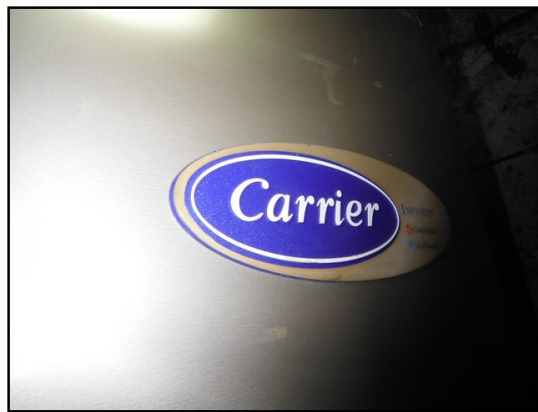
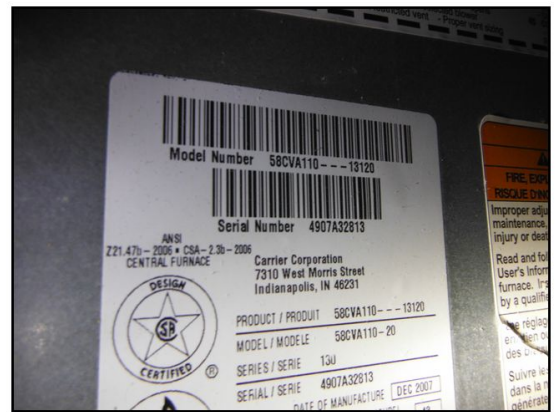
HOUSE HEATER EXHAUST VENT(S):

No significant deficiencies or anomalies observed at the time of inspection.

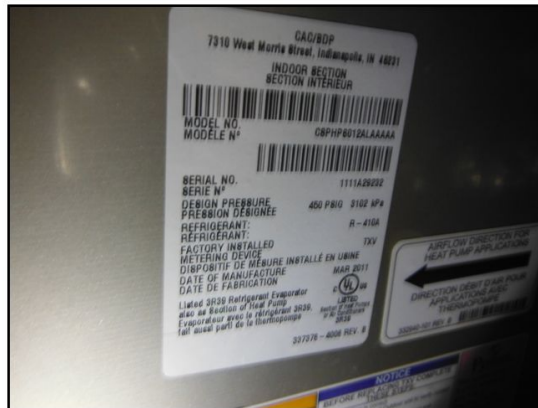
**CONDENSATION DRAIN PAN/DRAIN LINES:**

Missing 90 degree elbow fitting on end of emergency drain line to prevent condensation dripping back onto exterior wall.

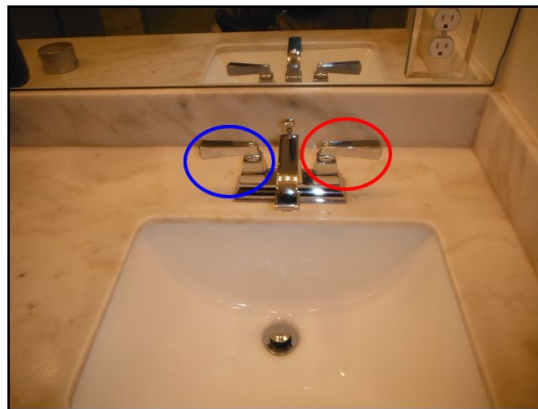
**FAUCETS:**

Hot/cold reversed, Hot water supply to any fixture shall be installed on the left side, Standard Plumbing Code; master right side sink.

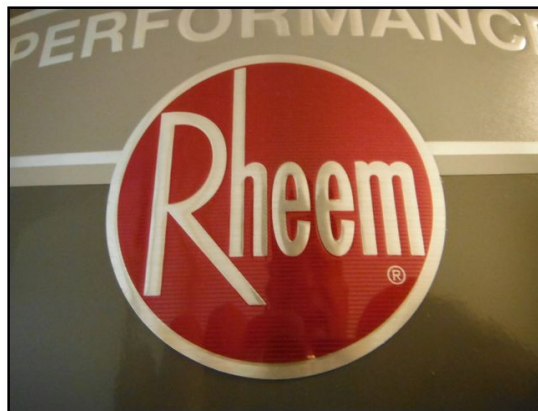
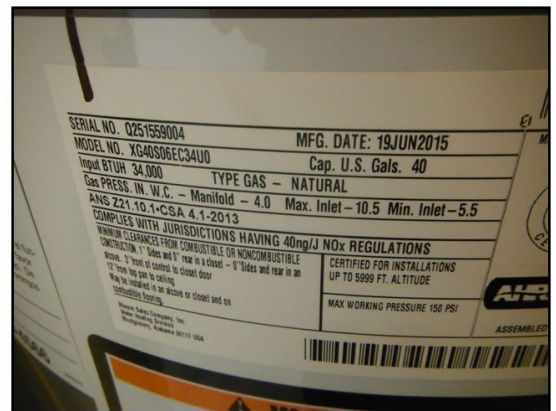
**WATER HEATER EXHAUST VENT(S):**

Reverse slope of water heater vent line, does not tilt upwards, possibly blocking proper venting. Ref. IRC 1803.3 "Connectors shall be installed with a slope of not less than 1/4 inch rise per foot of run."

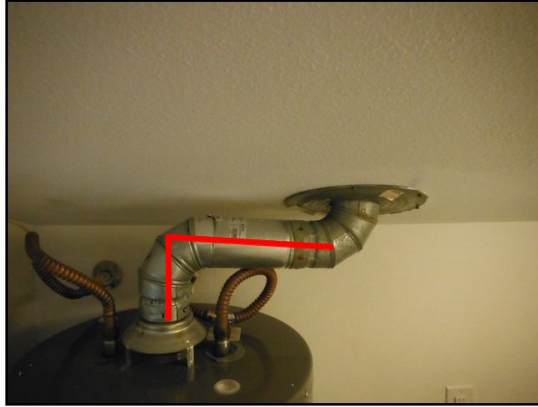
Not all double wall vent pipe connection(s) are properly secured together;

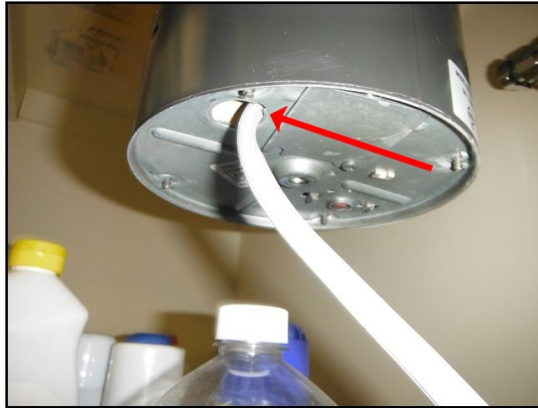
Electrical cord is not secured to base of disposal.
